4th March 2021

St Mary's Church Busselton – Follow-up Tree Assessment

Prepared for: The City of Busselton

Prepared by: Brett Moir

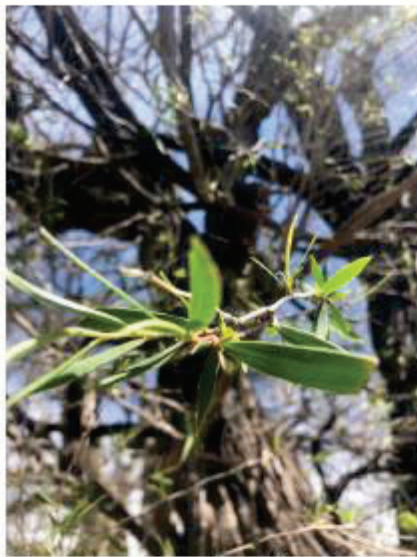
Those trees in poor health condition are exhibiting symptoms of stunted leaf growth with small undersized leaves where leaves exist at all. These symptoms are common when trees have been poisoned with herbicides and also when trees are being over-grazed by possum browsing.

Figure 2: Sparse and stunted foliage

I examined the trunk and buttresses of the trees to inspect for evidence the trees had been poisoned with herbicide and did not find any evidence of drill holes or cuts. I do not believe the trees have been vandalised by poisoning. I observed a large amount of possum scat beneath the trees and I believe the observed poor health condition is largely caused by over-grazing by possums combined with the age of the trees. This is likely exacerbated by the unusually high number of winter storms that occurred in 2020 where many trees in the region were heavily wind and salt scalded.

I have recommended the installation of possum bands to prevent possum's having access to the trees to be retained in order to give the stressed trees a chance to recover from over-grazing. This is meant as a temporary measure and should be re-evaluated in 12 month's time to determine whether tree health has improved sufficiently to allow the removal of these bands.

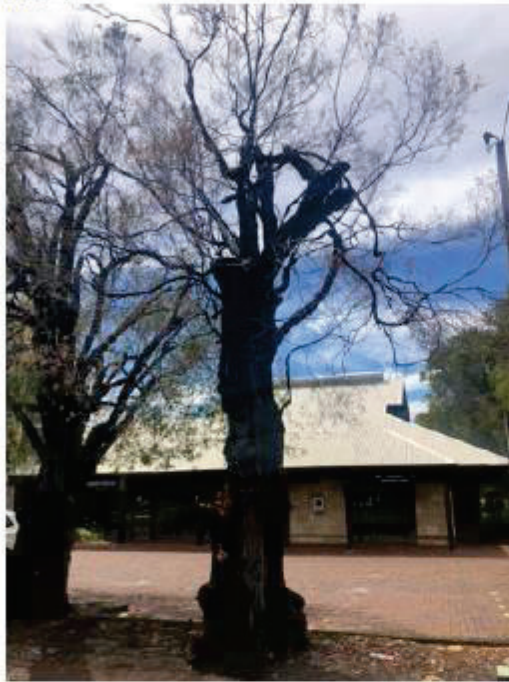
Tree 1

Tree No.	Tree Species	Age Class	DBH m	Height m	Vitality	Structure	Recommendations
1	<i>Agonis flexuosa</i>	Post-Mature	1	10	Fair/poor	Poor	Remove tree
2	<i>Agonis flexuosa</i>	Post-Mature	1.25	12	Fair/poor	Poor	Install through-bolt in lower fork – install possum band
3	<i>Agonis flexuosa</i>	Mature	0.7	10	Fair	Fair	Install possum band
4	<i>Agonis flexuosa</i>	Post-Mature	1.25	10	Fair	Poor	Install possum band
5	<i>Agonis flexuosa</i>	Semi-Mature	0.75	7.5	Good	Fair	Install possum band
6	<i>Agonis flexuosa</i>	Semi-Mature	0.85	7.5	Fair/poor	Fair	Install possum band
7	<i>Agonis flexuosa</i>	Young	0.15	4	Good	Good	Install possum band
8	<i>Agonis flexuosa</i>	Post-Mature	2	10	Poor	Poor	Remove tree
9	<i>Agonis flexuosa</i>	Post-Mature	1.2	10	Poor	Poor	Remove tree
10	<i>Agonis flexuosa</i>	Post-Mature	1.35	10	Poor	Poor	Remove tree
11	<i>Agonis flexuosa</i>	Mature	0.7	7.5	Poor	Fair	Remove tree

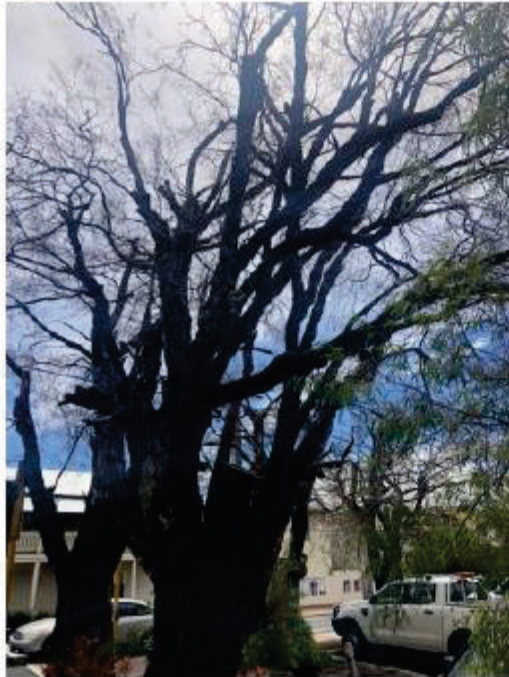
Tree 8

It is apparent that since the previous inspection a number of trees have rapidly declined in health. Trees 1, 2, 8, 9, 10 & 11 are all in Poor health condition with little live foliage.
