## Northern Star Resources Jundee Mine

### W1/2/3 Waste Rock Landform Rehabilitation Monitoring Summary

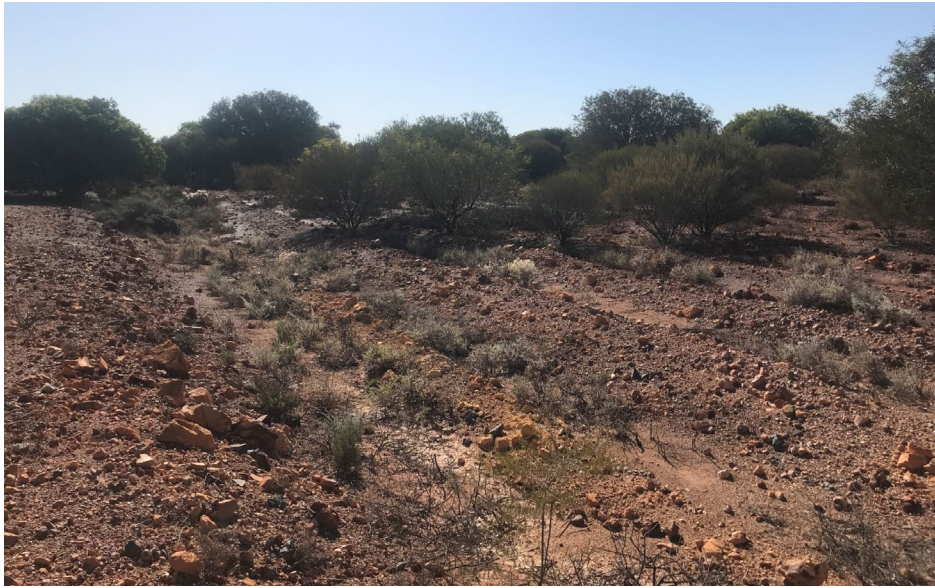
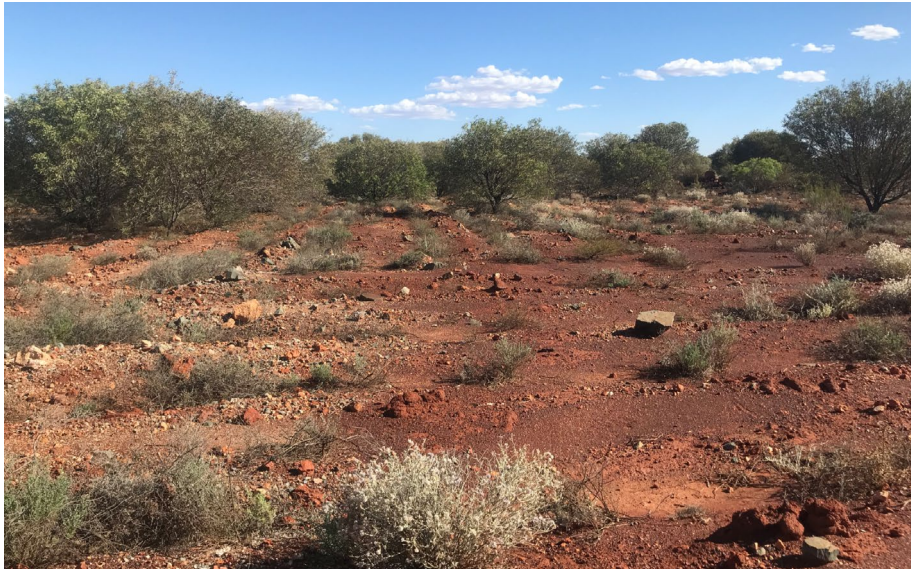
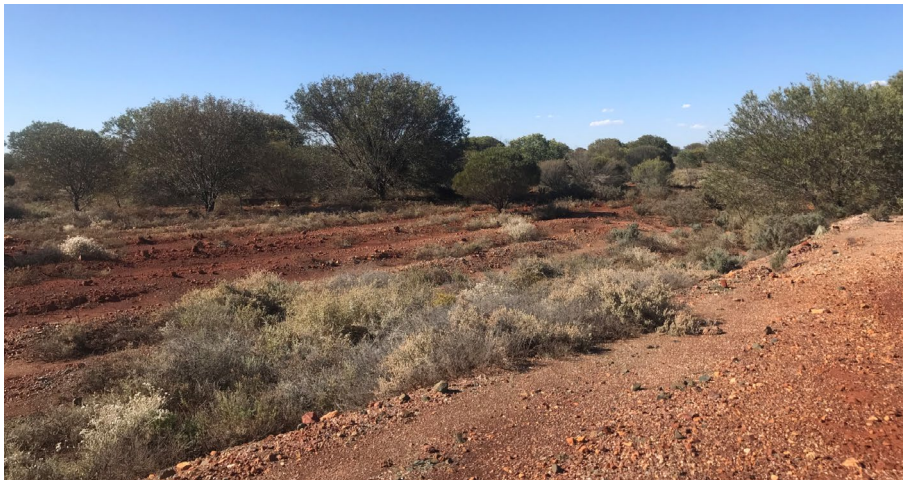
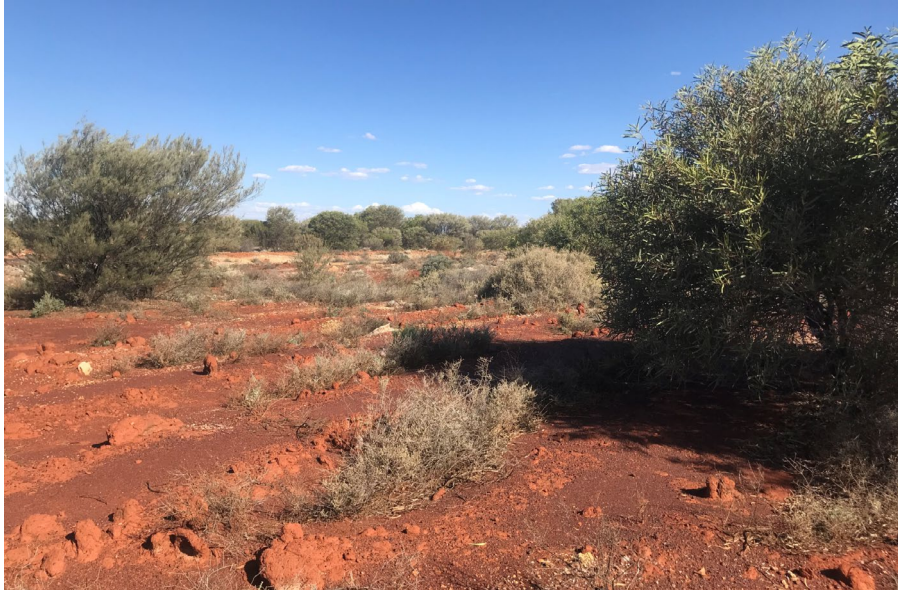
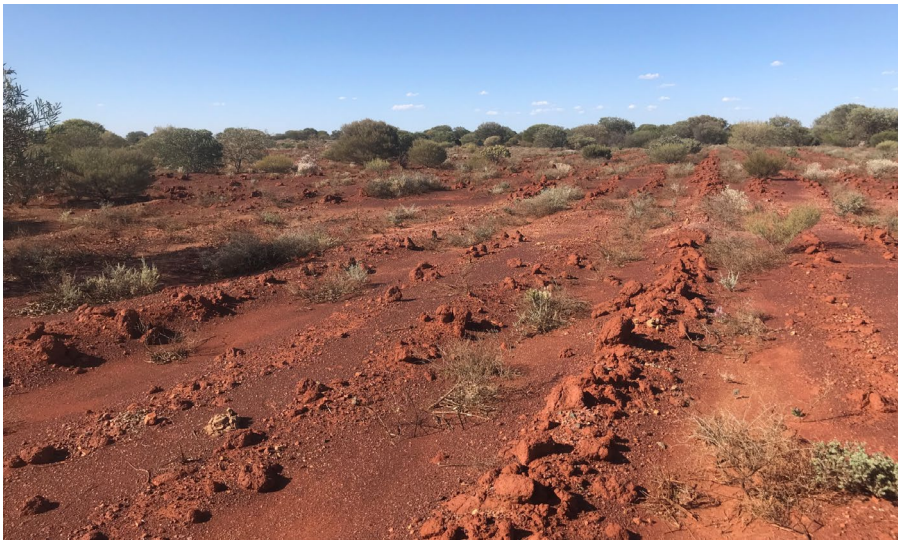
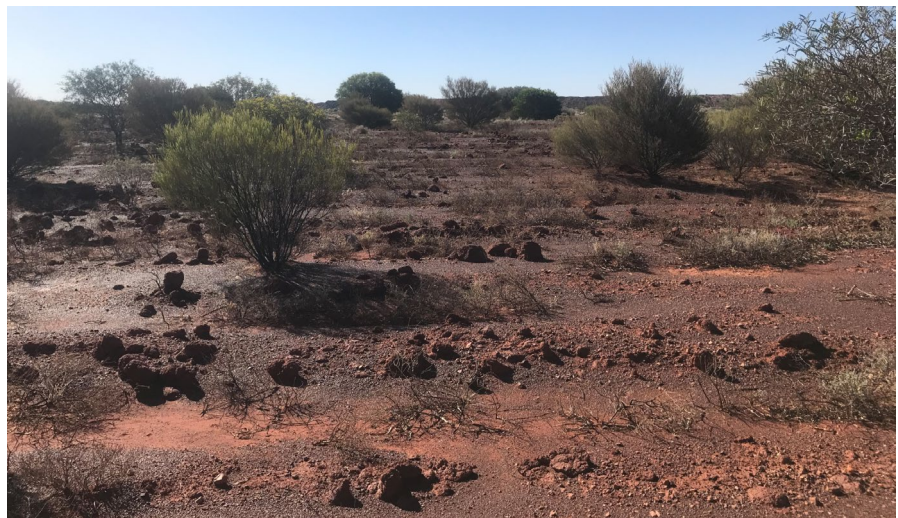
Appendix 2: W1/2/3 WRL Upper Surface Photographs

Representative photographs of the upper surface of the W1/2/3 WRL were taken in October 2022 to and are displayed in Appendix 2. Observations from October aligned to previous monitoring efforts including:

- Soil stability and infiltration is high with negligible erosion as a result of deep contour ripping and compartmentalisation of the upper surface;
- Woody vegetation dominates vegetation structure the which is likely to be attributed to the drought experienced as grasses and herbs have not been able to sustain through this dry period;
- Broadly vegetation cover on the surface of the dump is less than surrounding vegetation.
- Upper vegetation cover tends to have formed in patches, which is reflective of the Mulga patch/interpatch growth regime in the Murchison region; and,
- Lower vegetation cover has more uniform coverage on the upper surface relative to upper storey plants; however still appears to be in less presence than the surrounding vegetation/analogue.
