## **Attachment 3**

Site Photos (from GHD, 2020 and Tetra-Tech, 2021)

**Appendix A:**  
**Site Photographs**

DCARM  
Mucnea Armament Range (0964)

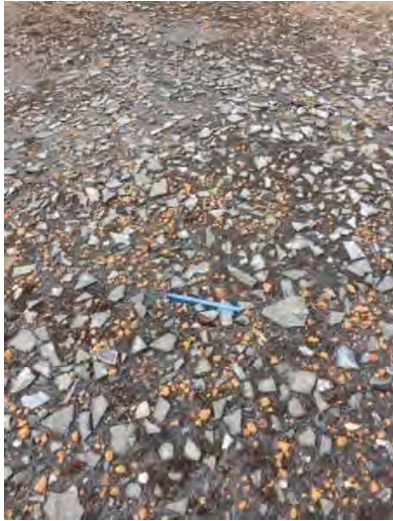
**Photo 1 Former T&C Building; ACM fragments 3 cm x 3 cm**

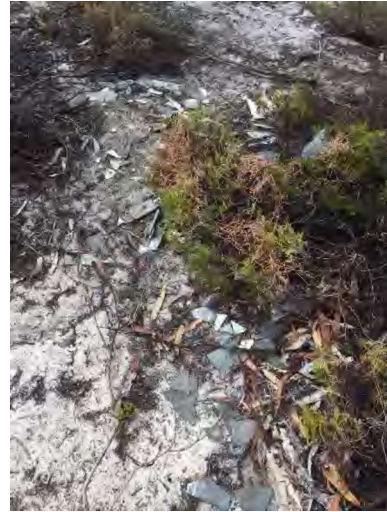
**Photo 2 Former T&C Building; ACM fragments**

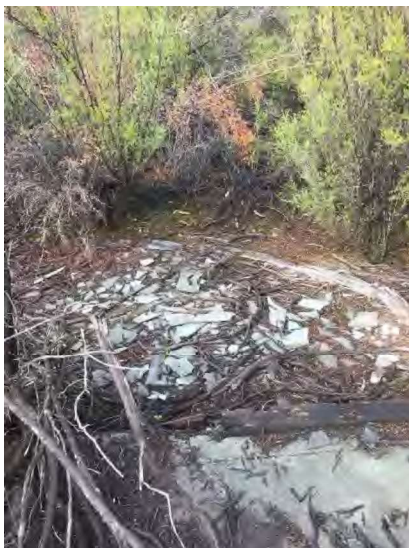
Significant amounts (>500) of larger fragments (generally 10 cm x 10 cm and bigger) were noted in vicinity to the former pump house (Photo 3), potentially a result of the structure being pushed over as part of the demolition, with the ACM not limited to one layer on the surface. ACM contamination was also noted extending into the heavily vegetated surrounding area (Photo 4)

**Photo 3 Former pump house; significant ACM fragments**

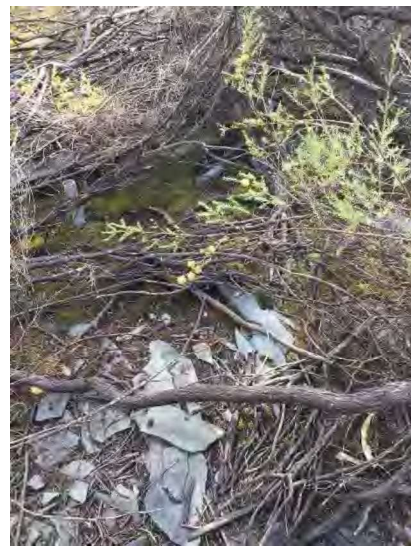
**Photo 4 Former pump house; significant ACM fragments**

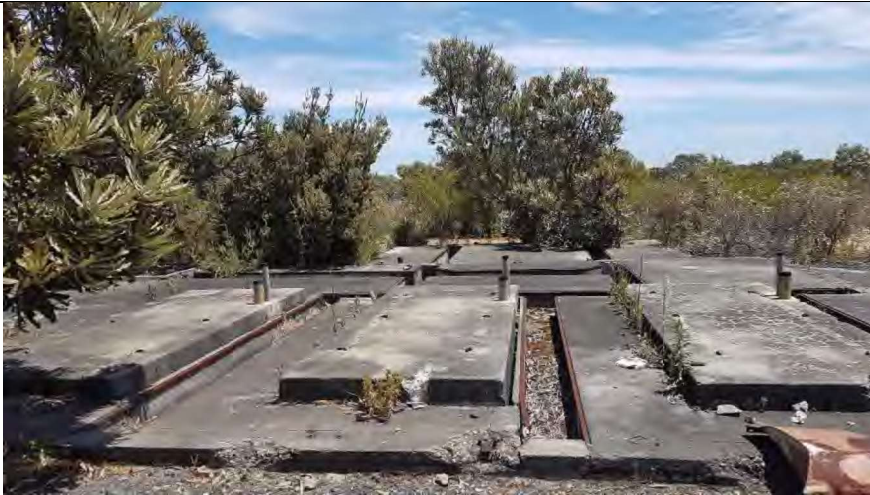
At the former powerhouse and the former observation tower, ACM contamination appeared more isolated than the other impacted areas, largely concentrated around the concrete pads and not significantly widespread (i.e. <2 m from the concrete pads). Additionally the ACM contamination at the former housing area consisted of fragments across the concrete pads, spreading into the adjacent bushland (approximately 2 m).

**Photo 1:** Former radar tracking station – former power house (facing south)

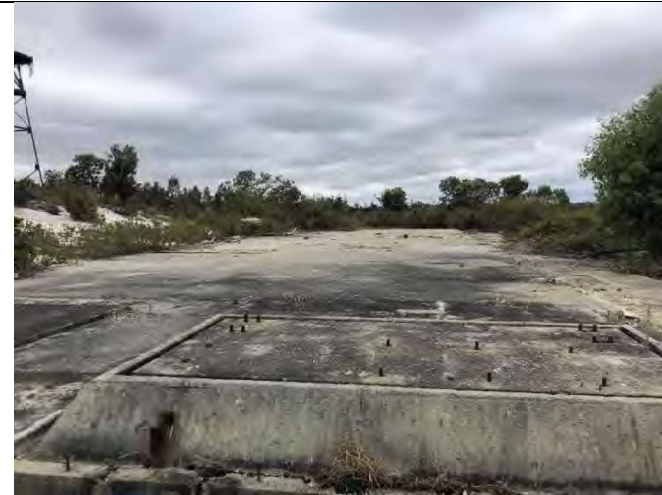
**Photo 2:** Former radar tracking station – former telemetry & control building (facing south)

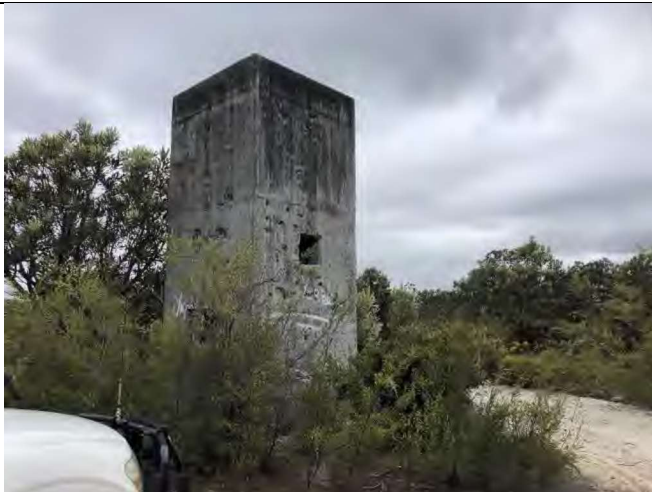
**Photo 3:** Former radar tracking station – Observation tower (boresight tower)

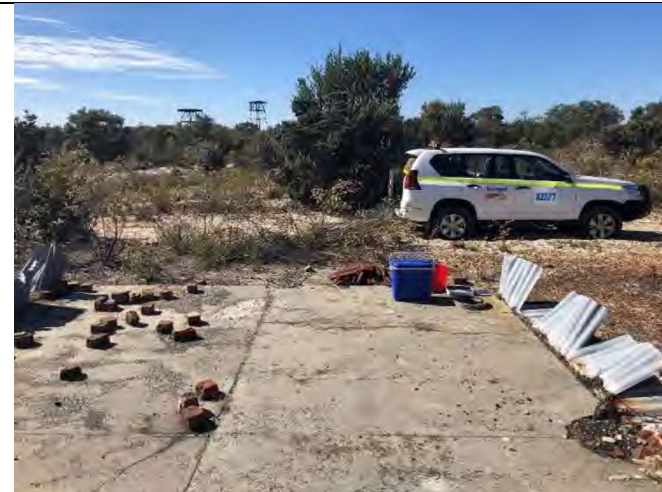
**Photo 4:** Former radar tracking station – former housing (facing south)

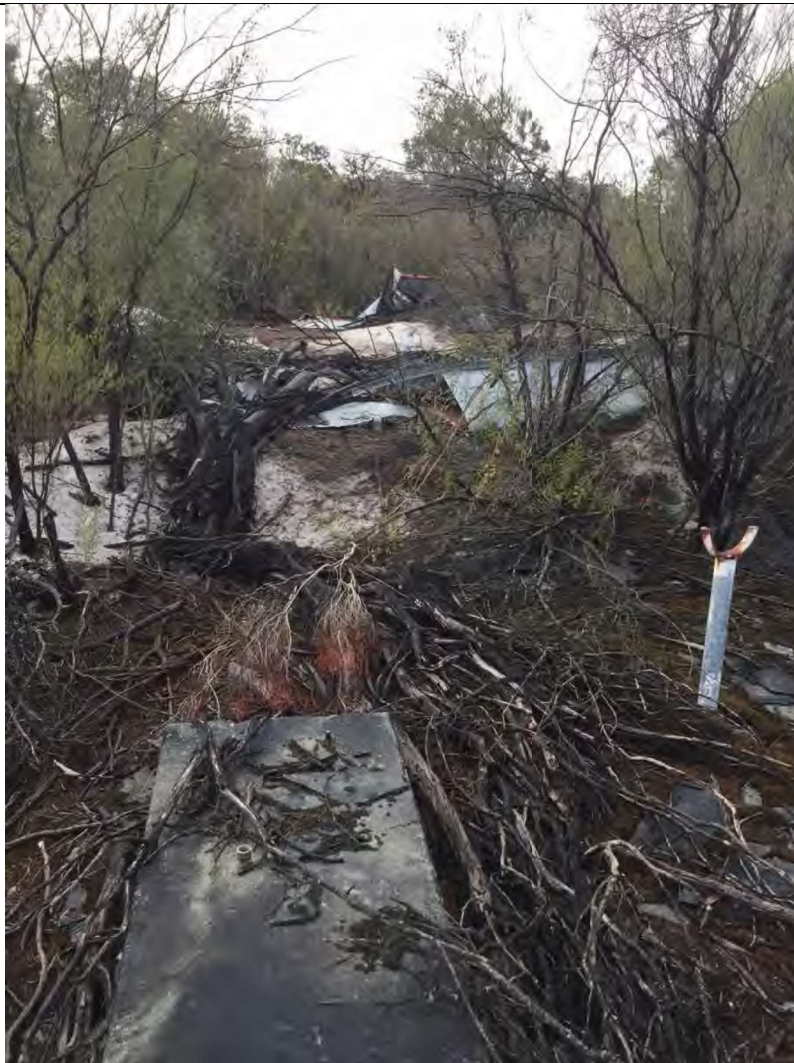
**Photo 5:** Former radar tracking station – former pump house

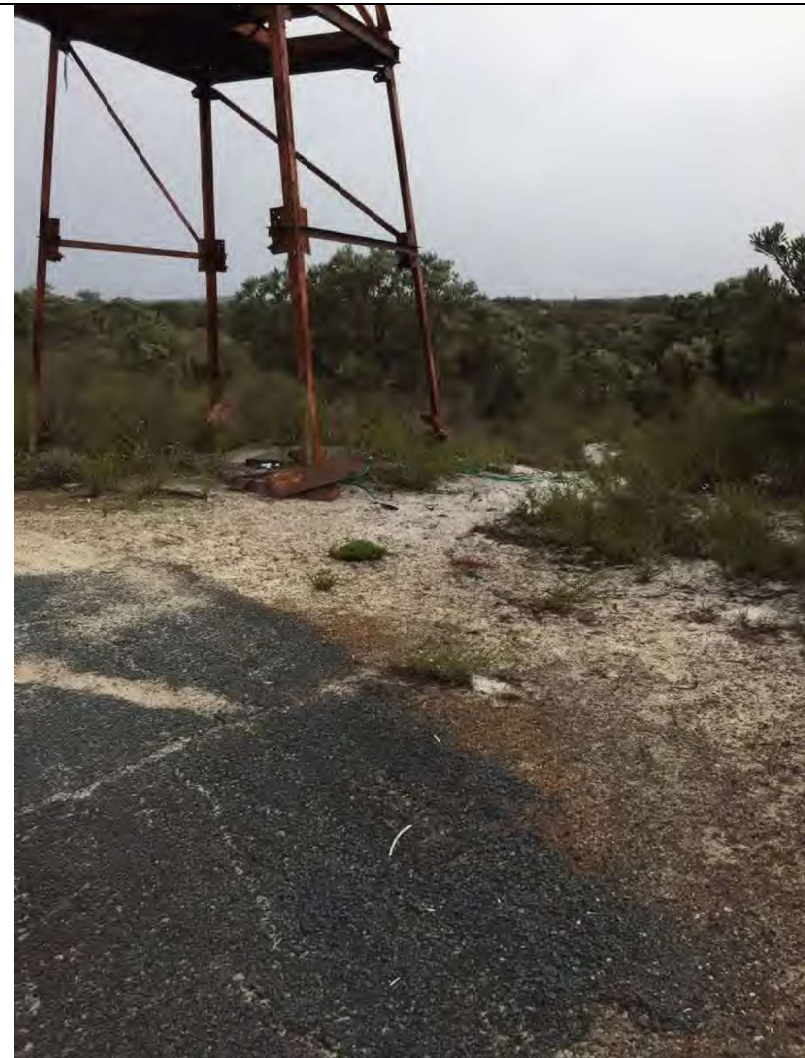
**Photo 6:** Former radar tracking station – former telemetry & control building

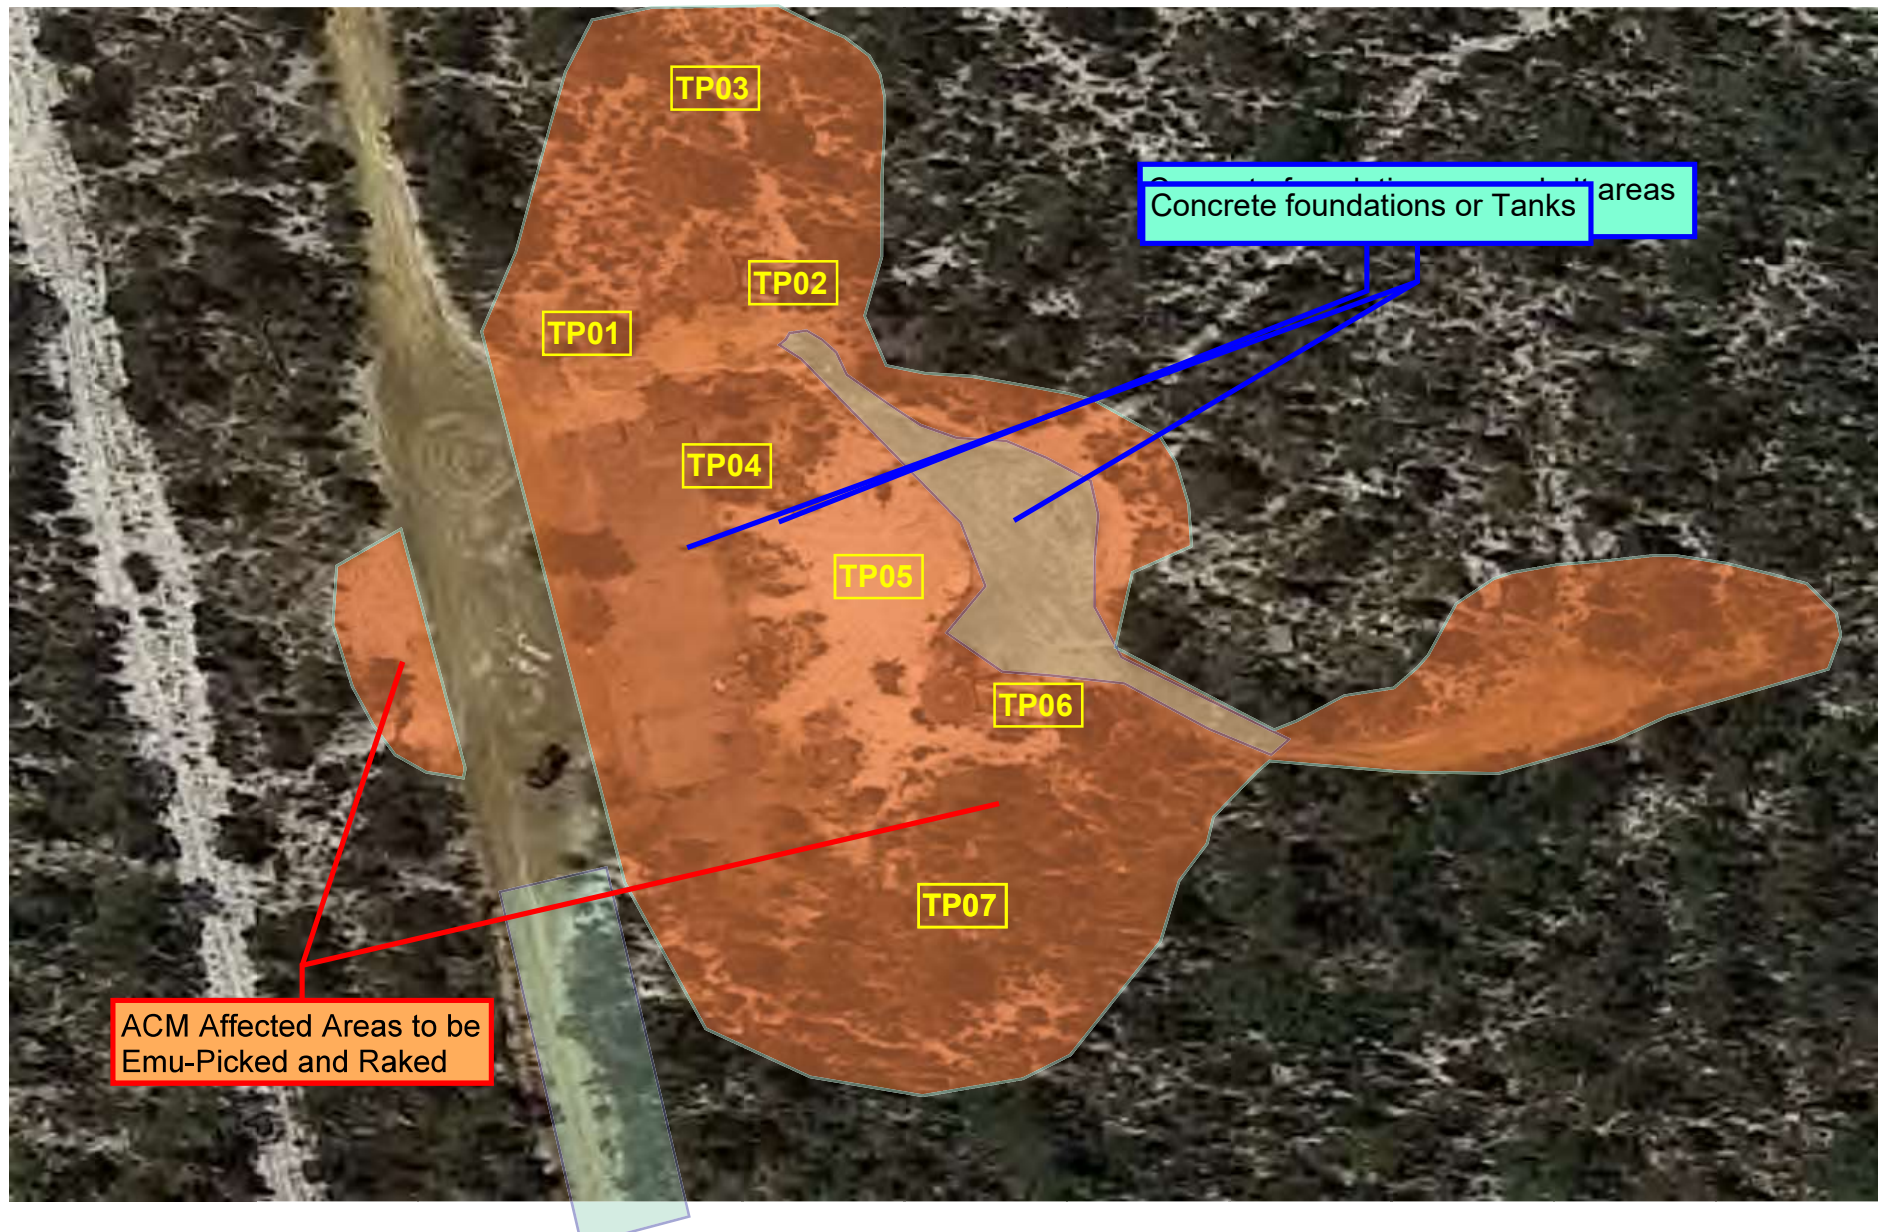
### ACM Affected Area 1

Grounds Surrounding Main Telemetry and Control  
Building Foundation and Antennas Tower

ACM Affected Areas to be  
Emu-Picked and Raked

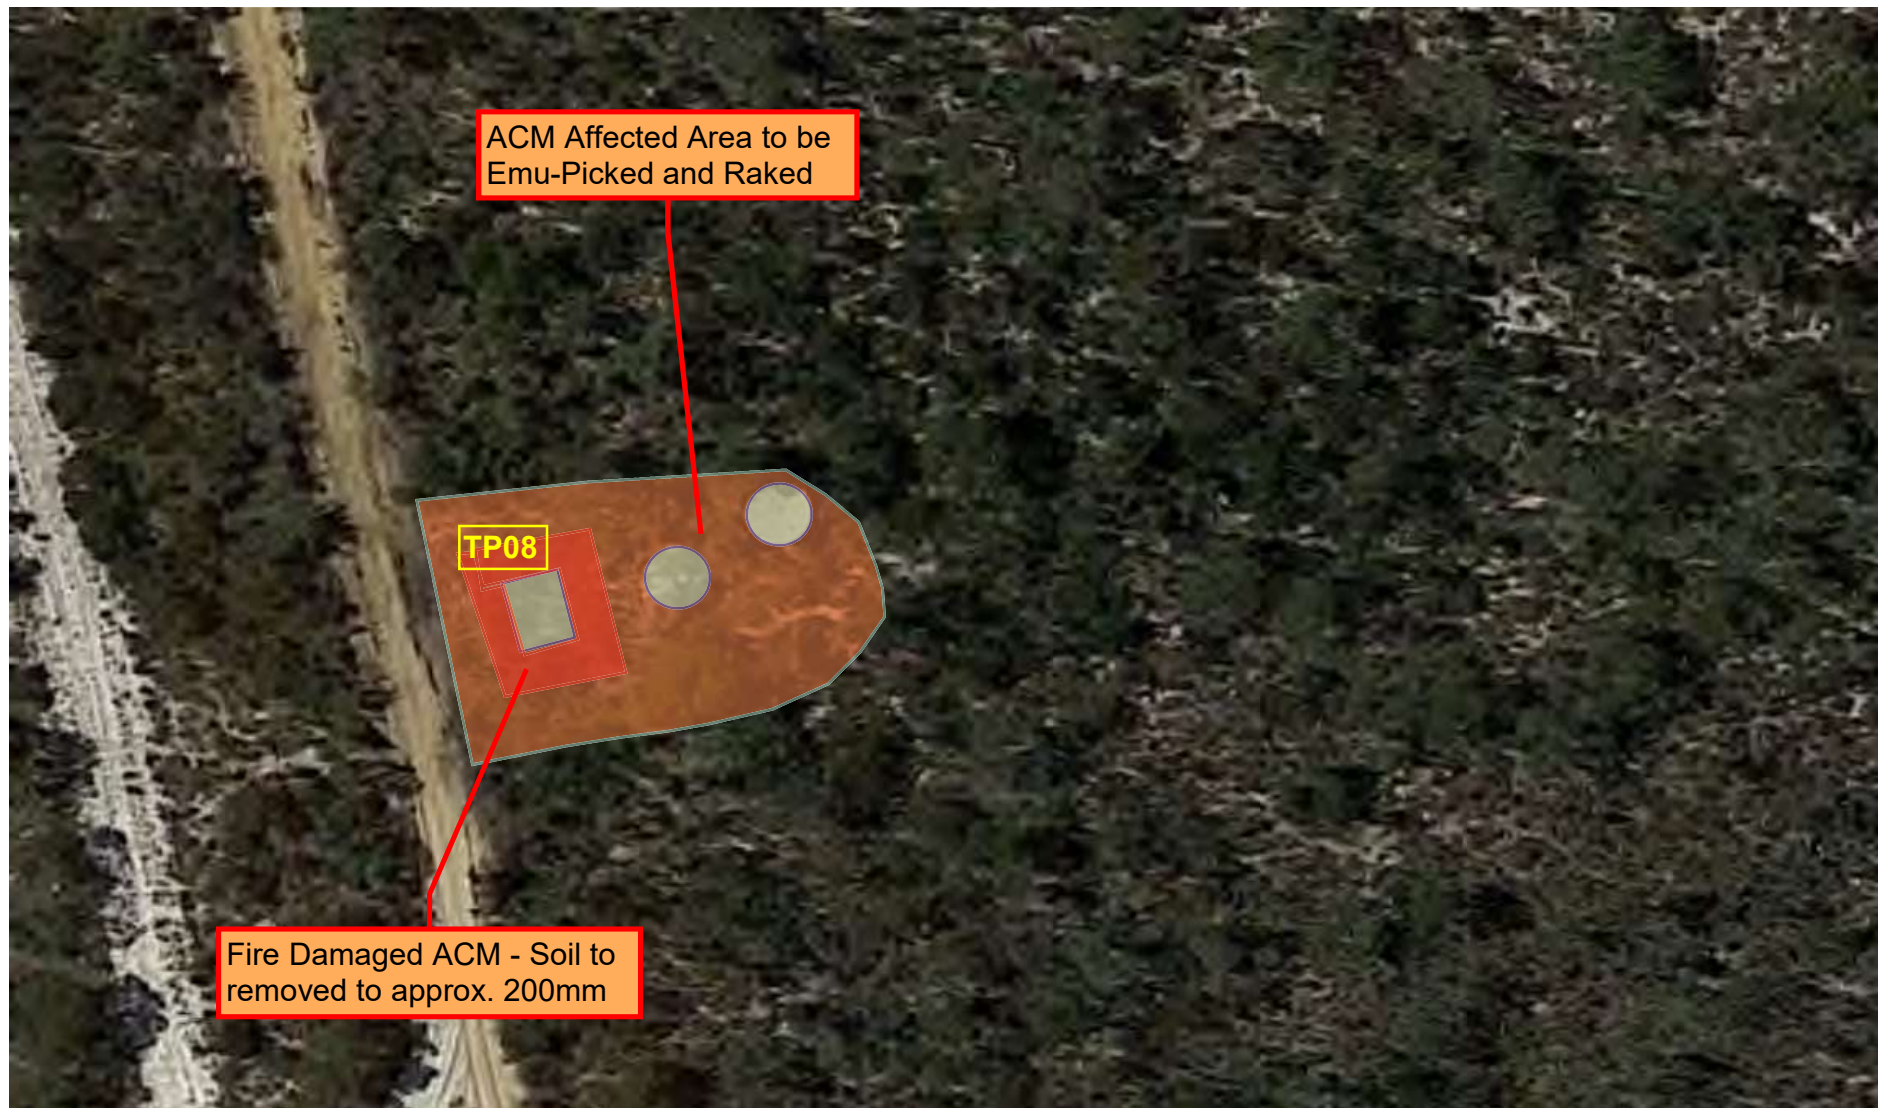
## **ACM Affected Area 2**

Grounds Surrounding Water Bore Building  
Foundations and Storage Tanks

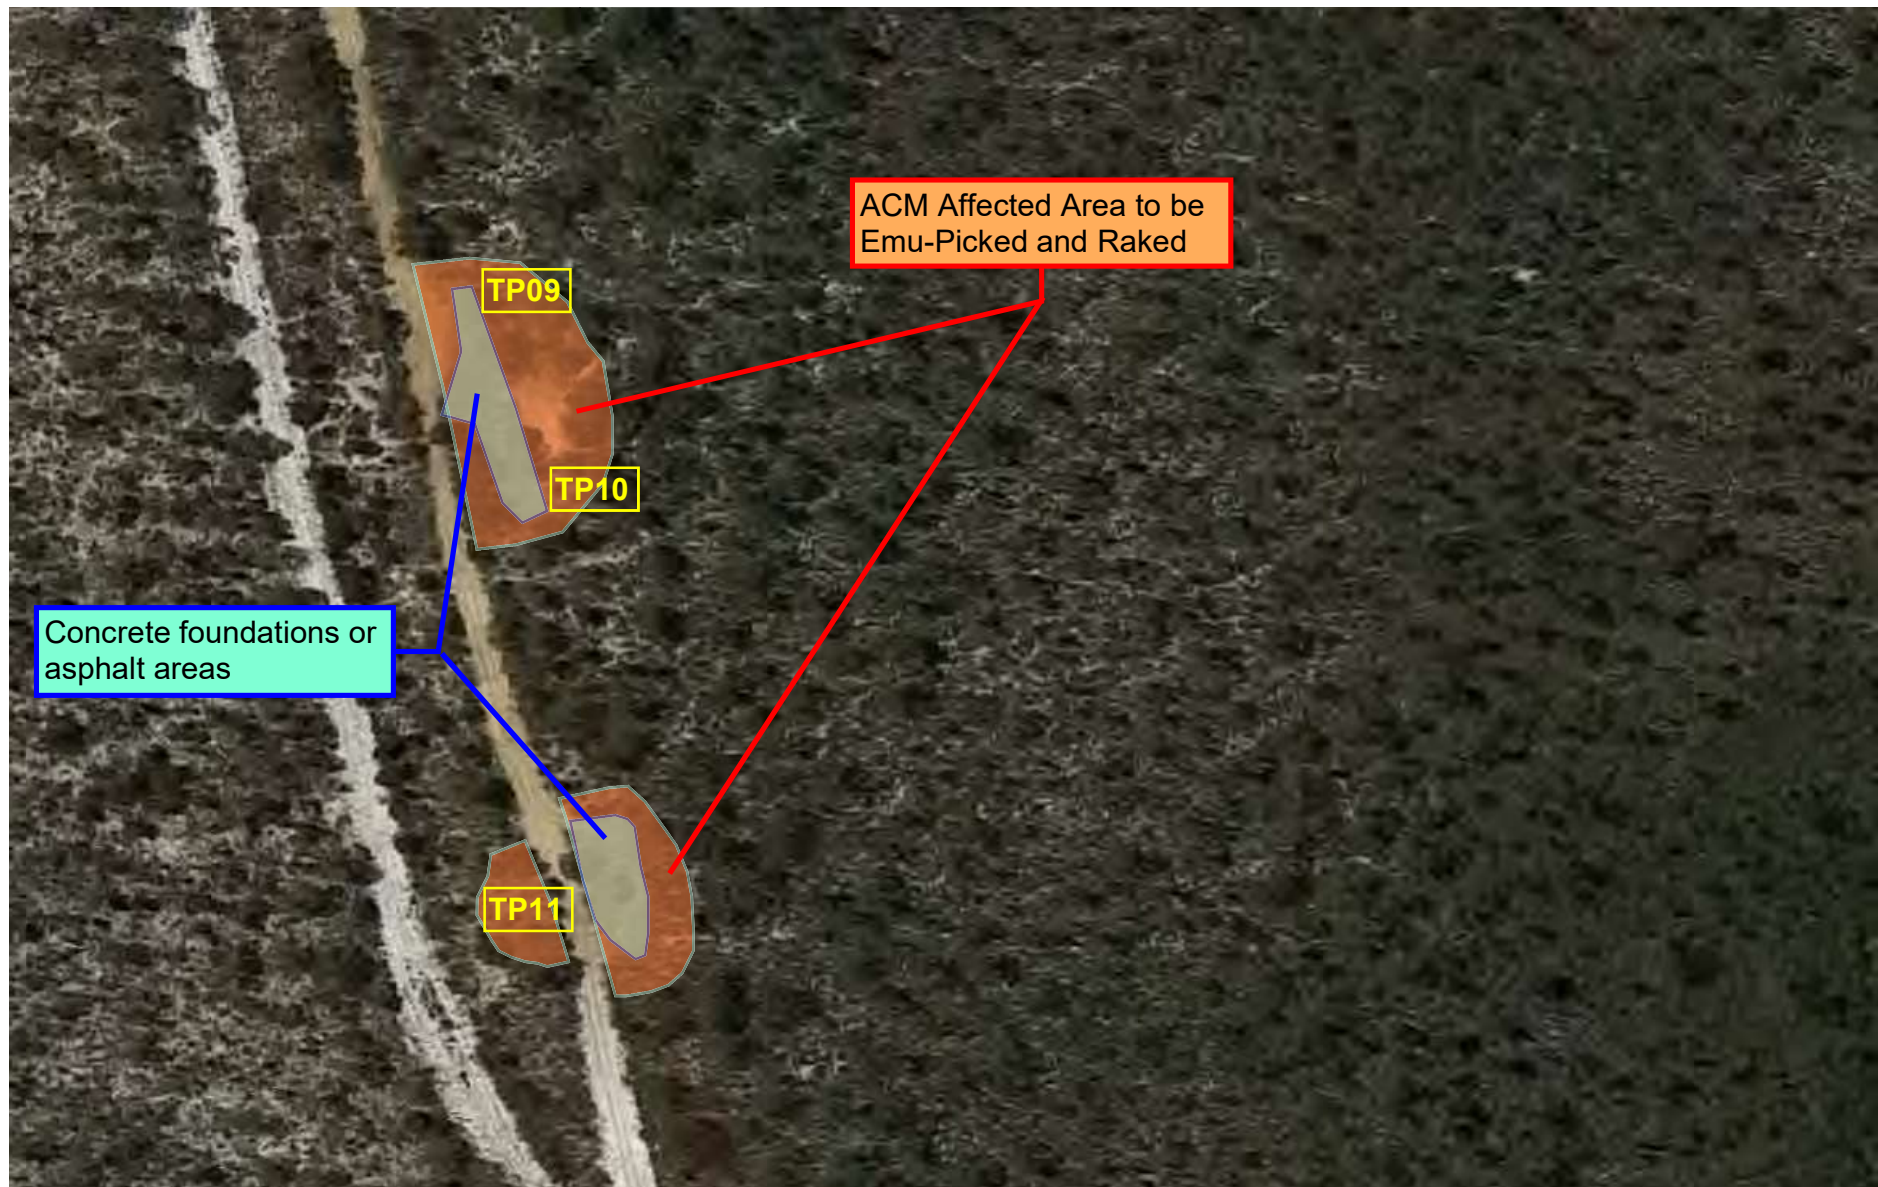
### **ACM Affected Area 3 & 4**

Grounds Surrounding Powerhouse Foundations and  
Ground to Air Transmitter Tower

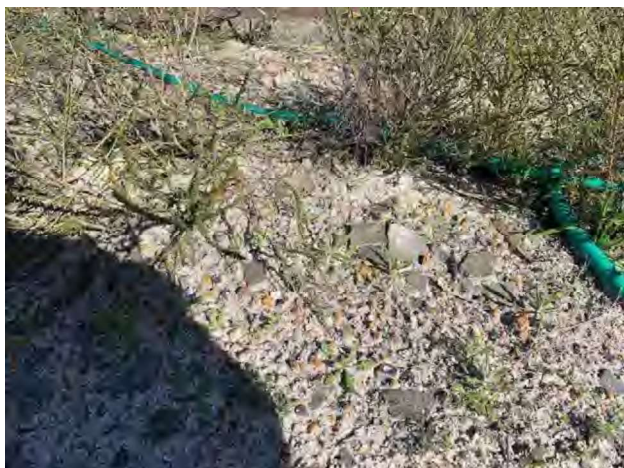
### Photographs 1:

Area 1 – Visible ACM surface debris

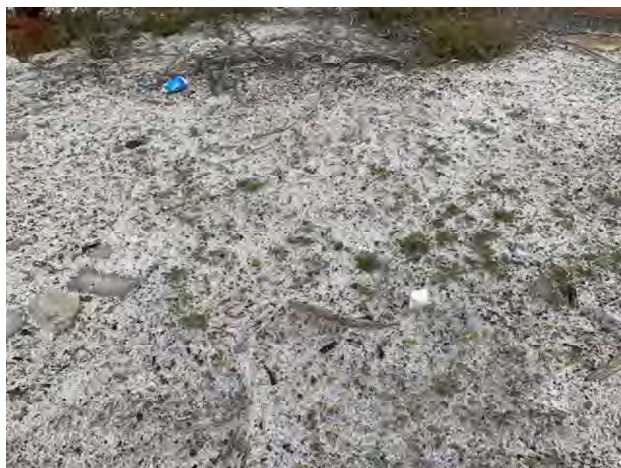
### Photographs 2:

Area 1 – Visible ACM surface debris

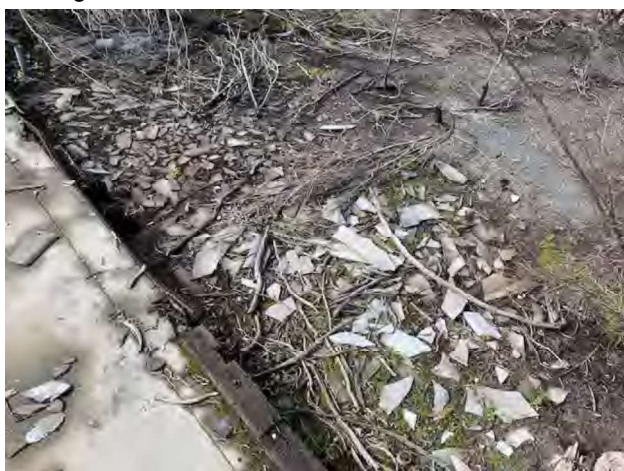
### Photographs 3:

Area 2 – Grounds outside Water Bore – Fire damaged ACM debris

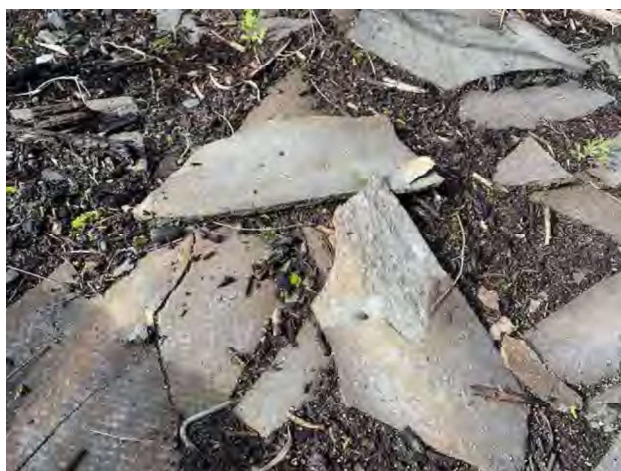
### Photographs 4:

Area 2 – Highly deteriorated, fire damaged ACM debris
