**Tree Inspection Report for a tree located at  
43 Reservoir Road, ORANGE GROVE WA 6109**

Request ID PRK24/2023  
 Inspection Date 8/05/2024  
 Amenity Score 56  
 Amenity Value/Quote NA  
 Removal Cost (inc GST) NA  
 Site Revisit Date  
 Inspecting Officer AVAUGHAN  
 TPZ Radius 15 m  
 SRZ Radius 3.1m

Request tree service - Tree Care or Maintenance  
 - Please assess Marri and Grass Tree immediately before intersection for the production of a tree report to support clearing

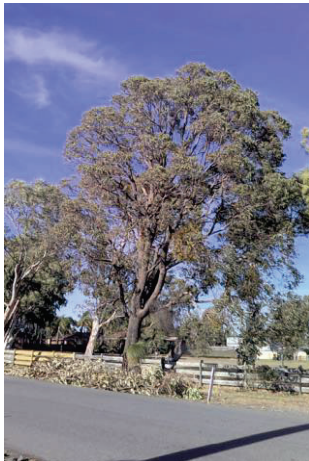
Inspection Item	Decision	Notes
<b>Tree details</b>		
Tree Species - add unique Tree ID to notes	Corymbia calophylla	
* Life Expectency	5 to 40 years	
Significant Tree	No	
<b>Measurements</b>		
Height (add actual measurements to notes)	10 to 15 m	13.8m as per clinometer
Current DBH (m)	0.6 to 0.9 m	77cm as per tape
Current DGL (m)	0.6 to 0.9 m	87cm as per tape
Current Canopy Width (m)	10 to 15 m	11m

* Form	Average	
Crown & Branch Condition	Average	Small diameter dead wood held in canopy. Small amount of Mistletoe held in canopy.
Trunk Condition	Average	Possible marri canker observed in lower trunk up to approximately 1.4 m above ground level. Appears to be cambium damage only. Adequate space for secondary thickening of codominant stems and first order branches at main unions.
Roots & Root Collar	Average	Buttressed
Canopy Colour	Normal	
Canopy Density	Normal	
<b>Protection Zone Sizes</b>		
SRZ Structural Root Zone	>1.2m	3.1m
<b>Target Assessments</b>		
Target Type	Property	Fencing
Likelihood of Failure	Possible	
Likelihood of Impact	Low	
Consequences	Minor	Risk Rating = Low
<b>Recommendations</b>		
Removal	Tree removal	
Include Inspection for Quotation and Invoicing?	Yes

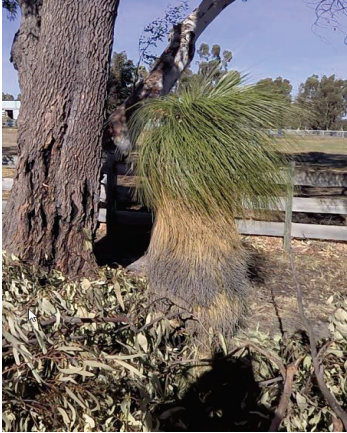
Xanthorrhoea spp.

1.7m as per tape  
 Cant measure due to skirt  
 Approximately 1m  
 1.7m

Double trunk

Tree removal  
 Yes
