ROAD SAFETY INSPECTION

Crooks Road Merredin 0.00 – 1.50 SLK

Road Safety Branch

Inspection Ref: PTS/RSB/RSI/2023/PS/15

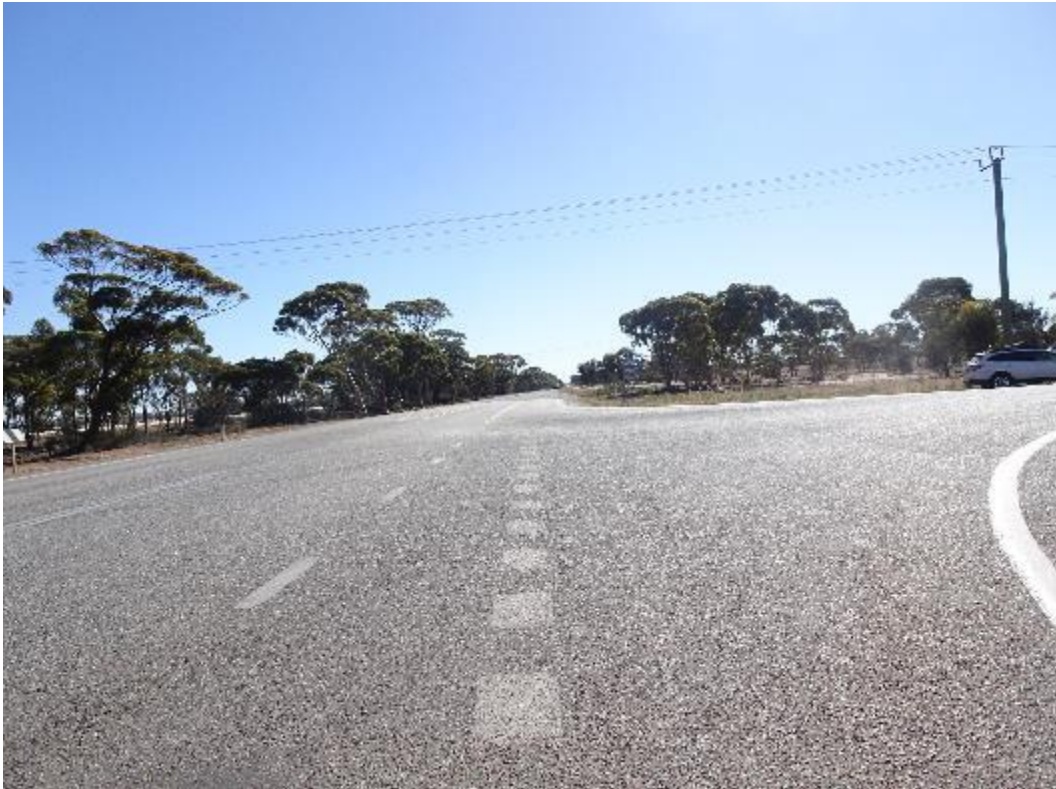
There are no give way holding lines at the intersections of Insignia Way & Gabo Road at Crooks Road. The holding lines at the intersection of Crooks Road and Great Eastern Highway, and Crooks Road and Goldfields Road are worn to the extent that they are no longer visible to approaching drivers.

There is a risk that drivers may overshoot the intersections which could result in right-angle crashes.

Finding 2.1 – Faded Giveaway lines at intersection of Crooks Road and Great Eastern Highway

Give way hold lines should be provided in accordance with Australian Standards.

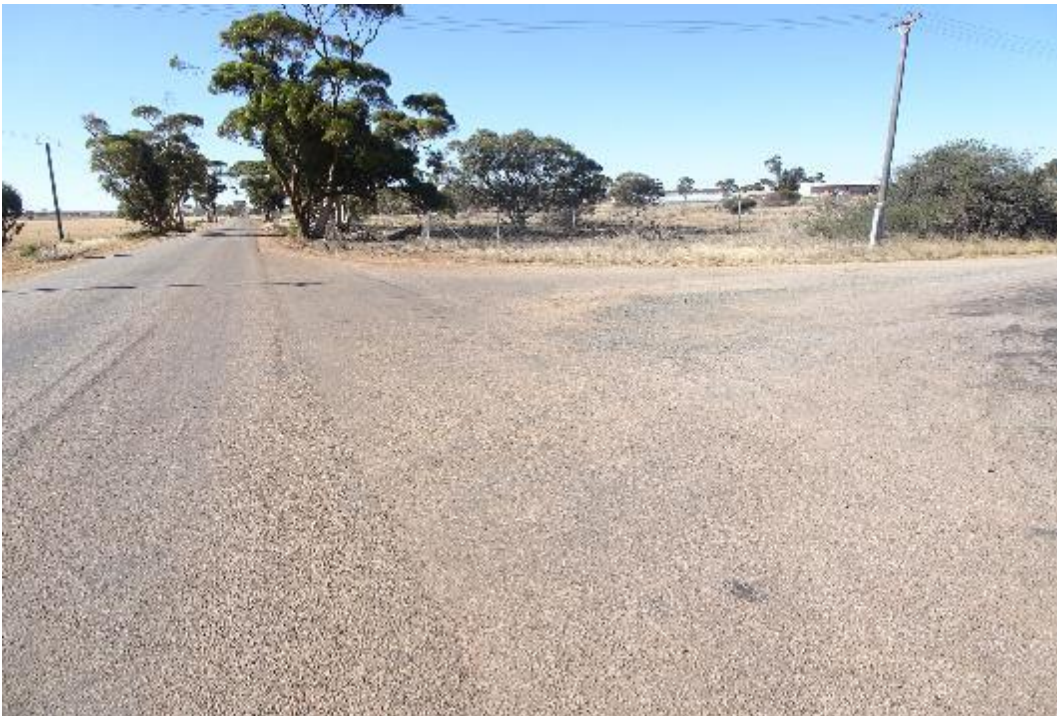
Finding 2.1 – Absence Give way lines at intersection of location

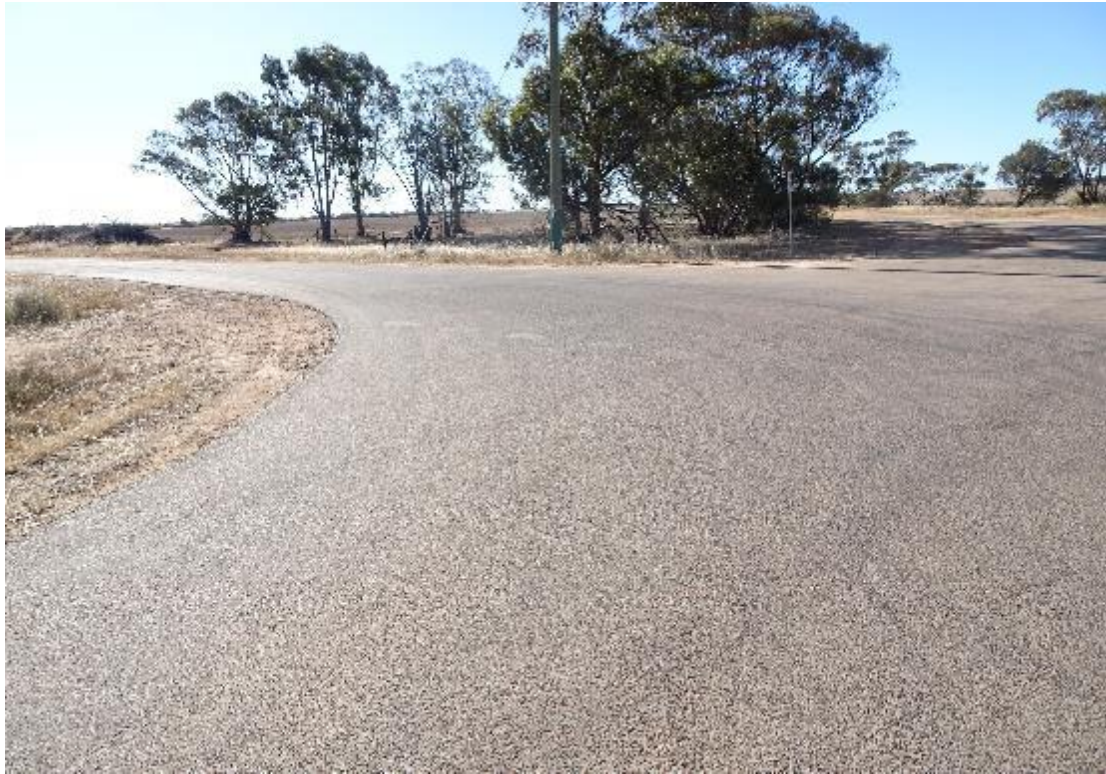
Finding 2.1 – Faded Give way lines Crooks Rd & Goldfields Rd

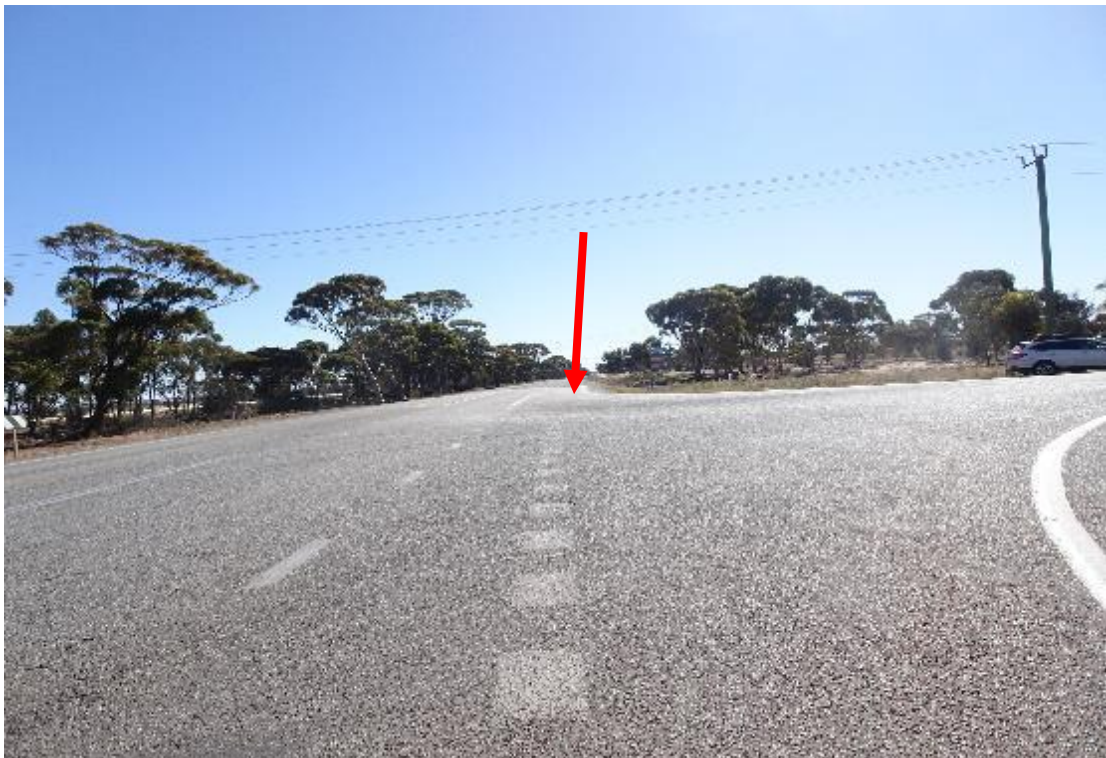
There is a depression in the road surface on Crooks Road in close proximity to its intersection with Great Eastern Highway which could result in an area of ponding during wet conditions.

There is a risk that southbound vehicles braking on Crooks Road approaching the intersection could lose traction during wet conditions overshooting the intersection resulting in right angle crashes.

Finding 2.2 – Depression in road surface at intersection of Crooks Road and Great Eastern Highway

The road surface level should be regraded to remove the surface depression to minimise the risk of ponding in accordance with Austroads Guidelines.

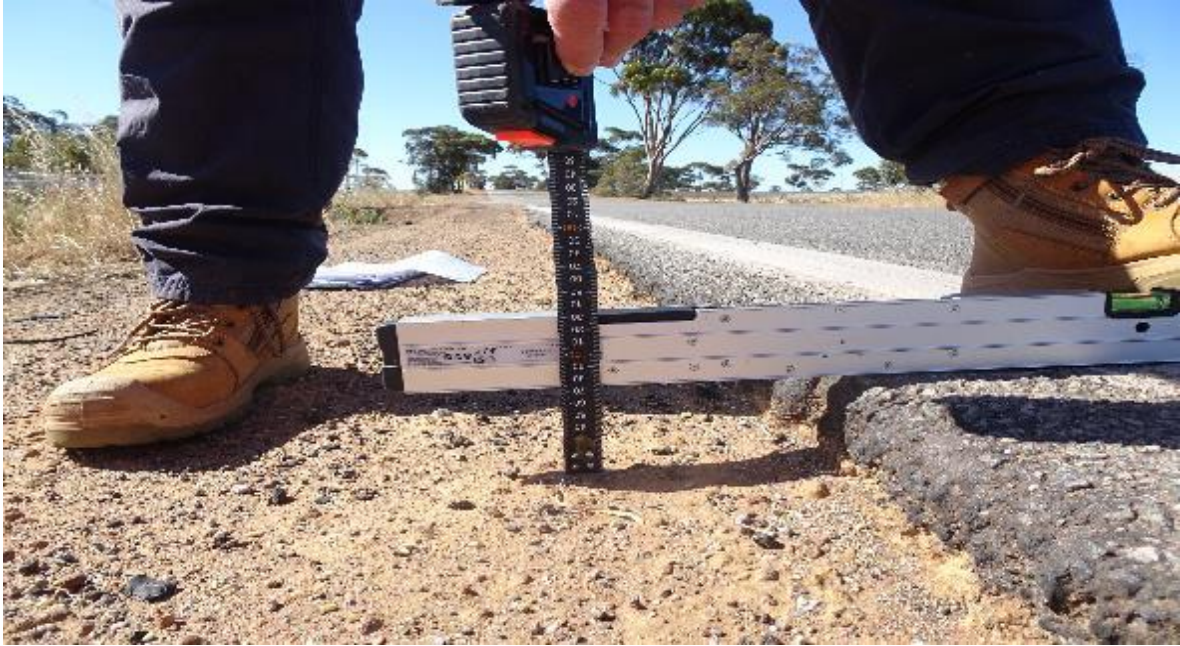
Crooks Road has an insufficient sealed width of between 5.8 m and 6.0 m through this road section that carries a high proportion of heavy vehicles. There is evidence that vehicles are straying from the sealed surface with sections of the route showing significant pavement edge break and edge drop in excess of 70 mm.

There is a risk that vehicles straying from the narrow-sealed road surface may lose control or collide with opposing vehicles.

Finding 2.3 – Typical example of edge drop (numerous locations)

The sealed surface should be widened to accommodate the high proportion of heavy vehicles on Crooks Road in accordance with Austroads guidelines.

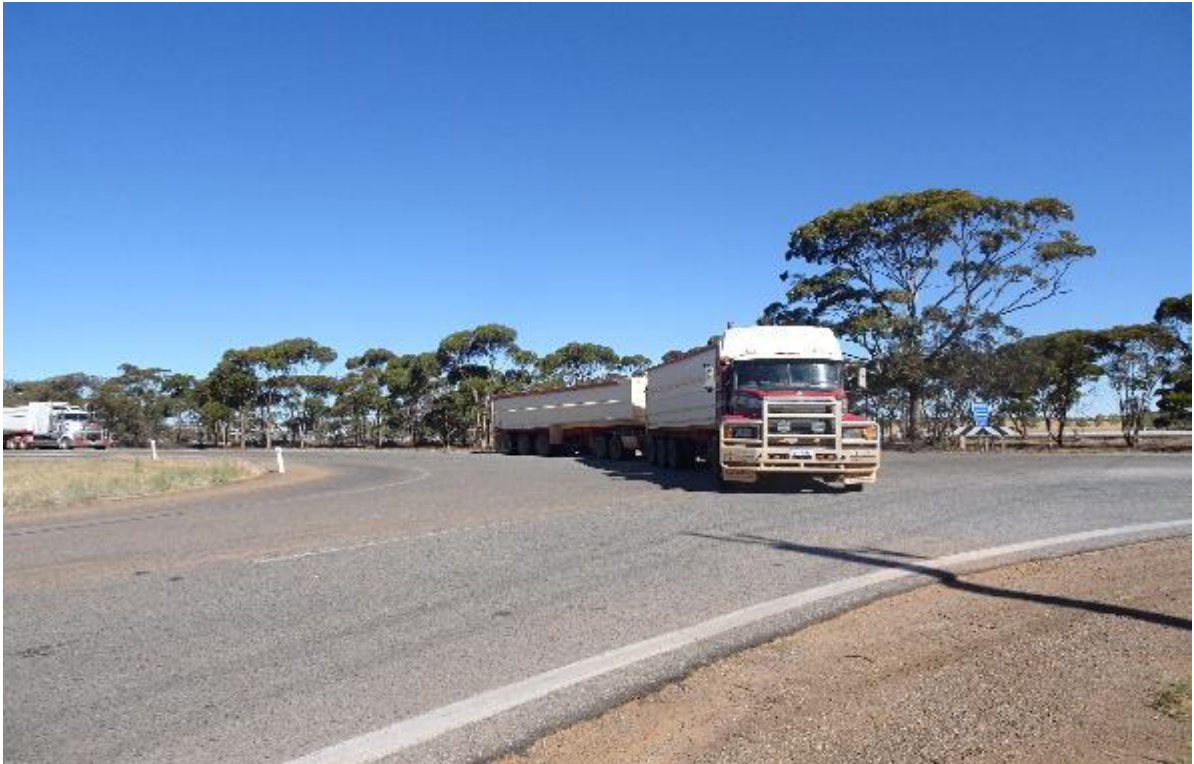
The intersections of Crooks Road and Great Eastern Highway, Gabo Road and Insignia Way have insufficient turning path space for large vehicles to safely negotiate these intersections. Large vehicles were observed to encroach into opposing traffic lanes to make the turning manoeuvres and remain on the sealed surface at these intersections.

There is a risk that large turning vehicles at these intersections could collide with other vehicles at the intersection which could result in head on or side swipe crashes.

Finding 2.4 – Insufficient swept path at intersection of Crooks Road and Great Eastern Highway

Swept path analysis should be conducted on all intersections to ensure that adequate turning clearances are achieved and modifications made to existing seal widths and radius if required in accordance with Austrroads guidelines.

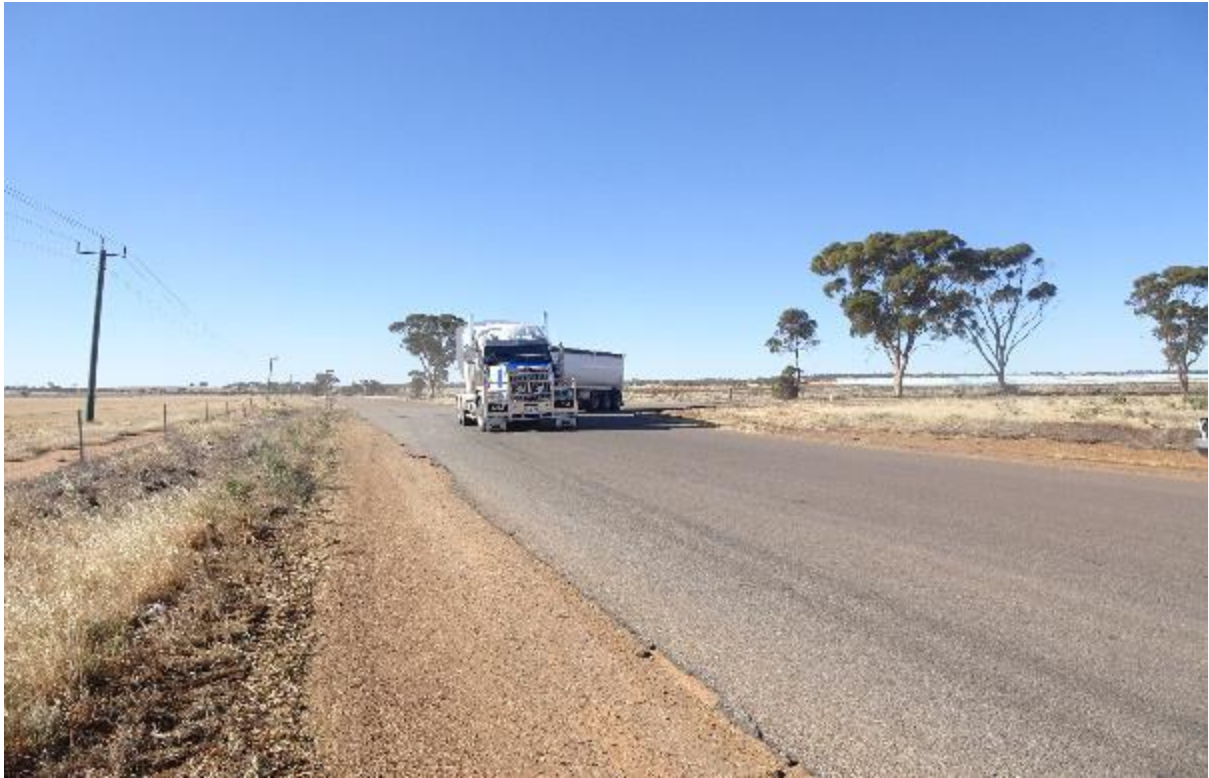
Finding 2.4 – Insufficient swept path at intersection of Crooks Road and Gabo Avenue

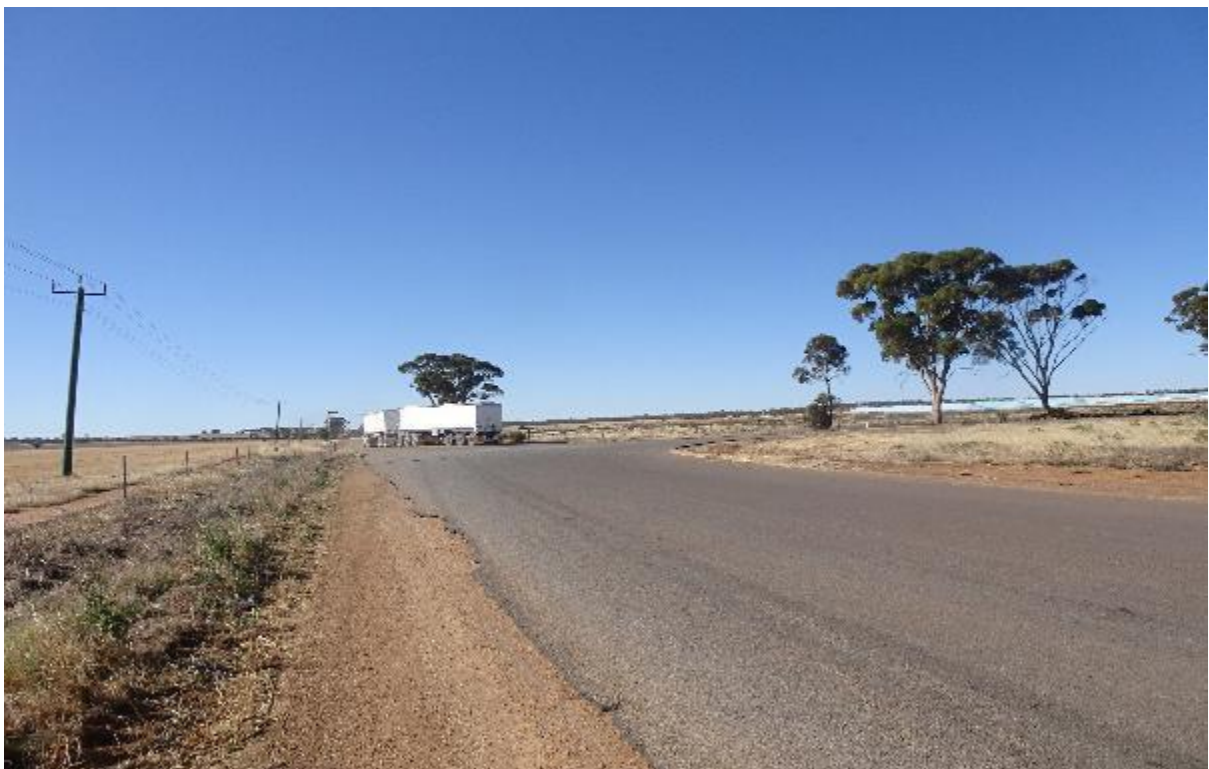
Finding 2.4 – Insufficient swept path at intersection of Crooks Road and Gabo Avenue

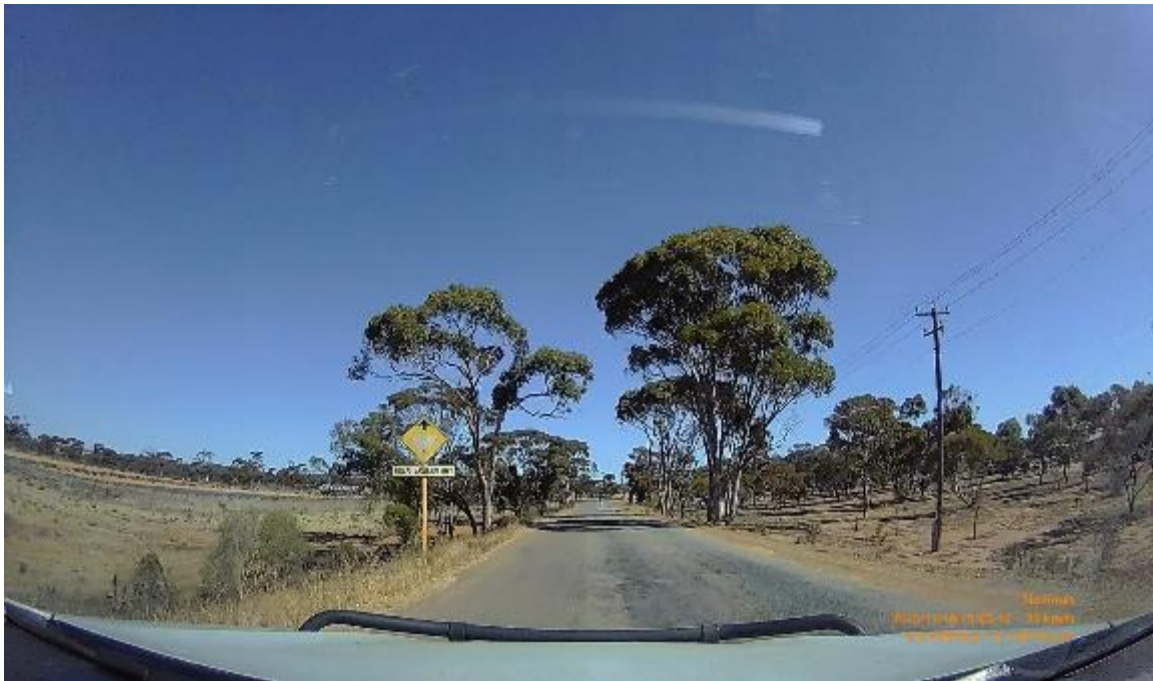
The Give Way Sign Ahead (W3-2) warning sign on Crooks Road on the approach to Great Eastern Highway for southbound drivers is sun faded and has lost its reflectivity.

Finding 2.5– Damaged sign Crooks Road approaching Great Eastern Highway

Appropriate signs should be provided and signs in poor condition should be replaced in accordance with Australian standards and Austrroads guidelines.

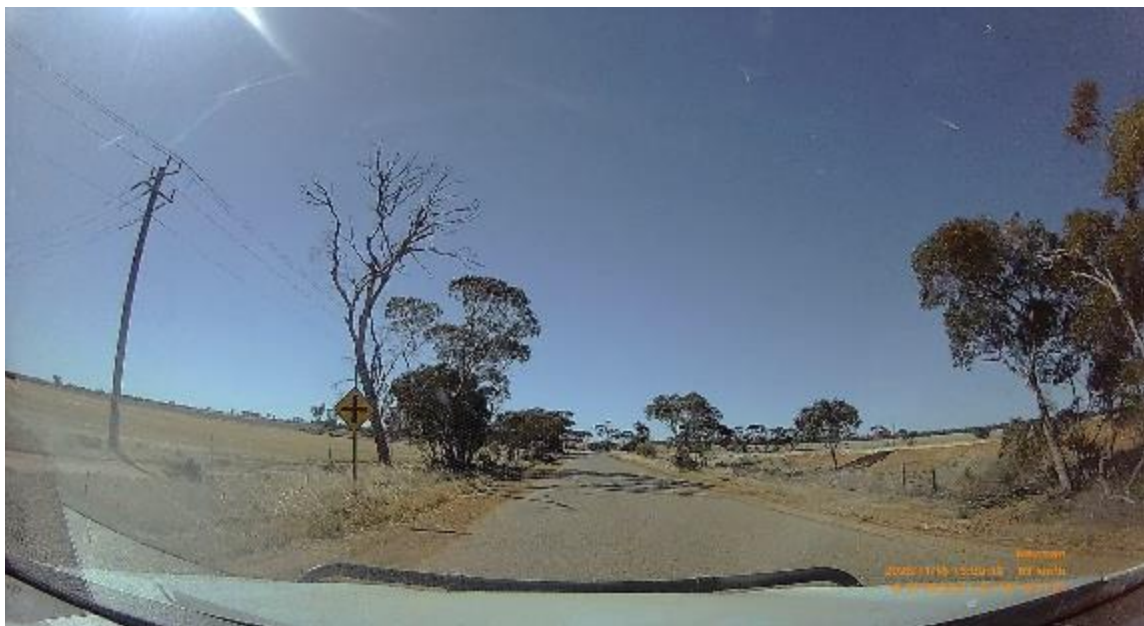
The Cross Road (W2-1) warning signs for northbound vehicles on Crooks Road and for southbound vehicles on Hubeck Road approaching the intersection of Goldfields Road are likely to mislead drivers about the road layout ahead.

Finding 2.5– Misleading Cross Road warning sign on Crooks Road northbound approach to Goldfields Road

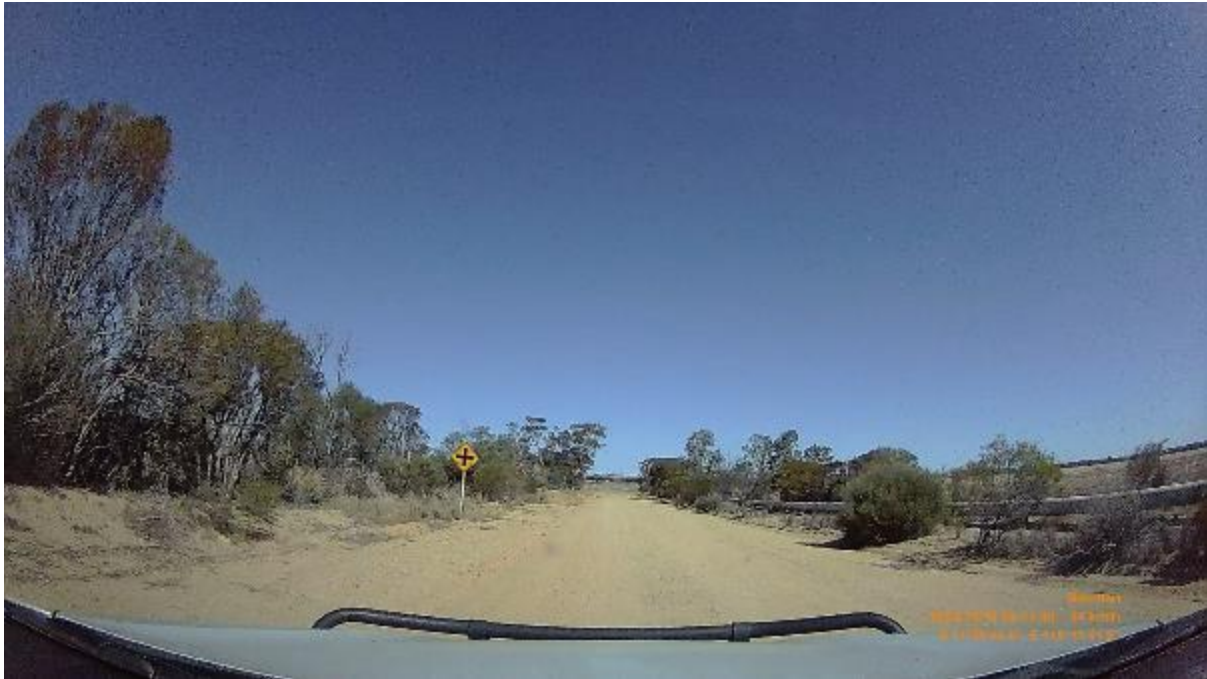
Finding 2.5– Misleading Cross Roads warning sign on Hubeck Road southbound approach to Goldfields Road.

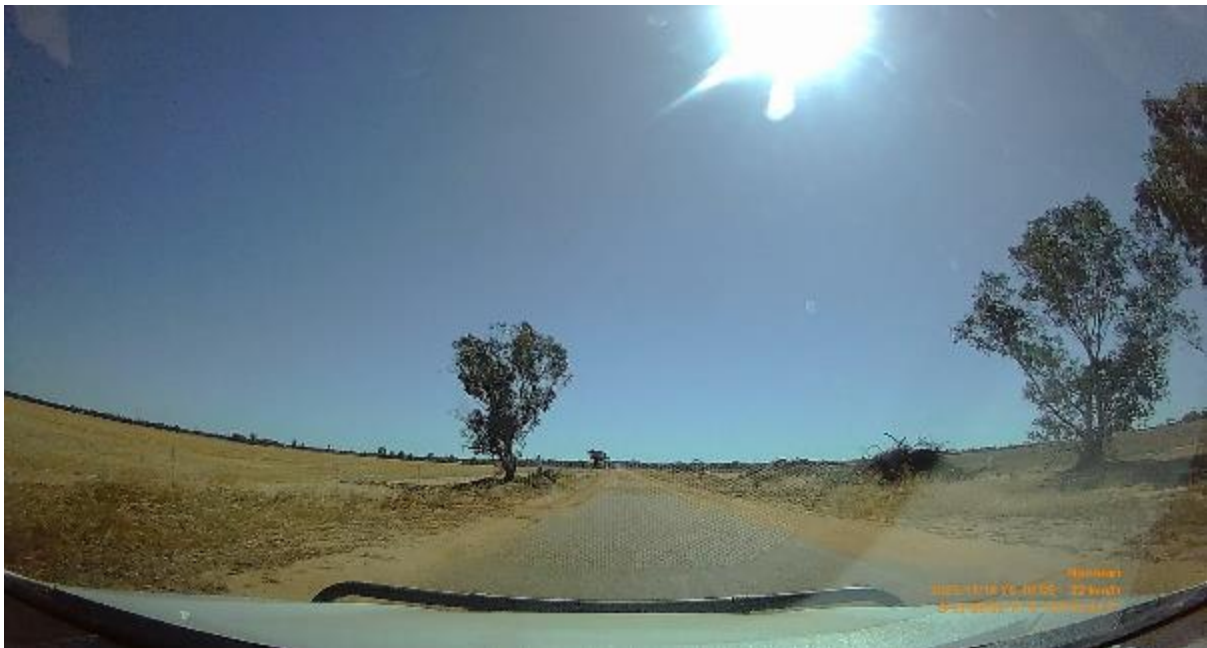
There is no Gravel Road (W5-19) warning sign provided for westbound drivers travelling on Goldfields Road west of Crooks Road where it transitions from a sealed to a gravel surface.

Finding 2.5– Absence of Gravel Road Ahead warning sign westbound on Goldfields Road

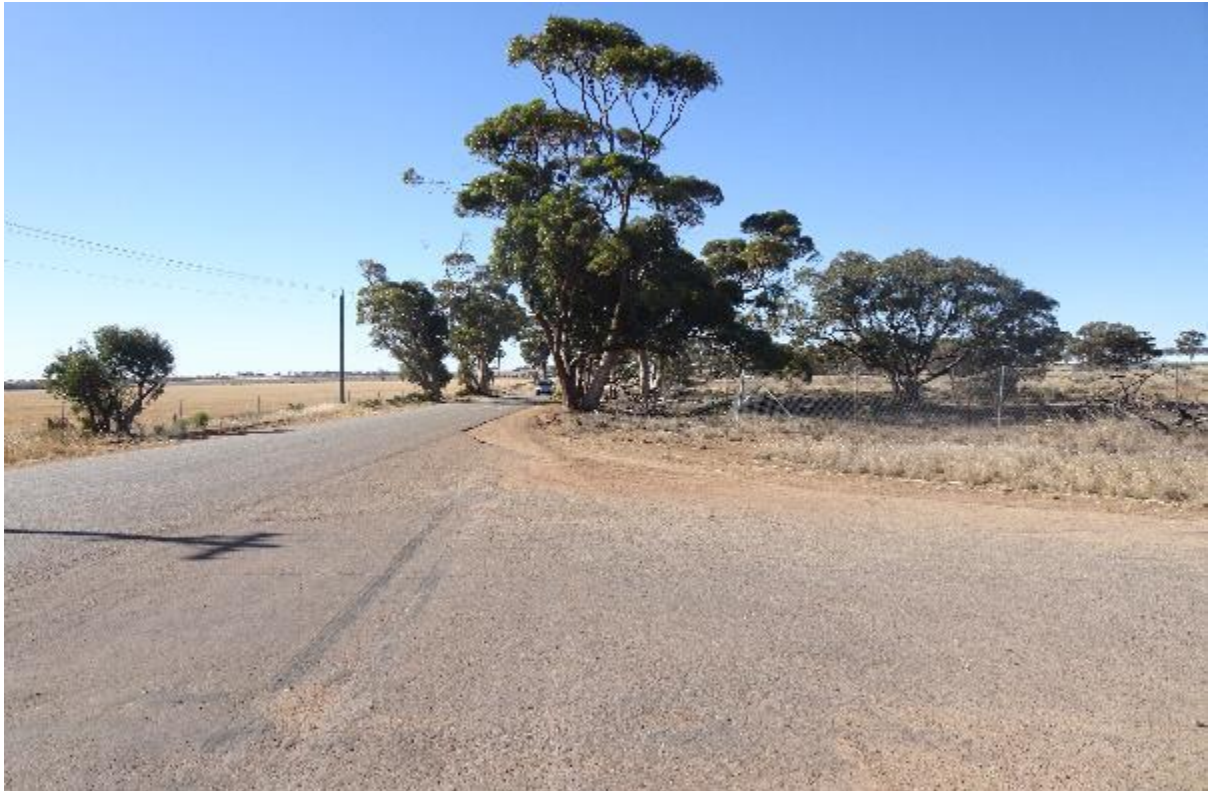
There are trees located to the north of the intersection of Crooks Road and Insignia Way on the eastern verge resulting in insufficient Safe Intersection Sight Distance (SISD) for vehicles exiting Insignia Way and entering Crooks Road.

The trees situated to the north reduces Safe Intersection Sight Distance to 90m. *Austroads Guide to Road Design Part 4A: Unsignalised and Signalised Intersection* indicates that Safe Intersection Sight Distance is the minimum distance which should be provided on the major road at any intersection. Using an operating speed of 110 km/h and reaction time of 2.0 seconds the required Safe Intersection Sight Distance is 285 m measured 5 m back from the intersection hold point.

Finding 2.6– Insufficient Safe intersection sight distance to north at Insignia Way

Trees should be removed to provide adequate Safe Intersection Sight Distance in accordance with Austroads Guidelines.

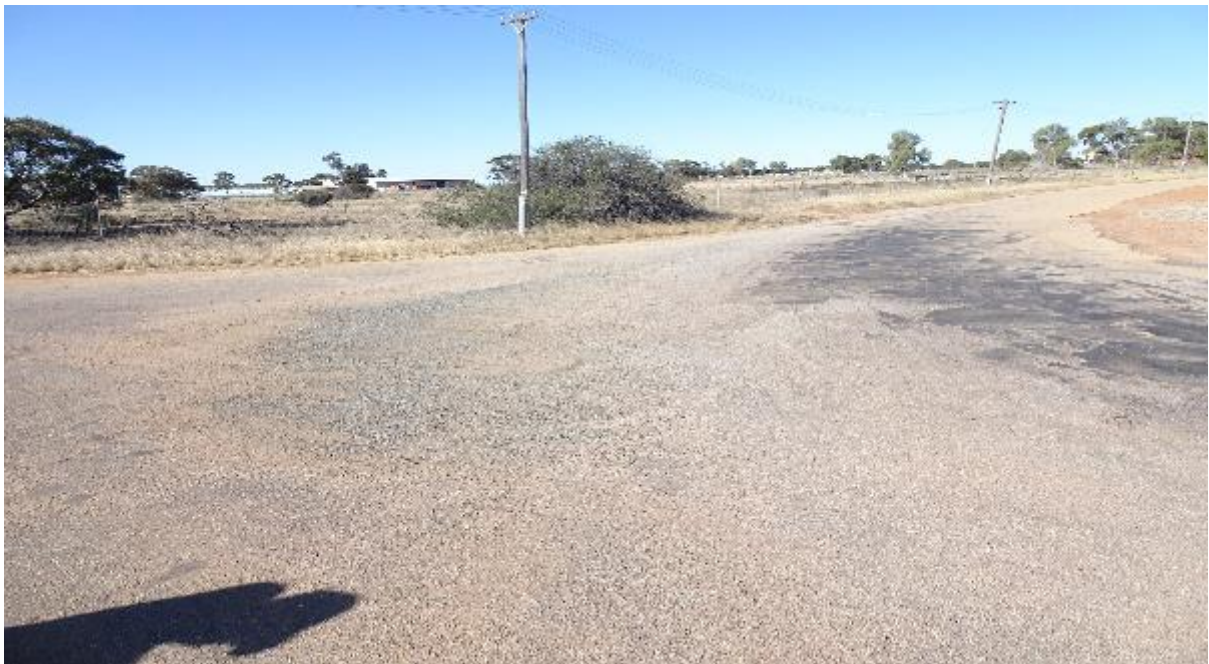
Significant amounts loose aggregate was observed to be spread across the intersection of Insignia Way and Crooks Road.

The road surface on Insignia Way on approach to Crooks Road is in poor condition due to potholes, previous patching works and significant edge break resulting in an uneven and inconsistent surface.

Finding 2.7 & 2.8– Loose aggregate and poor surface condition at intersection of Insignia Way and Crooks Road

Loose aggregate should be removed from the road surface in accordance with Austroads guidelines.

The road surface should be resealed to provide adequate surface friction for road users in accordance with Austrroads guidelines.

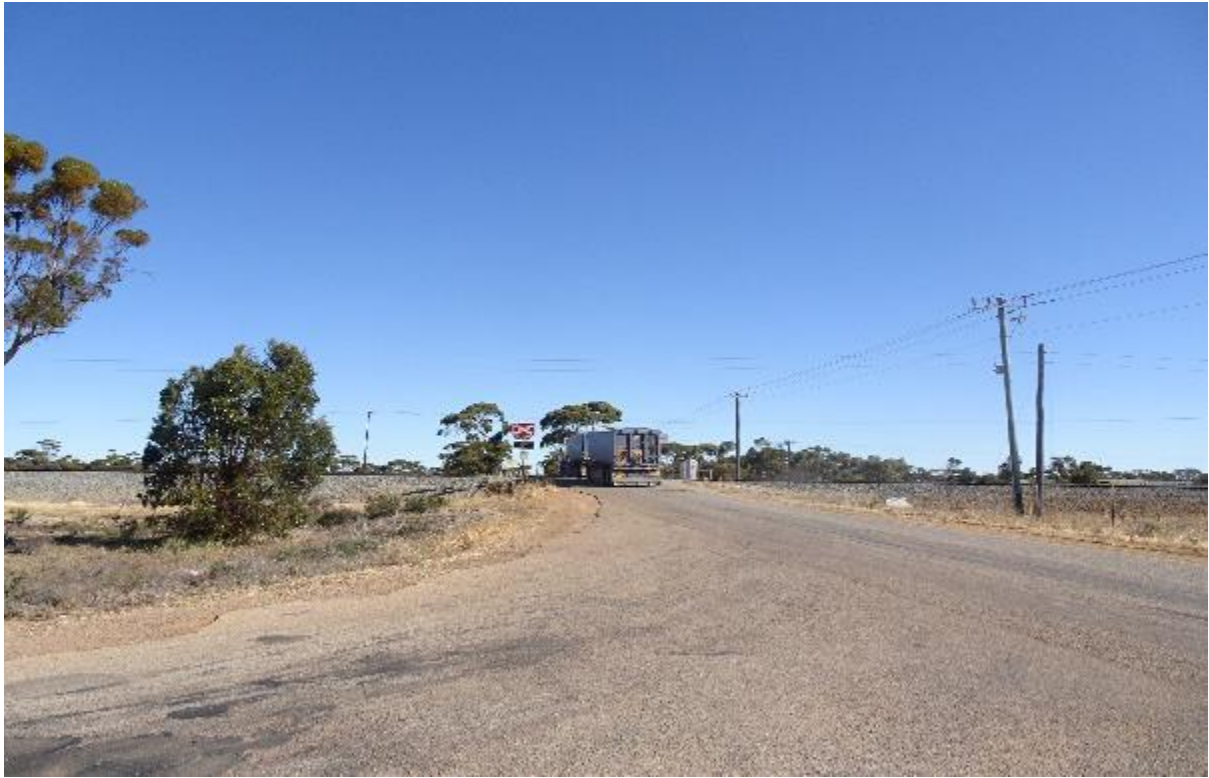
The seal width on the approach to, and across the railway level crossing, located on Crooks Road south of Insignia Way is narrow resulting in large vehicles having to negotiate the crossing in the centre of the existing seal utilising both north and southbound lanes.

The crossing is situated on a crest with restricted sightlines. Large vehicles are required to negotiate the level crossing in the middle of the roadway which could result in head on or rear end crashes.

The seal width at the crossing was measured to be 6.2 m.

Finding 2.9– Narrow seal at level crossing on Crooks Road

Adequate seal width should be provided on the approach to and at the railway level crossing in accordance with Austroads Guidelines.

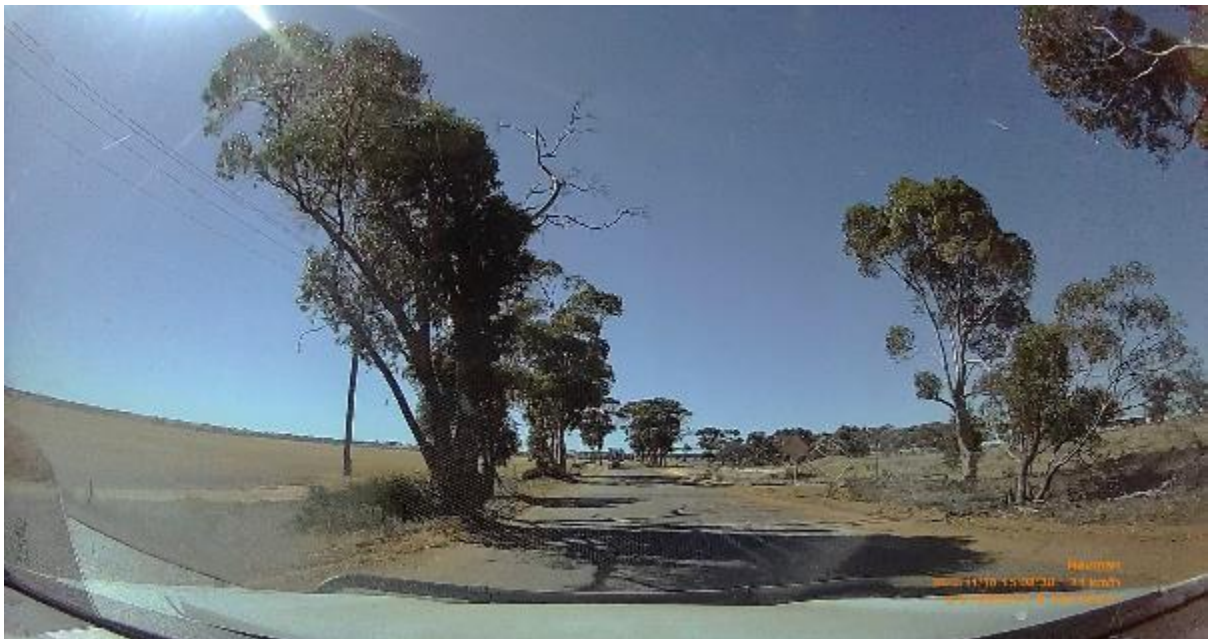
There are trees, located on the verge along Crooks Road that pose a risk to vehicle occupants in the event an errant vehicle leaves the road. The trees were measured to be as close as 1.0 m from the travelled way.

There is a risk that an errant vehicle may leave the travelled way and collide with a tree situated within the clear zone resulting in an increased severity run off road crash.

Finding 2.10– Roadside hazards within clear zone along Crooks Road

Trees located within the clear zone should be removed or suitably protected in accordance with Austroads Guidelines.
