INTERSECTION OF HENLEY BVD & WELLARD RD, WELLARD PRELIMINARY TREE REPORT

PREPARED FOR:
PORTER ENGINEERING
EVAN WILLIAMS
DIRECTOR TRAFFIC AND TRANSPORT
EVAN@PORTERENG.COM.AU

PREPARED BY:
LUKE LUMBUS
ARBORICULTURAL CONSULTANT
E: LUKE@ARBORIBUS.COM.AU - M: 0406 396 778
WWW.ARBORIBUS.COM.AU

DATE ISSUED: 9 AUGUST 2024
© ARBORIBUS CONSULTING 2024.

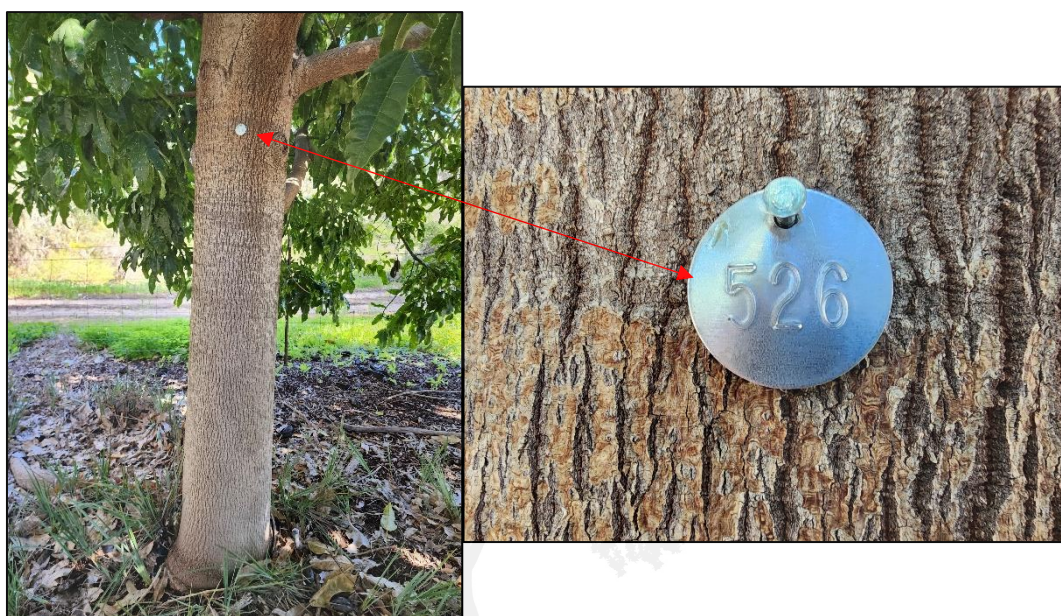
Figure 2. Showing metal tree tag and numbering of the identified trees installed approx. 1.5 meters from ground level

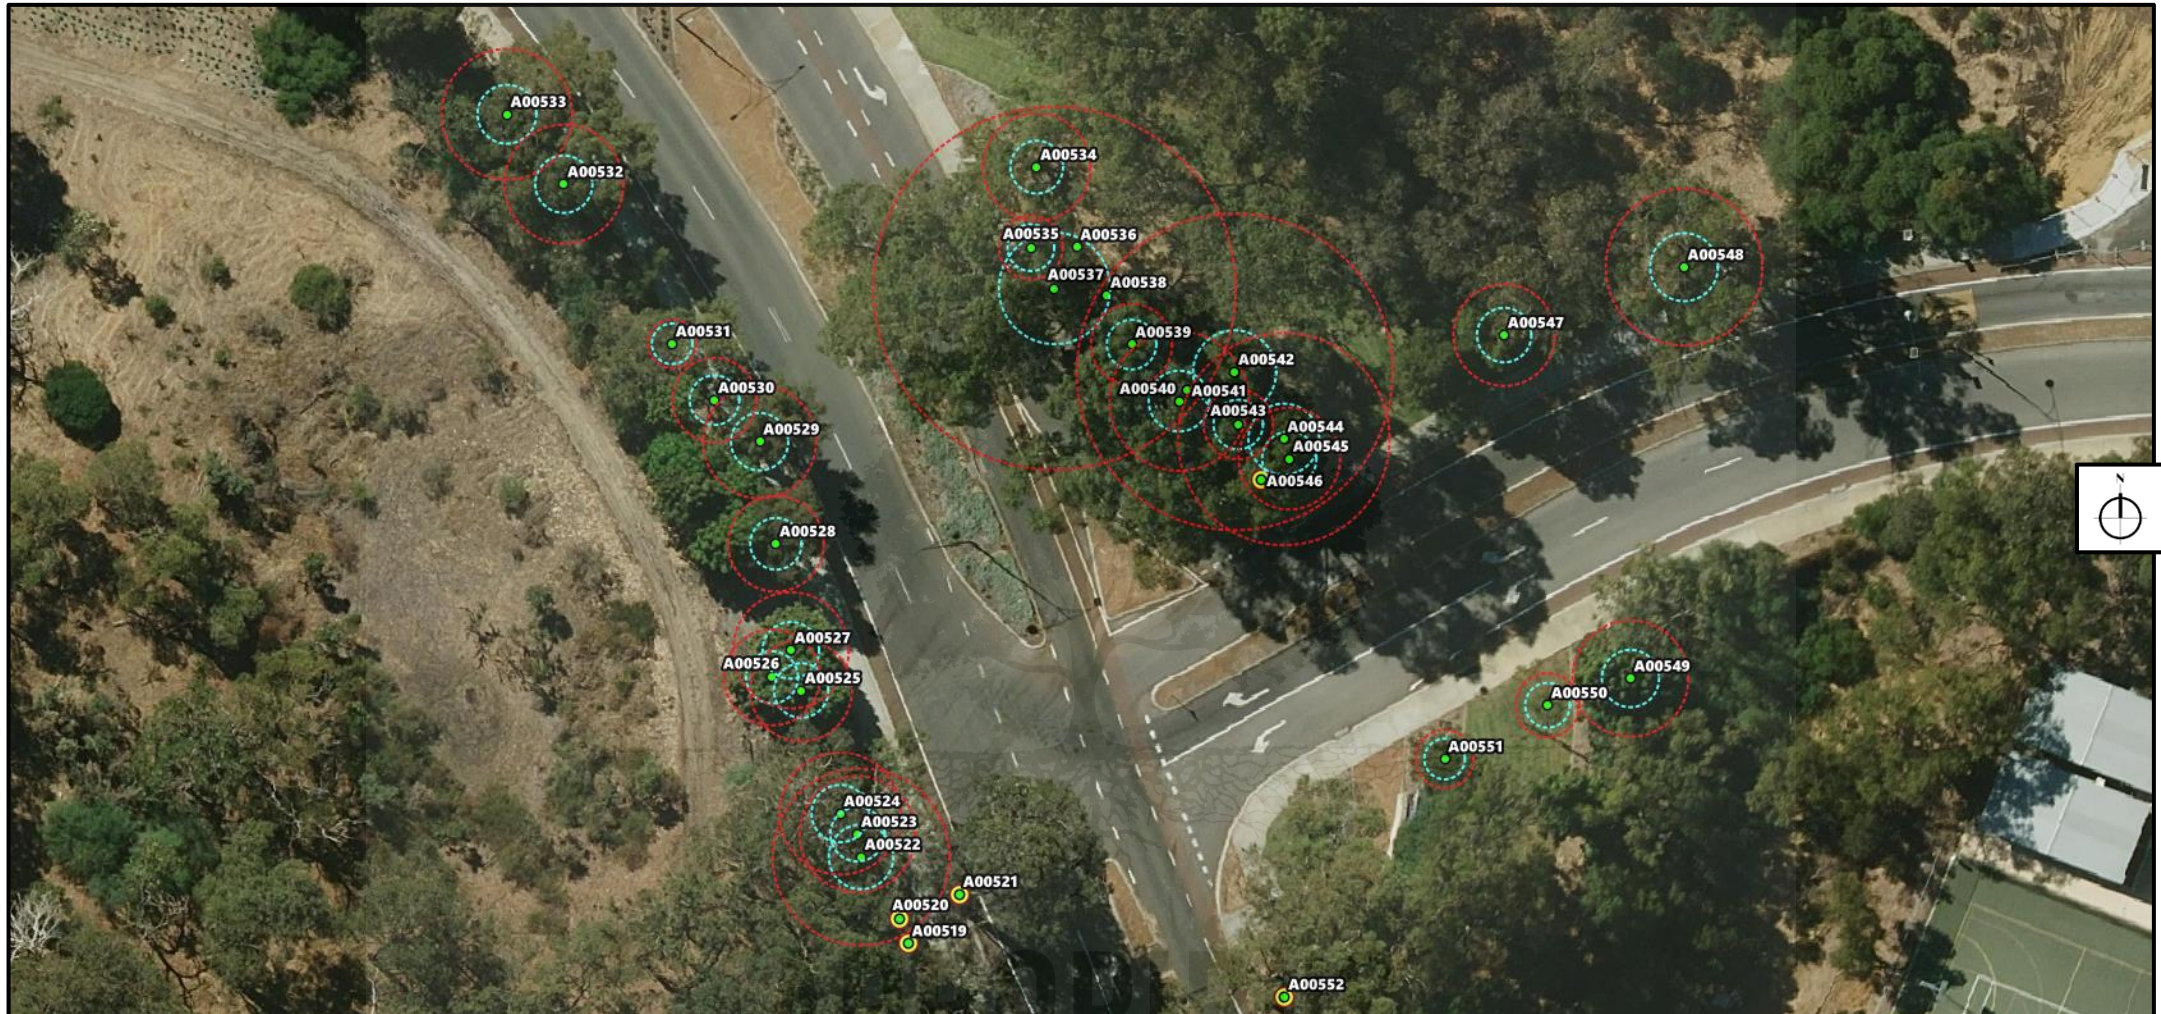
Figure 7. Image showing TPZ delineations (Red dashed lined) & SRZ delineations (Aqua dashed lined) & Trees identified for removal (yellow dot) . Please note: The location of the trees and TPZ & SRZ are indicative and for reference purposes only. Aerial image source <https://web.metromap.com.au/map> Image Date - 16 March 2024 Geographic Information System (GIS) via QGIS <http://www.qgis.org>

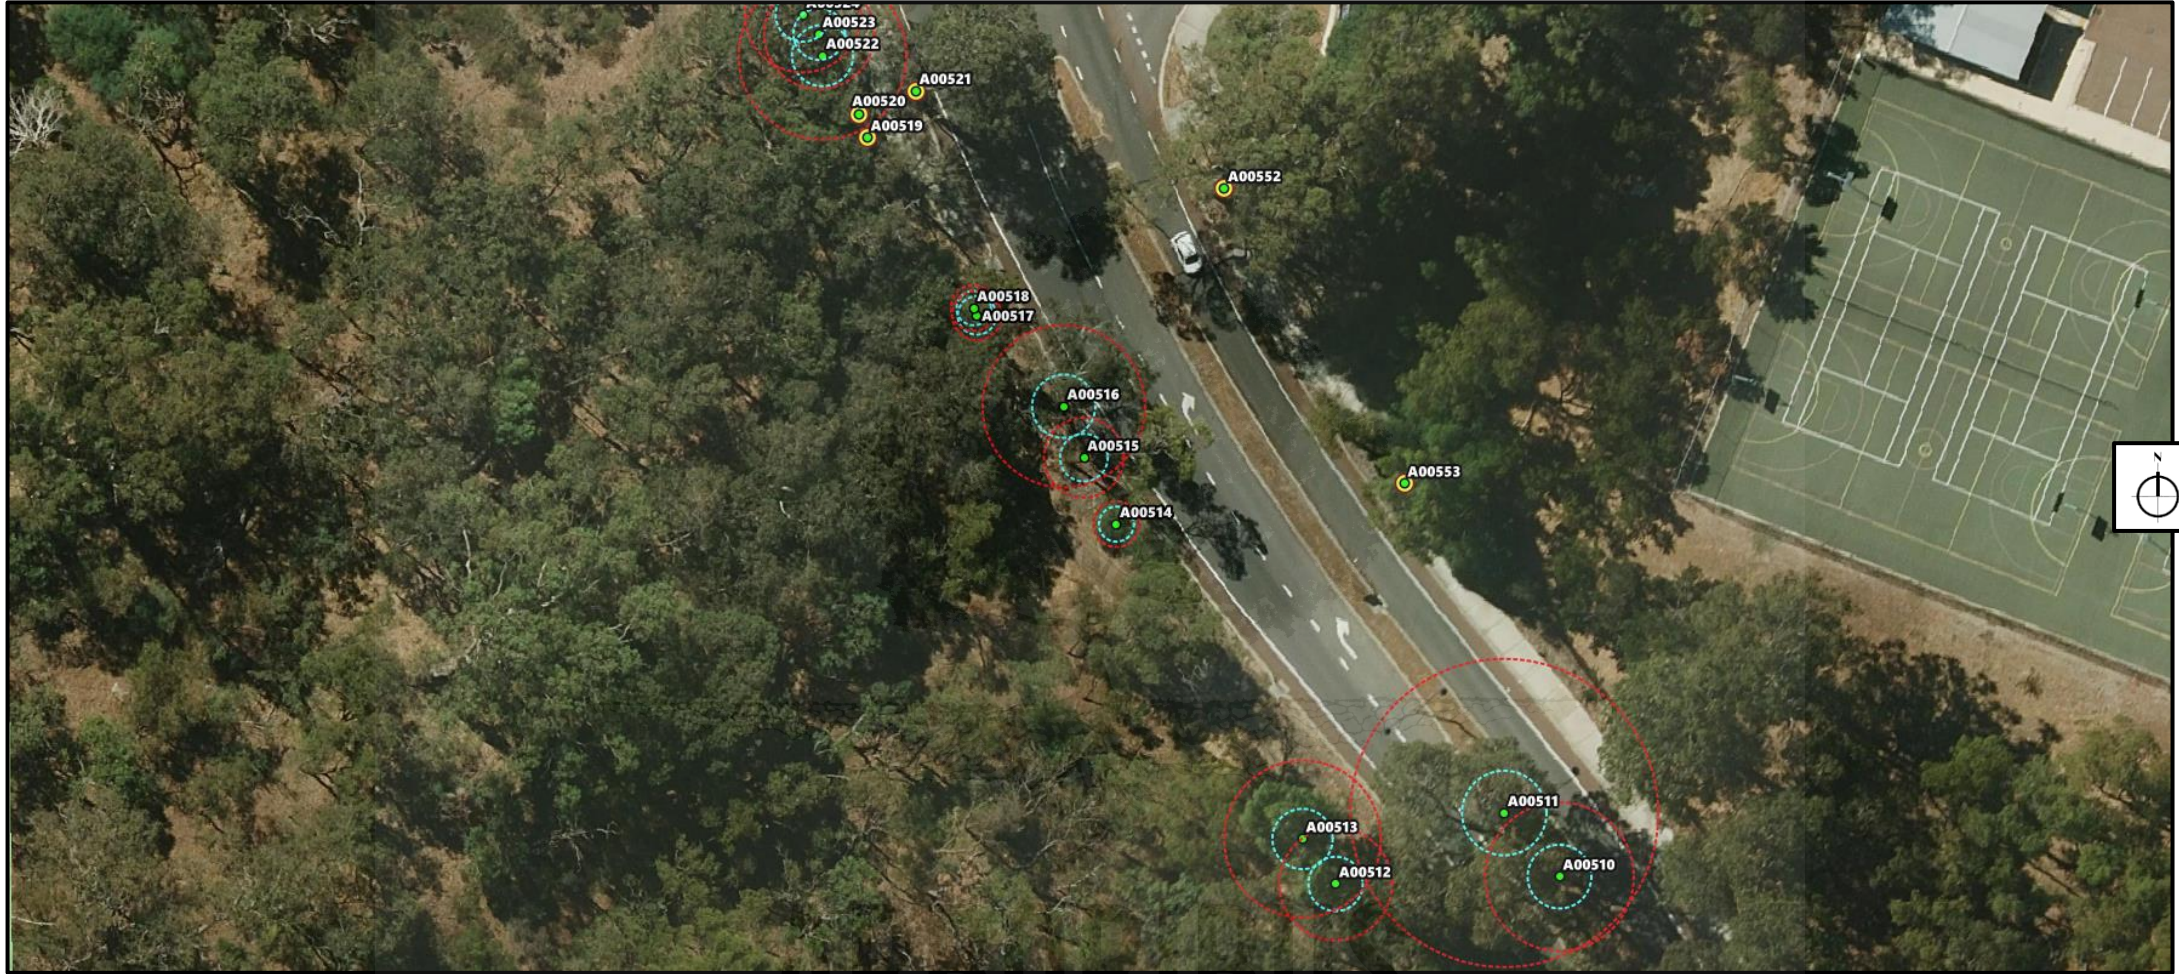
Figure 8. Image showing TPZ delineations (Red dashed lined) & SRZ delineations (Aqua dashed lined) & Trees identified for removal (yellow dot) . Please note: The location of the trees and TPZ & SRZ are indicative and for reference purposes only. Aerial image source <https://web.metromap.com.au/map> Image Date - 16 March 2024 Geographic Information System (GIS) via QGIS <http://www.qgis.org>
