December 20, 2024

**RE: Initial assessment of trees in area for potential facility; Potters Gorge Wellington
Dam National Park**

4. Summary of Key Findings

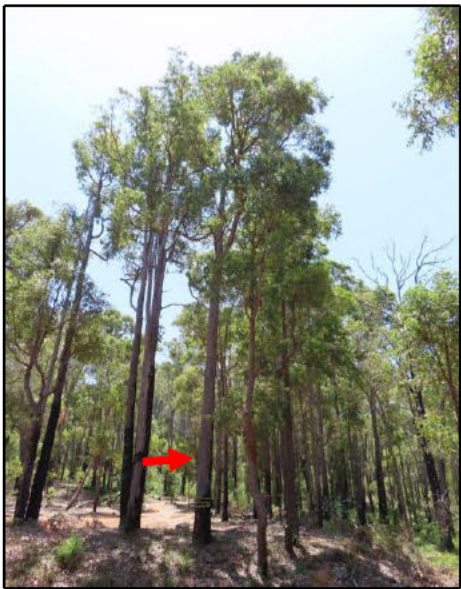
Tree Tag #	Tape Ref	Species	Approx. Height (metres)	DBH (cm)	Health	Structure	Image	Comments	Suitability
538	Blue/ Yellow B1	Jarrah (<i>Eucalyptus marginata</i>)	20	44	Excellent	Good

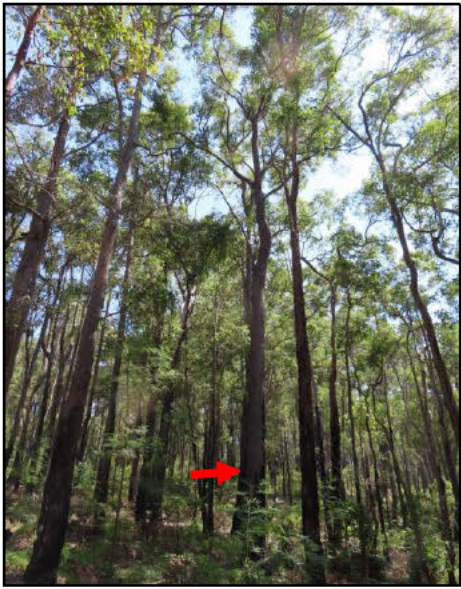
Good tree	Suitable, but lower third only
641	Blue G1	Jarrah (<i>Eucalyptus marginata</i>)	19	50	Good	Acceptable

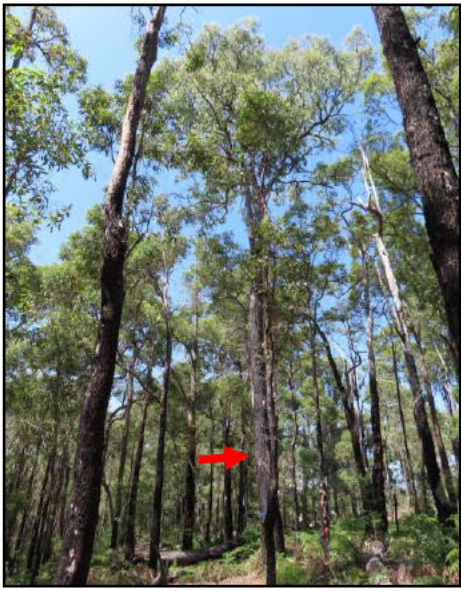
Large mature tree. Area of decay lower main stem but not of any major concerns at this time. Leggy form	Suitable; up to around half of its height
642	Blue G2	Jarrah (<i>Eucalyptus marginata</i>)	22	60	Good	Acceptable

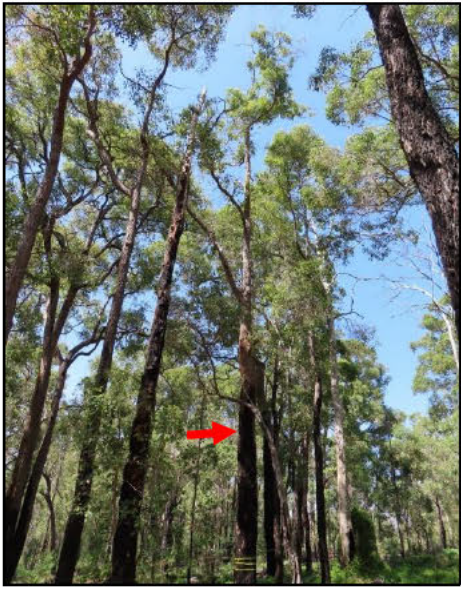
Large mature tree. Good tree. Leggy form	Suitable; up to 2/3rd height
643	Yellow B3	Marri (<i>Corymbia calophylla</i>)	18	51	Fair	Acceptable

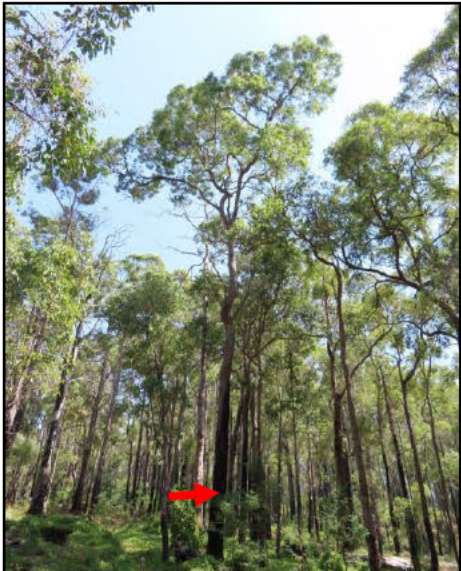
Canopy slightly sparse. Remaining leaf still good condition. Some larger deadwood in its canopy. Leggy form. Struggling	Just suitable, but lower third only and may not have much life span remaining
644	Yellow B2	Marri (<i>Corymbia calophylla</i>)	20	53	Good	Good

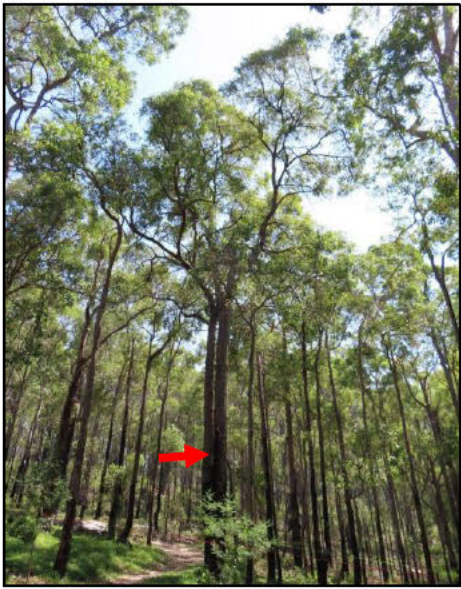
Tree Tag #	Tape Ref	Species	Approx. Height (metres)	DBH (cm)	Health	Structure	Image	Comments	Suitability
645	Yellow C1	Jarrah (<i>Eucalyptus marginata</i>)	22	69	Good	Good

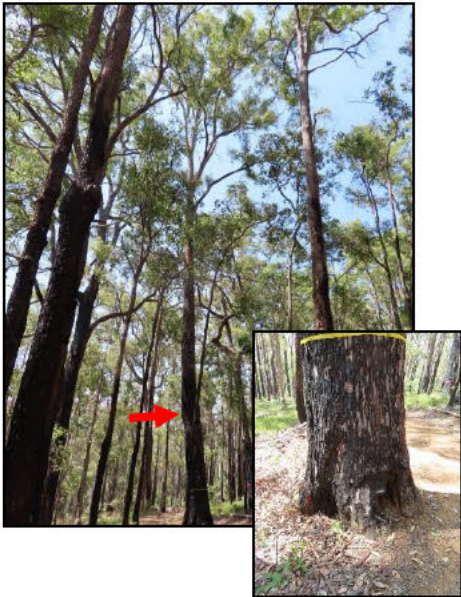
Large mature tree. Area of decay lower main stem but not of any major concerns at this time. Leans slightly downhill. Looks to be root stable but would be one to monitor if being used as it may be one that causes future issues longer term	Suitable, but lower third only

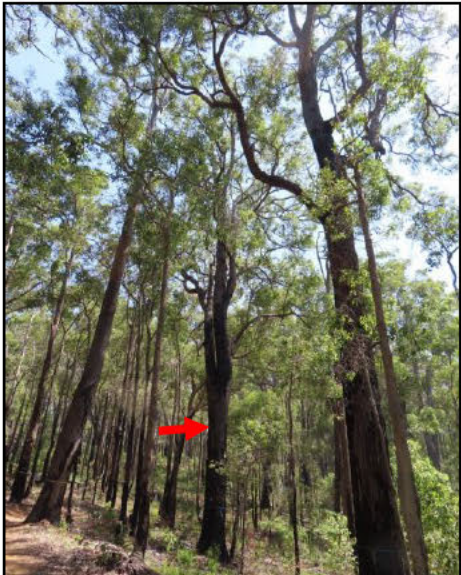
Large mature tree. Area of decay lower main stem but not of any major concerns at this time. Good tree	Suitable; up to 2/3rd height

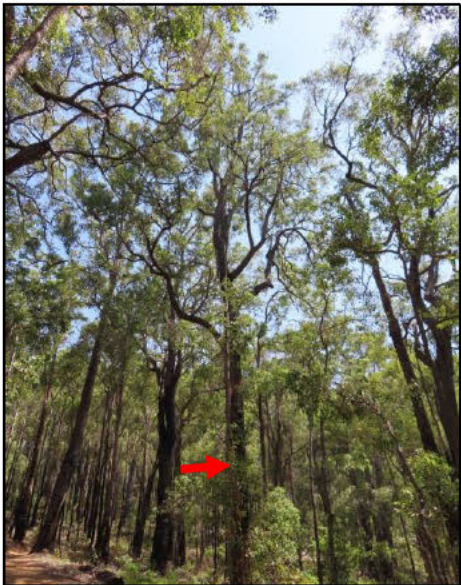
Large mature tree. Area of decay lower main stem but not of any major concerns at this time. Good tree	Suitable; up to 2/3rd height
651	Red D10	Marri (<i>Corymbia calophylla</i>)	18	50	Fair	Acceptable

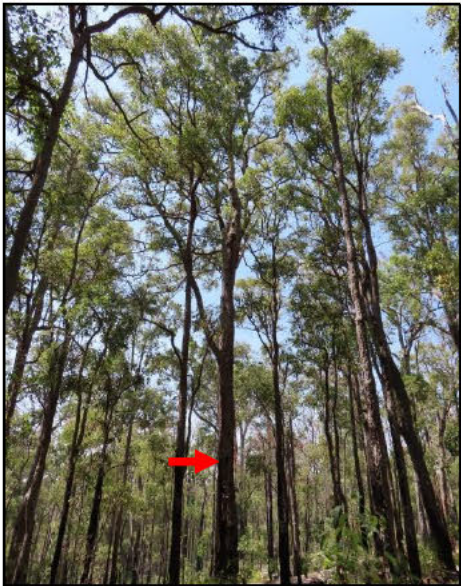
Very leggy form with no lower canopy. Signs of decay in main stem around 10-12m above ground level	Just suitable; lower quarter only though
652	Blue/ Red G5	Jarrah (<i>Eucalyptus marginata</i>)	23	71	Good	Good

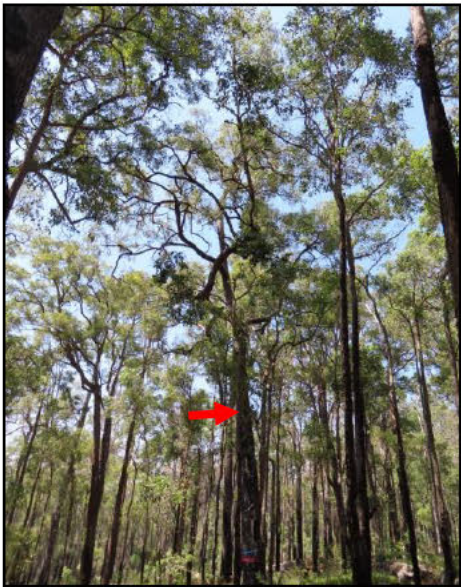
Large mature tree. Good tree. Leans slightly downhill but looks to be root stable at this time	Suitable, but lower half only
653	Yellow C6	Jarrah (<i>Eucalyptus marginata</i>)	16	25	Good	Acceptable

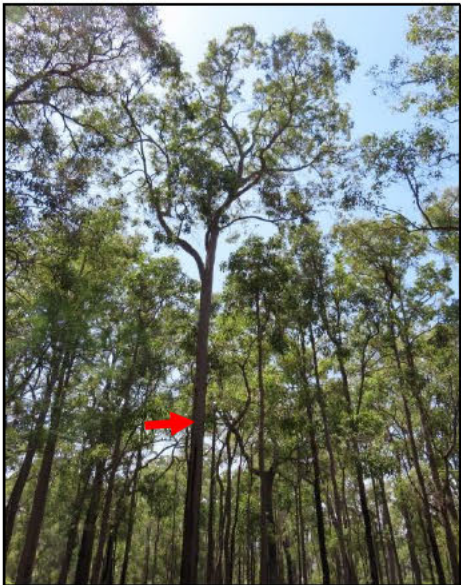
Good tree. Marri Canker noted. Looks to be minimal impact to its health at this time. Leggy form	Just suitable; lower quarter only though
656	Yellow B5	Marri (<i>Corymbia calophylla</i>)	15	45	Fair	Acceptable

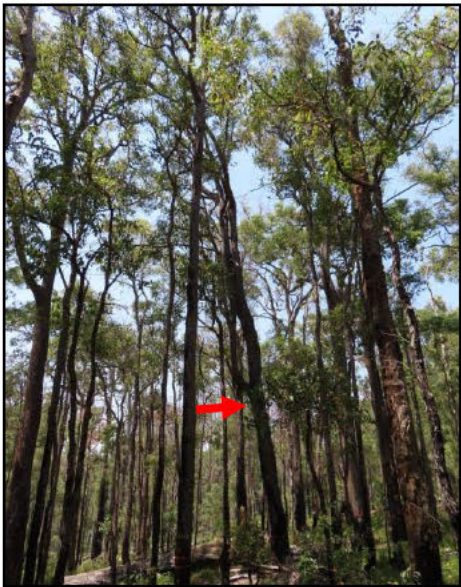
Large mature tree. Health ok but area of decay in lower main stem and leans slightly downhill (looks to have been hit by a fallen tree a long time ago). Looks ok for now but may be one that causes issues or concerns longer term	Questionable Suitability; lower quarter only
663	Red D7	Jarrah (<i>Eucalyptus marginata</i>)	24	62	Good	Acceptable

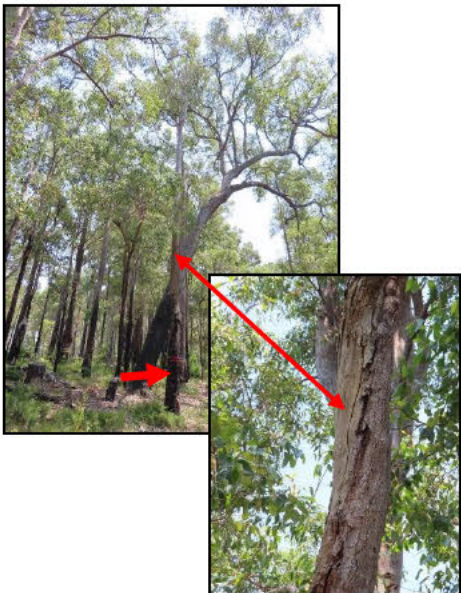
AVERAGE TREE. Canopy slightly sparse. Remaining leaf still good condition. Very leggy form and area of decay noted a few meters above ground level which looks likely to be a cause of issues longer term	Questionable Suitability. Only use lower first 2-3 metres
NOTE; Nr #666	not being used	Jarrah (<i>Eucalyptus marginata</i>)	20	70	Good	Acceptable

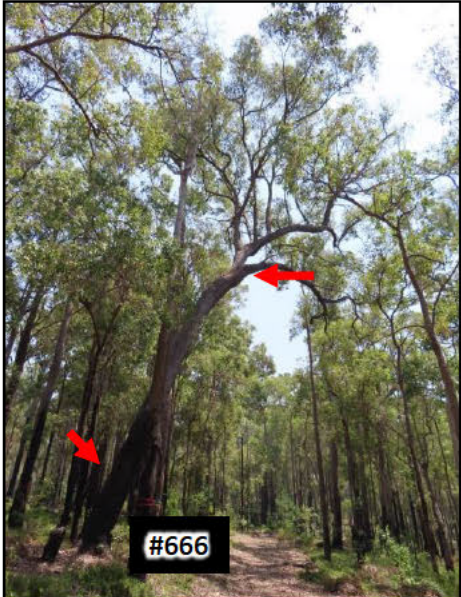
Large mature tree. Grown on a major angle/lean. Not being selected for use but may need some load reduction works depending on what Targets may be introduced into its Fall Zone	not being used but may need some load reduction works depending on what Targets may be introduced into its Fall Zone

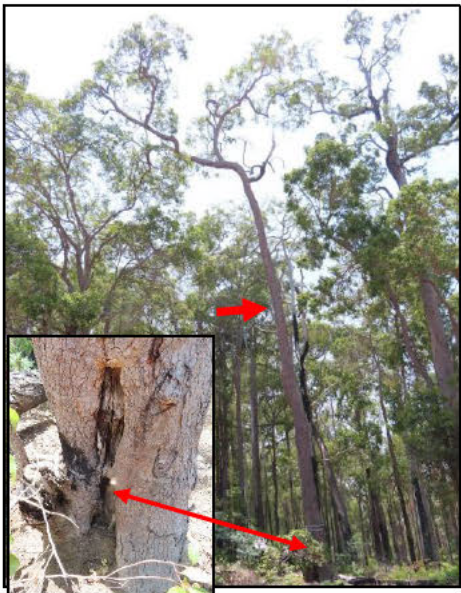
Large mature tree. Canopy slightly sparse. Remaining leaf still good condition. Very leggy form with no lower canopy. Leans slightly. Area of decay in lower main stem. Ok but form may cause issues in the future longer term	Questionable Suitability. Only use lower first 3-4 metres
676	Red E1 & Red E2	Marri (<i>Corymbia calophylla</i>)	18	39, 26	Good	Acceptable

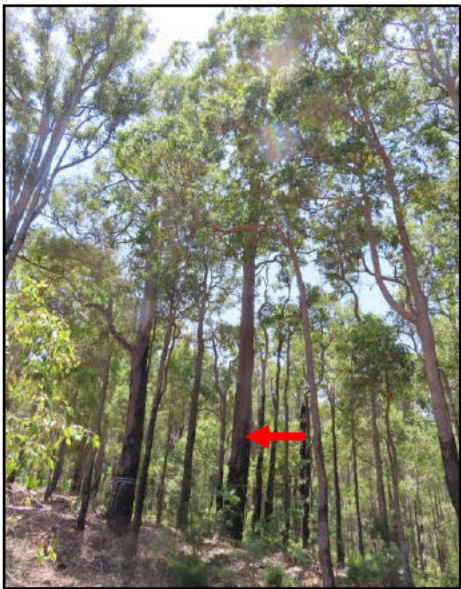
Large mature tree. Good tree. Marri Canker noted. Looks to be minimal impact to its health at this time. Some larger deadwood in its canopy	Suitable; up to 2/3rd height
685	Blue/ White F1	Jarrah (<i>Eucalyptus marginata</i>)	24	68	Good	Good

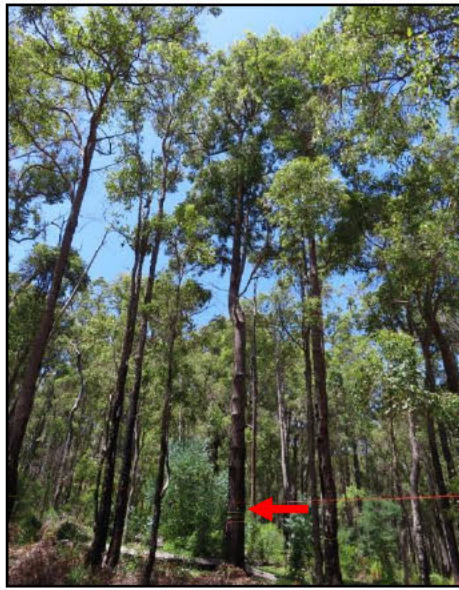
Large mature tree. Good tree. Leggy form with no lower branch structures. Swoop on main stem but doesn't look to be a concern at this time	Suitable, but lower third only
