## Construction of Emergency Access Way (EAW)

Falls Road Hovea

Site visit 14 December 2023

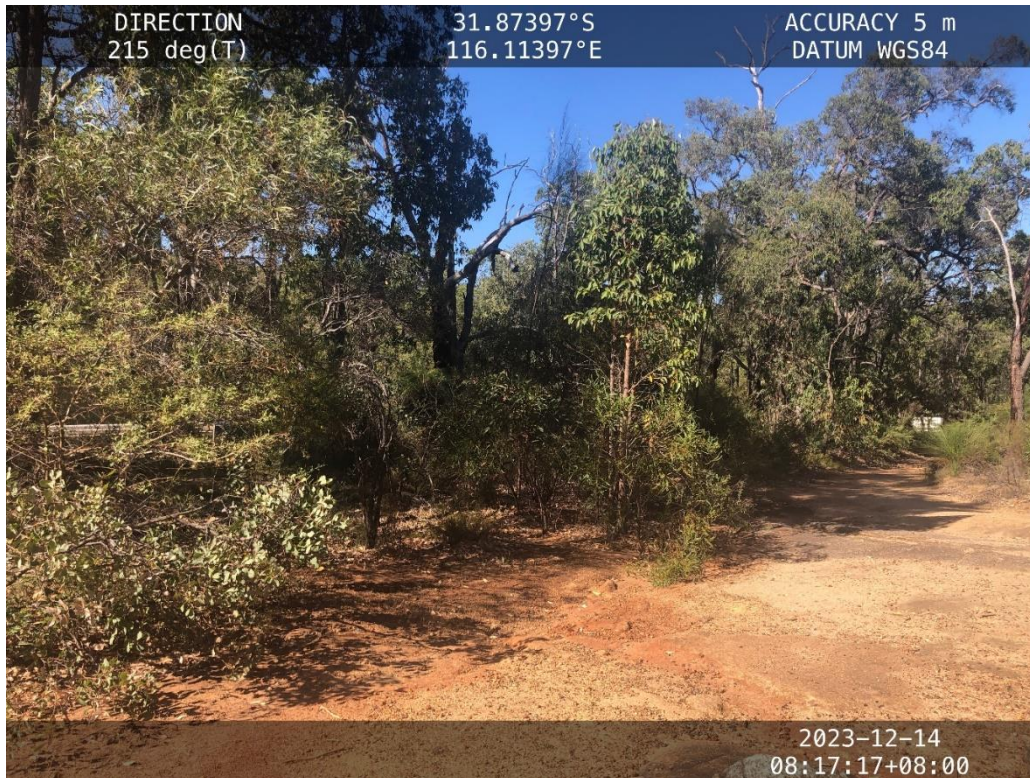
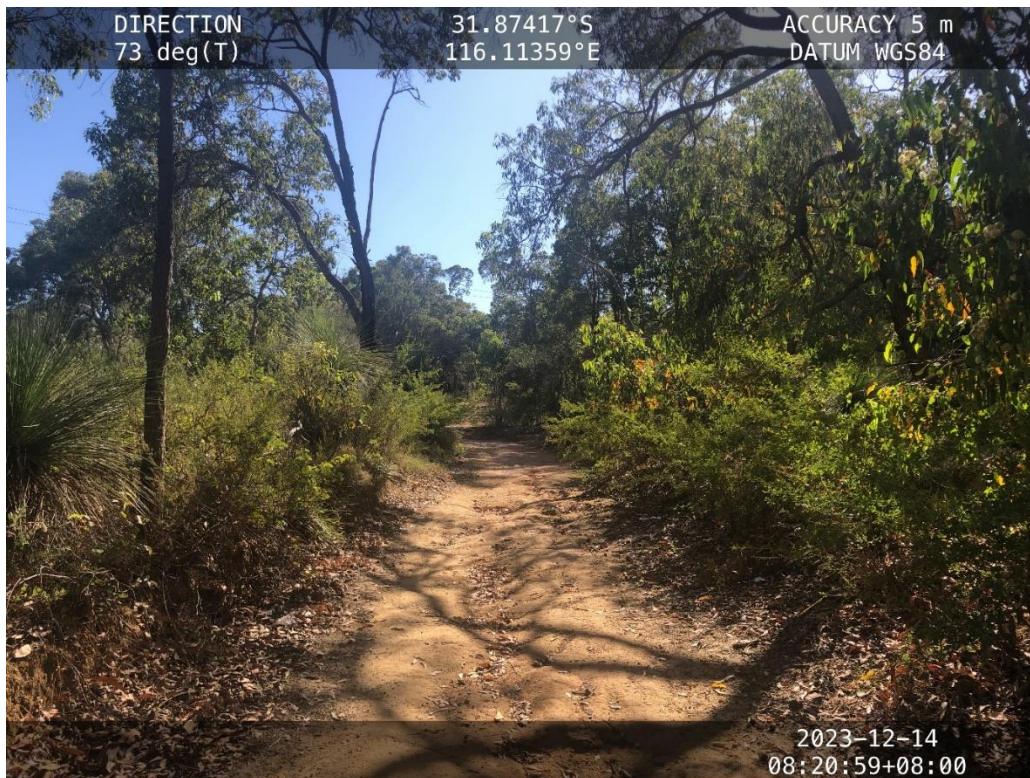
**Photo 1 and 2 (above):** Native vegetation either side of the existing track will be impacted to construct the emergency access way (EAW). This measures 40sqm on the north side and 45sqm on the southern side of the track. Figure 1 highlights the areas that will be cleared (shown as Area 1).

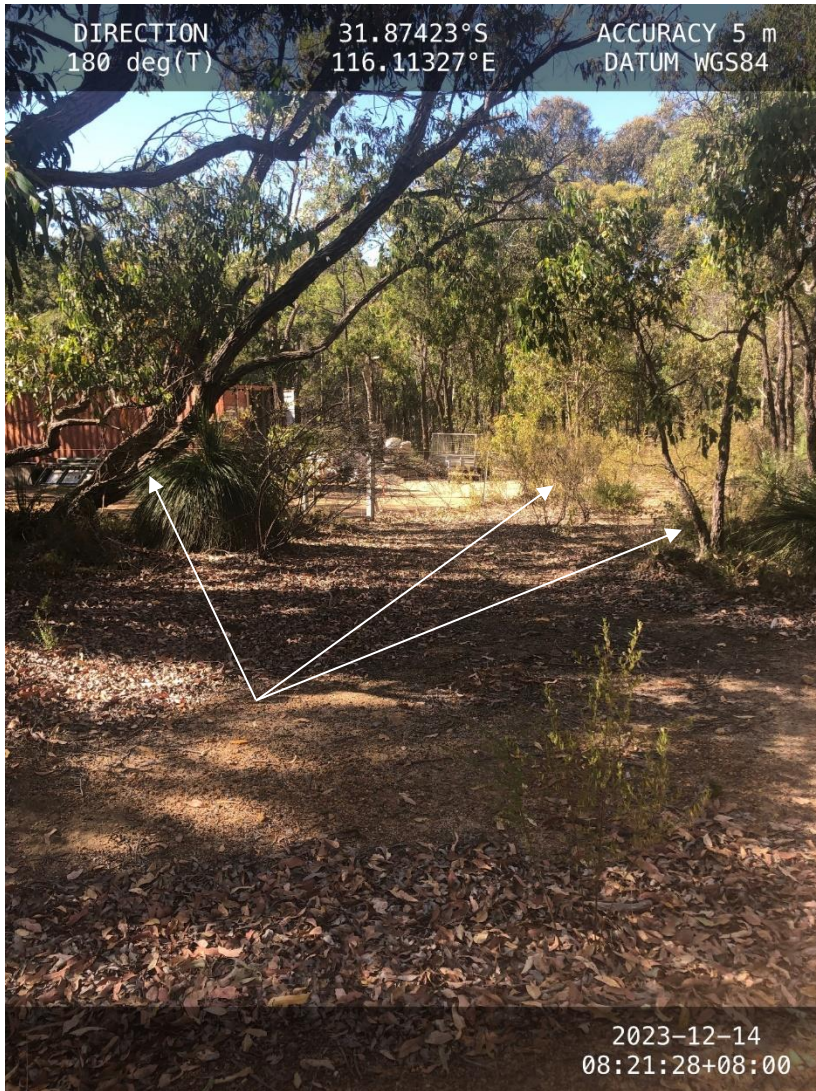
**Photo 3:** White arrows show native vegetation that will be removed. This is two (2) native trees (with no native vegetation underneath), and a small cluster of native shrubs measuring 5sqm.

Figure 2 highlights the area that will be cleared (shown as Area 2).

Grass tree will be retained. Overhanging branches removed to allow emergency access.

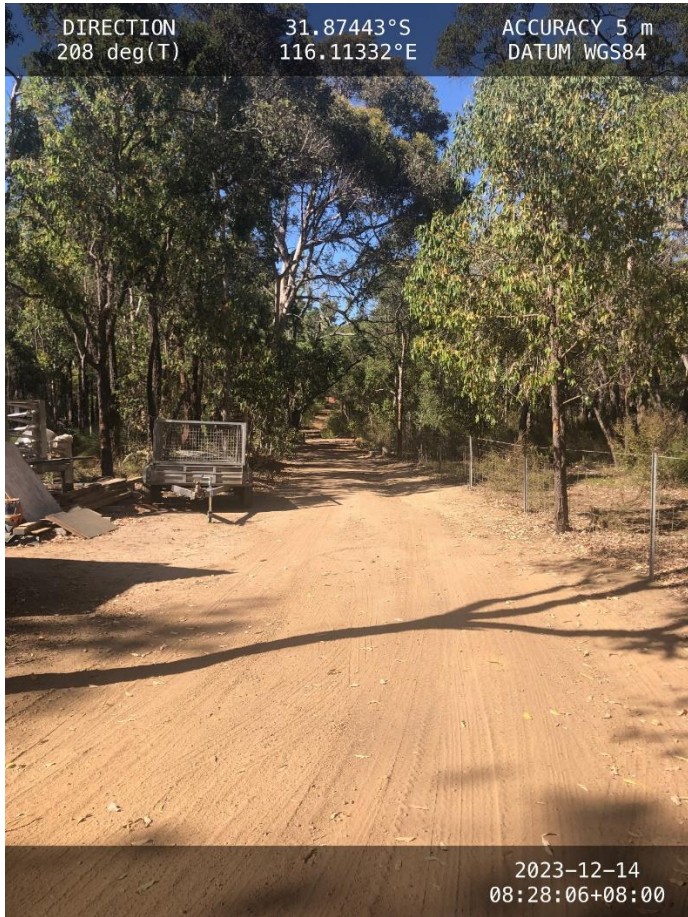
**Photo 4 (left):** No clearing required as access way already exists and is sufficient width.

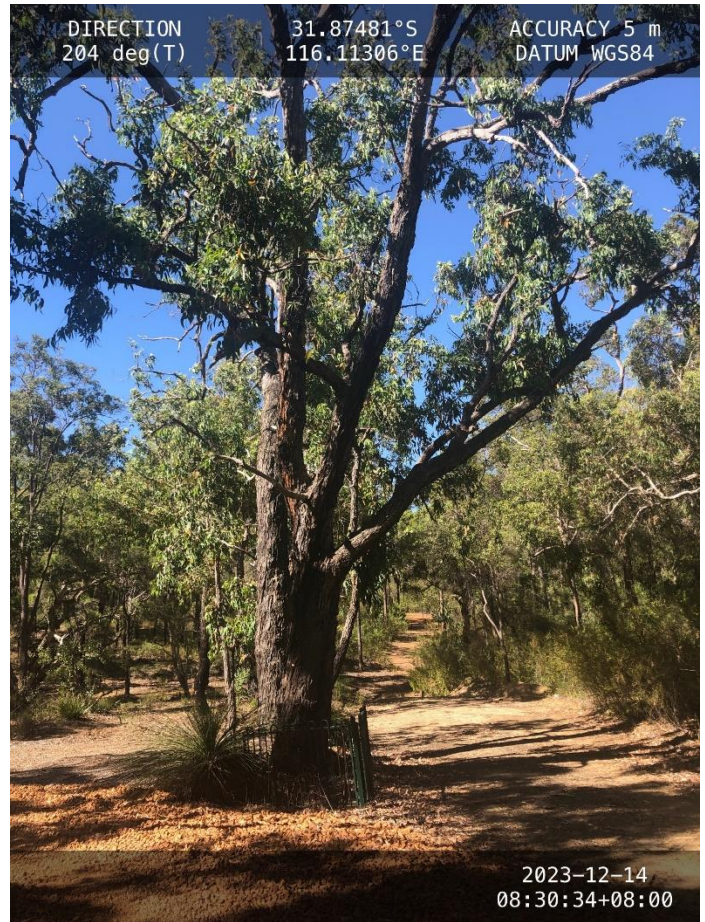
**Photo 5 (right):** Pruning (only) required of the branch that overhangs the access way.

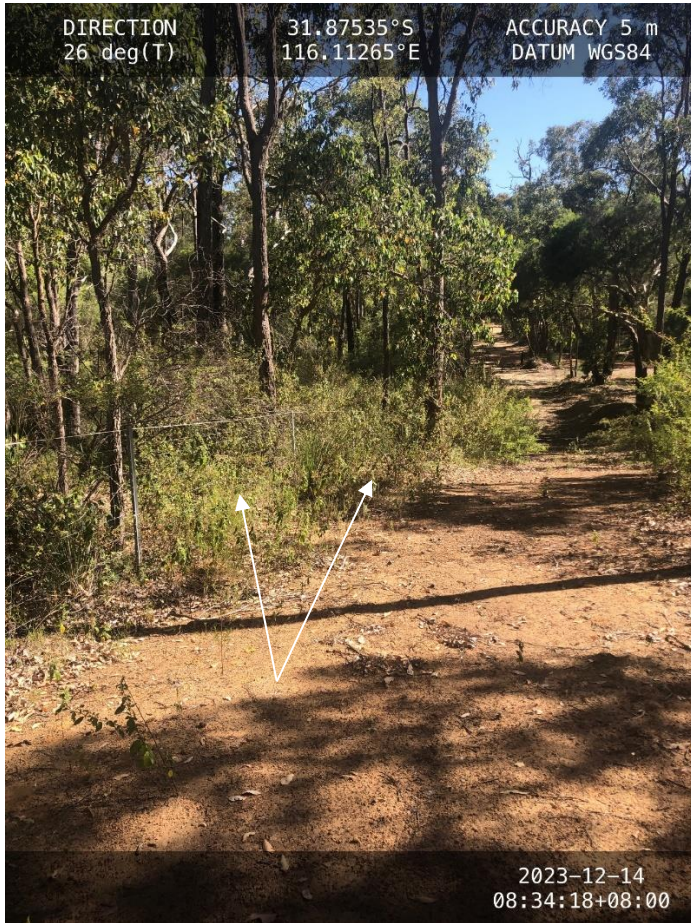
**Photo 6 (top left):** Native vegetation to be cleared along the western boundary of the EAW. The total area measures 42sqm. Figure 3 highlights the total area (shown as Area 3).

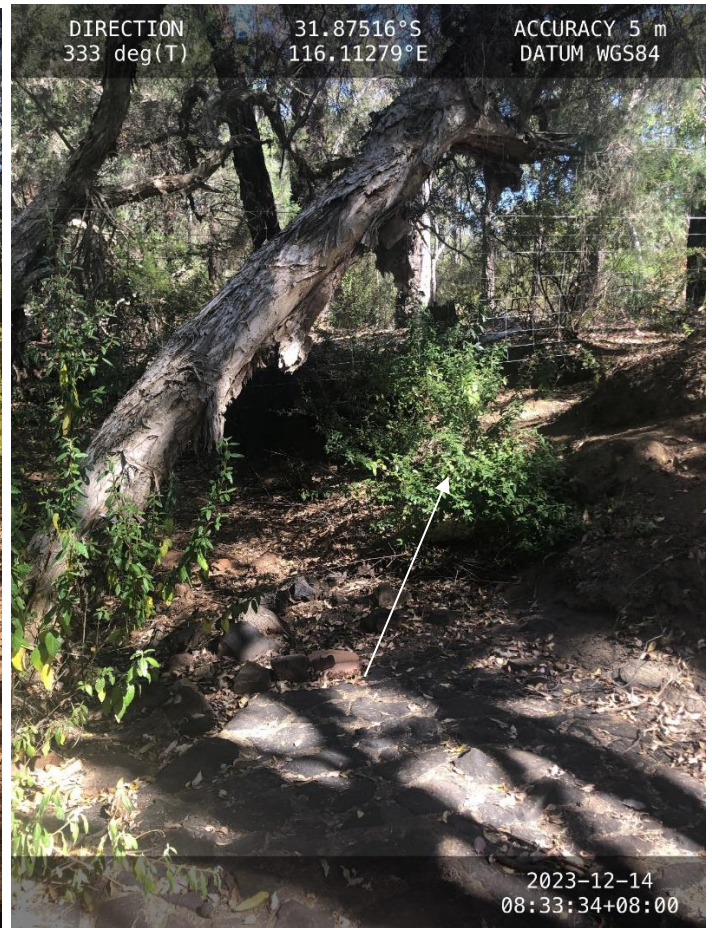
**Photo 7 (top right):** Jane Brook Watercourse. Future works include constructing a crossing suitable for a fire appliance.

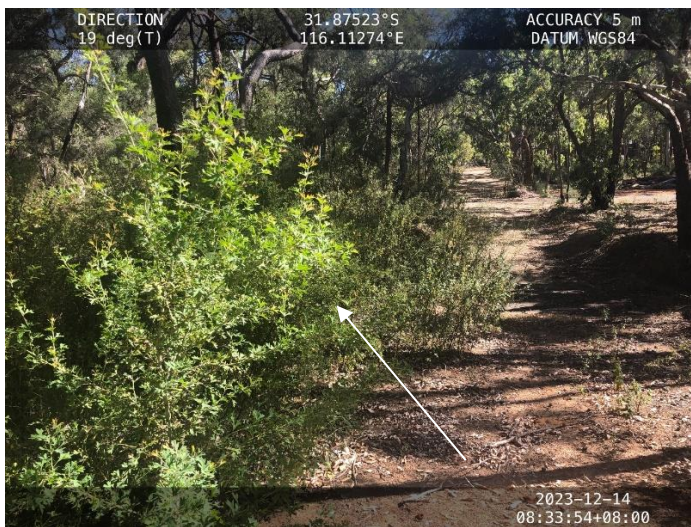
**Photo 8 (bottom left):** Alternative view of the native vegetation along the western boundary of the EAW.

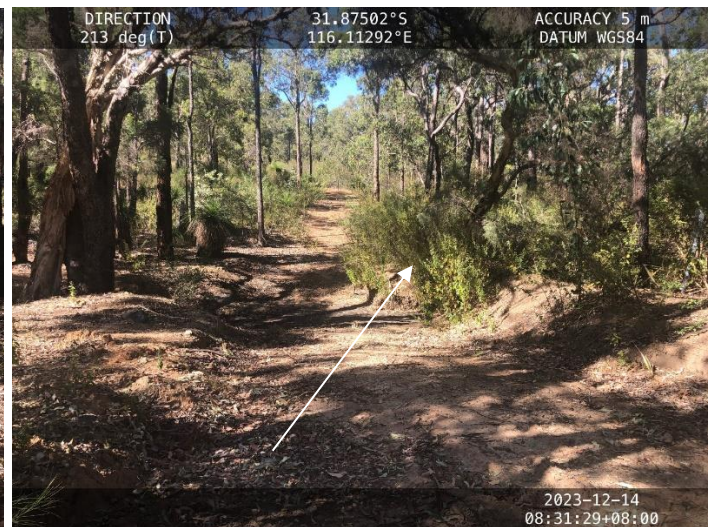
**Photo 9 (bottom right):** Alternative view of the native vegetation along the western boundary.

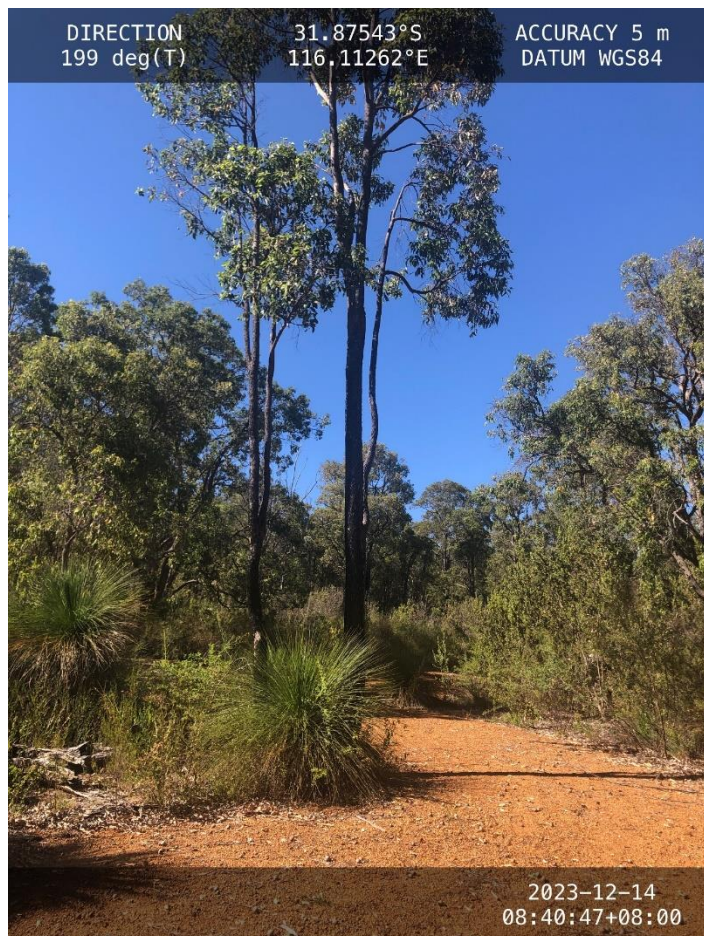
**Photo 10 (top left):** Clump of native vegetation, two small native trees (under 20cm DBH) on the east side of the track, to be removed. Measures 4-5sqm.

Figure 4 highlights the areas above to be cleared (shown as Area 4).

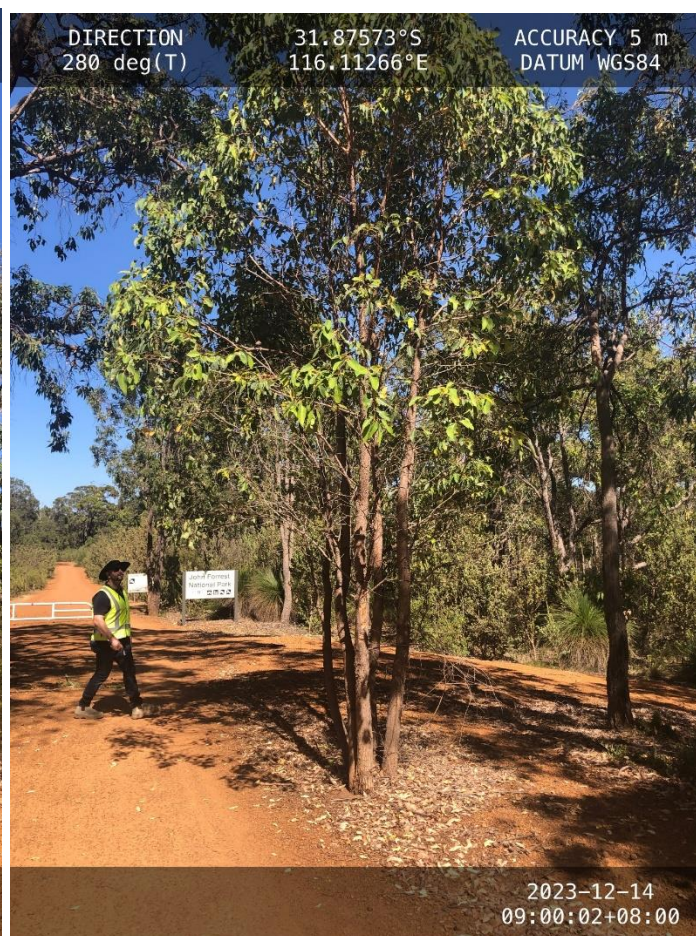
**Photo 11 (top right):** Clump of four (4) saplings all under 10cm DBH. No native vegetation underneath.

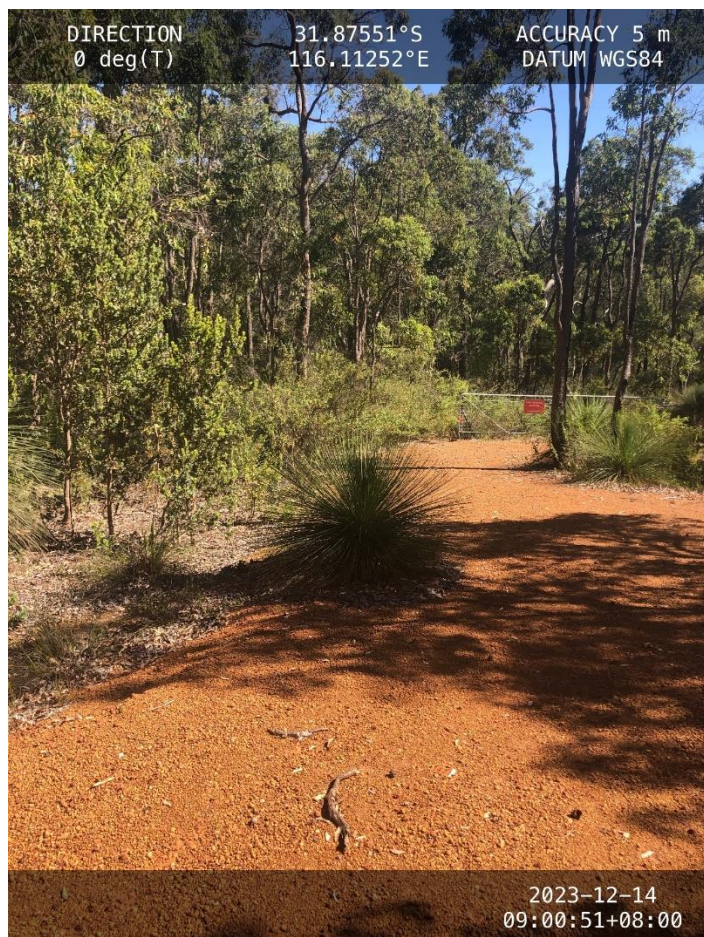
**Photo 12 (bottom left):** one grass tree impacted. Approx. 2sqm.

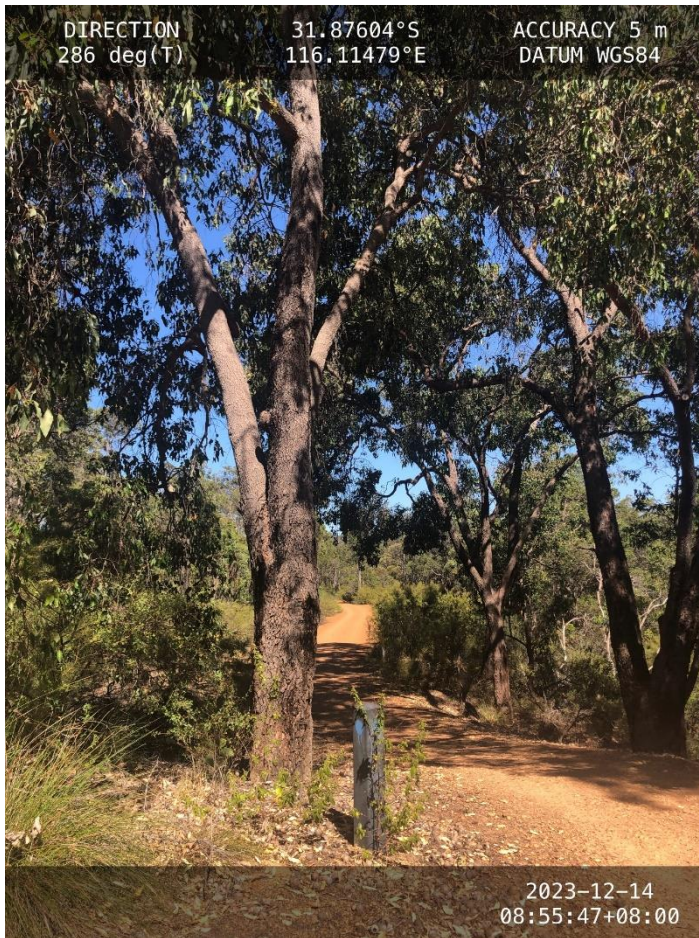
**Photo 13 (above left):** Marri tree to be removed and measures 50cm DBH. Current width of the track is not wide enough to all the passage of a large fire appliance.

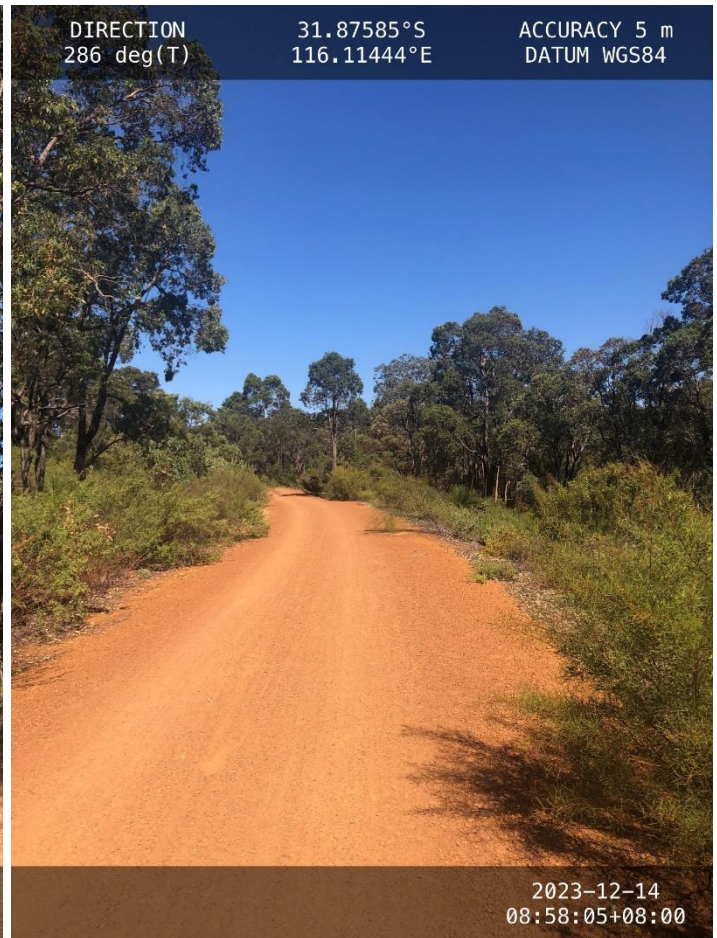
**Photo 14 (above right):** Heritage trail track. No clearing required (except for the Marri tree as shown in the photo above). The track is clear already and meets the requirements for the EAW.

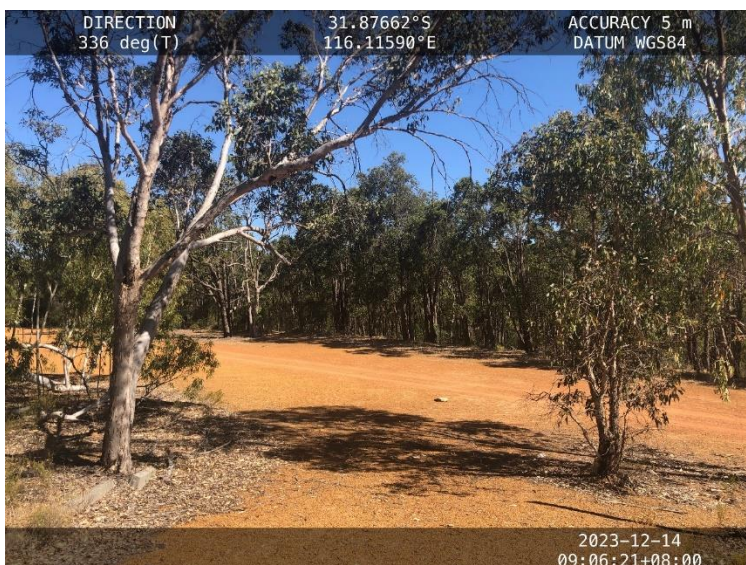
**Photo 15:** Track is wide enough to allow the passage of a fire appliance. No clearing required.
