Attachment 2 – Map of Proposed Clearing Area

Author: G. Davis	Proposed Clearing Area for Mullaloo Wall Repairs	
		Scale (A4): 1:650		
		Date: 6/11/2025		
		<div>10 0 50</div> <div>Metres</div>

Attachment 4 – Photos of Proposed Clearing Area Taken on 22 August 2025

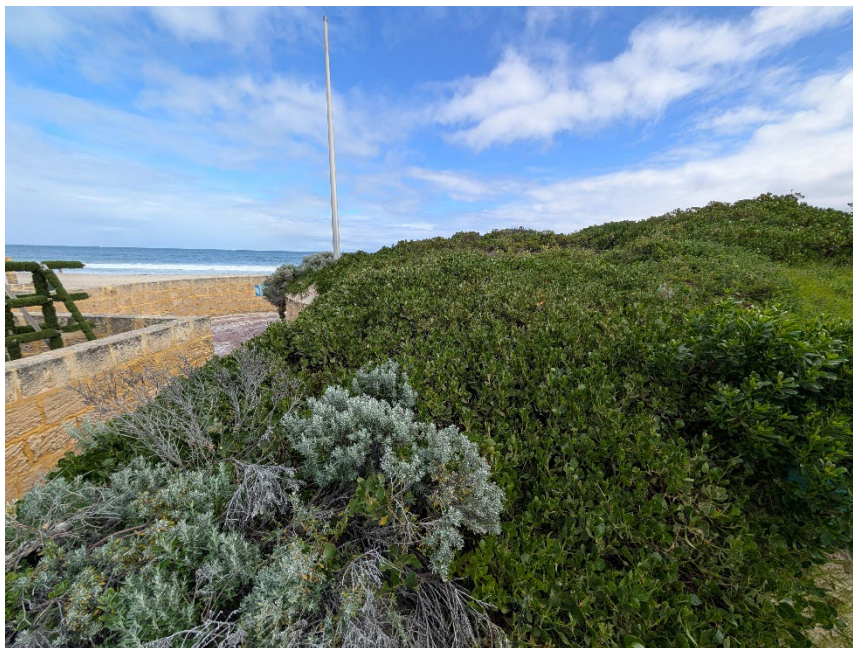
Plate 1: Proposed clearing area facing West towards Mullaloo Beach. *Scaevola crassifolia* and *Olearia axillaris* will need to be either removed or pruned back to allow space for works.

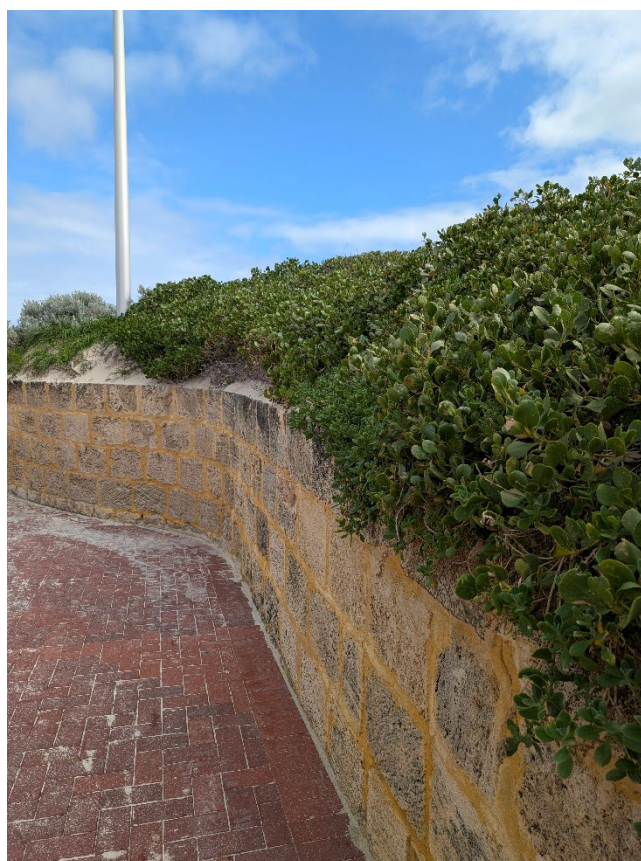
Plate 2: Proposed clearing area from ground level perspective, facing in the same direction as Plate 1.

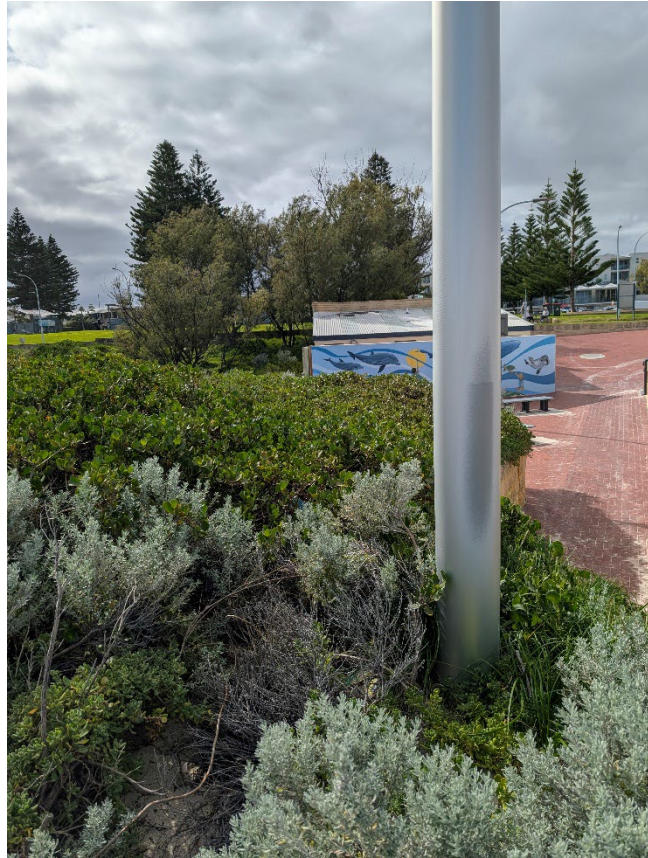
Plate 3: Proposed clearing area facing East towards Tom Simpson Park public toilets.

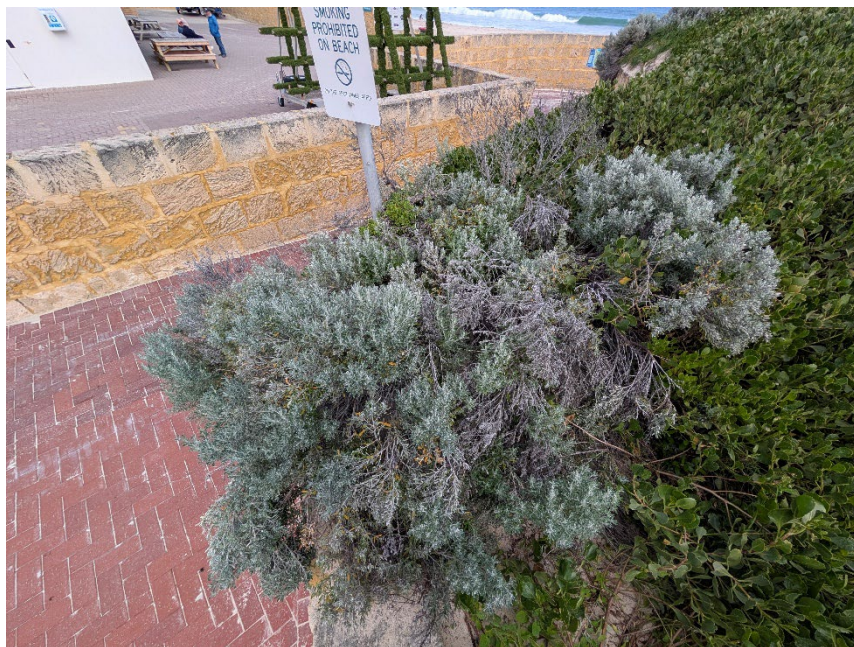
Plate 4: A large *Olearia axillaris* bush that will need to be removed to provide access for crew to conduct maintenance.

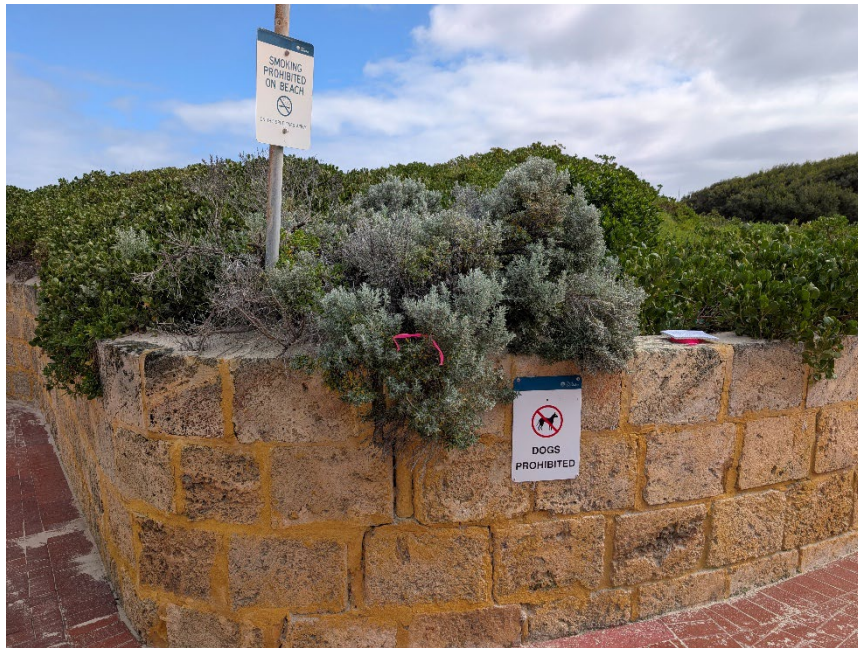
Plate 5: Frontal view of *Olearia axillaris* photographed in Plate 4.

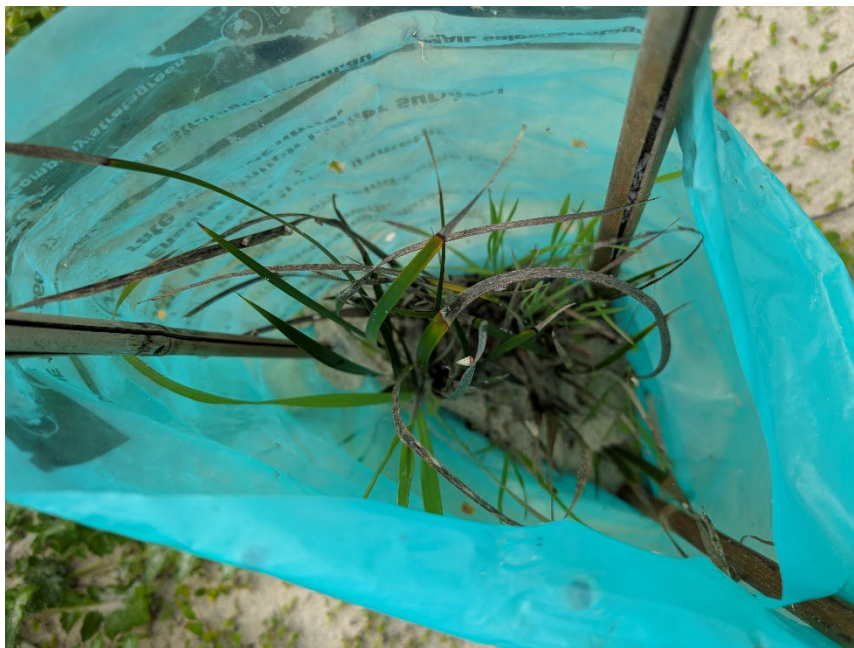
Plate 6: Planted *Lepidosperma gladiatum* within proposed clearing area.

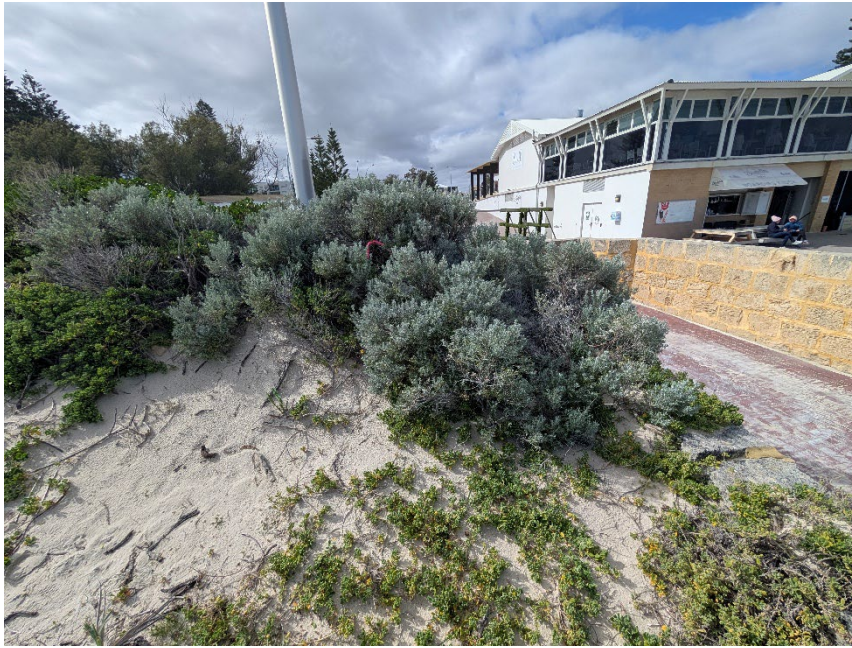
Plate 7: *Olearia axillaris* that will need to be cleared for access. Photographed on Western side of proposed clearing site, facing East towards Tom Simpson Park public toilets.

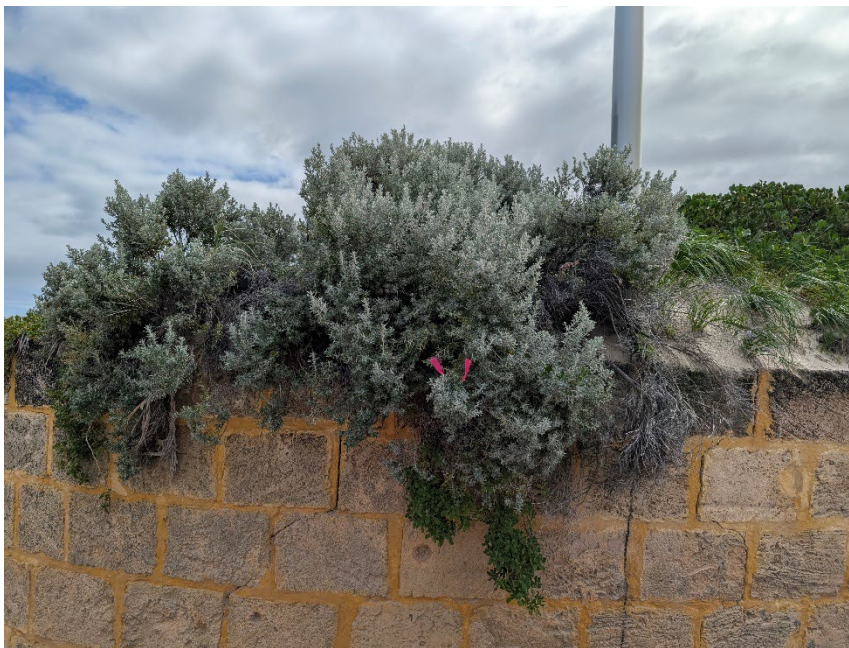
Plate 8: Photo of same *Olearia axillaris* taken in Plate 7, facing limestone wall.

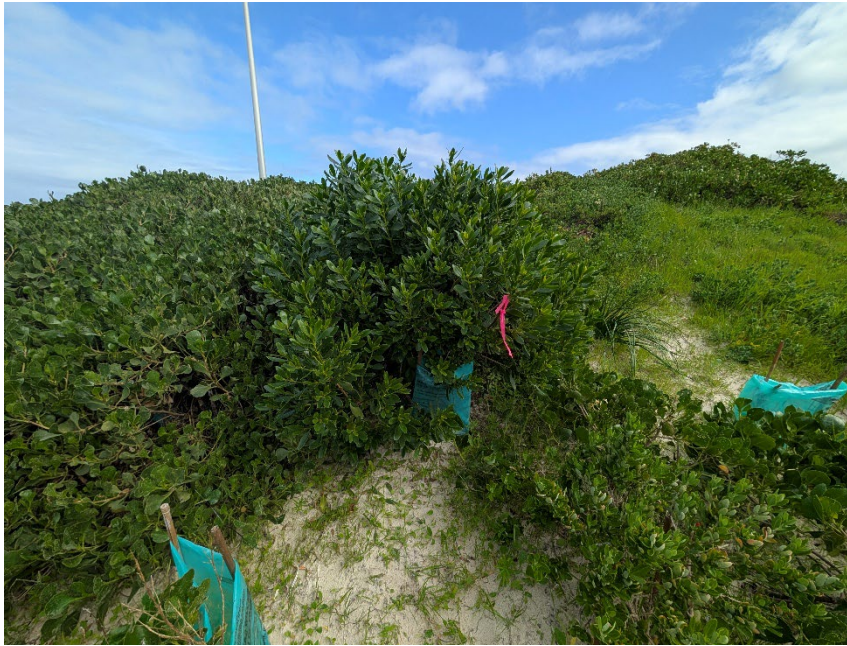
Plate 9: *Myoporum insulare* that will be pruned back to provide access for maintenance.

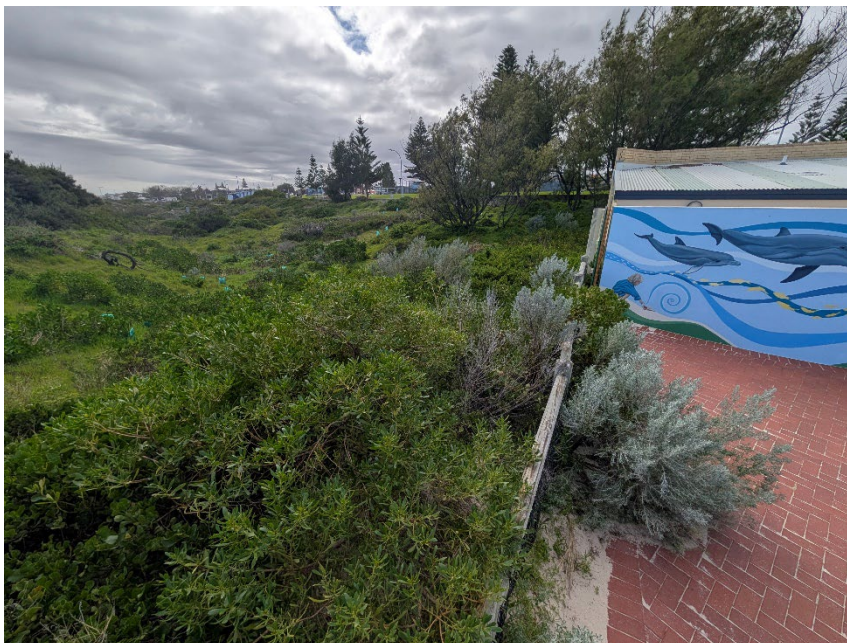
Plate 10: Eastern access point considered for access to limestone wall. This entry point was decided against, as the area contained a large coverage of established native plants that would need to be removed.

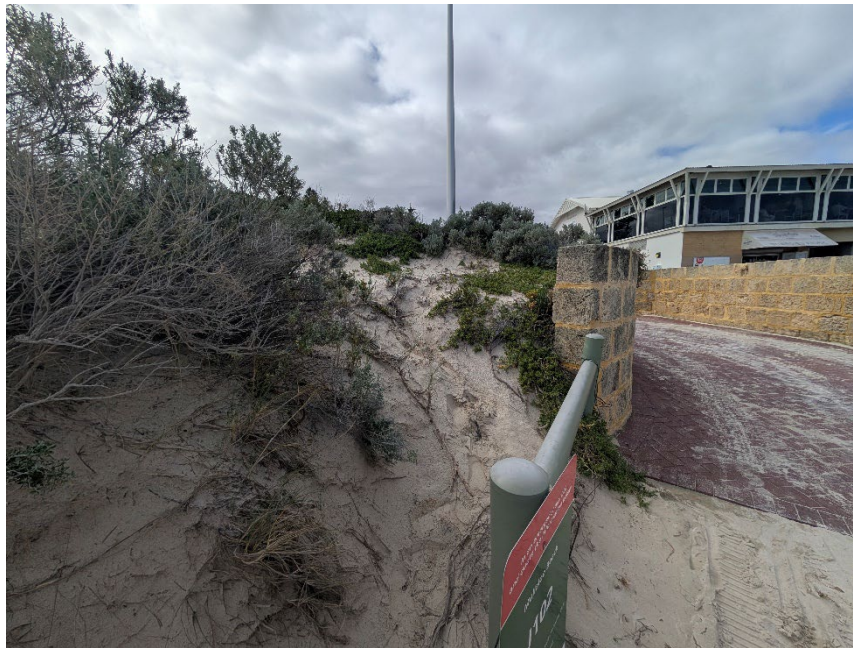
Plate 11: Western entry point that was considered as an entry point for contractors. This entry point was decided to be the most appropriate point, as the area is fairly degraded with little coverage of native vegetation.

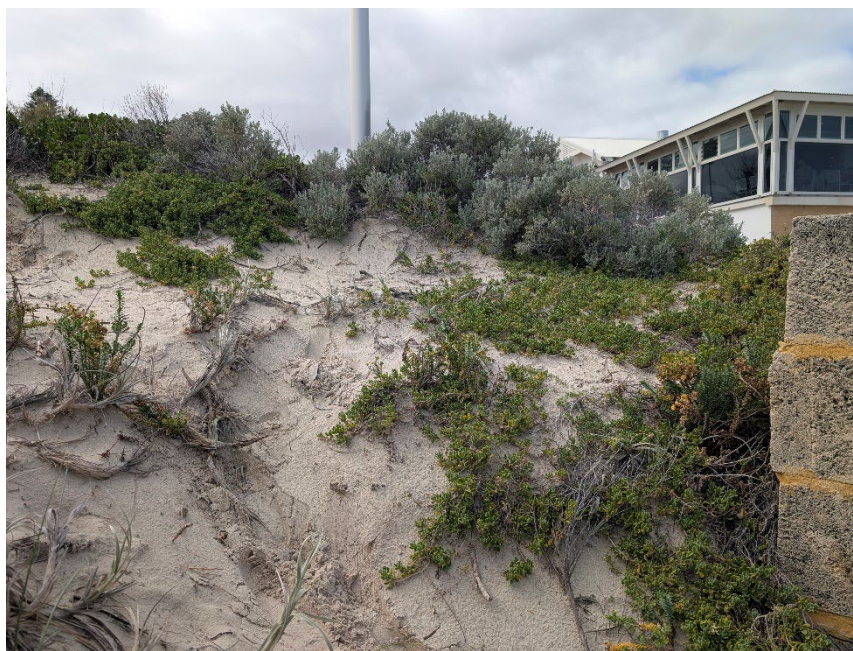
Plate 12: Close up photo of Western entry point with large barren patches of sand with established weeds, such as *Tetragonia decumbens*. *Olearia axillaris* seen in background is the same *Olearia axillaris* from Plates 7 and 8.

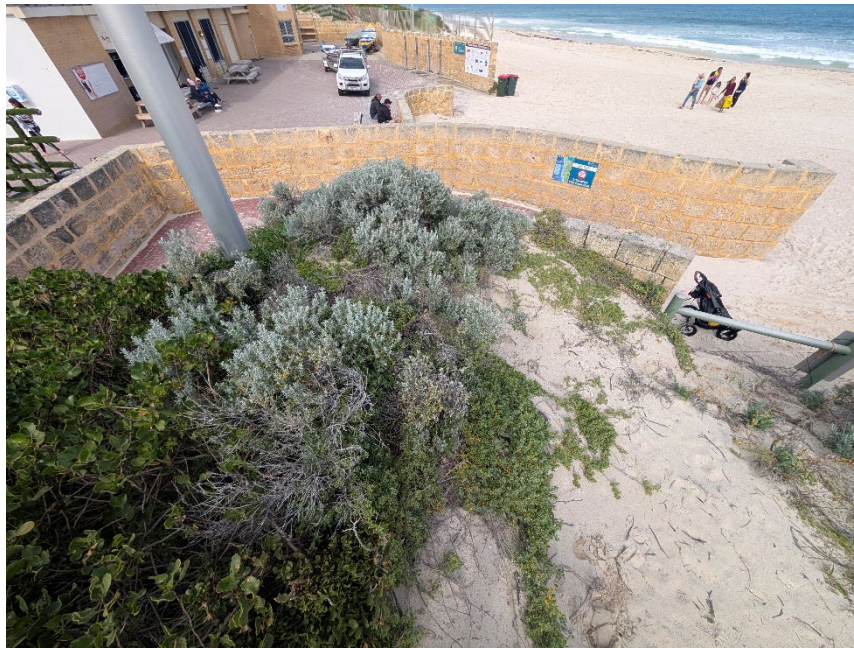
Plate 13: Aerial perspective of Plates 7, 8, 11 and 12.

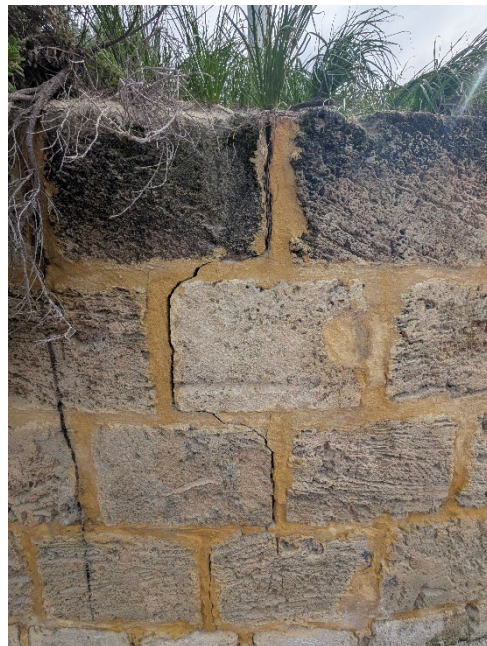
Plate 14: Example 1 of deterioration on limestone wall.

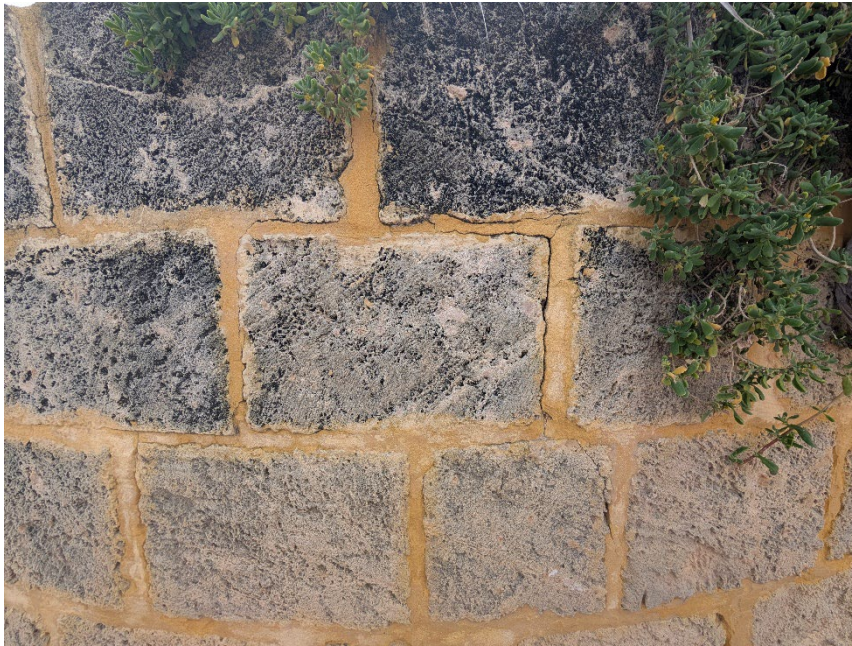
Plate 15: Example 2 of deterioration on limestone wall.

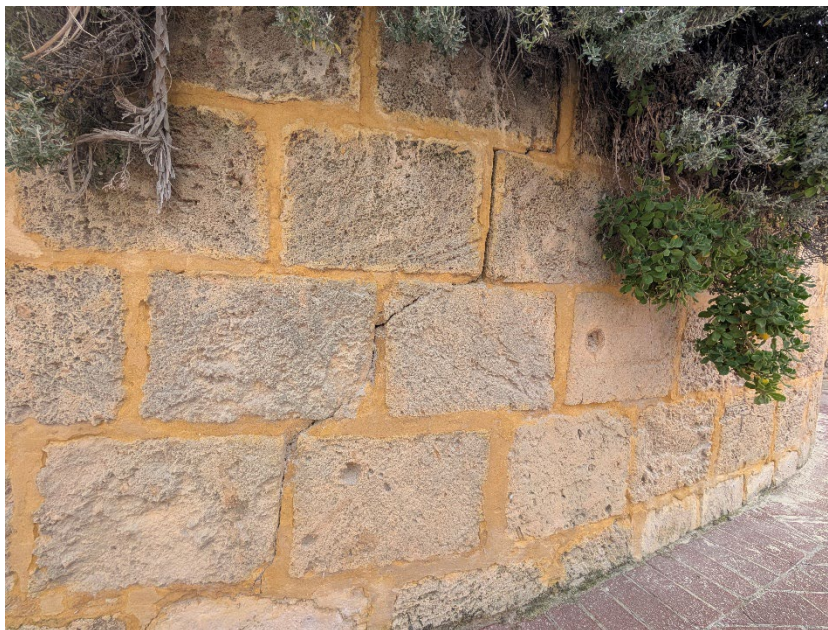
Plate 16: Example 3 of deterioration on limestone wall.

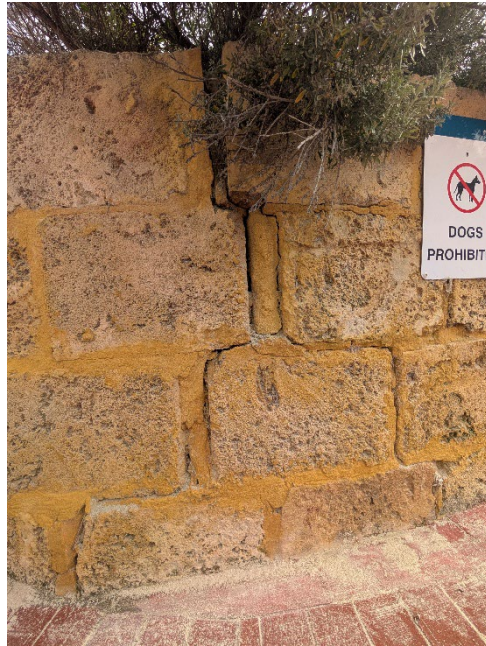
Plate 17: Example 4 of deterioration on limestone wall.

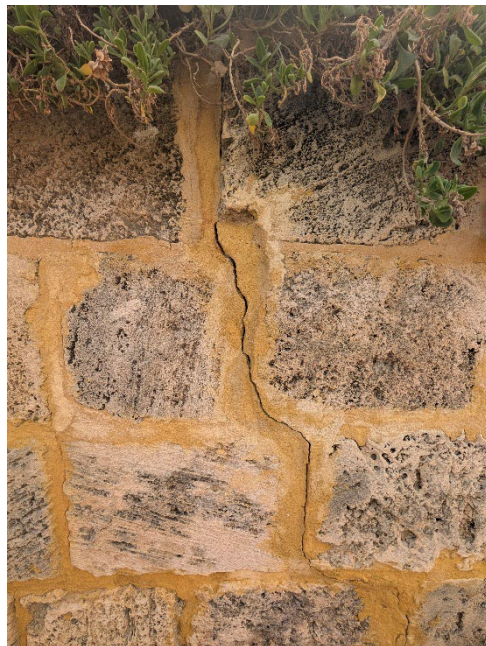
Plate 18: Example 5 of deterioration on limestone wall.

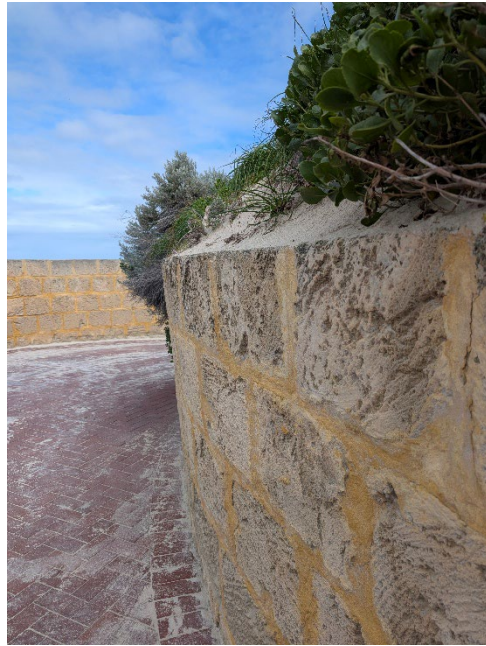
Plate 19: Example 1 of top end of limestone wall beginning to bend from the weight of the sand dunes.

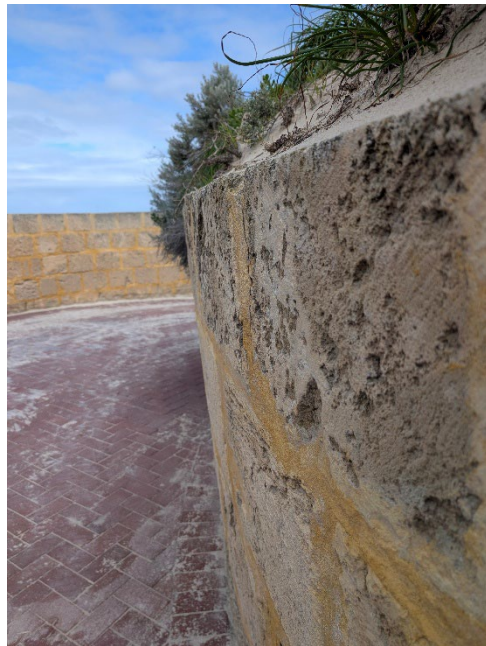
Plate 20: Example 2 of top of limestone wall beginning to bend from the weight of the sand dunes.
