Arboricultural Report – RCB, Balcatta Road, Balcatta

Arboricultural Report – Recycling Centre Balcatta (RCB)

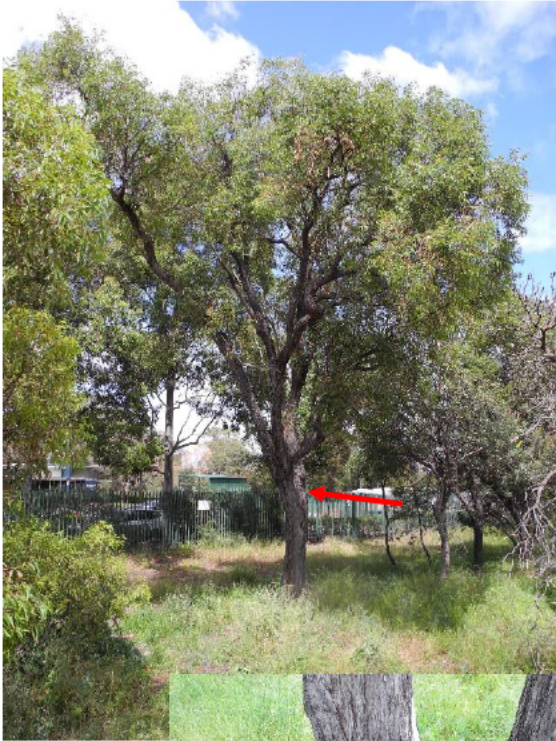
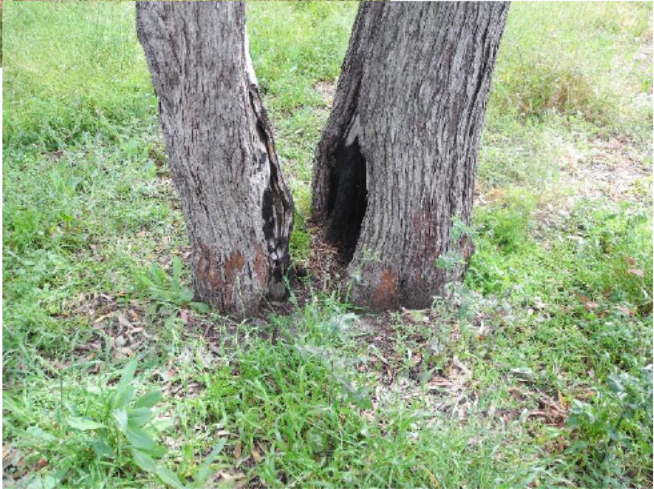
Tree 81

Tree no	Species	Height (m)	Canopy Spread (m)	DBH (mm)	Health and structural condition	TPZ (m radius)	SRZ (m radius)	Comments/Recommendations
81	<i>Eucalyptus marginata</i> Jarrah	16	14	620	Good health and fair structural condition with a full canopy of healthy foliage supported by the northern stem while the southern stem is in decline. Fire damage at the base separates the two stems with the northern stem displaying prominent adaptive secondary growth. The southern stem supports a declining canopy and evidence of active termites. Both stems hold deadwood. There was no evidence of significant branch failure from this tree and the tree appears to remain root firm.	7.4	2.7	Endemic species of high retention value. Fire damage and some termite activity in trees of the species is commonly observed within urban areas. Species retains deadwood and while healthy is able to develop new wood in response to previous tissue loss. Termites may be restricted to the central pith, bark or sapwood.

- **Trees 81 & 85** were found to be in fair health and predominantly sound structural condition despite evidence of trunk and basal wounds associated with previous fire damage and evidence of some termite activity within the trees' structure.

- **Trees 81 and 85** are both twin-stemmed and both display an asymmetric form with the more vigorous northern stem leaning and their canopies developing in a northerly direction over the proposed sealed area.

- **It is recommended that these two trees are removed if works are to proceed as per the draft drawings provided, it can be demonstrated that:**
 - Excavation to a depth greater than 300mm will be required within approximately 50% of the TPZ area and encroach within the SRZ radius of the trees.

- Crown reduction pruning to accommodate the movement of large vehicles will require severe reduction of the more vigorous northern stem sections and thereby require the removal of more than approximately 33% of the live crown of the trees.

- **If modification of the plans is to be considered with a view to retaining these trees, it is advised that:**
 - A fenced tree protection area will be required to exclude all excavation within 2.5m of the base of the trees.

- Pruning removes no more than approximately 30% of the live canopy of each tree and is carried out by a minimum Certificate Level 3 qualified arborist.

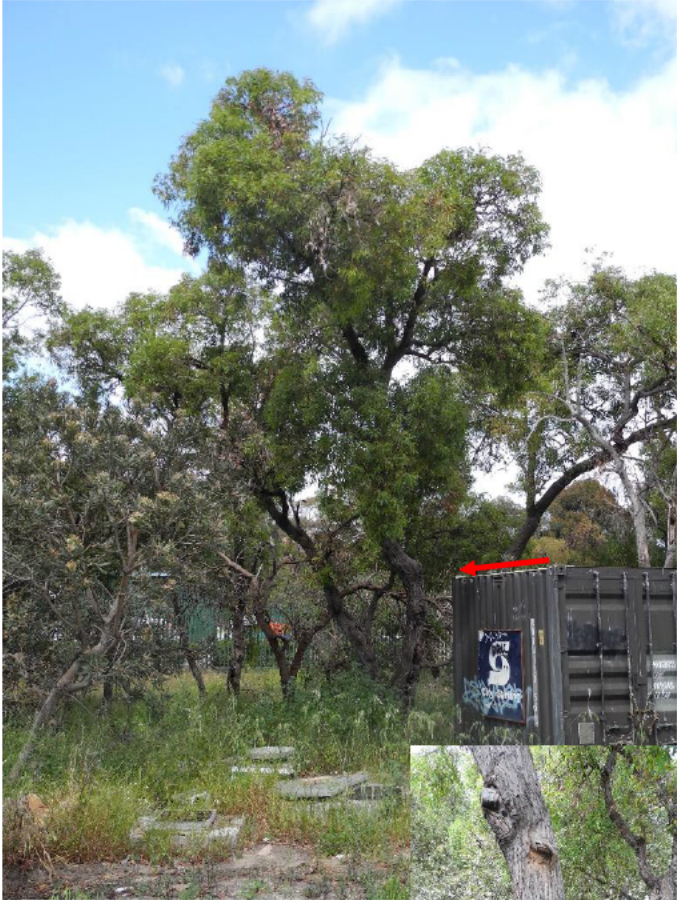
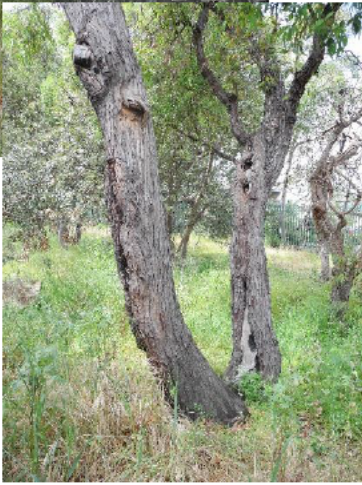
Tree 85

85	<i>Eucalyptus marginata</i> Jarrah	9.2	10	520	Good health and fair structural condition with a full canopy of healthy foliage supported by both the northern and southern stems. Fire damage at the base was evident with a small cavity and some termite damage visible displaying prominent adaptive secondary growth. The southern stem supports a less vigorous canopy and there is some evidence of active termites. Both stems hold some deadwood. There was no evidence of significant branch failure from this tree and the tree appears to remain root firm.	6.2	2.5	Both trees display an asymmetric form with the northern stems leaning and lateral growth extending over the sealed area for heavy vehicle planned for construction close to the base of the trees.
