Arboricultural Report - Balcatta Recycling Centre

December 13, 2024
Total Tree Count:
145

Brief

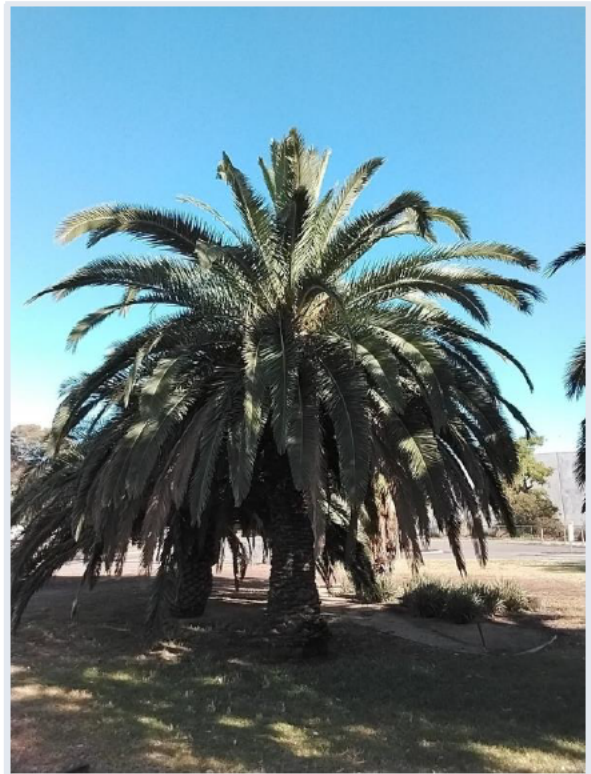
Canary Island Date Palm Tree ID #1

Latin Name:	Phoenix canariensis
Latitude:	-31.864116644032
Longitude:	115.81931792258
Tree Height (Estimated) [m]:	8.1
Canopy Spread [m]:	7
DBH [cm]:	76
Health:	Good
Structure:	Good
Problems:	
Notes:	
Priority:	None
Tree Work:	No Works
Observation Comments:	
Tree Protection Zone (TPZ) [m]:	9.12
Structural Root Zone (SRZ) [m]:	3.01
Useful Life Expectancy:	20-40 years
Retention Value:	High
Risk of Harm Number:	Not applicable

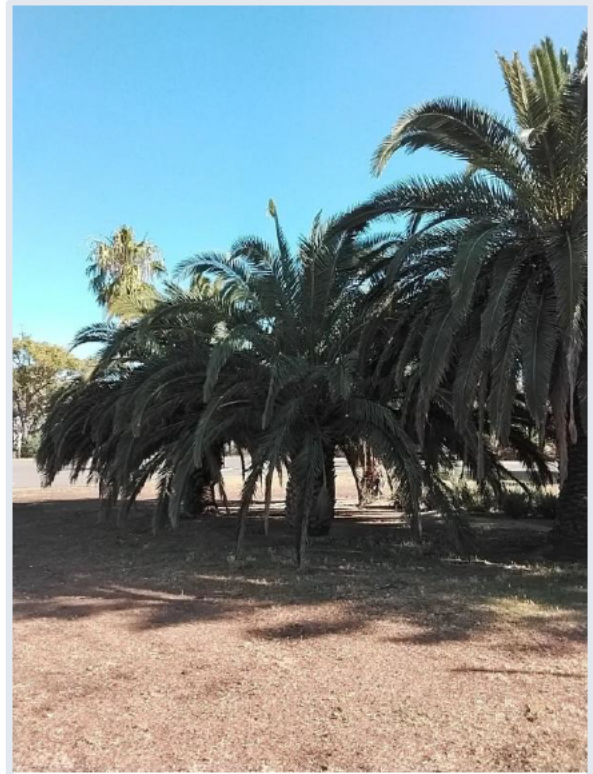
Canary Island Date Palm Tree ID #2

Latin Name:	Phoenix canariensis
Latitude:	-31.864095515478
Longitude:	115.8192554941
Tree Height (Estimated) [m]:	5.8
Canopy Spread [m]:	7.5
DBH [cm]:	92
Health:	Good
Structure:	Good
Problems:	
Notes:	
Priority:	None
Tree Work:	No Works
Observation Comments:	
Tree Protection Zone (TPZ) [m]:	11.04
Structural Root Zone (SRZ) [m]:	3.38
Useful Life Expectancy:	20-40 years
Retention Value:	High
Risk of Harm Number:	Not applicable

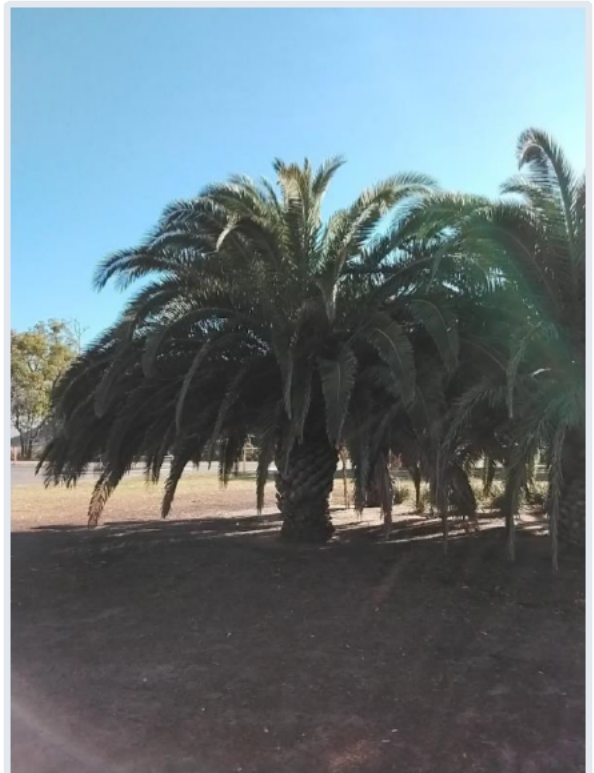
Canary Island Date Palm Tree ID #3

Latin Name:	Phoenix canariensis
Latitude:	-31.864066015199
Longitude:	115.81924344651
Tree Height (Estimated) [m]:	5.6
Canopy Spread [m]:	6
DBH [cm]:	107
Health:	Good
Structure:	Good
Problems:	
Notes:	
Priority:	None
Tree Work:	No Works
Observation Comments:	
Tree Protection Zone (TPZ) [m]:	12.84
Structural Root Zone (SRZ) [m]:	3.09
Useful Life Expectancy:	20-40 years
Retention Value:	High
Risk of Harm Number:	Not applicable

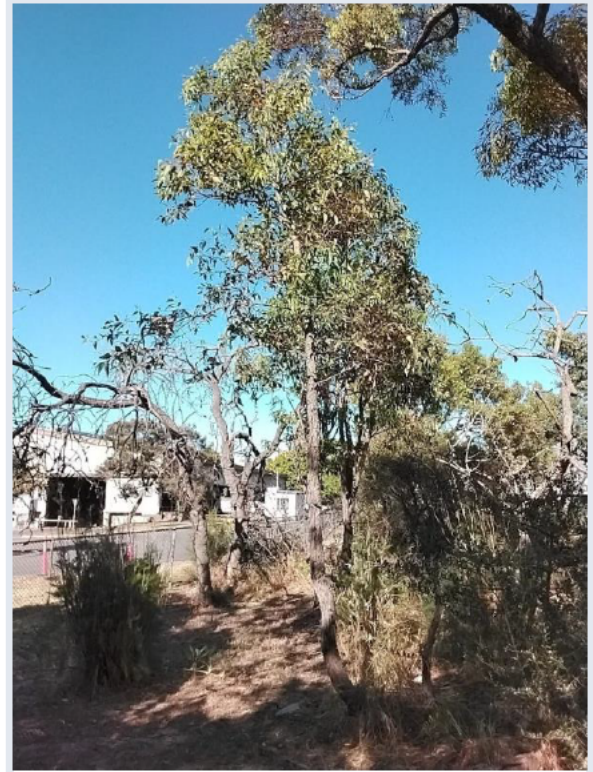
Jarraah Tree ID #9

Health: Good

Structure: Good

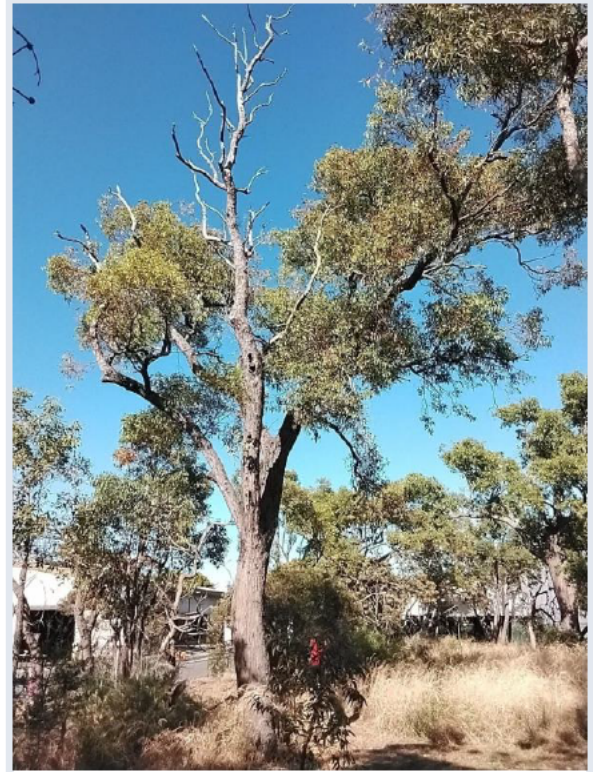
Jarraah Tree ID #10

Health: Fair

Structure: Good

Problems: Deadwood major >50,
Hollow, Basal decay,
Epicormic growth,
Multi Crown leaders

Priority: Low

Tree Work: Remove major
deadwood

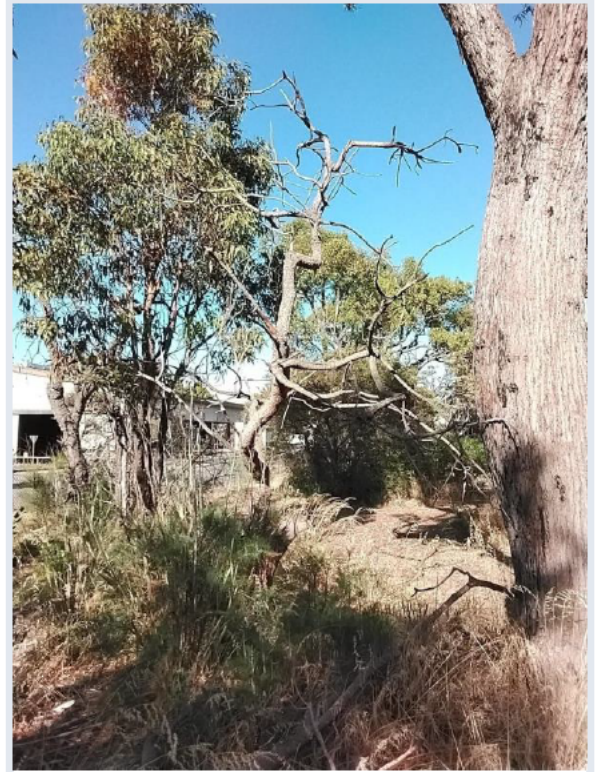
Banksia Tree ID #11

Latin Name:	Banksia species
Latitude:	-31.863590954274
Longitude:	115.81936173182
Tree Height (Estimated) [m]:	3.5
Canopy Spread [m]:	0
DBH [cm]:	12
Health:	Dead
Structure:	Fair
Problems:	Deadwood major >50
Notes:	
Priority:	Low
Tree Work:	Remove Tree
Observation Comments:	
Tree Protection Zone (TPZ) [m]:	2
Structural Root Zone (SRZ) [m]:	1.49
Useful Life Expectancy:	0 years
Retention Value:	Low
Risk of Harm Number:	Not applicable

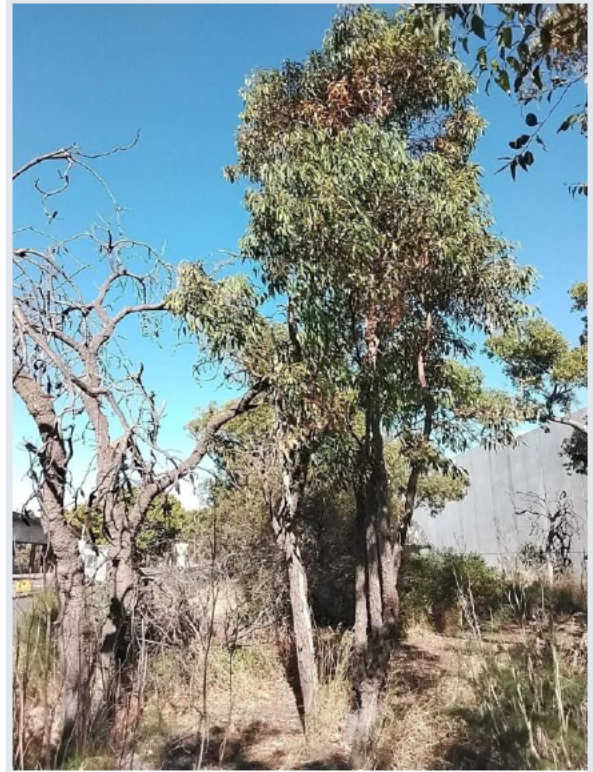
Jarrah Tree ID #12

Latin Name:	Eucalyptus marginata
Latitude:	-31.863641450289
Longitude:	115.81936392225
Tree Height (Estimated) [m]:	7.2
Canopy Spread [m]:	3
DBH [cm]:	25.98
Health:	Good
Structure:	Fair
Problems:	Deadwood minor <50, Basal bifurcation, Multi Crown leaders
Notes:	
Priority:	None
Tree Work:	No Works
Observation Comments:	
Tree Protection Zone (TPZ) [m]:	3.12
Structural Root Zone (SRZ) [m]:	2.49
Useful Life Expectancy:	40+ years
Retention Value:	High
Risk of Harm Number:	Not applicable

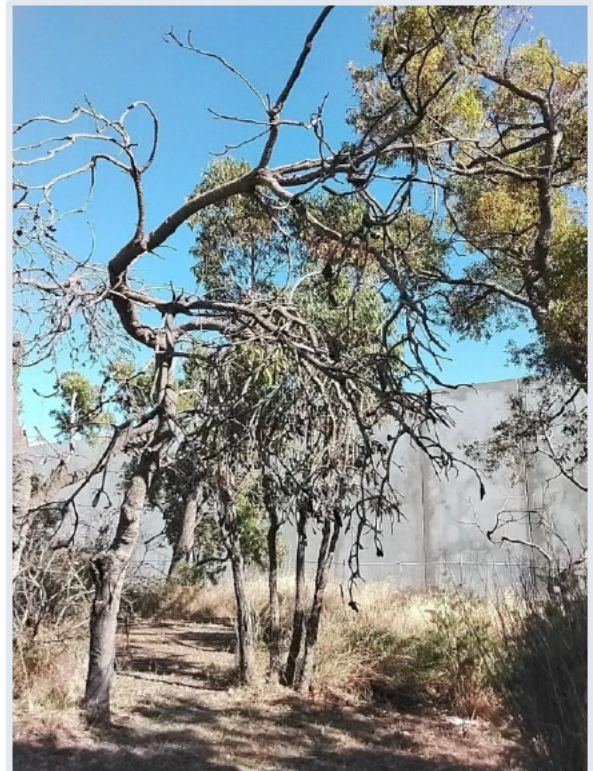
Banksia Tree ID #13

Latin Name:	Banksia species
Latitude:	-31.863631483906
Longitude:	115.81934749368
Tree Height (Estimated) [m]:	4.5
Canopy Spread [m]:	0
DBH [cm]:	26
Health:	Dead
Structure:	Fair
Problems:	Deadwood major >50
Notes:	
Priority:	Low
Tree Work:	Remove Tree
Observation Comments:	
Tree Protection Zone (TPZ) [m]:	3.12
Structural Root Zone (SRZ) [m]:	1.85
Useful Life Expectancy:	0 years
Retention Value:	Low
Risk of Harm Number:	Not applicable

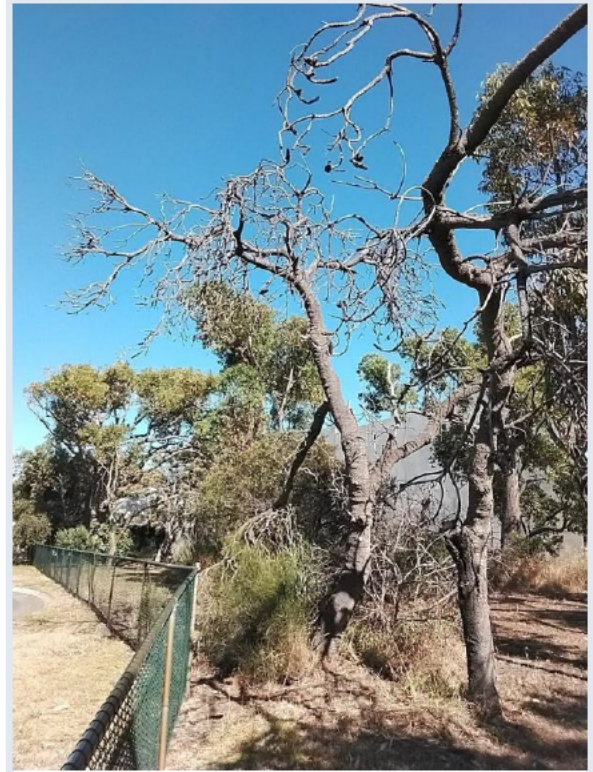
Banksia Tree ID #14

Latin Name:	Banksia species
Latitude:	-31.863655934594
Longitude:	115.81931354136
Tree Height (Estimated) [m]:	6
Canopy Spread [m]:	0
DBH [cm]:	31
Health:	Dead
Structure:	Fair
Problems:	Deadwood major >50
Notes:	
Priority:	Low
Tree Work:	Remove Tree
Observation Comments:	
Tree Protection Zone (TPZ) [m]:	3.72
Structural Root Zone (SRZ) [m]:	2.1
Useful Life Expectancy:	0 years
Retention Value:	Low
Risk of Harm Number:	Not applicable

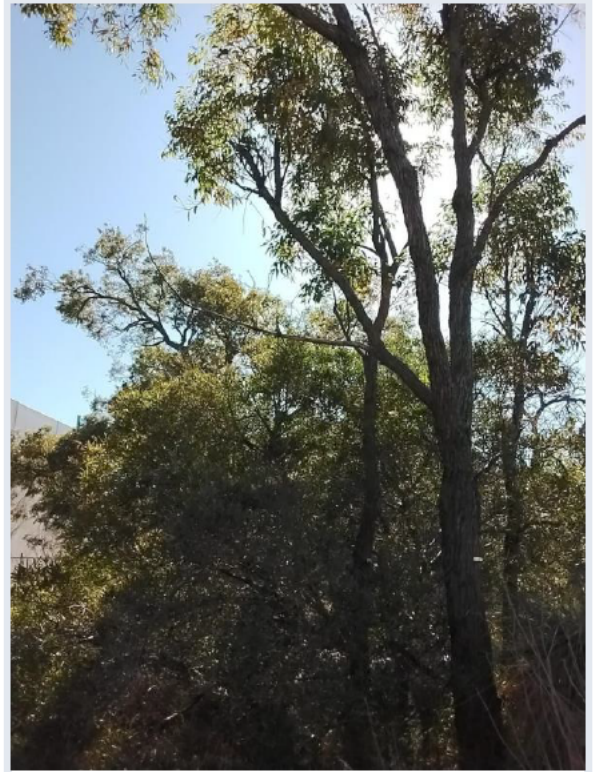
Jarraah Tree ID #17

Latin Name:	Eucalyptus marginata
Latitude:	-31.863596269433
Longitude:	115.81923468427
Tree Height (Estimated) [m]:	6.5
Canopy Spread [m]:	2
DBH [cm]:	15
Health:	Good
Structure:	Good
Problems:	
Notes:	
Priority:	None
Tree Work:	No Works
Observation Comments:	
Tree Protection Zone (TPZ) [m]:	2
Structural Root Zone (SRZ) [m]:	1.57
Useful Life Expectancy:	40+ years
Retention Value:	High
Risk of Harm Number:	Not applicable

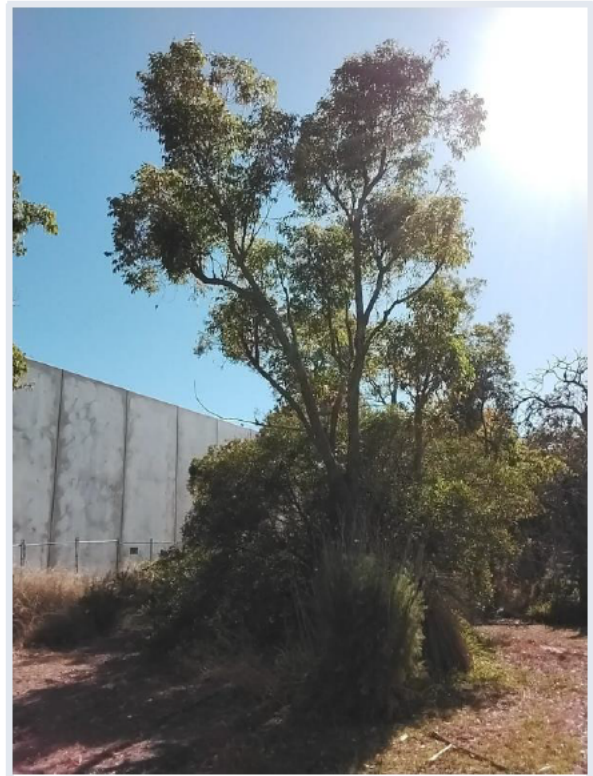
Jarraah Tree ID #18

Latin Name:	Eucalyptus marginata
Latitude:	-31.863617929613
Longitude:	115.81921058904
Tree Height (Estimated) [m]:	10.6
Canopy Spread [m]:	4
DBH [cm]:	28
Health:	Good
Structure:	Good
Problems:	Codominant Stem, Deadwood minor <50
Notes:	
Priority:	None
Tree Work:	No Works
Observation Comments:	
Tree Protection Zone (TPZ) [m]:	3.36
Structural Root Zone (SRZ) [m]:	2.05
Useful Life Expectancy:	40+ years
Retention Value:	Very high
Risk of Harm Number:	Not applicable

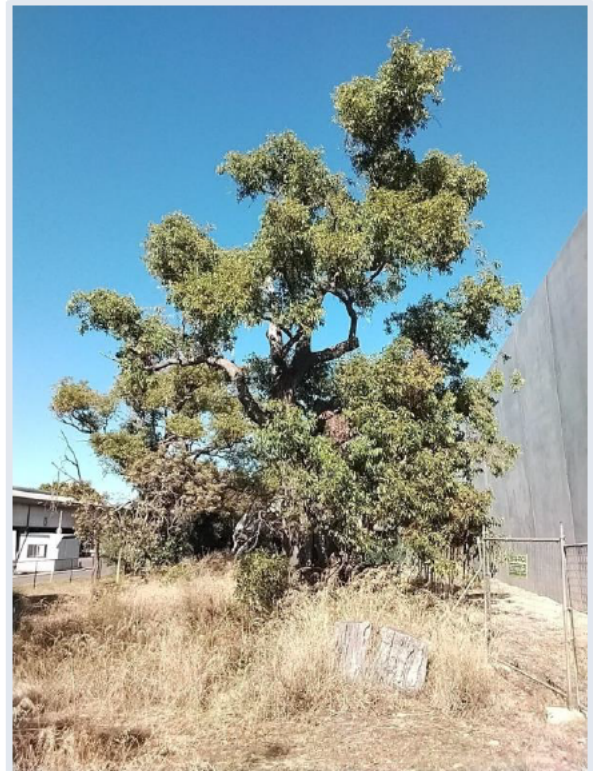
Jarraah Tree ID #19

Problems: Deadwood major >50,
Hollow, Basal decay,
Deadwood minor <50,
Epicormic growth,
Trunk Decay, Basal
bifurcation, Fire
damage, Secondary
stem

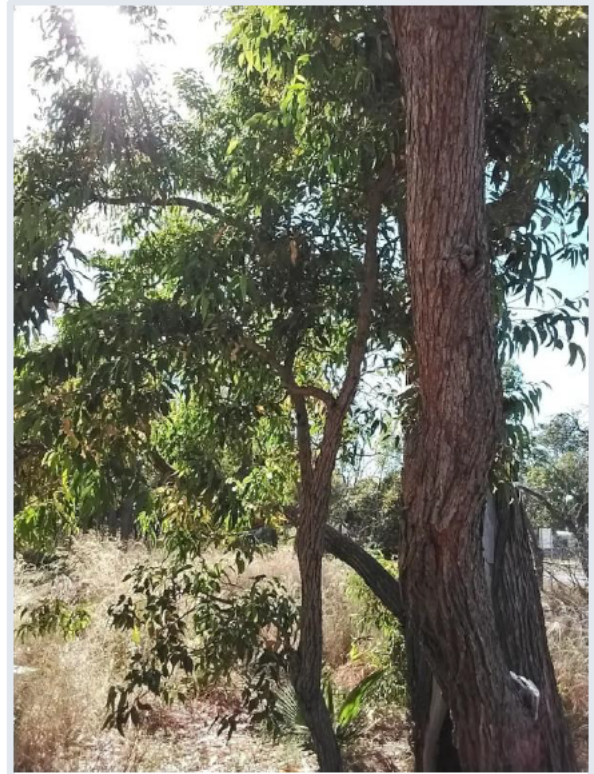
Jarraah Tree ID #20

Latin Name:	Eucalyptus marginata
Latitude:	-31.863520790937
Longitude:	115.81925768404
Tree Height (Estimated) [m]:	3.2
Canopy Spread [m]:	2
DBH [cm]:	13
Health:	Good
Structure:	Fair
Problems:	Suppressed canopy, Chlorotic foliage
Notes:	
Priority:	None
Tree Work:	No Works
Observation Comments:	
Tree Protection Zone (TPZ) [m]:	2
Structural Root Zone (SRZ) [m]:	1.49
Useful Life Expectancy:	40+ years
Retention Value:	High
Risk of Harm Number:	Not applicable

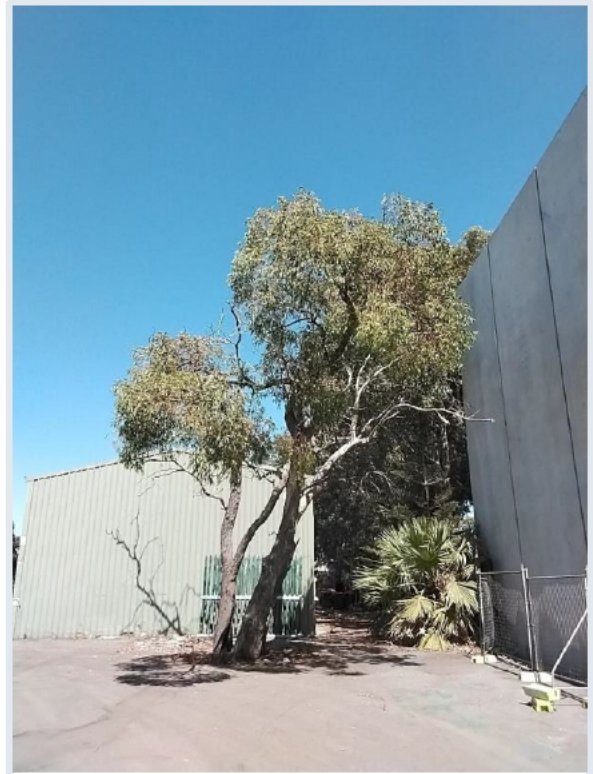
Latin Name:	Eucalyptus marginata
Latitude:	-31.863521287097
Longitude:	115.81825551153
Tree Height (Estimated) [m]:	12.5
Canopy Spread [m]:	5
DBH [cm]:	78.44
Health:	Poor
Structure:	Poor
Problems:	Deadwood major >50, Decay, Hollow, Basal decay, Deadwood minor <50, Epicormic growth, Trunk Decay, Leaning, Fire damage, Multi Crown leaders
Notes:	Remove 2 dead stems, consider removing 3rd.
Priority:	Moderate
Tree Work:	Remove Tree
Observation Comments:	
Tree Protection Zone (TPZ) [m]:	9.41
Structural Root Zone (SRZ) [m]:	4.14
Useful Life Expectancy:	1-5 years
Retention Value:	Low
Risk of Harm Number:	Not applicable

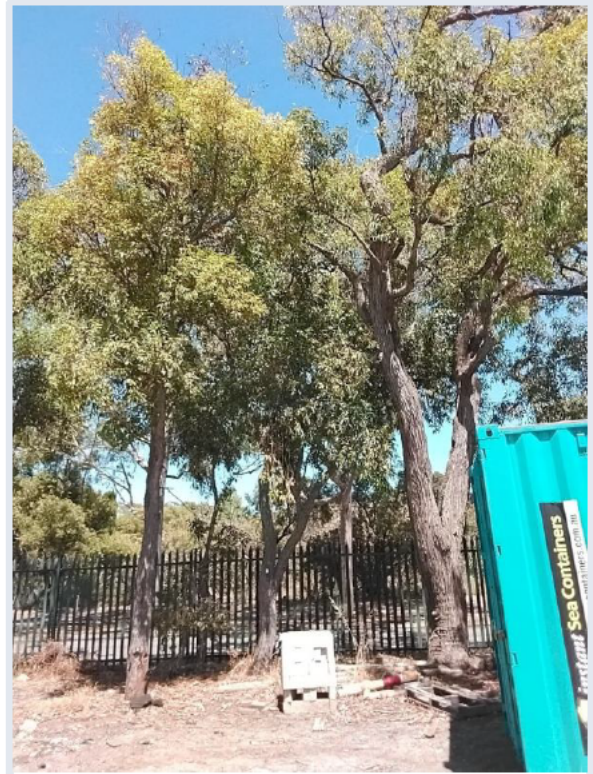
Jarraah Tree ID #55

Problems: Codominant Stem,
Deadwood major >50,
Decay, Deadwood
minor <50, Fire
damage, Bark wound,
Secondary stem

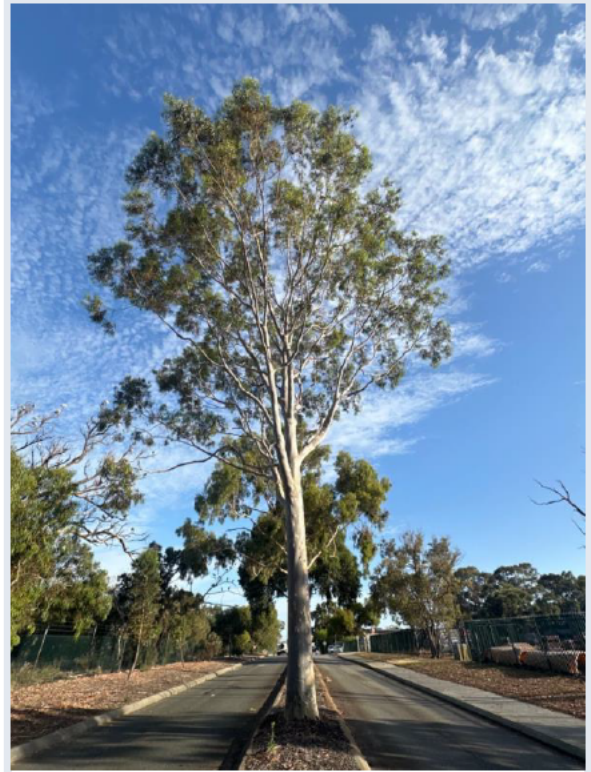
Latin Name:	Corymbia citriodora
Latitude:	-31.864445335847
Longitude:	115.81725981546
Tree Height (Estimated) [m]:	19.2
Canopy Spread [m]:	12
DBH [cm]:	59
Health:	Good
Structure:	Fair
Problems:	Deadwood major >50, Infrastructure damage kerb
Notes:	
Priority:	None
Tree Work:	No Works
Observation Comments:	
Tree Protection Zone (TPZ) [m]:	7.08
Structural Root Zone (SRZ) [m]:	2.9
Useful Life Expectancy:	40+ years
Retention Value:	Very high
Risk of Harm Number:	Not applicable

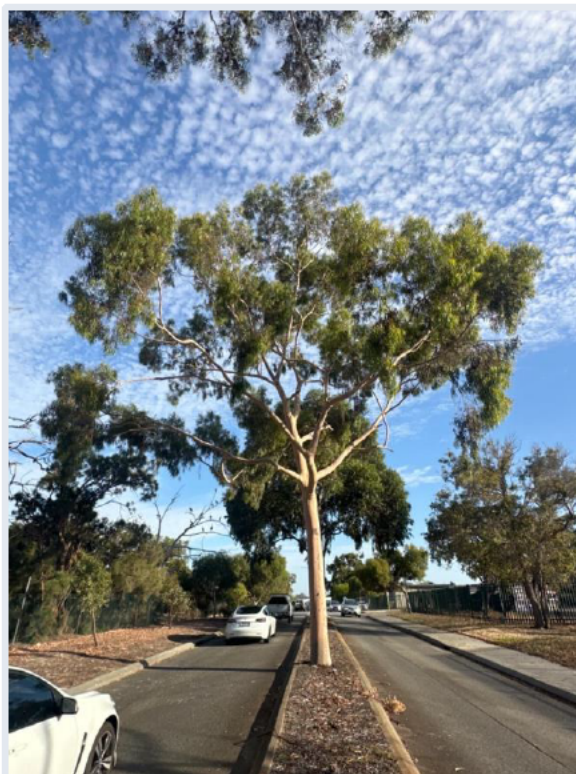
Lemon Scented Gum Tree ID #96

Latin Name:	Corymbia citriodora
Latitude:	-31.864296126816
Longitude:	115.81725847435
Tree Height (Estimated) [m]:	17.5
Canopy Spread [m]:	12.5
DBH [cm]:	47
Health:	Good
Structure:	Fair
Problems:	Deadwood major >50, Infrastructure damage kerb
Notes:	
Priority:	None
Tree Work:	No Works
Observation Comments:	
Tree Protection Zone (TPZ) [m]:	5.64
Structural Root Zone (SRZ) [m]:	2.51
Useful Life Expectancy:	40+ years
Retention Value:	Very high
Risk of Harm Number:	Not applicable

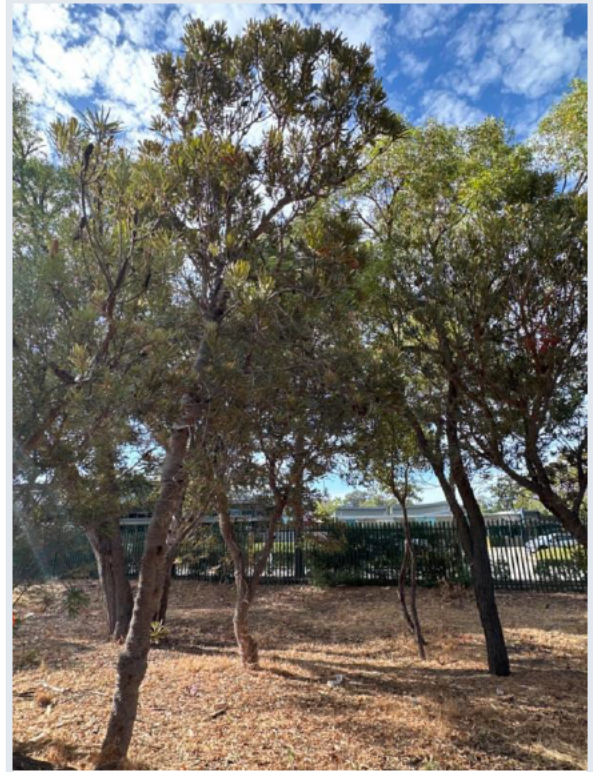
Firewood Banksia Tree ID #110

Problems: Codominant Stem,
Deadwood major >50,
Hanging branch, Basal
decay, Deadwood
minor <50, Epicormic
growth, Leaning, Fire
damage, Secondary
stem

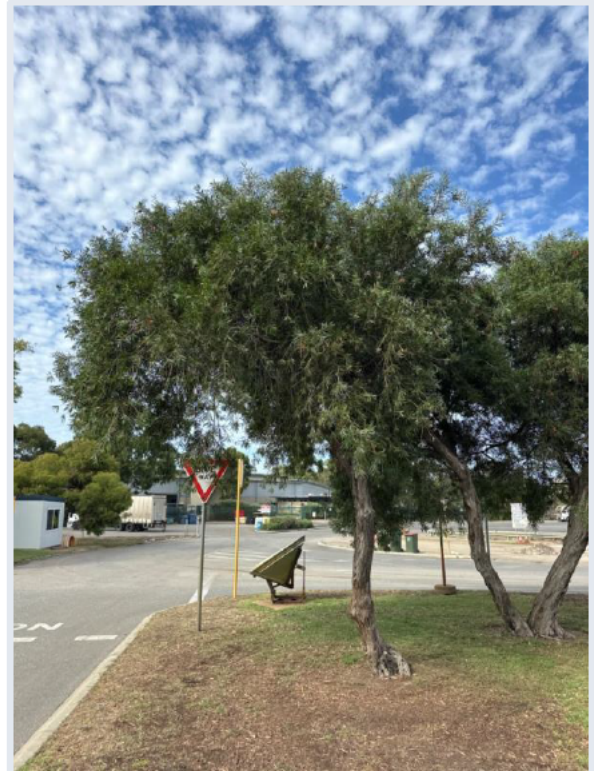
Jarraah Tree ID #130

Problems: Codominant Stem, Basal decay, Deadwood minor <50, Epicormic growth
