# City of Wanneroo Assets Structural Assessment

## Coastal Assets

City Of Wanneroo

30 July 2021

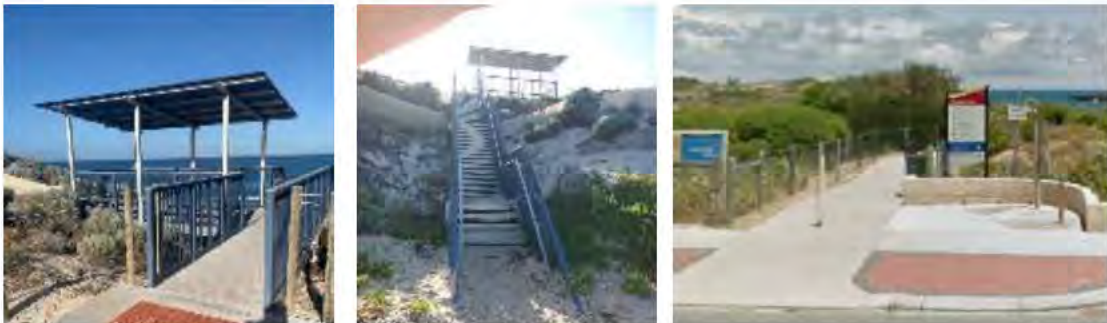
Figure 3.1 C1 Assets

In addition to this, shower facilities are also provided at the edge of the street access, which is bordered by a limestone retaining wall. Refer Figure 3.1 for general photos of the structures. The inspection was completed from ground level, the battery limits of the inspection are shown in Figure 3.2. The assets within site C1 were found to be in good condition with a number of elements requiring maintenance within 1-2 years.

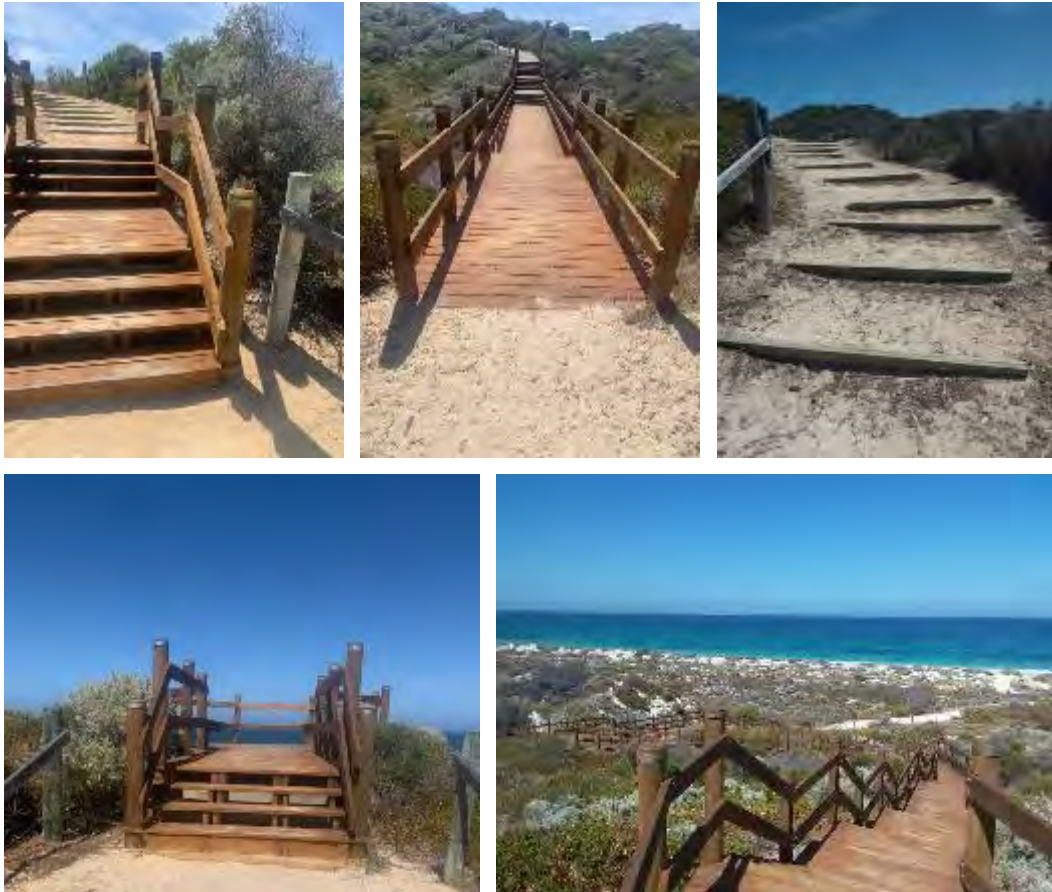
Figure 3.5 C3 Assets

Site C3 provides beach access and a coastal lookout via a pathway from the corner of Lookout Drive and Capricorn Esplanade, in Yanchep. Based on provided information the assets were constructed circa 2013. The pathway consists of 2 sets of timber staircases and a timber lookout. Timber sleepers and crushed limestone are used intermittently throughout the pathways. Refer Figure 3.5 for general photos of the structures. The inspection was completed from ground level, the battery limits of the inspection are shown in Figure 3.6. The assets within site C3 were found to be in relatively good condition with a number of elements requiring maintenance within 1 -2 years.

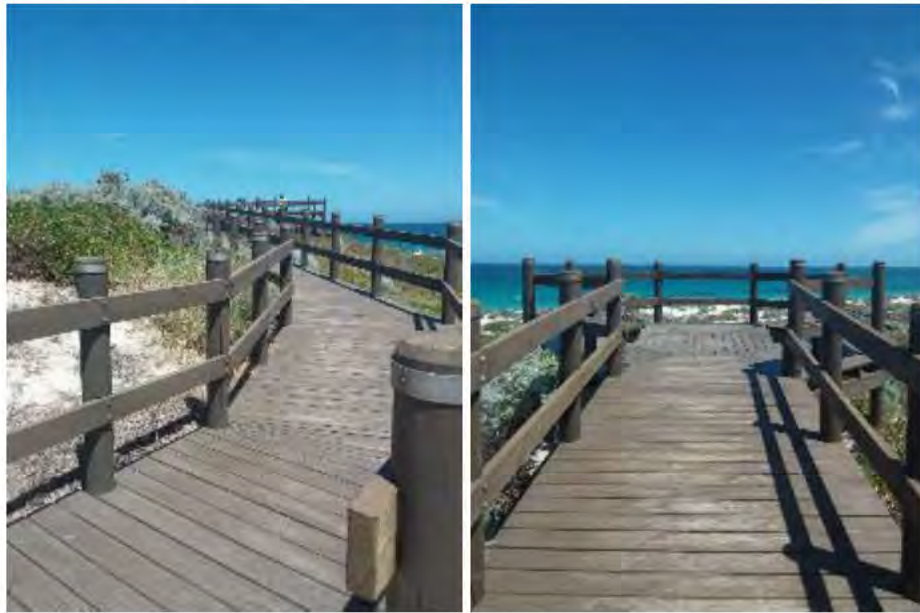
Figure 3.7 C4 Assets

Site C4 provides a coastal lookout at the Mary Lindsay Lookout off Capricorn Esplanade in Yanchep. Based on provided information the lookout was constructed circa 2011. The structure consists of a timber boardwalk, stairs, and round platform area. Refer Figure 3.7 for general photos of the structures. The inspection was completed from ground level, the battery limits of the inspection are shown in Figure 3.8. The assets within site C4 were found to be in good condition with only minor maintenance required within 5 years.

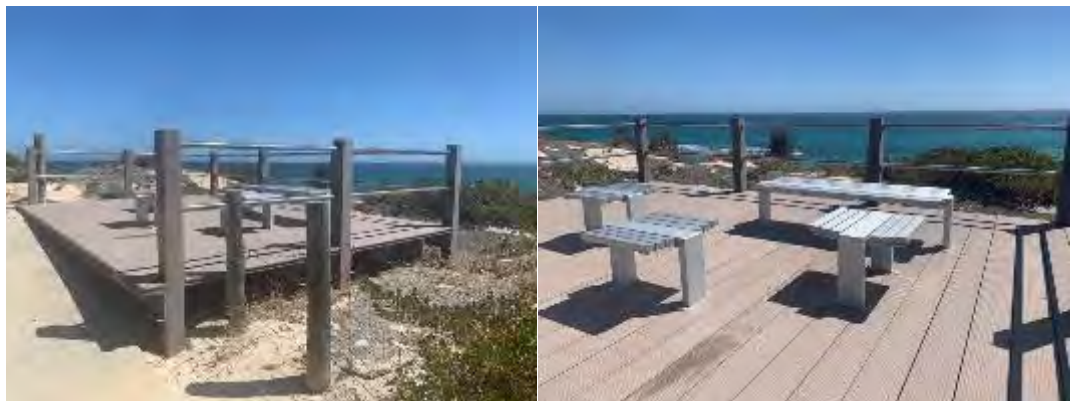
Figure 3.9 C5 Assets

Site C5 consists of an elevated platform lookout with bench seats. The lookout is accessed from the west side of the car park at the Old Yanchep Surf Life Saving Club. Based on provided information the platform was constructed circa 2020. The platform consists of a steel support system, composite material decking and a combination of steel and composite balustrade. There are four benches comprised of composite material and stainless steel. Refer Figure 3.9 for general photos of the structures. The inspection was completed from ground level, the battery limits of the inspection are shown in Figure 3.10. The assets within site C5 were found to be in good condition with no maintenance for at least 5 years.

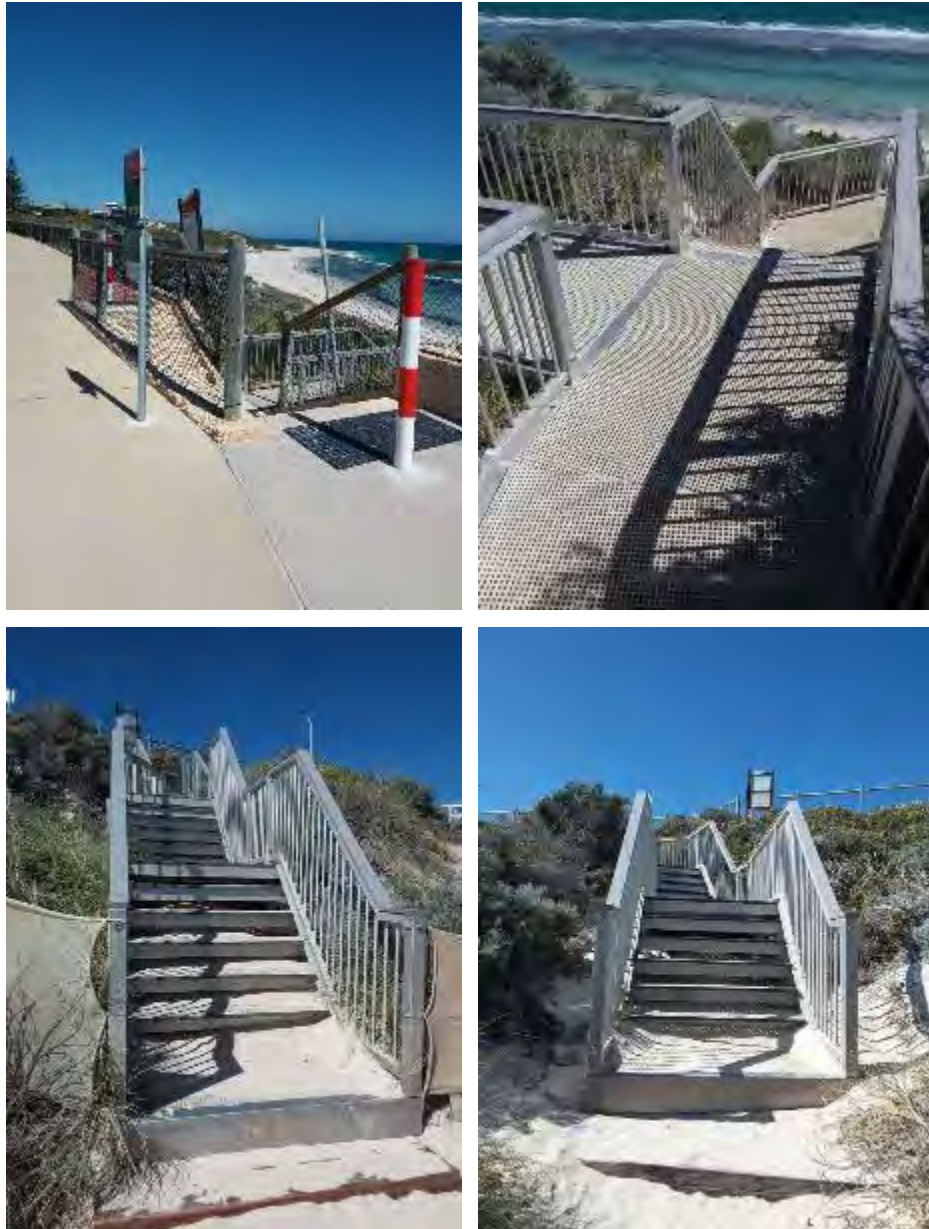
Figure 3.13 C7 Assets

Site C7 provides beach access south of Yanchep Lagoon on Brazier Road in Yanchep. Based on provided information the staircase was constructed circa 2016. The site consists of a set of two sets of limestone stairs with mesh fencing, leading to two sets of composite fibre staircases which branch from a single platform. Refer Figure 3.13 for general photos of the structures. The inspection was completed from ground level, the battery limits of the inspection are shown in Figure 3.14. The assets within site C7 were found to be in good condition with localised maintenance required within 1 – 2 years.

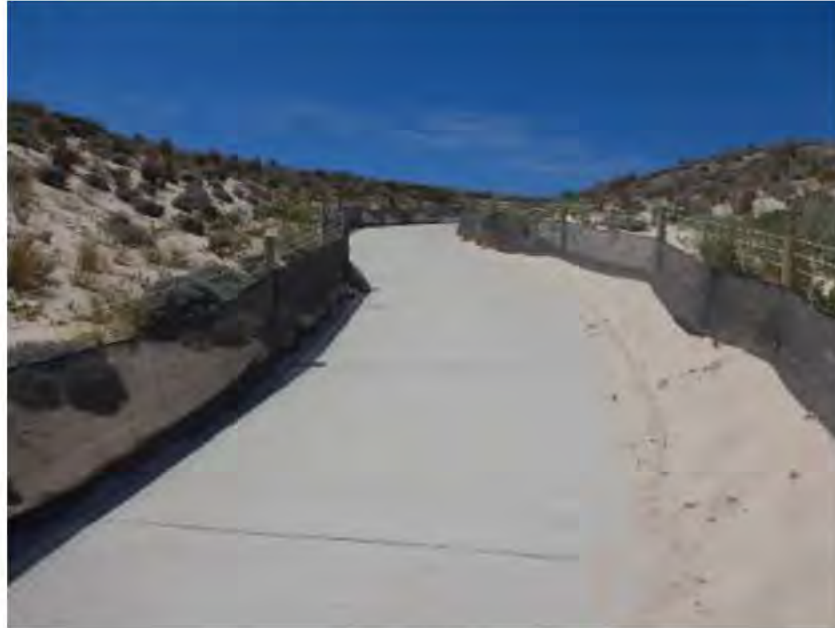
Figure 3.19 C10 Assets

Site C10 consists of a concrete path providing beach access from the car park on Idyllic View, in Eglinton. Based on provided information the concrete path was constructed circa 2018. The path has steel mesh and fabric fencing along both sides and bollards to stop vehicle access. Refer Figure 3.19 for general photos of the structures. The inspection was completed from ground level, the battery limits of the inspection are shown in Figure 3.20. The assets within site C10 were found to be in good condition with only minor maintenance required.

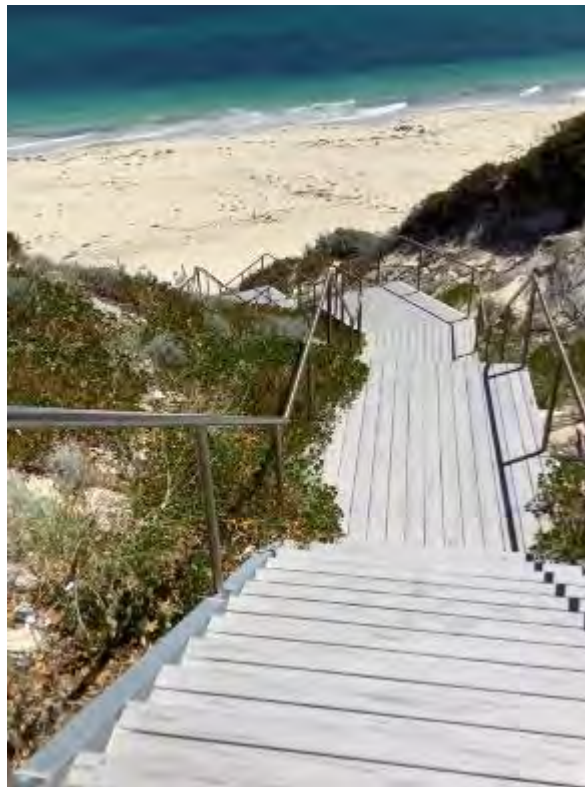
Figure 3.21 C11 Assets

Site C11 provides beach access via a composite fibre staircase from Idyllic View, in Eglington. No drawings were available/provided to GHD, hence the age of the structure is not known. The staircase is constructed from composite materials, steel support frame and is fitted with a stainless-steel handrail either side. Refer Figure 3.21 for general photos of the structures. The inspection was completed from ground level, the battery limits of the inspection are shown in Figure 3.22. The assets within site C11 were found to be in good condition with no maintenance required for at least 5 years.

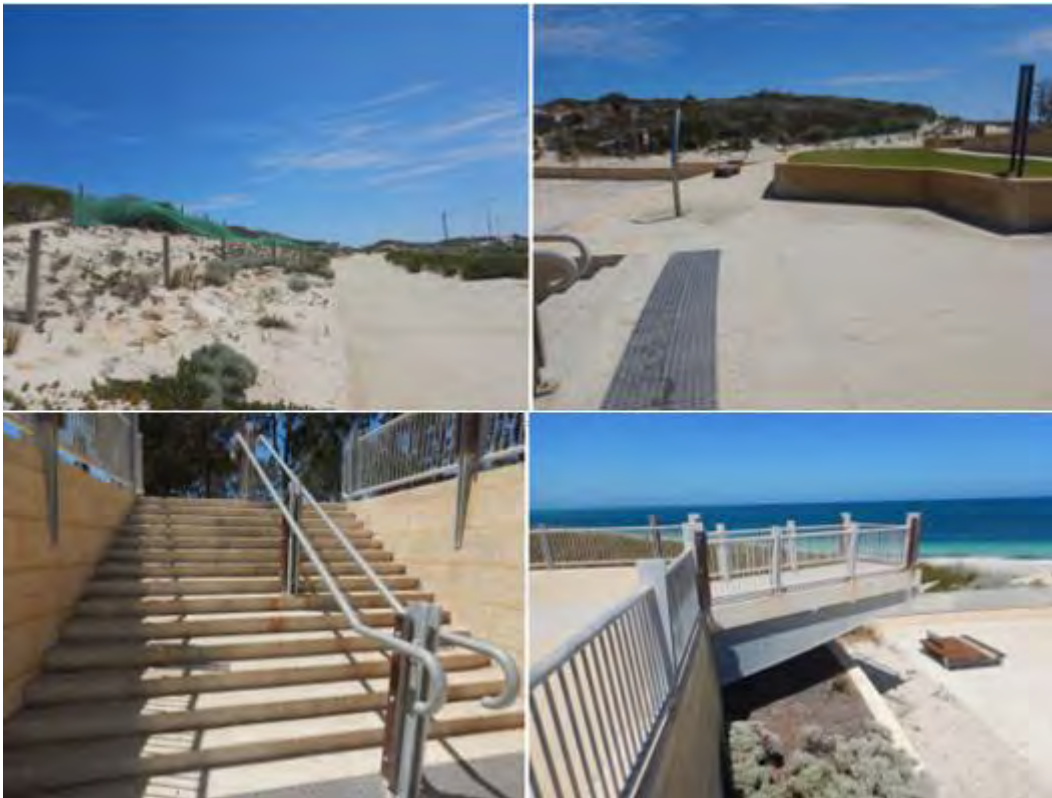
Figure 3.23 C12 Assets

Site C12 comprises of a vehicle access ramp from carpark to the beach, a collection of concrete walkway paths, stairs, handrails and limestone retaining walls along the border of Waterfront Park. There is a lookout area to the south east of the park, which is boarded with steel handrailing. Based on provided information the assets were constructed circa 2019. Refer Figure 3.23 for general photos of the structures. The inspection was completed from ground level, the battery limits of the inspection are shown in Figure 3.24. The assets within site C12 were generally found to be in good condition with the exception of a number of items which require maintenance required within 1 – 2 years. There was a bench which had failed with danger tape which requires immediate remediation.

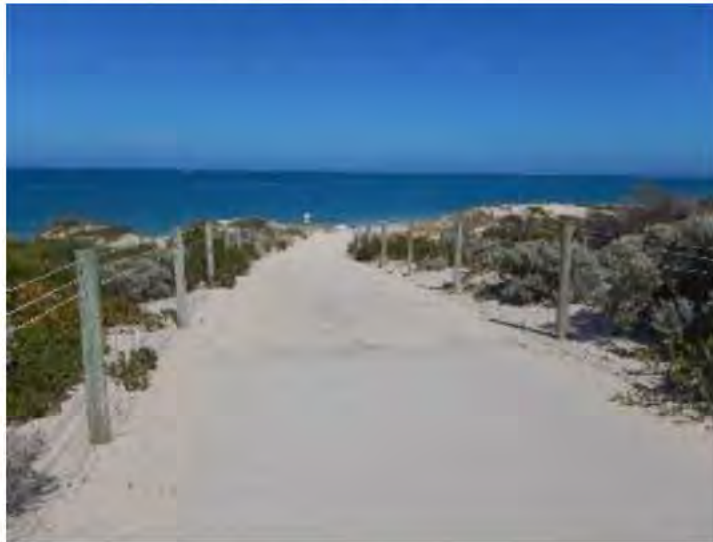
Figure 3.27 C14 Assets

Site C14 provides vehicle access to the beach from the car park on Thala View, in Jindalee. No drawings were available/provided to GHD, hence the age of the structure is not known.. This vehicle ramp consists of two sections with a concrete base slab section at the entry from the car park, extending to an exposed aggregate concrete base leading to the beach as seen below. Refer Figure 3.27 for general photos of the structures. The inspection was completed from ground level, the battery limits of the inspection are shown in Figure 3.28. The assets within site C14 were found to be in good condition with minor maintenance required within 5 years.

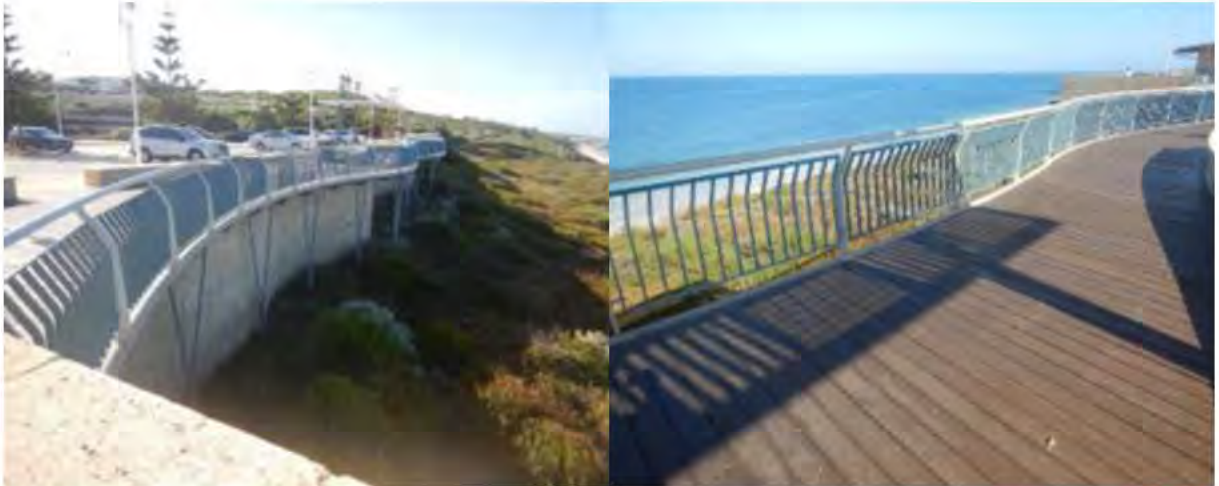
Figure 3.33 C17 Assets

Site C17 consists of a boardwalk along Jindalee Foreshore by the Jindalee Beach Shack. Based on provided information the boardwalk was constructed circa 2009. The boardwalk consists of a timber decking with a composite and coated steel handrail on the oceanside, and small sections of limestone walls on the other side, it is supported by a steel structure and limestone retaining wall. Refer Figure 3.33 for general photos of the structures. The inspection was completed from ground level, the battery limits of the inspection are shown in Figure 3.34. The assets within site C17 were found to be in good condition with only one urgent maintenance requirement.

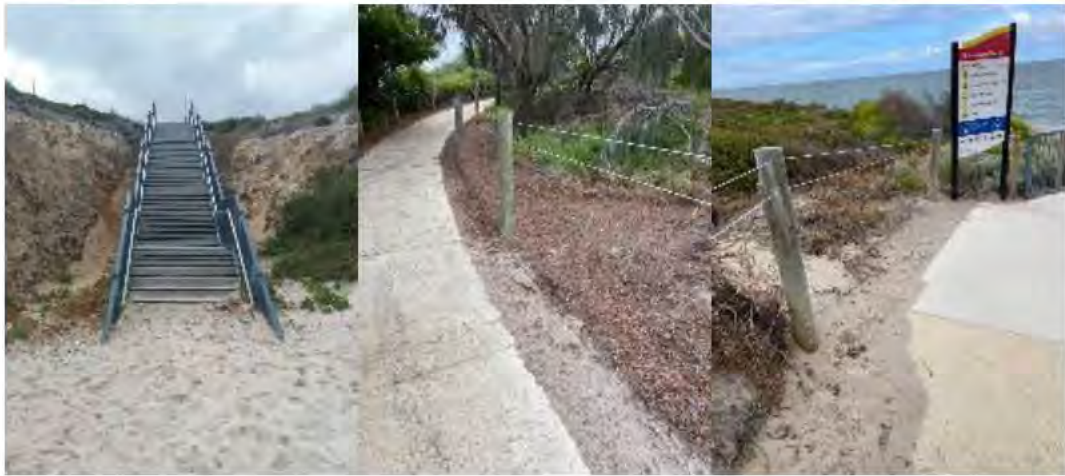
Figure 3.37 C19 Assets

Site C19 provides beach access from the car park at the end of Waterland Point, in Quinns Rocks. Based on provided information the staircase were constructed circa 2018, no information has been provided on the concrete path. The site comprises of a concrete path leading to a steel/composite material staircase leading directly to the beach. A timber and steel mesh fence borders the length of the concrete path. The staircase is fitted with a stainless steel handrailing. Refer Figure 3.37 for general photos of the structures. The inspection was completed from ground level, the battery limits of the inspection are shown in Figure 3.38. The assets within site C19 were found to be in good condition with the exception of heavy corrosion to the existing stair structure pedestals and localised damage to the fencing which requires maintenance within 6 months and 1 – 2 years respectively.

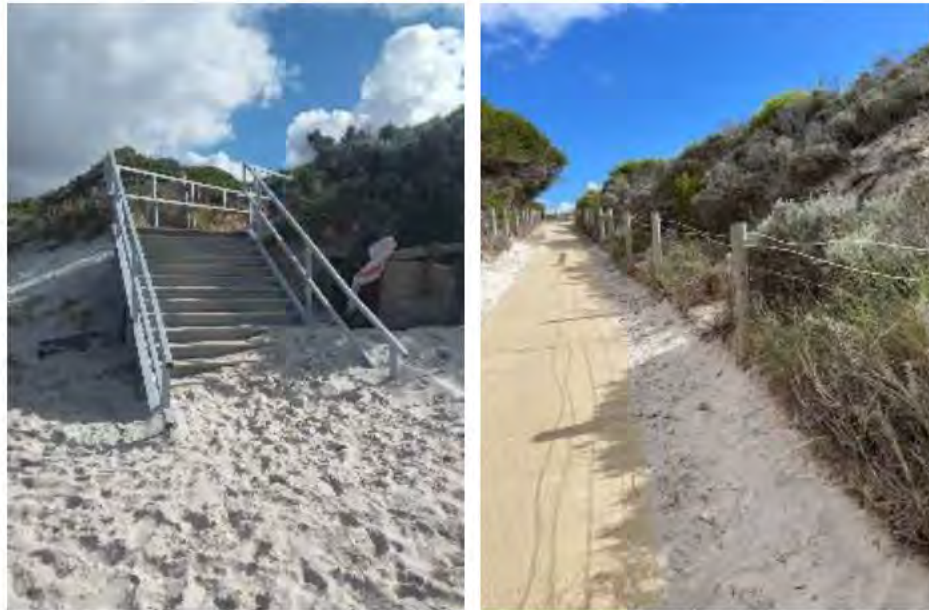
Figure 3.39 C20 Assets

Site C20 provides beach access from the car park on Ocean Drive, in North Quinns Rocks. No drawings were available/provided to GHD, hence the age of the structure is not known. The site comprises of a concrete path boarded by a timber and steel mesh fence, which leads to a steel / composite staircase which provides access to the beach. Refer Figure 3.39 for general photos of the structures. The inspection was completed from ground level, the battery limits of the inspection are shown in Figure 3.40. The assets within site C20 were found to be in good condition with the exception of a number of items which require maintenance within 1 – 2 years.

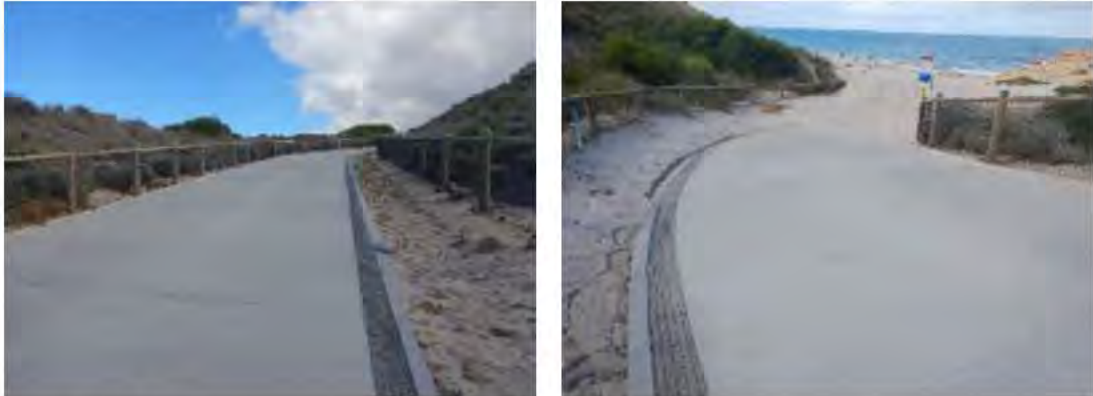
Figure 3.41 C21 Assets

Site C21 provides vehicular beach access from the car park at Queenscliff park on Ocean Drive, in Quinns Rocks. Based on provided information the vehicle access ramp was constructed circa 2017. The site consists of a concrete vehicle access ramp which is lined by timber and coated steel wire mesh fence along both sides for the full length. Refer Figure 3.41 for general photos of the structures. The inspection was completed from ground level, the battery limits of the inspection are shown in Figure 3.42. The assets within site C21 were found to be in good condition with the exception of corroded traffic bollards which require maintenance within 1 -2 years.

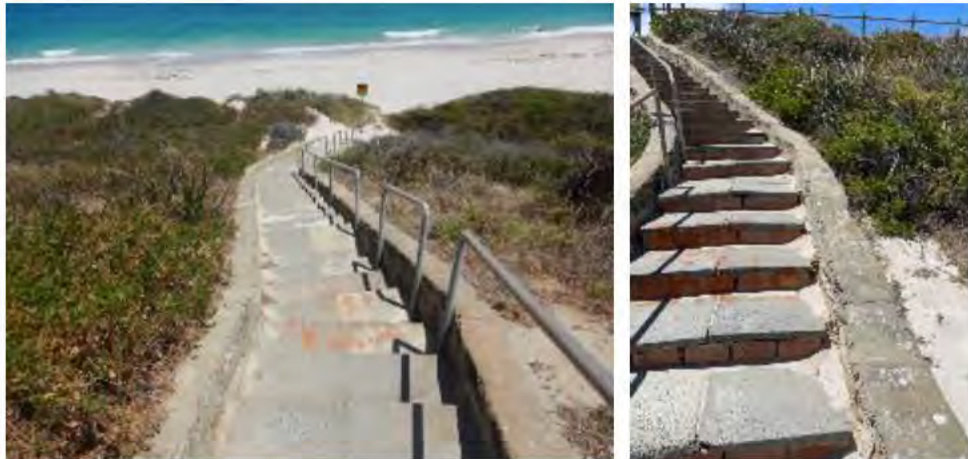
Figure 3.47 C24 Assets

Site C24 provides beach access via a staircase of Ocean Drive, in Jindalee. No drawings were available/provided to GHD, hence the age of the structure is not known. The stairs are constructed from concrete pavers laid on top of bricks. A grouted rock retaining wall borders the stair case with a steel handrails provided along the North side.. Refer Figure 3.47 for general photos of the structures. The inspection was completed from ground level, the battery limits of the inspection are shown in Figure 3.48. The assets within site C24 were found to be in adequate condition with visible signs of deterioration to the stairs and handrailing.

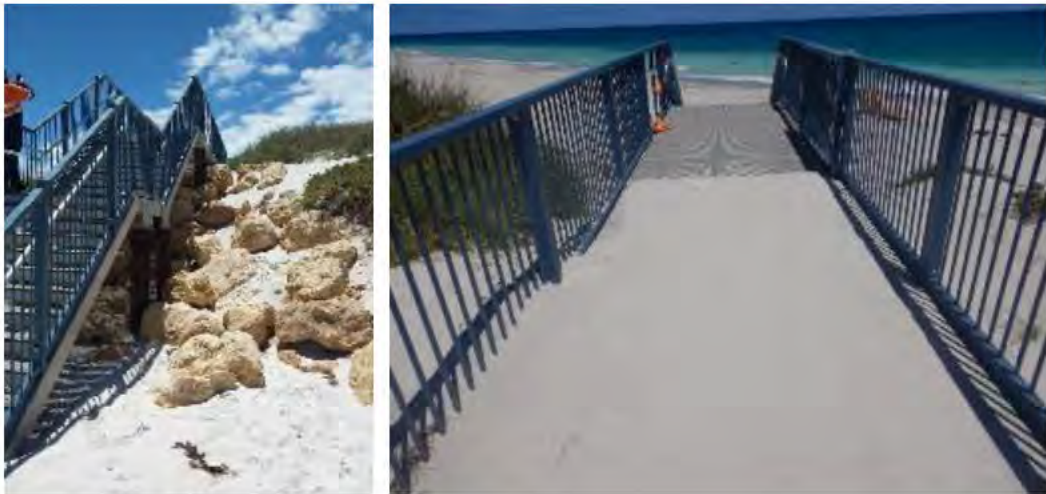
Figure 3.49 C25 Assets

Site C25 provides beach access via a staircase near Frederick Stubbs Park, off Ocean Drive in Quinns Rocks. Based on provided information the staircase was constructed circa 2018. The staircase is comprised of coated steelwork supports and balustrades with FRP decking. The staircase has replaced a previous structure and has been installed on the previous structures footings.. Refer Figure 3.49 for general photos of the structures. The inspection was completed from ground level, the battery limits of the inspection are shown in Figure 3.50. The assets within site C25 were found to be in good condition with the exception of localised vandalism which has caused damage to the balustrades.

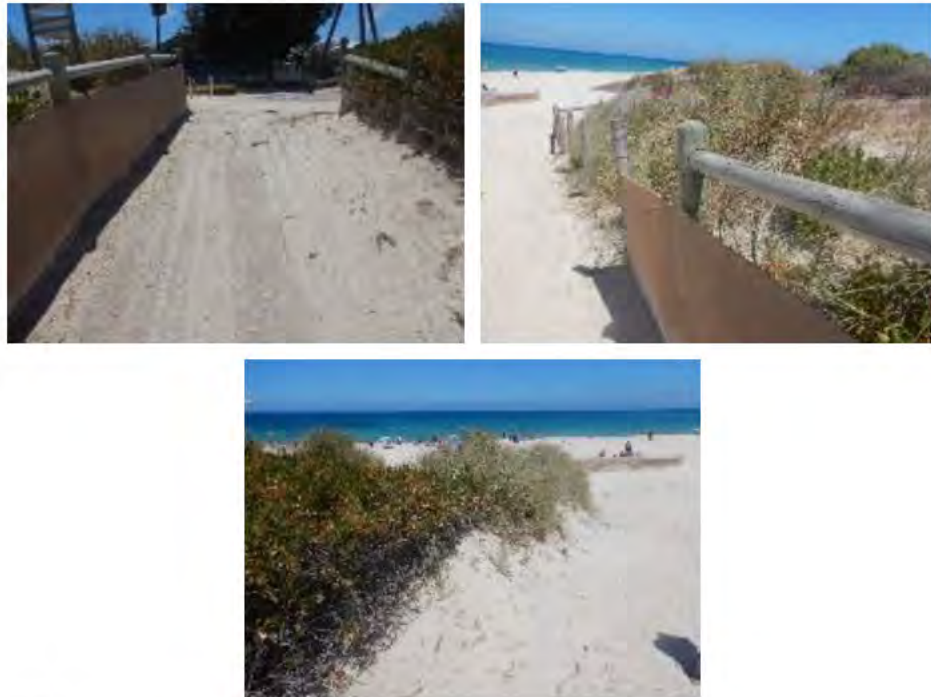
Figure 3.53 C27 Assets

Site C27 provides vehicle access to the beach from the foreshore on the South-West bend in Ocean Drive, Quinns Rocks. No drawings were available/provided to GHD, hence the age of the structure is not known. The concrete ramp is boarded by a timber and mesh fence, there is geofabric cloth on the North side fencing. Refer Figure 3.53 for general photos of the structures. The inspection was completed from ground level, the battery limits of the inspection are shown in Figure 3.54. The assets within site C27 were found to be in good condition, with the exception of minor defects to the fencing which requires maintenance.

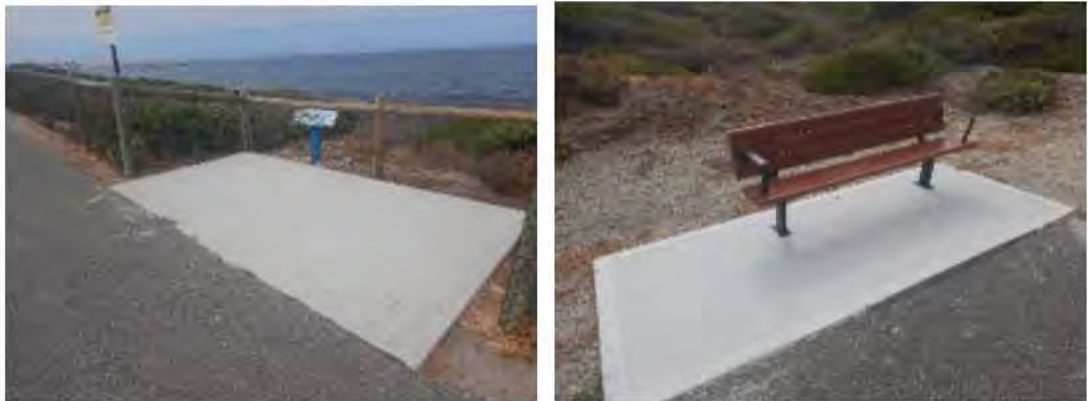
Figure 3.61 C31 Assets

Site C31 provides a lookout along the coastal walk accessed via a pathway at the intersection of Duncannon Rise and Kinsale Drive in Mindarie. Based on provided information the lookout was constructed circa 2018. The site consists of a newly constructed concrete slab, with a timber and coated mesh fence around the North, West and South sides. Refer Figure 3.61 for general photos of the structure. The inspection was completed from ground level, the battery limits of the inspection are shown in Figure 3.62. The assets within site C31 were found to be in good condition with the exception of minor maintenance required to the mesh staples within 5 years.

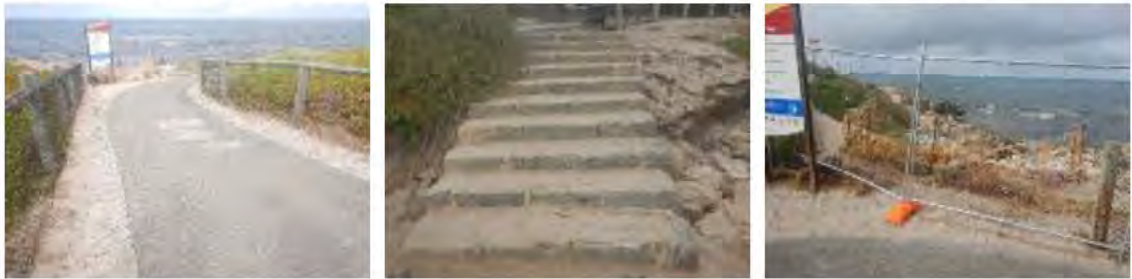
Figure 3.63 C32 Assets

Site C32 provides access to the beach from the parking lot at Rosslare Promenade in Mindarie via a dual use path. No drawings were available/provided to GHD, hence the age of the structure is not known. The site consists of an asphalt path which leads to a set of limestone steps down to the beach. The path is bordered by a steel mesh and timber fence and temporary fence in place of missing fence areas. Refer Figure 3.63 for general photos of the structures. The inspection was completed from ground level, the battery limits of the inspection are shown in Figure 3.64. The assets within site C32 were found to be in average condition with a number of items requiring urgent maintenance.

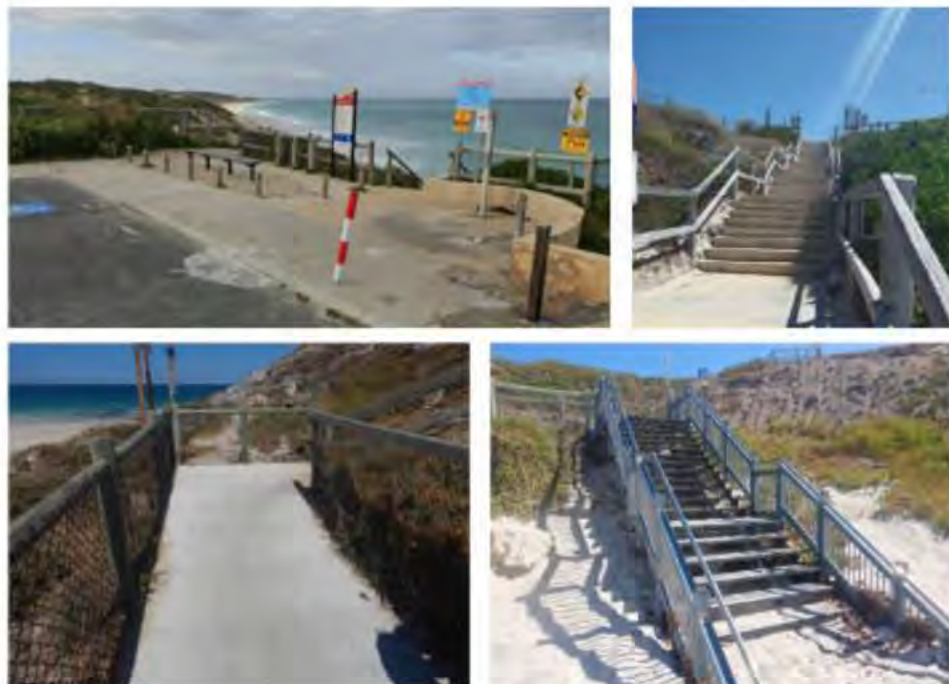
Figure 3.65 C33 Assets

Site C33 provides a coastal lookout and beach access to the South Mindarie Foreshore from the parking area off Alexandria View, opposite Stockton Lane in Mindarie. Based on provided information the lookout and beach access path were constructed circa 2004. The site consists of a lookout and shower area, with a set of concrete steps leading down to a concrete path and a subsequent set of composite fibre stairs which give access to the beach. Information provided by the CoW suggest repair works to the concrete path and installation of composite stairs were completed circa 2020. Refer Figure 3.65 for general photos of the structures. The inspection was completed from ground level, the battery limits of the inspection are shown in Figure 3.66. The assets within site C33 were found to be in good condition, however there were a number of items requiring maintenance.

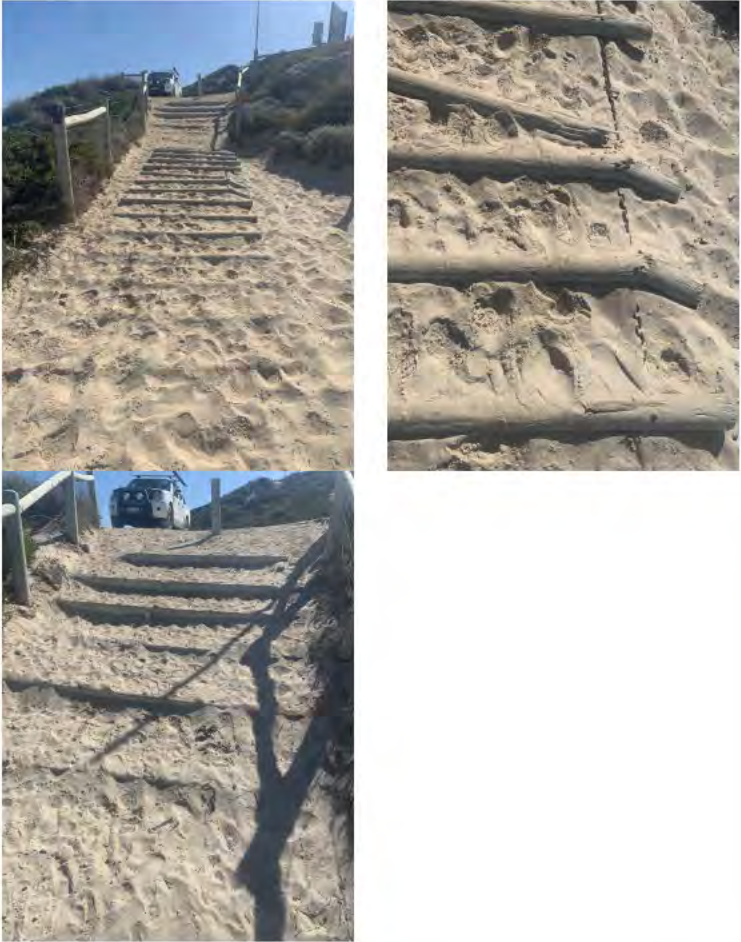
<b>Other Comments/Inspection Limitations</b>	Lower half buried

<b>Maintenance Recommendation</b>	Replace broken and corroded chain. The sleepers and connections can be monitored and reinspected at the next scheduled inspection.
<b>Maintenance Timeframe</b>	Within 6 months
<b>Multi Photo</b>

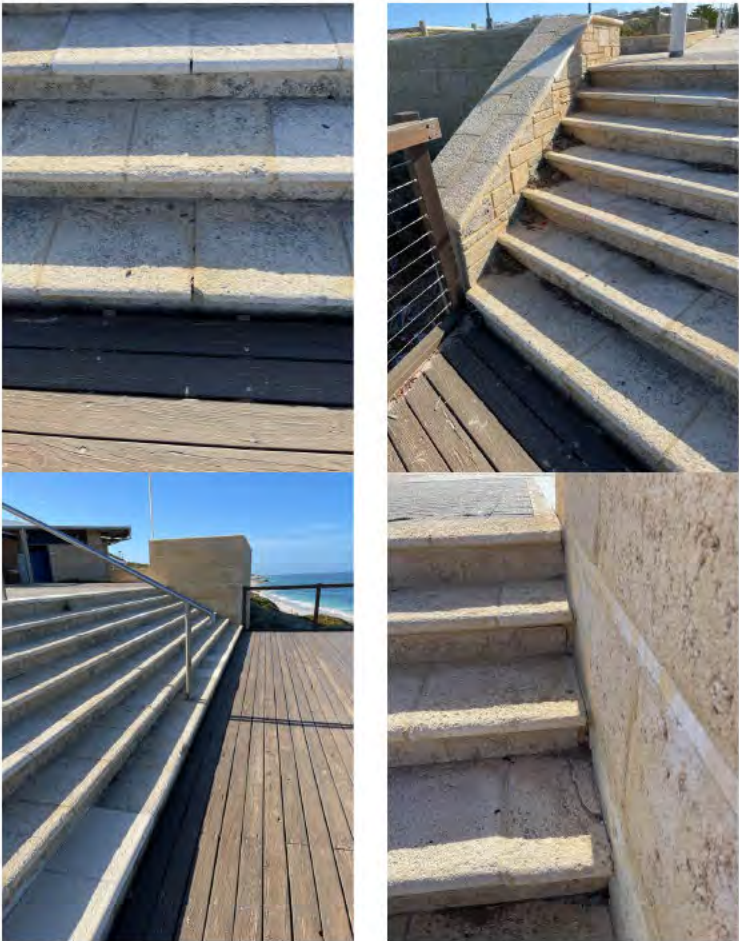
No access to foundations assumed to be in good condition

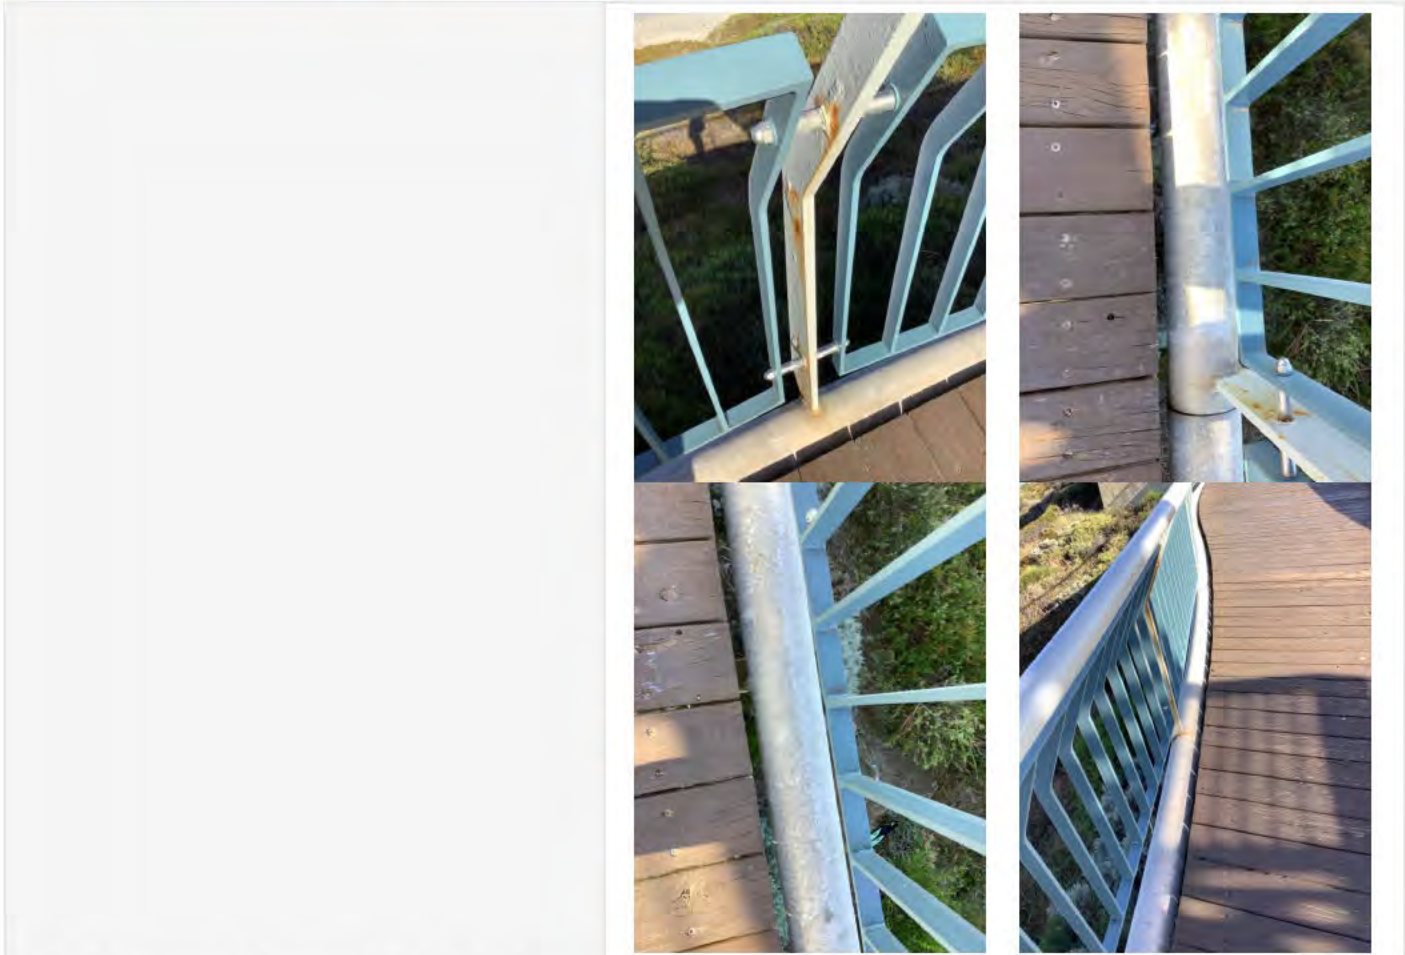
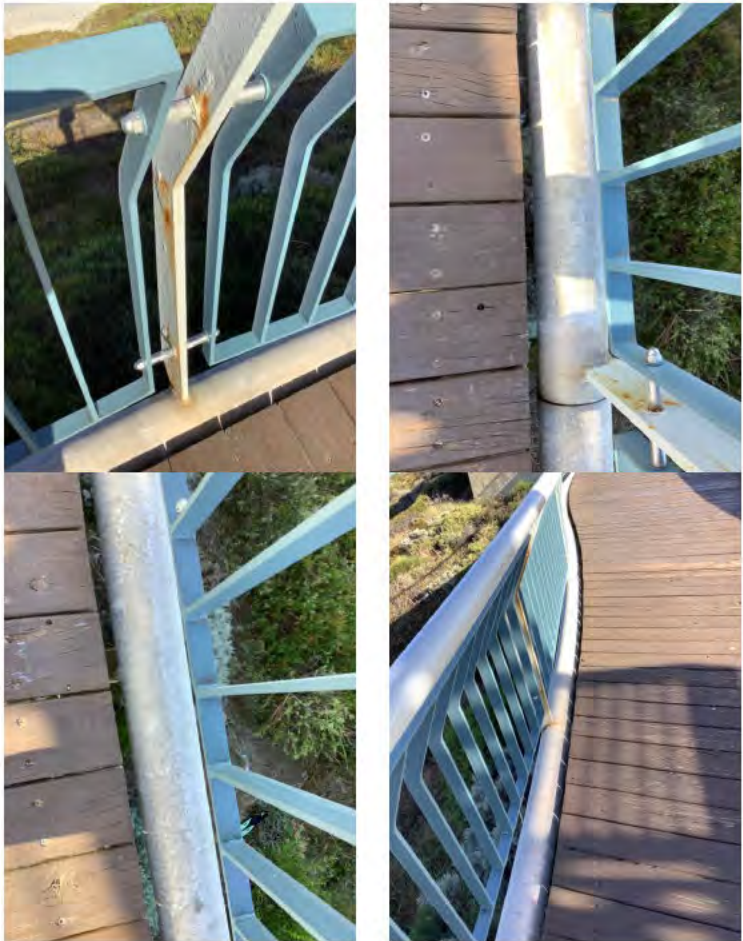
This fencing and handrail consists of a galvanized steel bottom with coated steel posts and rails. The galvanized steel is rusting and so are the posts but not the fencing or the handrail top

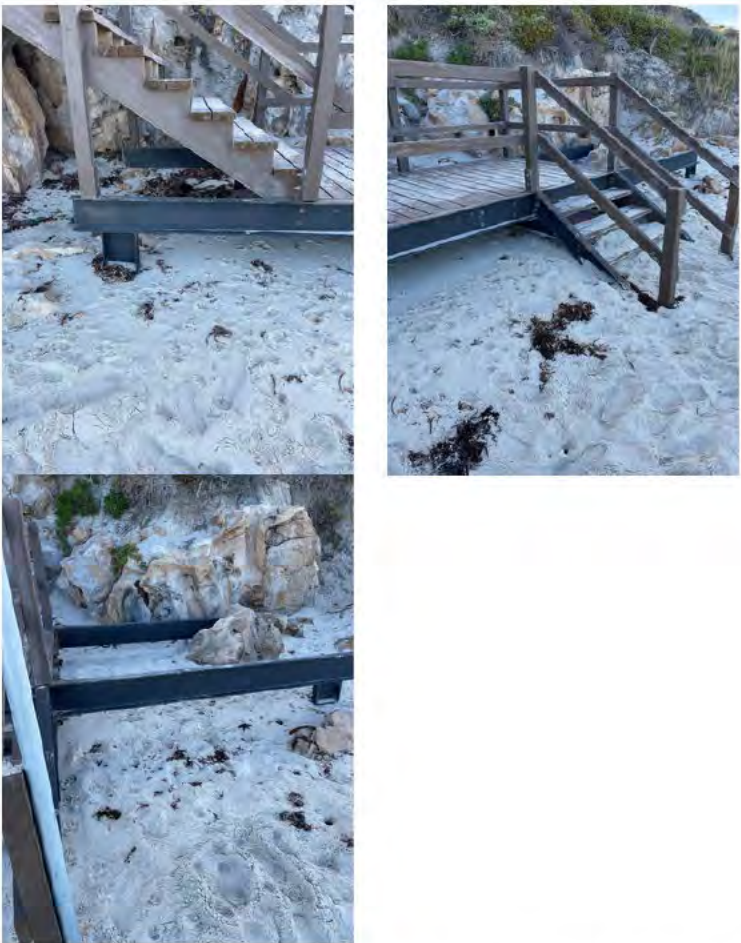
Typical corrosion to bolts similar to timber support portion of stairs

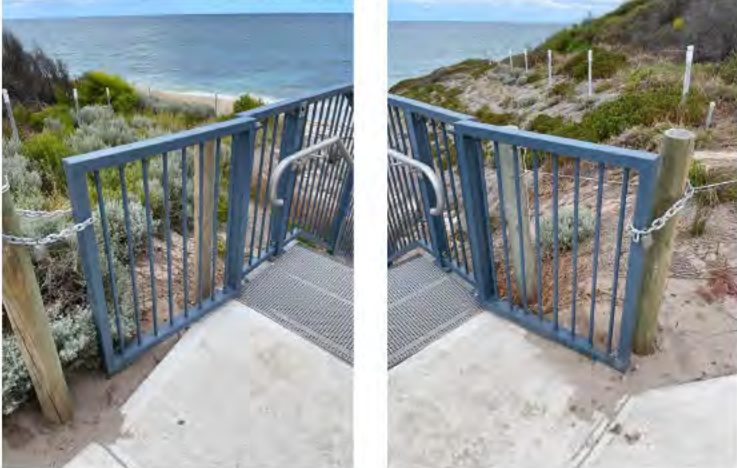
Corrosion on chain attaching gate to post
