RE: Recommended works Foreshore Reserve, Augusta WA 6290.

As per the request, the additional trees located in the foreshore reserve south of Turner Caravan Park were visually inspected for any major features or defects regarding the safety of people and property.

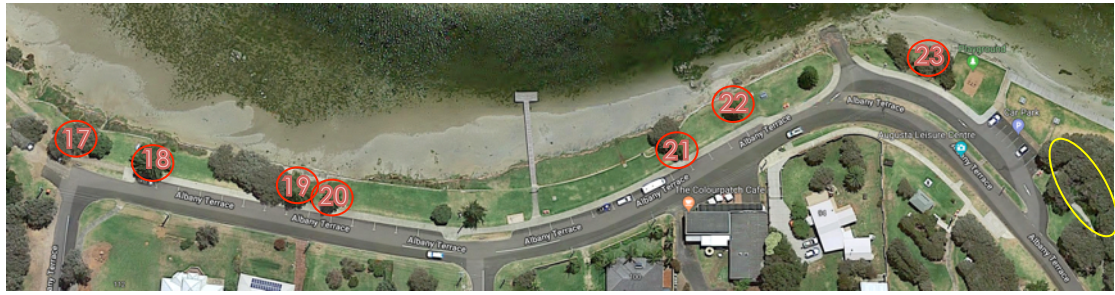
The bush reserve circled in yellow in Figure 1 requires some remedial works. There are dead trees, large hazardous deadwood, previously failed hanging branches and heavy extended lateral branches. Although not part of the request it has been mentioned as some of these trees in this area are likely posing more risk to public than the adjacent inspected trees.

Figure 1: Site location with specific works trees numbered and general locations circled in red. Bush reserve circled in yellow.
