Shire of Augusta Margaret River  
PO Box 61  
Margaret River 6285

RE: Recommended works Foreshore Reserve, Augusta WA 6290.

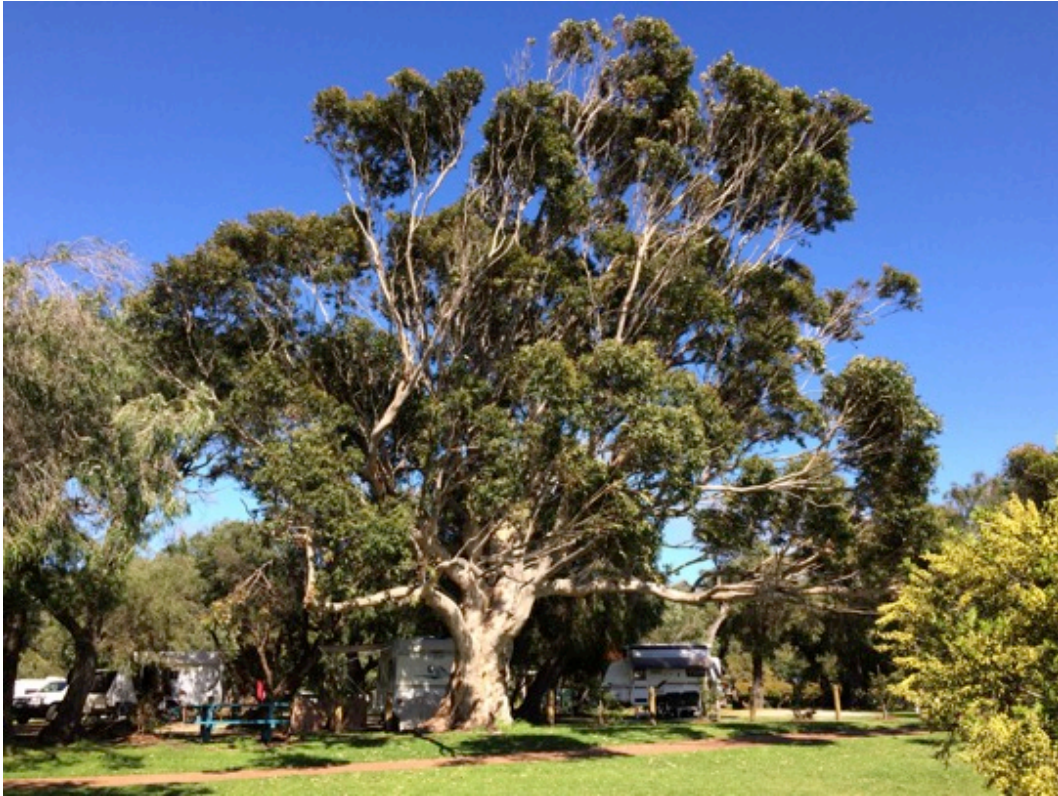
**Figure 2:** Tree 1.

The single Karri tree has a high target area underneath its canopy and is the largest of the trees on this site. The tree has likely had multiple failures over its lifetime that contributed to the form of the tree. There are a number of large extended laterals on this tree that should be reduced. A selective reduction of parts of the upper canopy is also recommended. Installation of tree cables on any suspect limbs during the canopy works is also recommended.

Tree Number	Tree I.D	Recommended Works
1	<i>Eucalyptus diversicolor</i>	Weight reduction of extended laterals. Crown reduction of Extended upright limbs. Removal of deadwood. Cable instalation if required or benifical.
2	<i>Agonis flexuosa</i>	Tree Removal.
3	<i>Agonis flexuosa</i>	Heavy Crown Reduction to suitable growth points..
4	<i>Agonis flexuosa</i>	Weight reduction of extended laterals. Crown reduction of Extended upright limbs. Removal of deadwood. Cable instalation if required or benifical.
5	<i>Agonis flexuosa</i>	Heavy Crown Reduction to suitable growth points..
6	<i>Agonis flexuosa</i>	Crown reduction. Reduction and or removal of laterals extending over footpath.
7	<i>Agonis flexuosa</i>	Tree Removal.
8	<i>Agonis flexuosa</i>	Weight reduction over picnic bench.
9	<i>Agonis flexuosa</i>	Tree Removal. Tree could potentialy be retained if suitable tree prop is engineered.
10	<i>Agonis flexuosa</i>	Weight reduction of extended laterals. Crown reduction of Extended upright limbs. Removal of deadwood. Cable instalation.

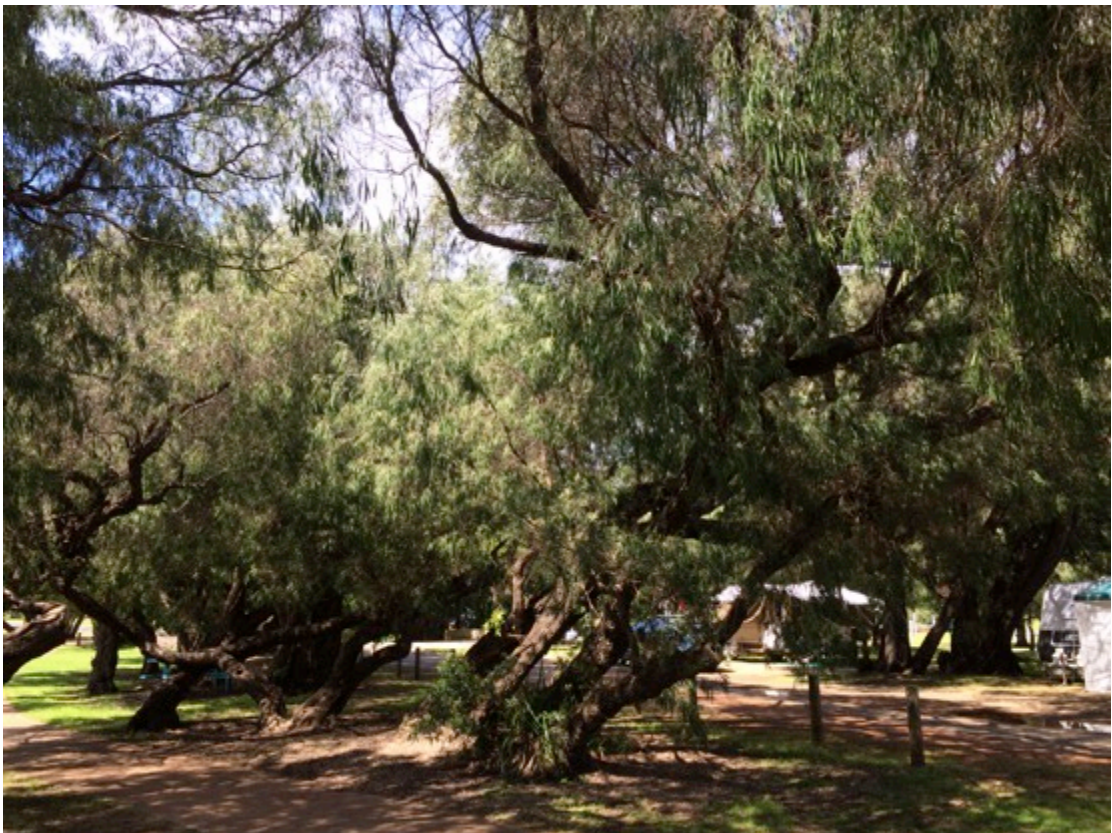
**Figure 15:** Tree 14. This is a stand of approximately 10 stems.

11	<i>Agonis flexuosa</i>	Heavy Crown Reduction to suitable growth points..
12	<i>Agonis flexuosa</i>	Heavy Reduction of eastern limbs to suitable growth points. Remove limbs if no suitable growth points.
13	<i>Agonis flexuosa</i>	Tree Removal.
14	<i>Agonis flexuosa</i>	Remove stem over footpath.
