Department of Water & Environmental Regulation

# R10407 AA DAM 360 Drainage Assessment

19 September 2019

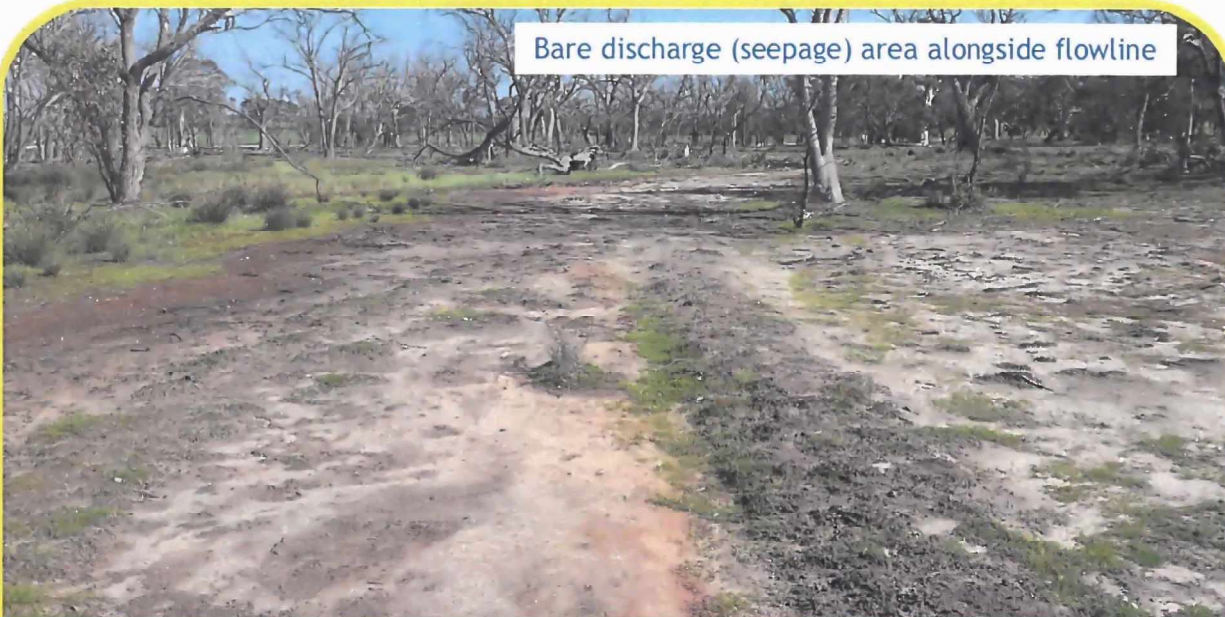
Bare discharge (seepage) area alongside flowline

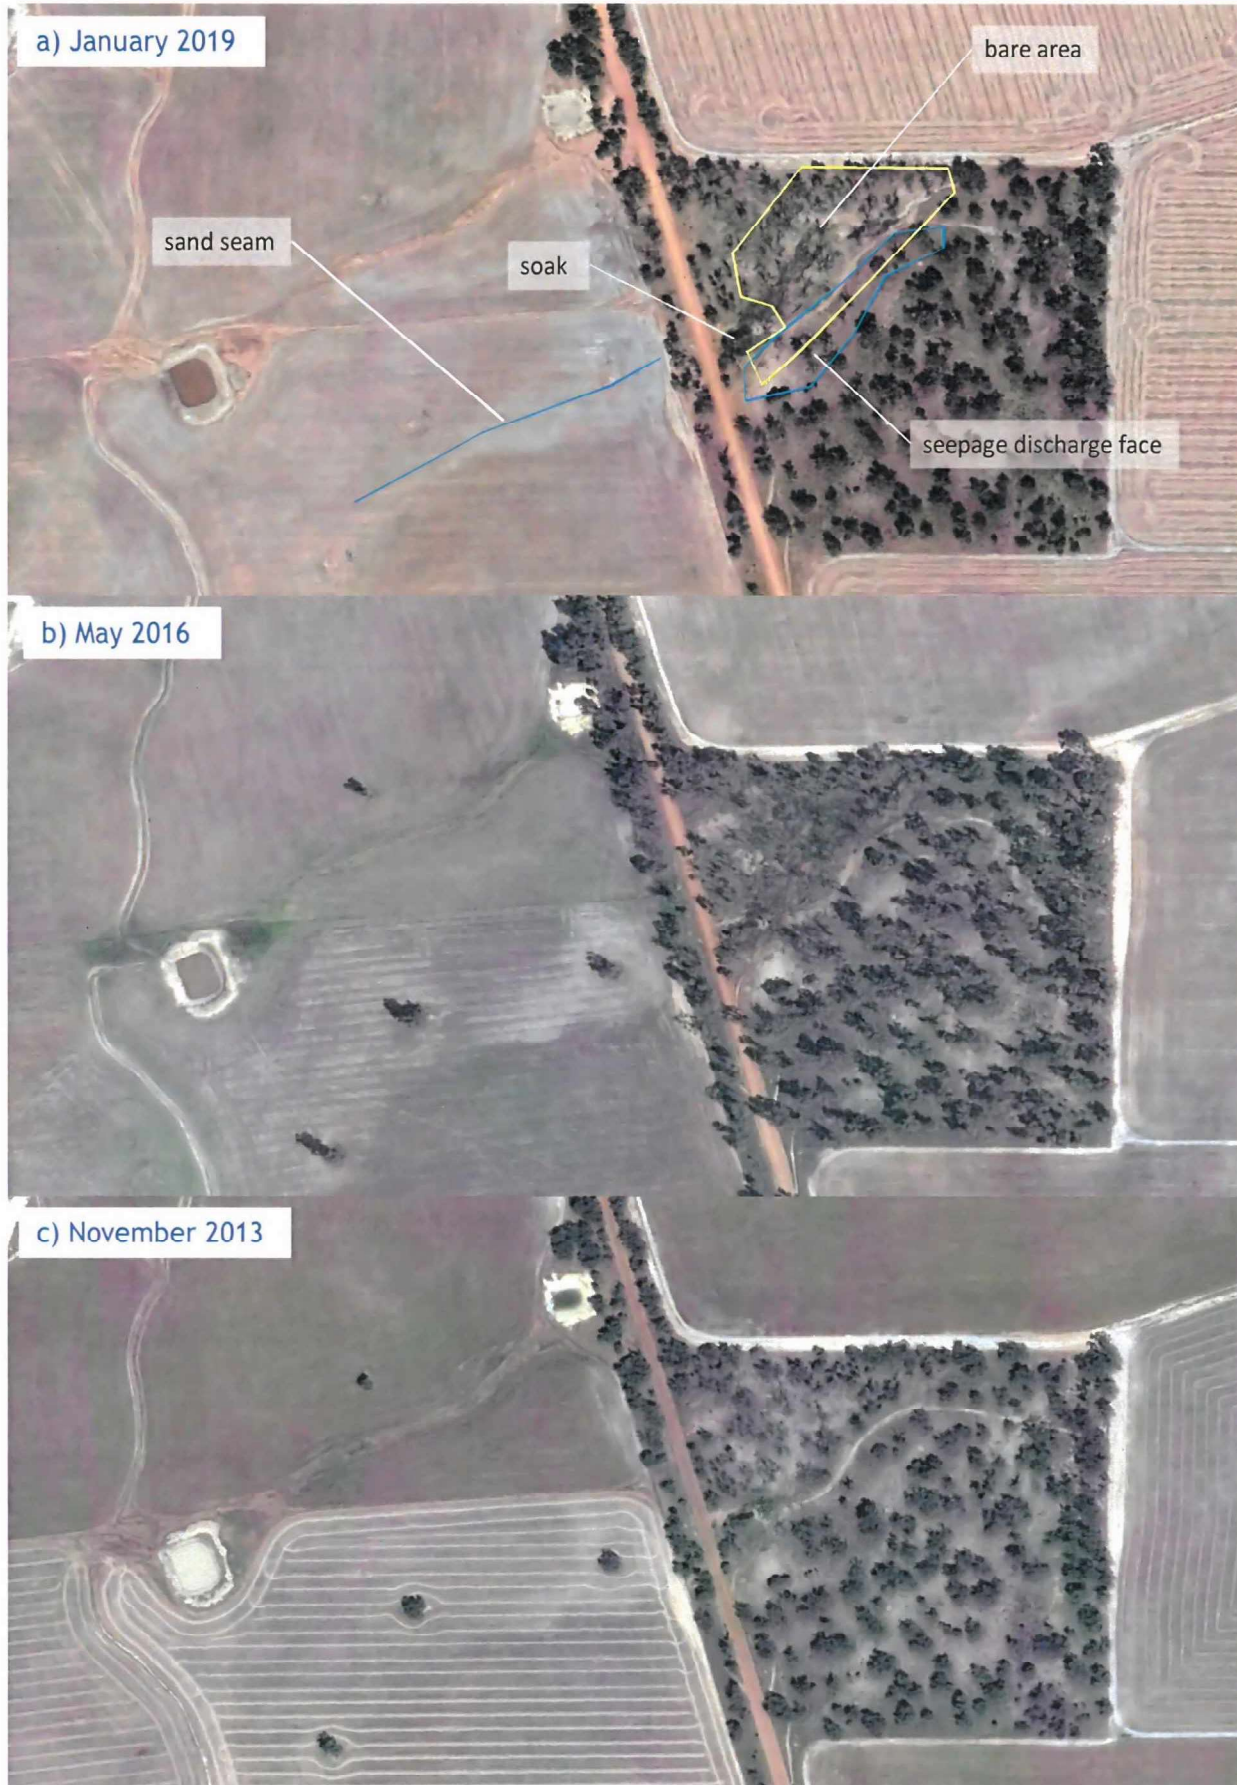
Figure 3. Aerial Imagery from Google Earth of R10407 at 3 times since inspection in 2012.

A site assessment was undertaken on 17<sup>th</sup> September, with John Firth (Land Conservation Officer, DPIRD) and the proponent farmers, Scott Angwin and Anthony Rowell. Since 2012, the health of the vegetation in the lower part of the reserve has declined significantly (Figure 3). Aerial imagery indicates that the reserve has only become degraded since around 2006 (Figure 2). Spiny rush has infested the soak and wet areas downslope. Bare areas have become more extensive above the flow line. Active seepage was observed along the slope in and just above the flowline, with a shallow hole dug being saline (in the order of 77 mS/cm). This appears to be hillside seepage from a perched water table derived from recharge on the slope to the east on a very firm clay base and is confined to within the reserve. Waterlogging in this area is exacerbated by runoff from Dongolocking Rd being directed into the reserve, however topsoil has not yet been eroded to any extent.

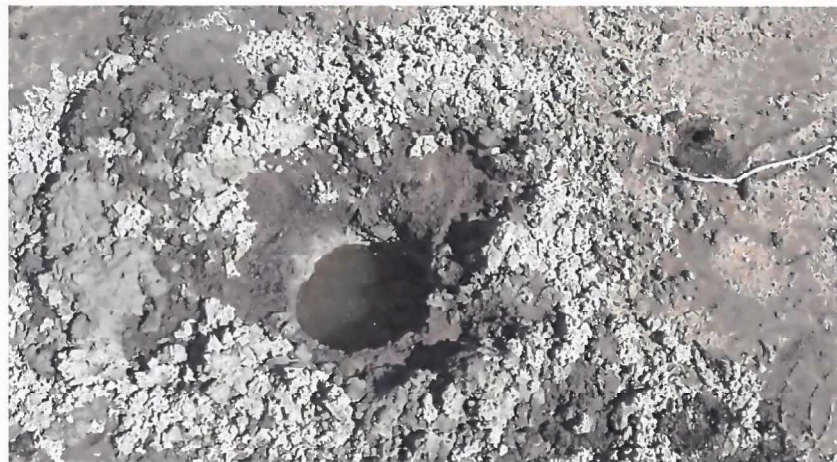
Auger hole in discharge area  $\approx$ 2 hours after drilling

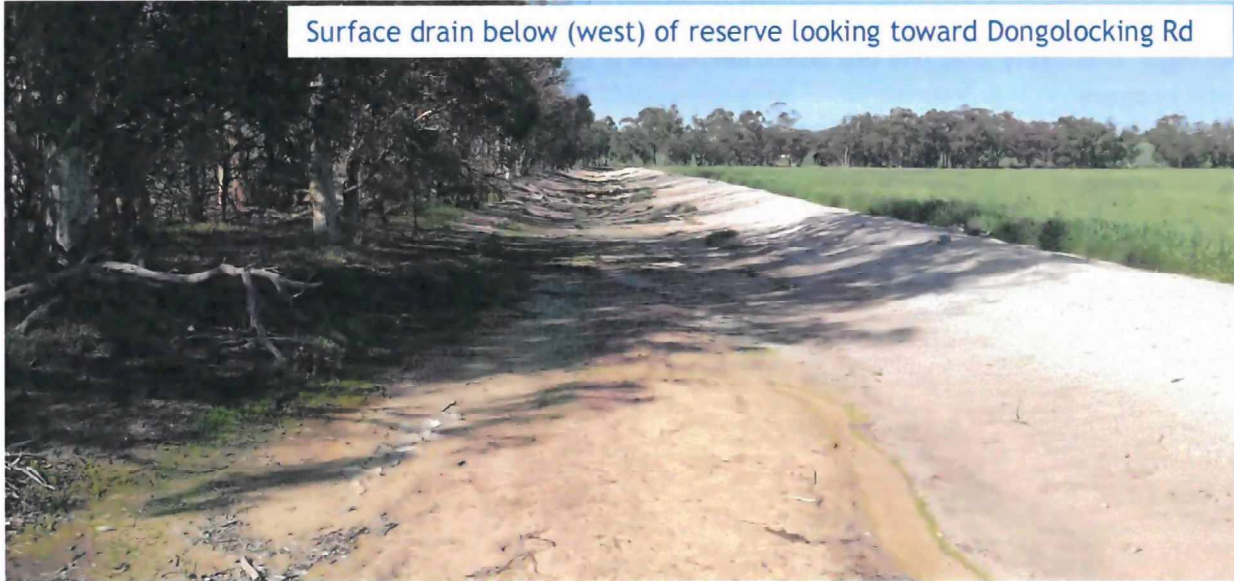
Surface drain below (west) of reserve looking toward Dongolocking Rd

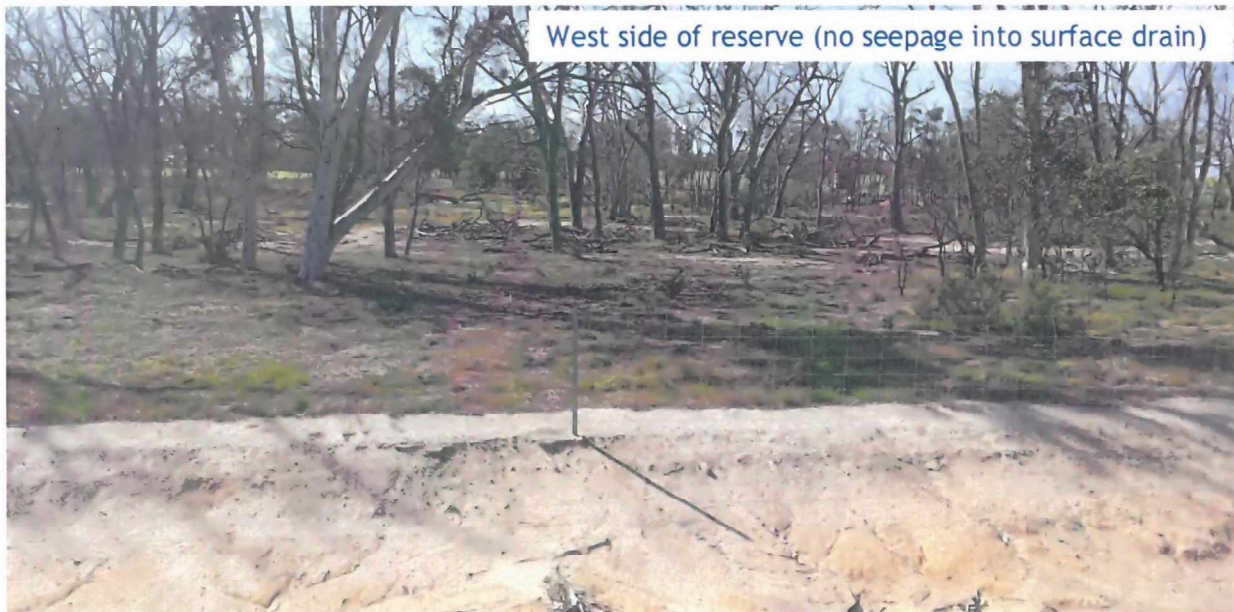
West side of reserve (no seepage into surface drain)
