Willowdale Access Road Assessment 2019

Dead tree area 7-8km down from Willowdale mine site

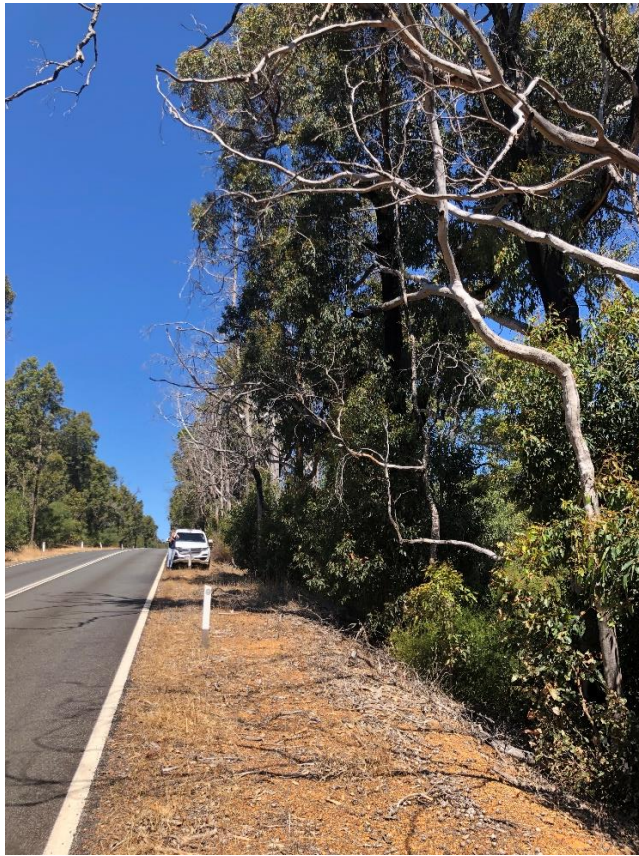
Lower Access Road

This area has approximately 15 dead trees that needs to be removed for road safety, the trees are either leaning or too close to the road. There are no signs of life in the existing trees, and if left the risk of decay causing future car accidents.

There is a substantial regrowth of new seedlings and the removal of these trees will help promote better shape.

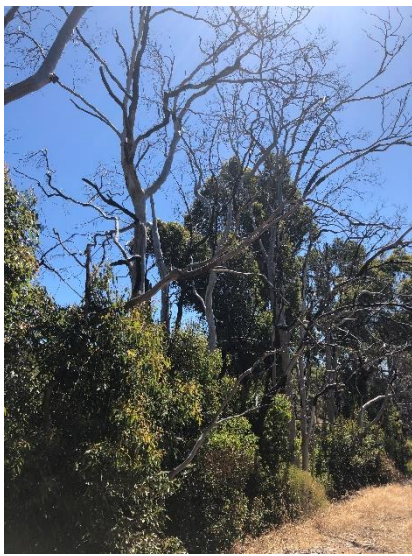
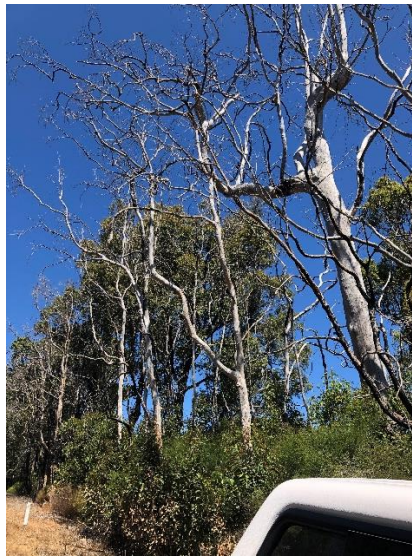
As you can see the Willowdale road is narrow and used frequently to locals and mining (ALCOA). The risk of these trees could be catastrophic if one was to fall or drop a branch.
