Private vehicle hits tree on Willowdale Road

Willowdale Access Road Assessment 2019

Dead tree area 7-8km down from Willowdale mine site

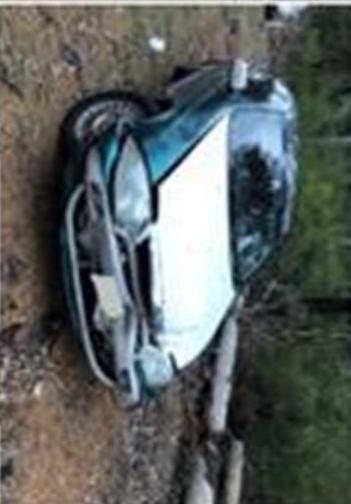
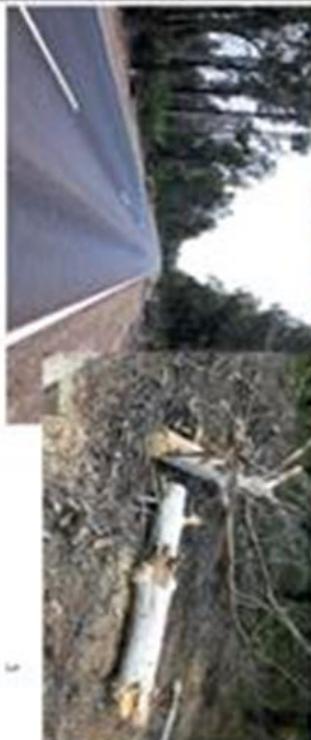
STATUS	Safety Investigation complete
WHEN	Thursday 4 th July 2019 @ 06:09
WHERE	Willowdale Road
WHAT	<ul style="list-style-type: none"> Employee travelling home from NS - 06:04 2 x employees came across tree, stopped with hazard lights Employee approaching did not see the tree until approx. 6-10m and took evasive action but contact was made Airbags deployed upon impact Driver was able to exit the car without assistance, colleagues attended to driver ERO attended the scene Driver was sore from deployment of airbags however sustained no other injuries
CORRECTIVE ACTIONS	<ul style="list-style-type: none"> Shire contacted and permission granted for Alcoa to arrange the removal of suspect trees - (WA Hort)
LEARNINGS	<ul style="list-style-type: none"> Report any suspect trees Always eliminate (if possible) and report and hazards

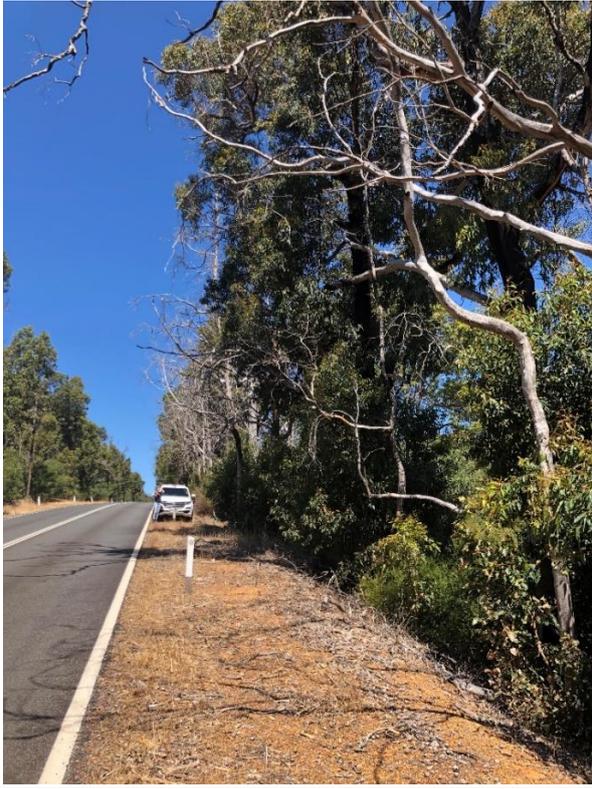
Lower Access Road

This area has approximately 15 dead trees that needs to be removed for road safety, the trees are either leaning or too close to the road. There are no signs of life in the existing trees, and if left the risk of decay causing future car accidents.

There is a substantial regrowth of new seedlings and the removal of these trees will help promote better shape.

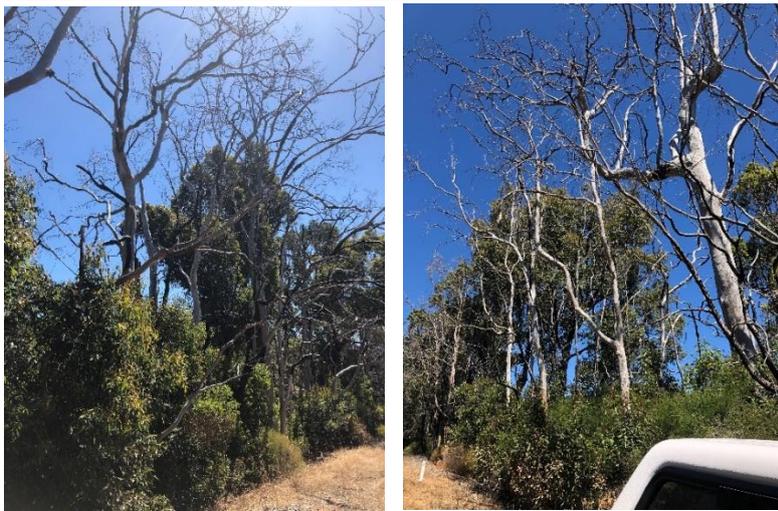
As you can see the Willowdale road is narrow and used frequently to locals and mining (ALCOA). The risk of these trees could be catastrophic if one was to fall or drop a branch.
