**Additional Photos – 13.01.2019**

# Willowdale Access Road Assessment 2019

## Dead tree area 7-8km down from Willowdale mine site

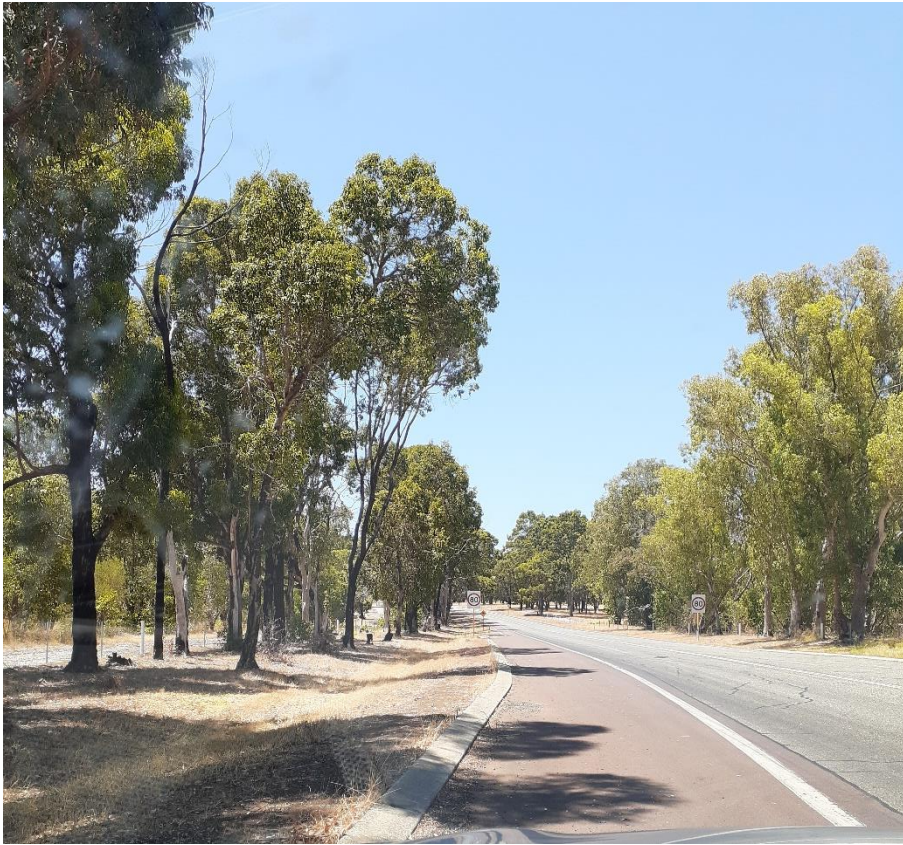
Overview of road verge from SW Highway to the 2km mark. Majority of the pruning is on the northern side of the road.

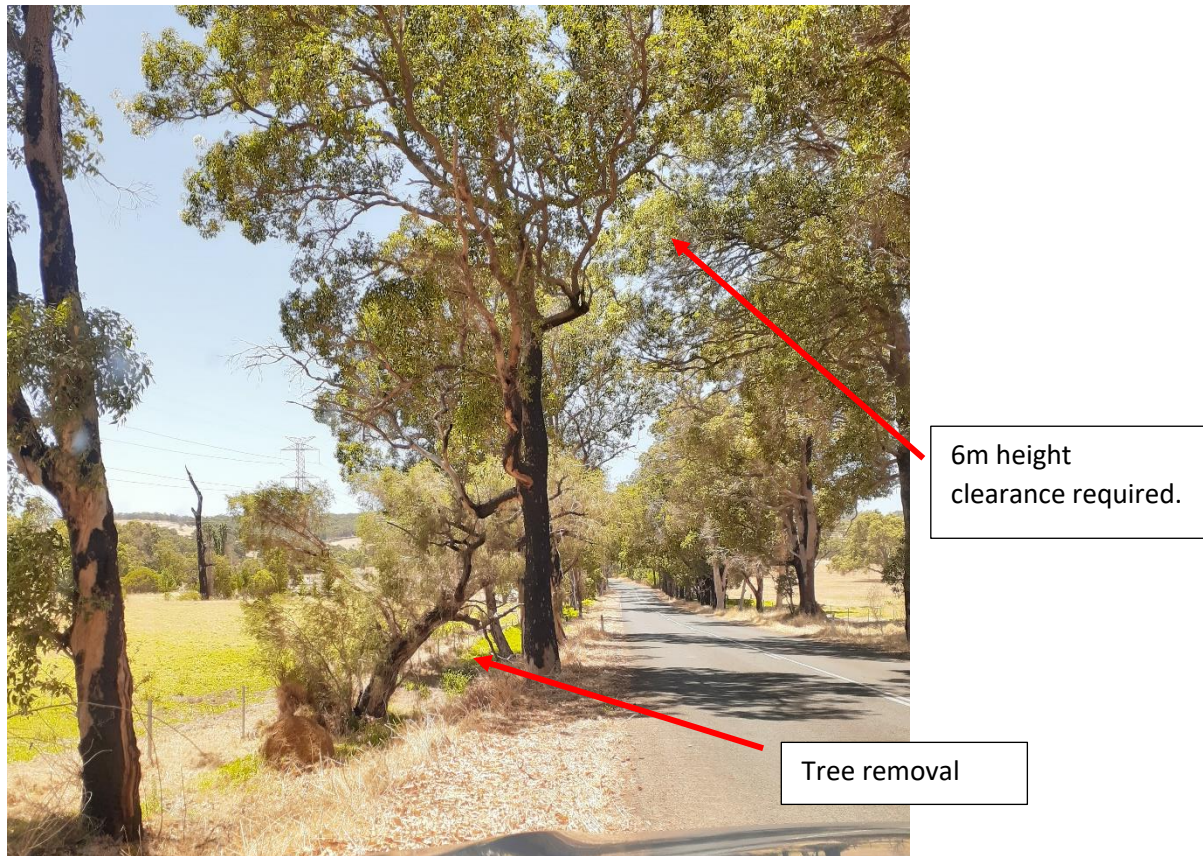
2km Verge view. The Trees are encroaching on the road with some trees like the one circled needing removal and others just needing pruning to allow for the 6m height clearance.

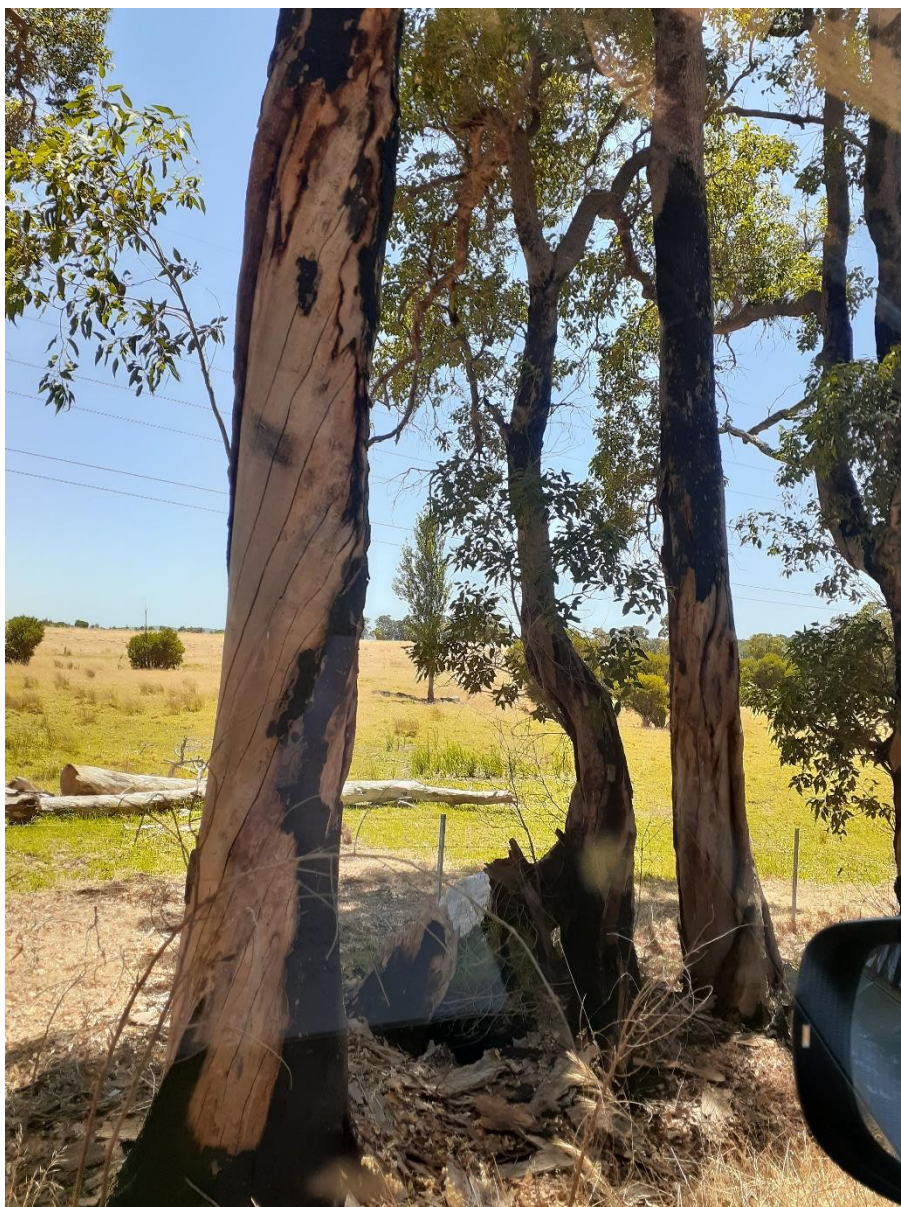
Closer image of the burnt trees which have become brittle and are causing limbs to drop onto the road which is causing a hazard to road users.

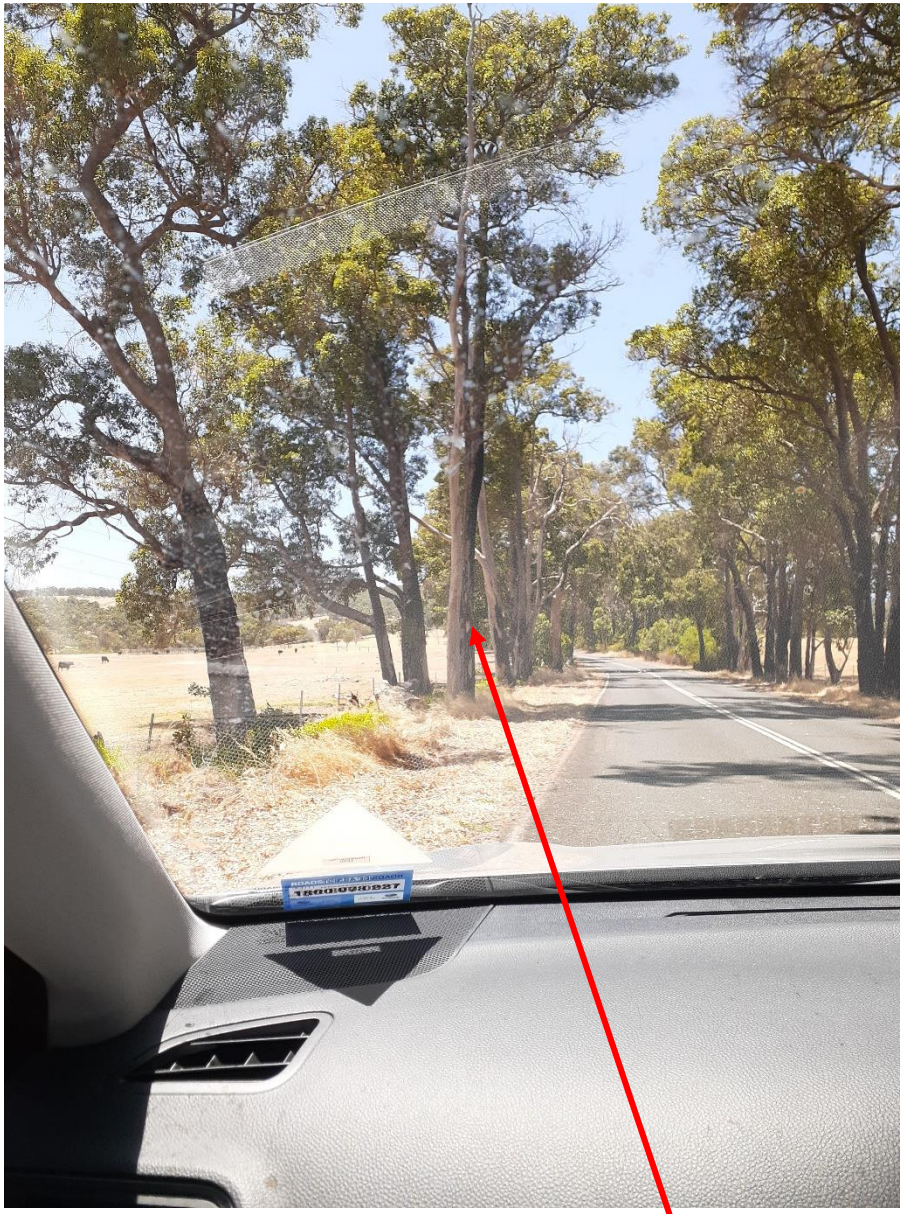
Large tree which is dead to be removed. This section only required the one removal.

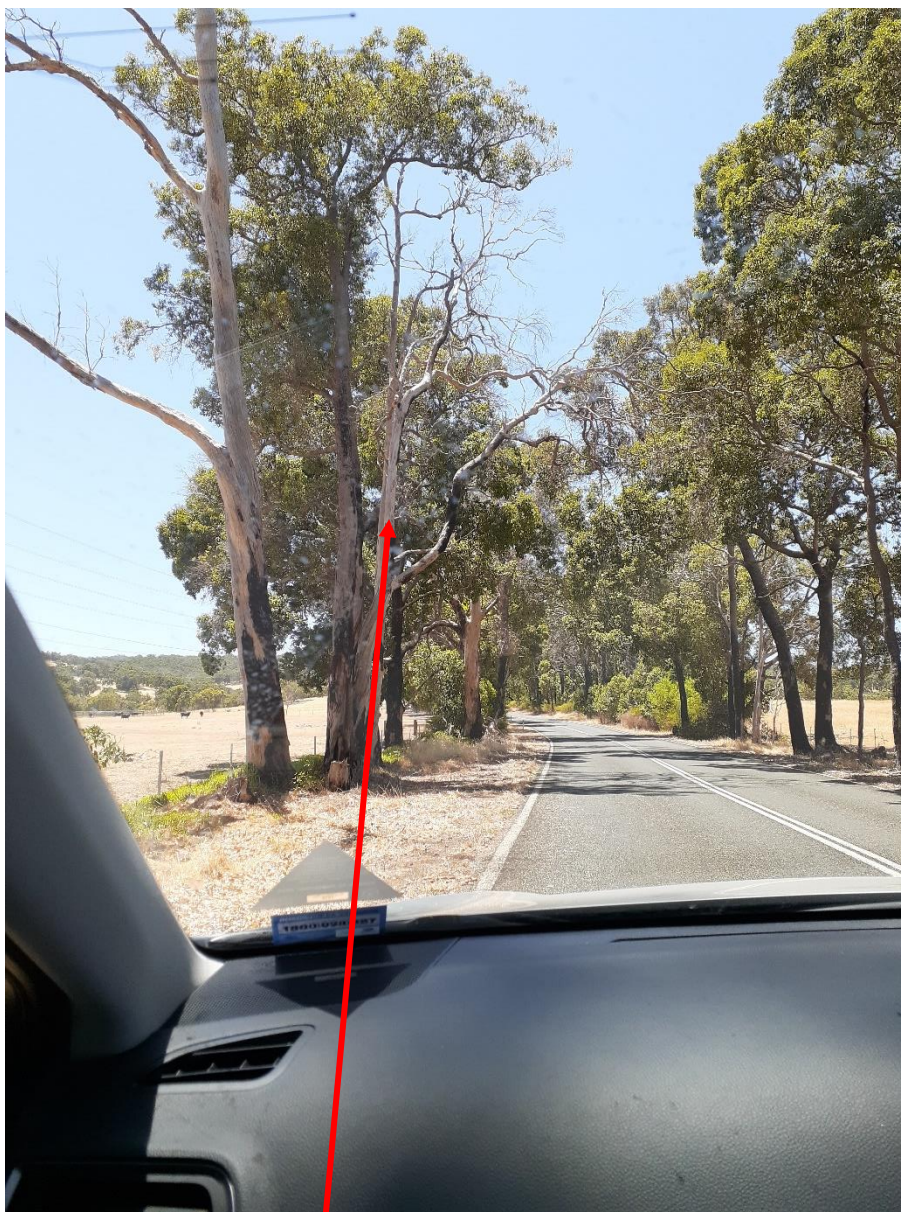
Dead tree on the norther section of the road which is overhanging the road. This section required a few tree removals of a similar type. These trees were burnt in the 2016 fires.

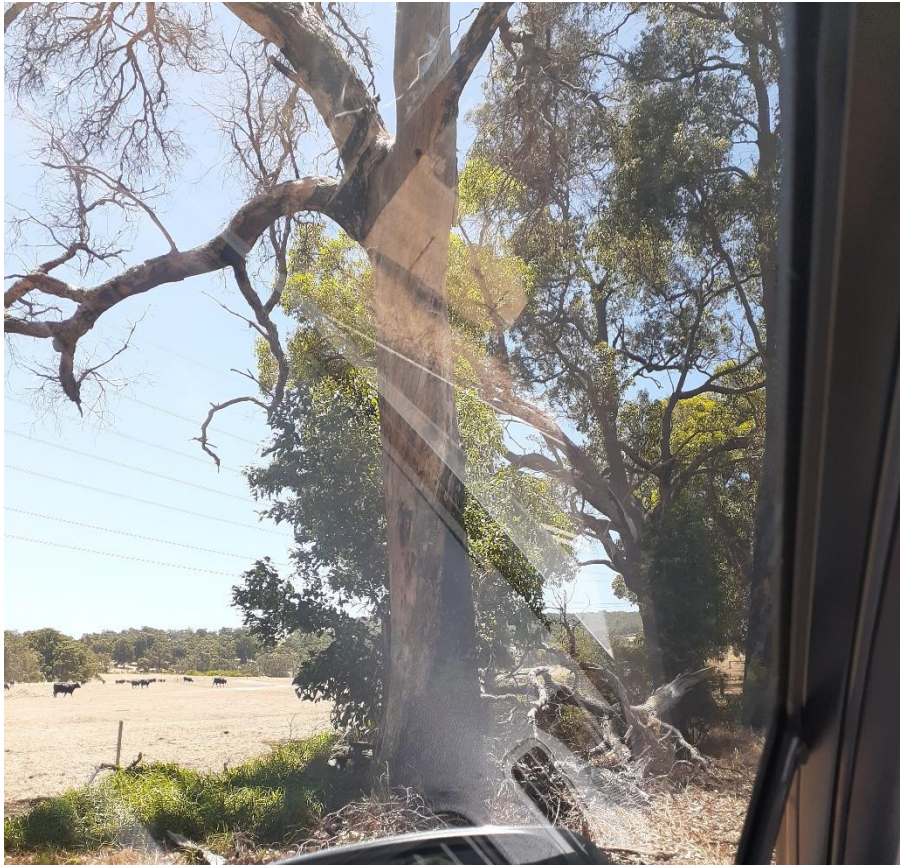
This is an example of what is happening with some of the dead trees. The dead limbs are falling on the road verge and road which is causing a hazard to road users.

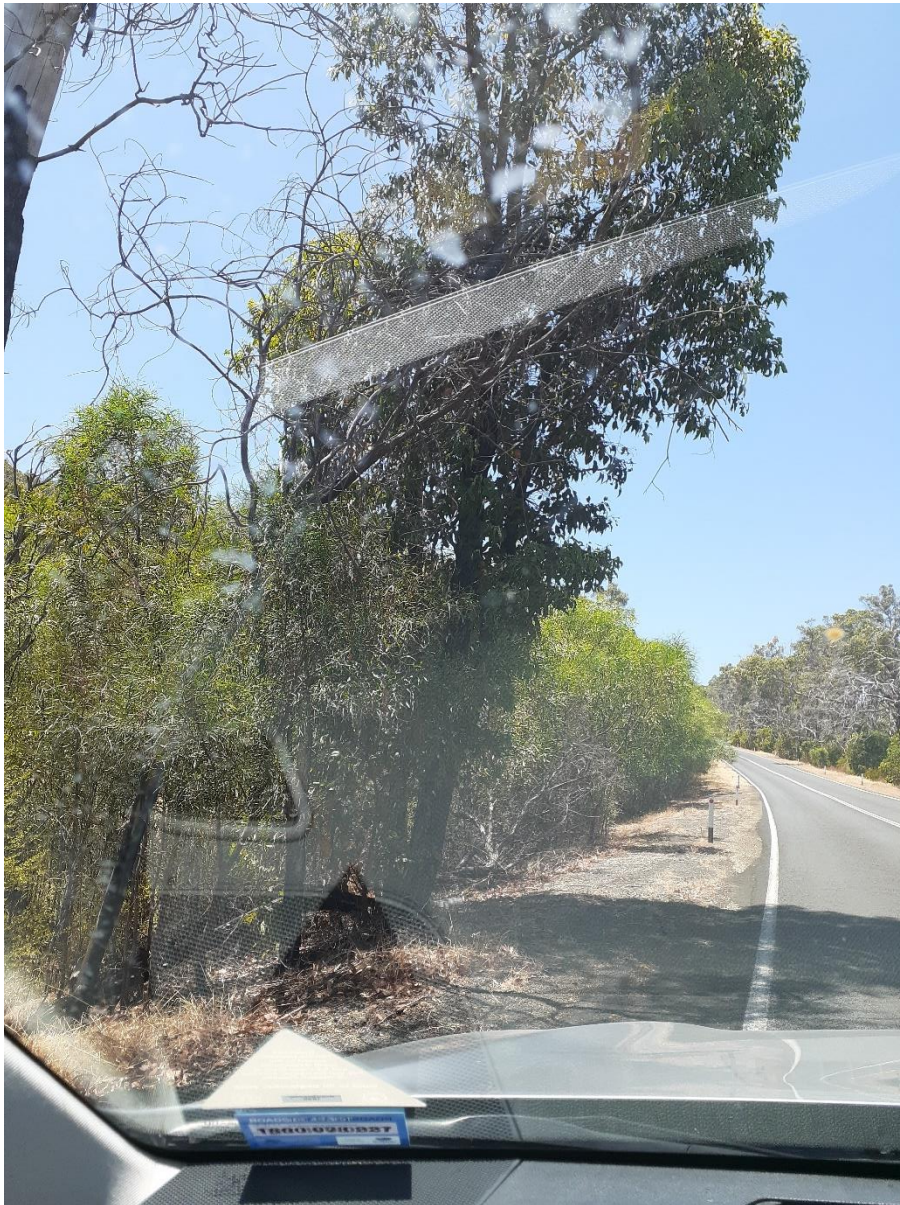
This section of the road has a large section of regrowth which will be mulched from the road verge by the posi track machine. The plan will be for us to create a 3m road verge from the edge of the seal.

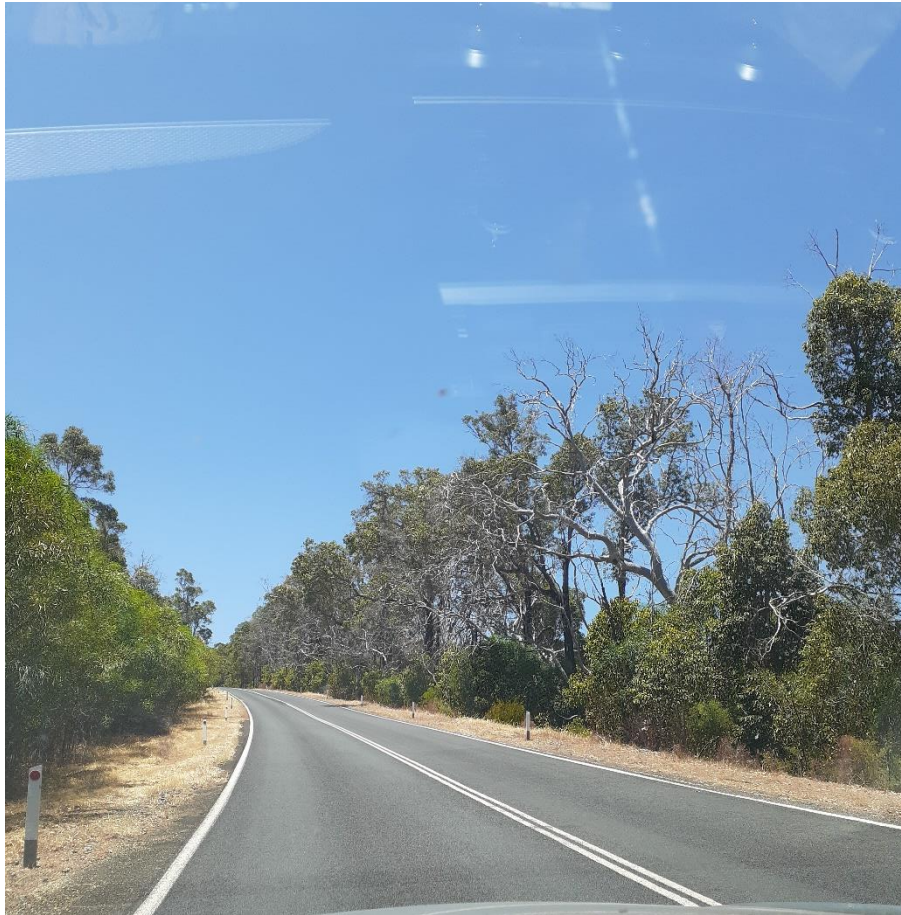
On the opposite section of the road there are several trees which are overhanging the road and causing a hazard to motorist. These vary between 3-5m from the edge of the seal. The trees are dead and are dropping limbs all the time.

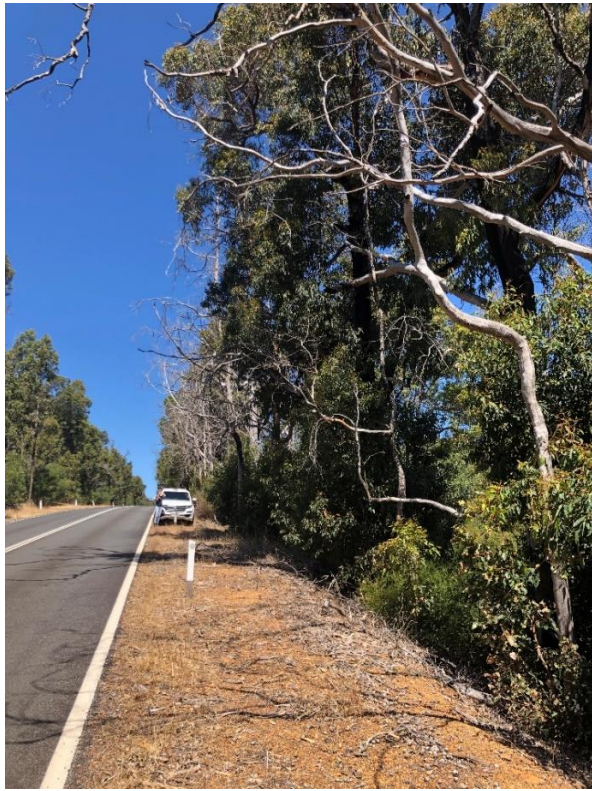
This area has approximately 15 dead trees that needs to be removed for road safety, the trees are either leaning or too close to the road. There are no signs of life in the existing trees, and if left the risk of decay causing future car accidents.

As you can see the Willowdale road is narrow and used frequently to locals and mining (ALCOA). The risk of these trees could be catastrophic if one was to fall or drop a branch.
