Nanga Road, Waroona WA

Road Improvements between Slk 0.37 – 2.02.

Road Safety Audit

Stage 3 - Detailed Design

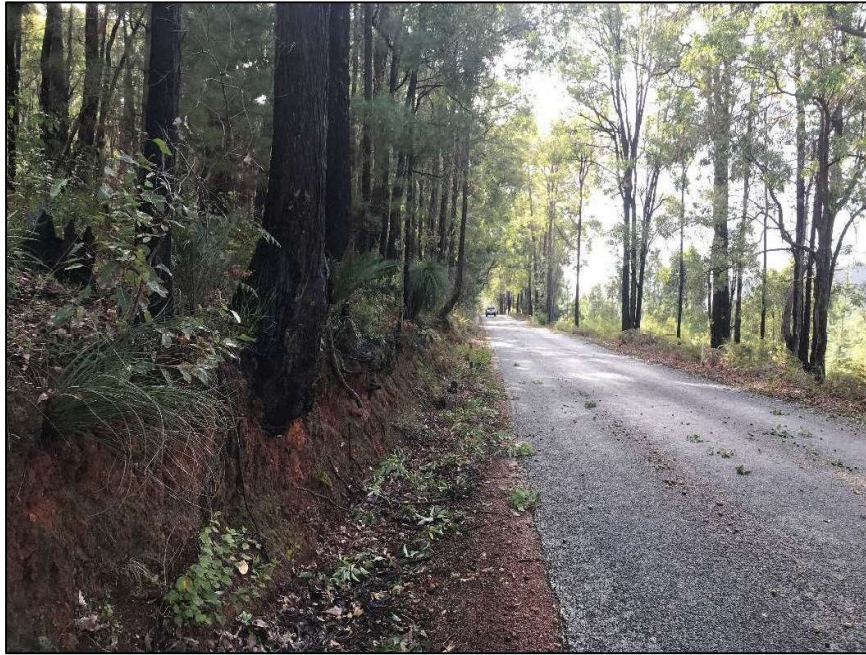
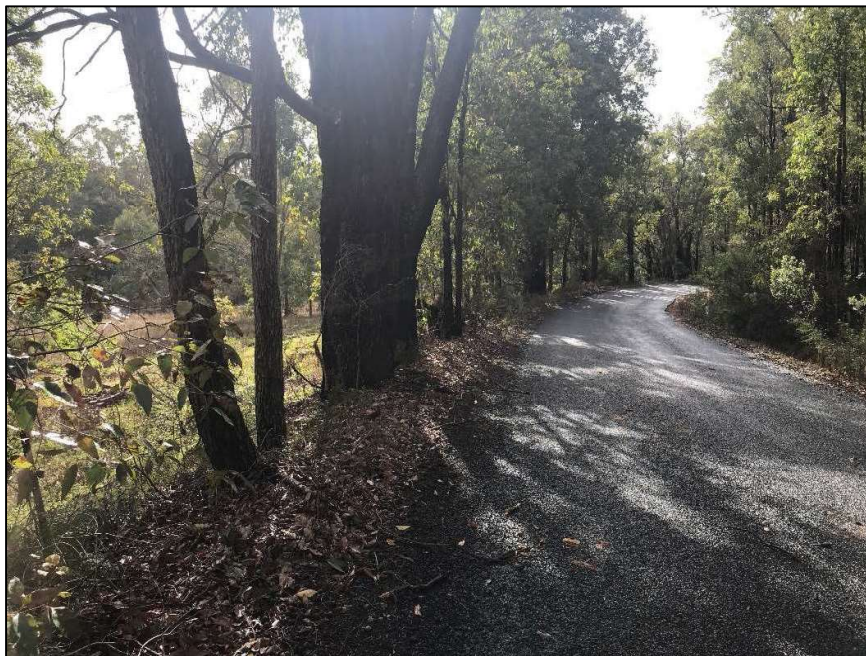
Large trees are close to the traffic lane.

There are large trees located on the verge, close to the traffic lane that pose a risk to vehicle occupants in the event an errant vehicle leaves the road, particularly those on the outside of curves.

Finding 2.1 Non frangible trees close to the traffic lane, a hazard to an errant vehicle.

Determine the Network Roadside Risk Intervention Threshold for the road. If the action is to treat only the isolated hazards, then those that present a higher risk should be treated first. These will be the isolated hazards that are closer to the road.

Alternatively, use the Austroads: Guide to Road Design Part 6 - Roadside Design Safety and Barriers (2010) Table 4.1: Clear zone distances from the edge of through travelled way and provide a suitable clear zone.

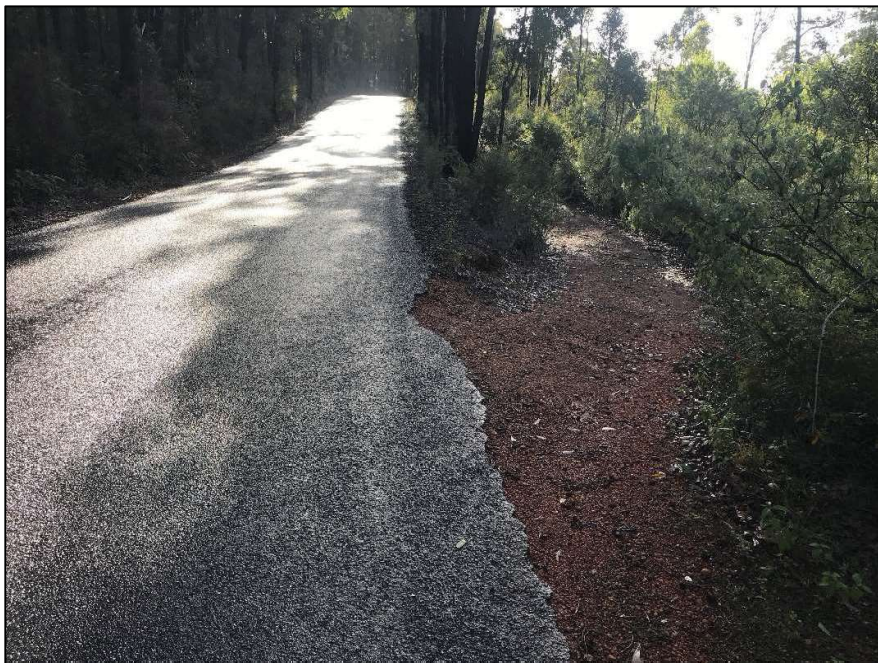
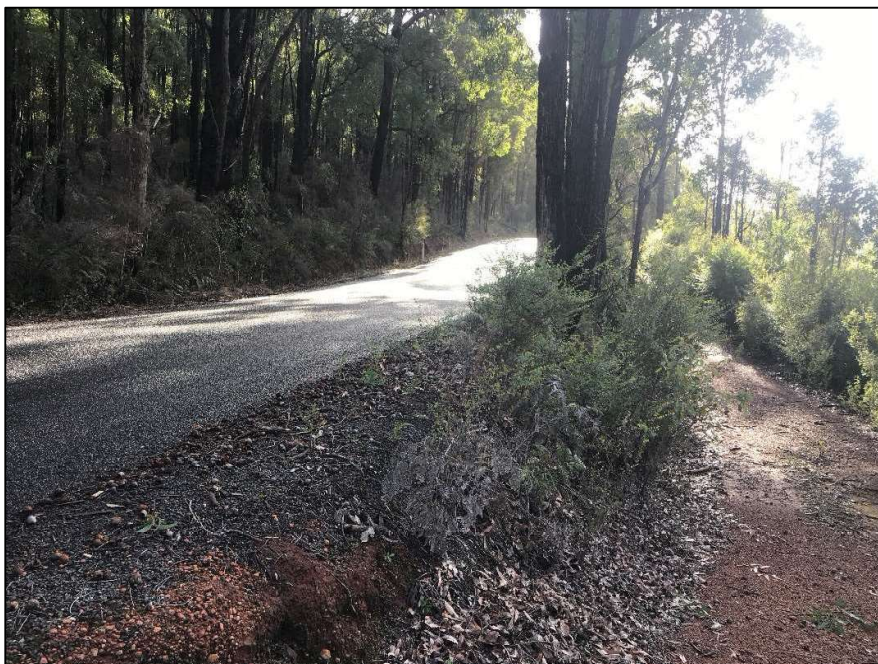
There are several camping areas and small side-tracks with restricted sightlines due to vegetation.

The limited sight distance can result in restart intersection crashes where the driver stops at the intersection, then restarts resulting in a crash. Restart crashes can be the result of insufficient Safe Intersection Sight Distance (SISD), drivers pulling out in front of an approaching vehicle, hidden by vegetation resulting in a right-angle crash.

Finding 2.2 – Insufficient sight distance from the side-track. Consider closing the access to the road.

Finding 2.2 – – Insufficient sight distance from the side-track. Consider closing the access to the road.

Clear the vegetation to provide Safe Intersection Sight Distance at the intersection locations.

Remove access from tracks where access is unsuitable.

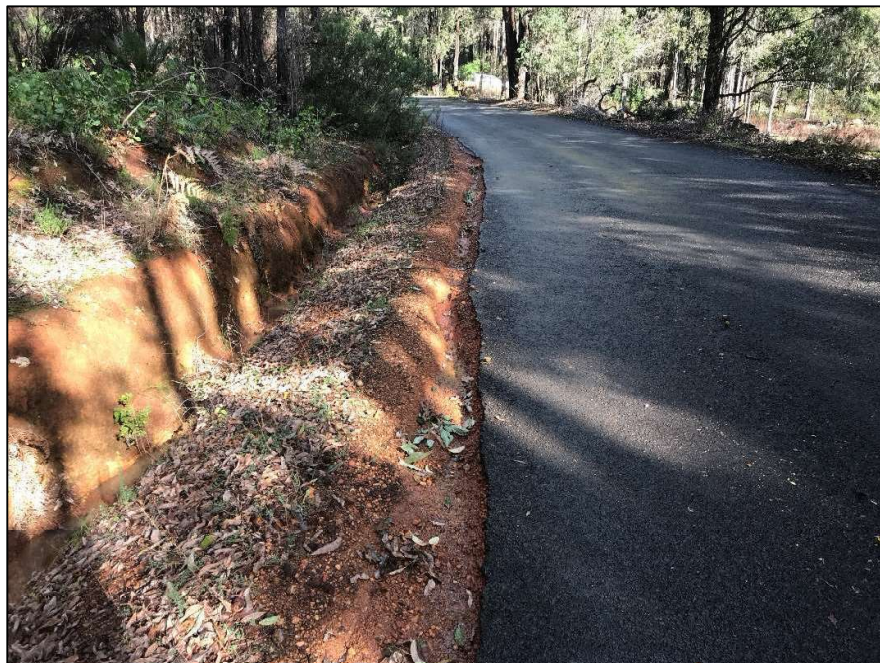
The existing gravel shoulder is very narrow and in poor condition.

There is a risk of run off road crashes as the result of inadequate shoulder width.

Finding 2.4 – Gravel Shoulder is narrow and in poor condition.

Widen and improve the surface of the shoulder.

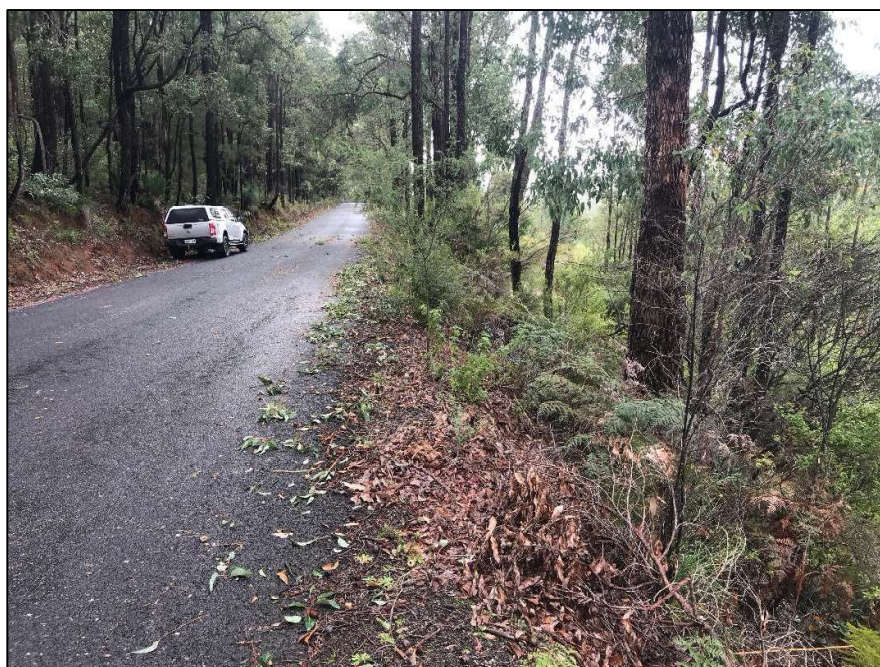
The batter from the gravel shoulder to the natural ground is too steep in several sections.

An errant vehicle may roll over when the batter of the verge is steeper than 3:1 for cars resulting in occupants being injured.

Finding 2.5 – Steep bank close to the traffic lane, a hazard to an errant vehicle.

Provide a suitable road safety barrier along the road section when verge batters trigger a high Network Roadside Risk Intervention Threshold.

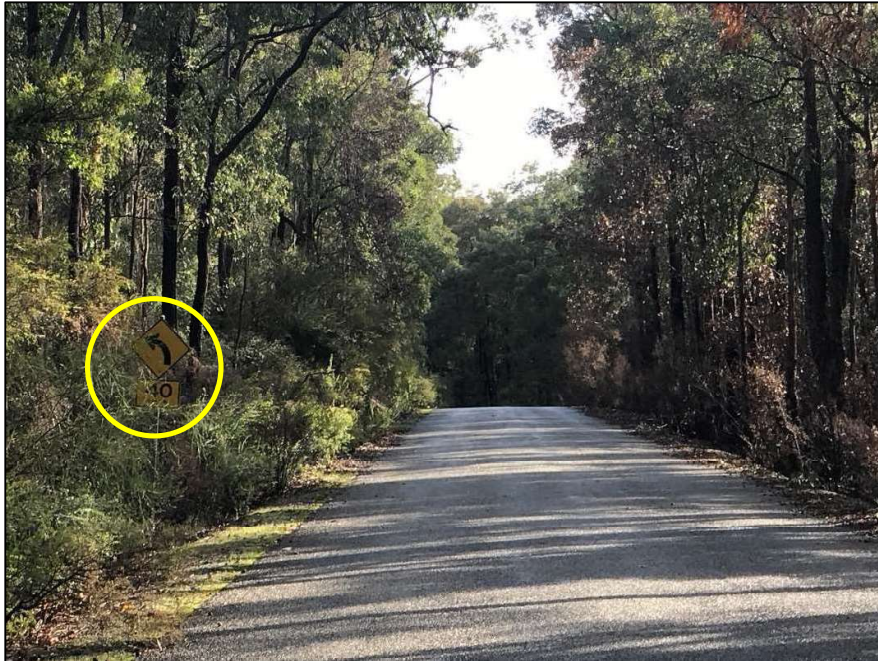
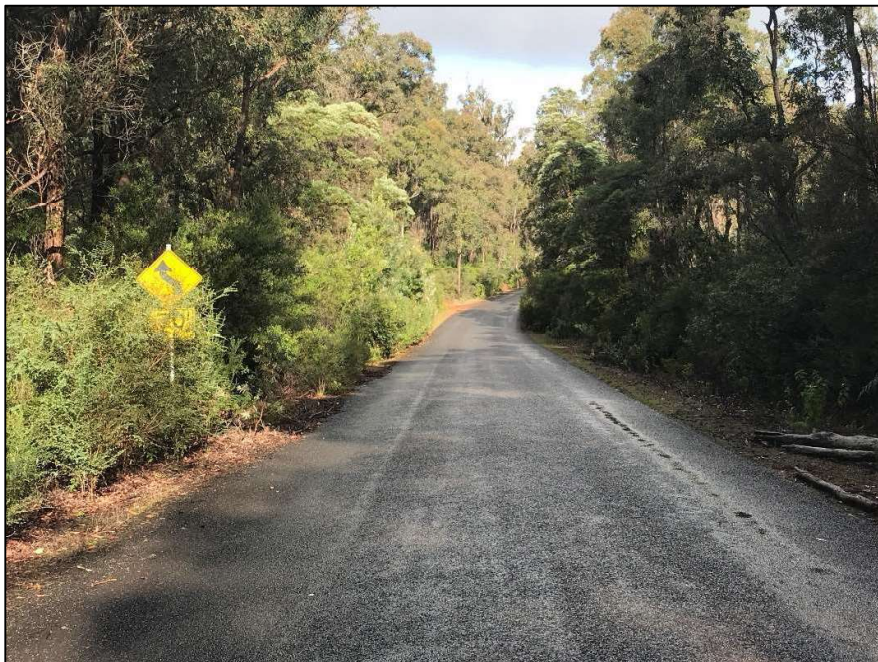
Finding 2.6 – Advance warning sign obscured by vegetation could result in the road user approaching the curve too fast.

| Findings and Recommendations | Project Manager | | |
|---|---|---|---|
| Recommendation Remove vegetation that is close to the road and or obscures advance warning signs and guideposts. [IMPORTANT MODERATE] | Choose an item. | | |

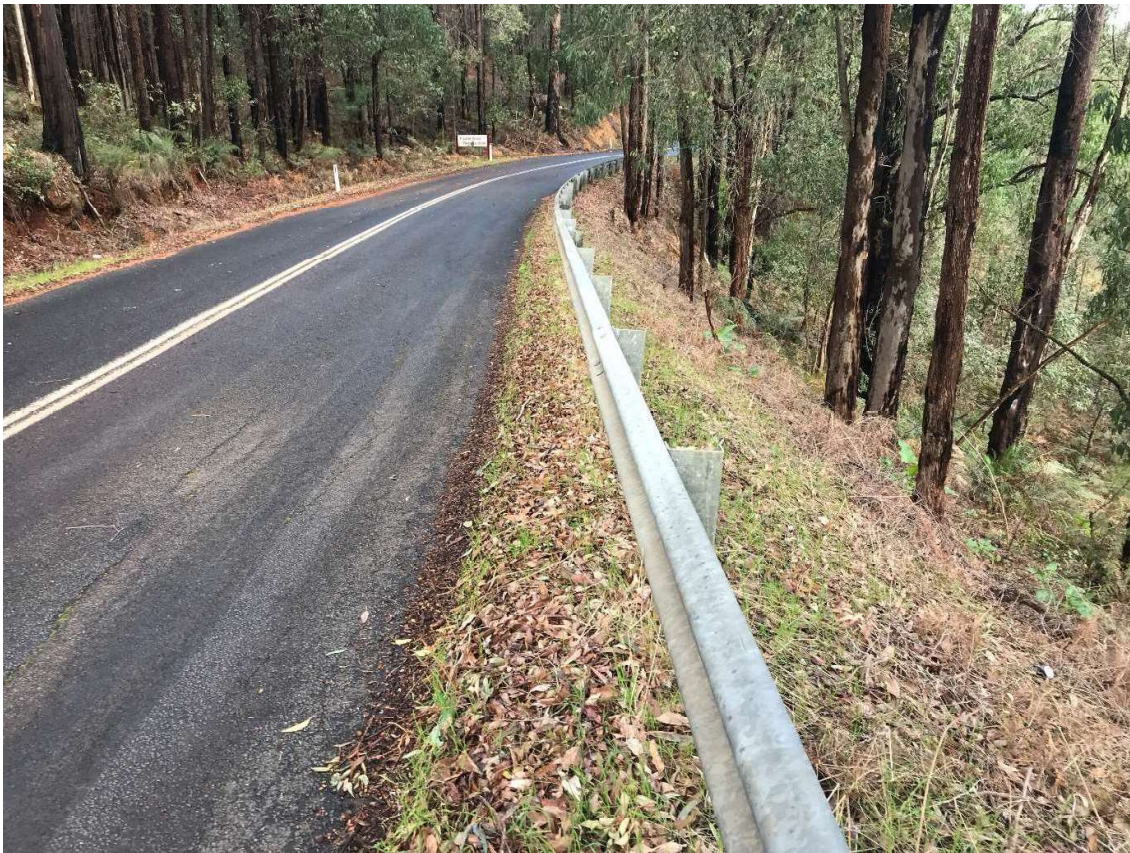
A visual inspection showed it seemed to have been side swiped a couple of times with minor damage not requiring repair. The ground being gravel appears to be suitable to instal the W beam without the full 600 mm to the hinge point.

This barrier is not to current standards as it does not have blockouts and looked a little low. It also has no delineation and the end treatment is a width marker sign.

Photo 1 – W Beam in Shire of Murray appears to be in good condition.

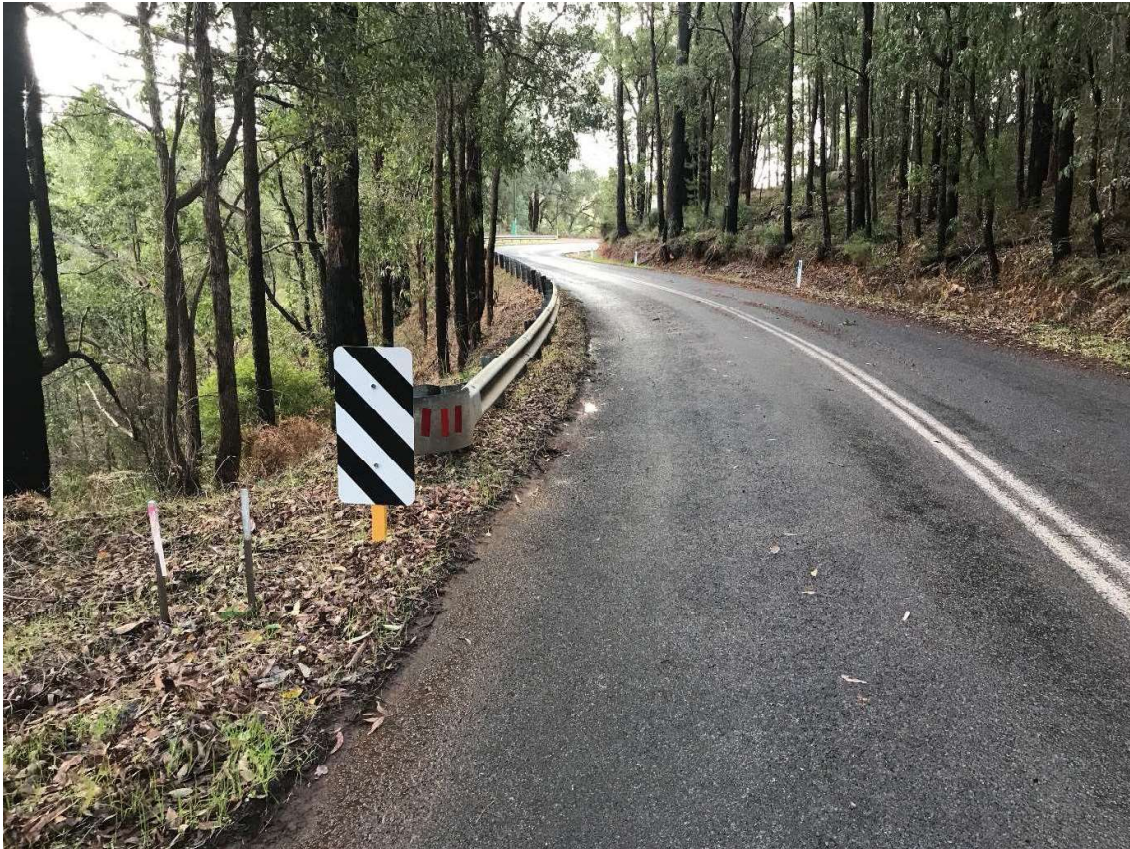
Photo 2 – W Beam in Shire of Murray with Width Marker signage and WA Melt end treatment.

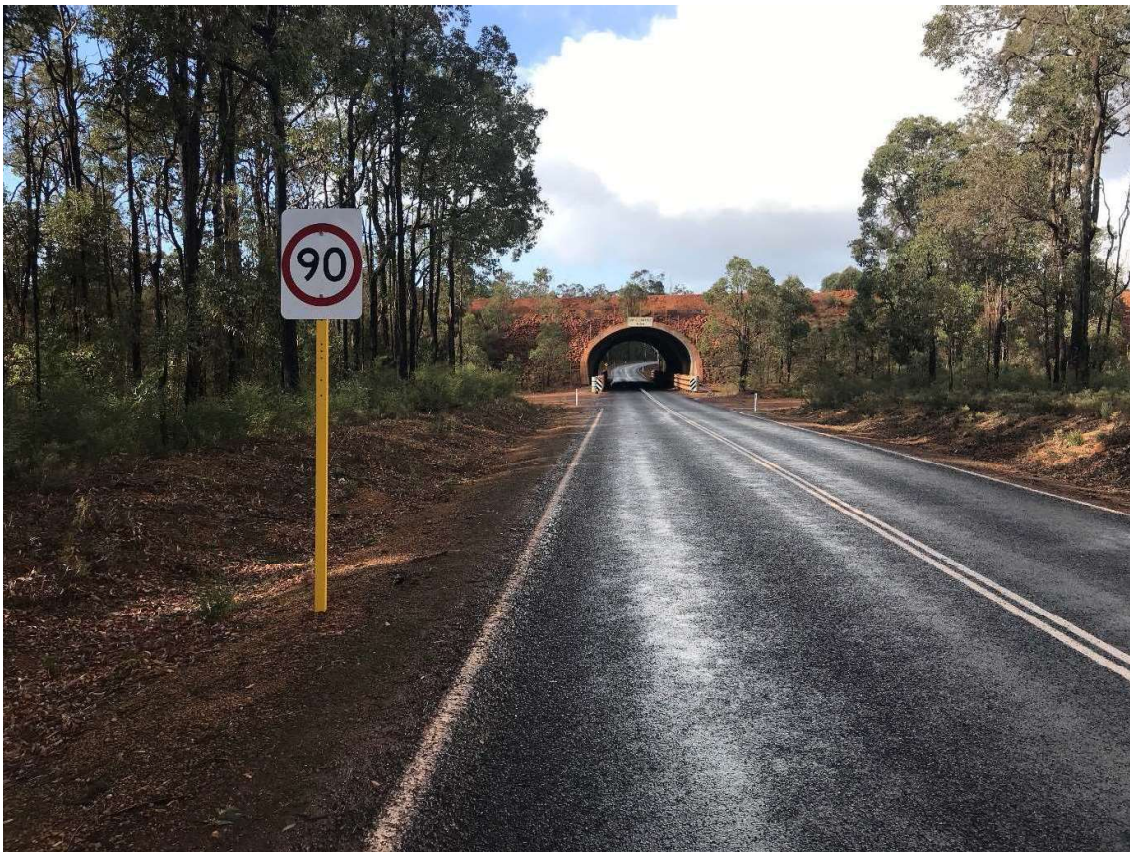
Photo 3 – 90 km/h repeater sign, poorly located placed just prior to the narrow tunnel.
