Nanga Road, Waroona WA

Road Improvements between Slk 0.37 – 2.02.

Road Safety Audit

Stage 3 - Detailed Design

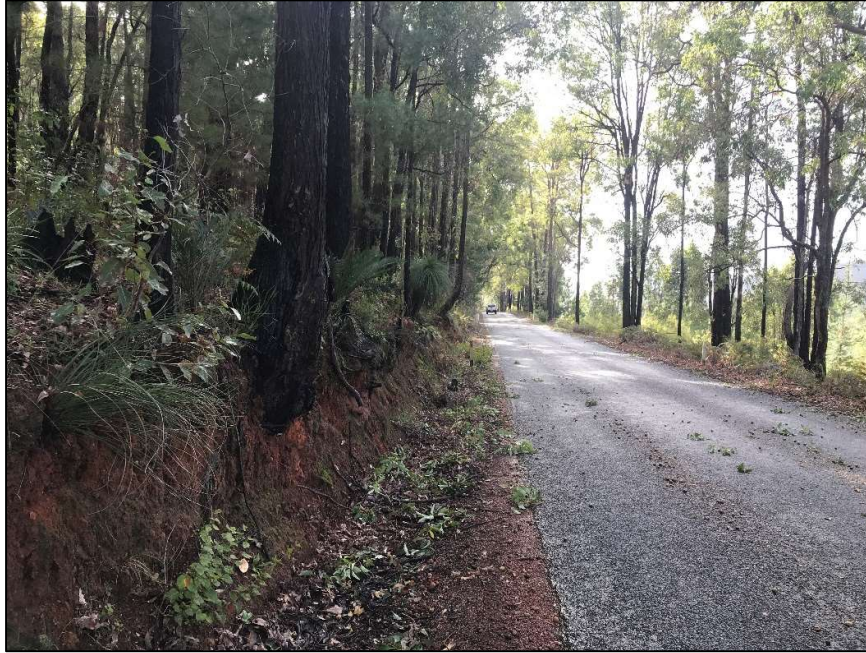
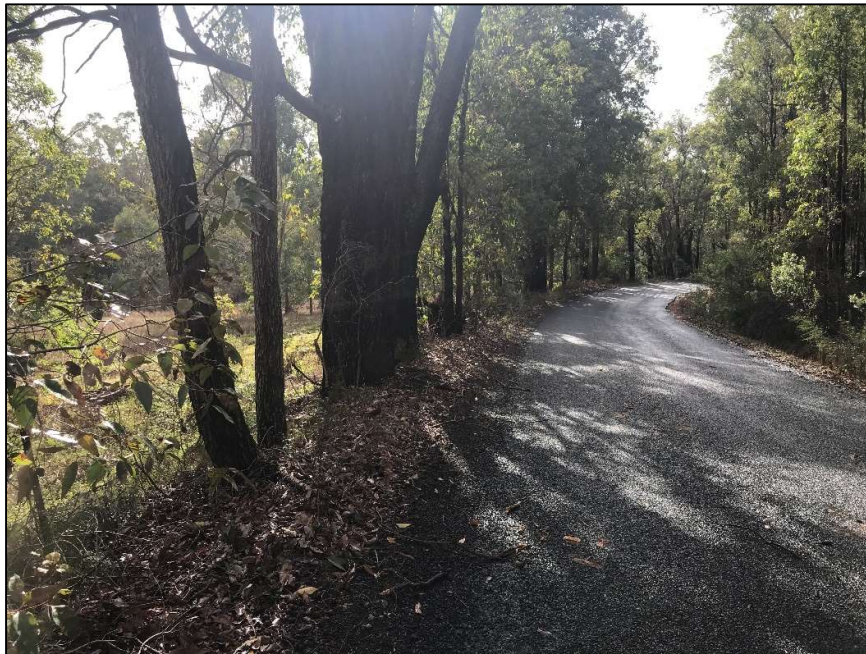
Large trees are close to the traffic lane.

There are large trees located on the verge, close to the traffic lane that pose a risk to vehicle occupants in the event an errant vehicle leaves the road, particularly those on the outside of curves.

Finding 2.1 Non frangible trees close to the traffic lane, a hazard to an errant vehicle.

Determine the Network Roadside Risk Intervention Threshold for the road. If the action is to treat only the isolated hazards, then those that present a higher risk should be treated first. These will be the isolated hazards that are closer to the road.

Alternatively, use the Austroads: Guide to Road Design Part 6 - Roadside Design Safety and Barriers (2010) Table 4.1: Clear zone distances from the edge of through travelled way and provide a suitable clear zone.

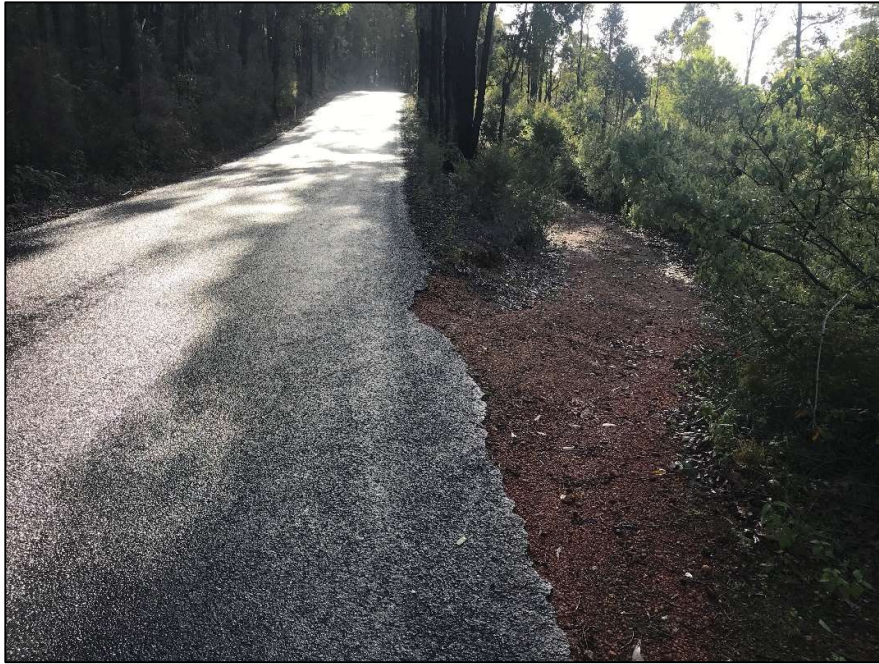
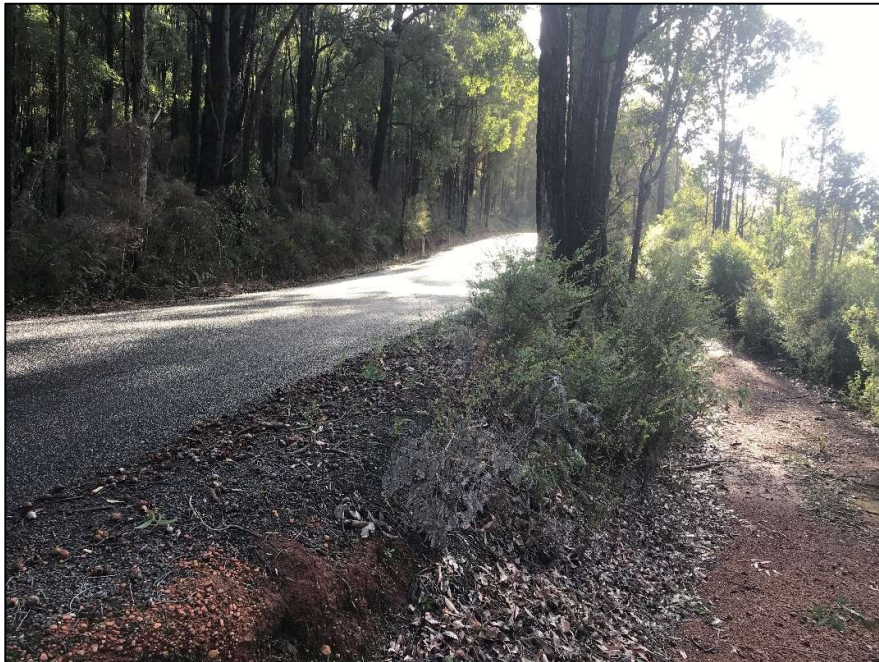
There are several camping areas and small side-tracks with restricted sightlines due to vegetation.

The limited sight distance can result in restart intersection crashes where the driver stops at the intersection, then restarts resulting in a crash. Restart crashes can be the result of insufficient Safe Intersection Sight Distance (SISD), drivers pulling out in front of an approaching vehicle, hidden by vegetation resulting in a right-angle crash.

Finding 2.2 – Insufficient sight distance from the side-track. Consider closing the access to the road.

Clear the vegetation to provide Safe Intersection Sight Distance at the intersection locations.

Remove access from tracks where access is unsuitable.

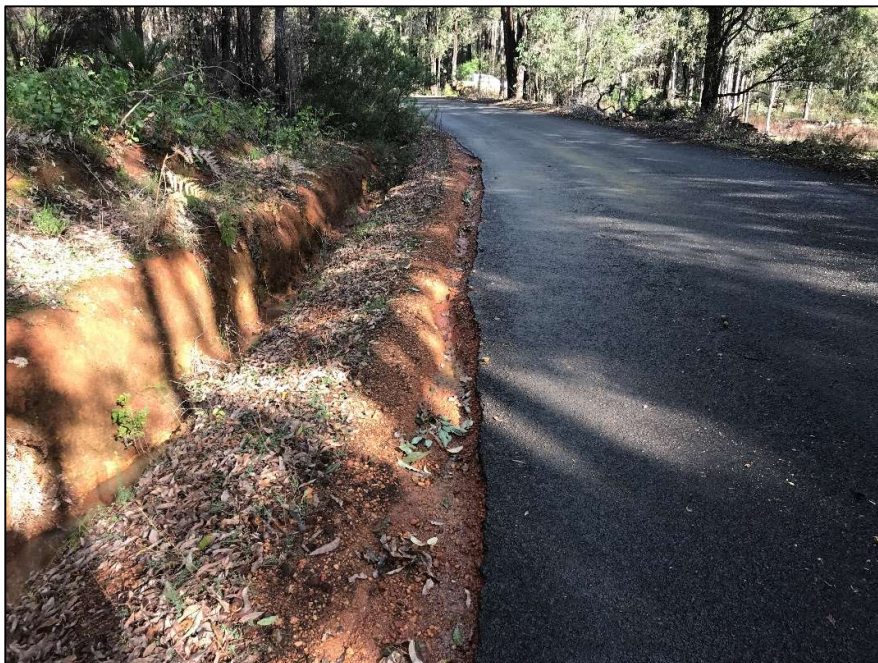
The existing gravel shoulder is very narrow and in poor condition.

There is a risk of run off road crashes as the result of inadequate shoulder width.

Finding 2.4 – Gravel Shoulder is narrow and in poor condition.

Widen and improve the surface of the shoulder.

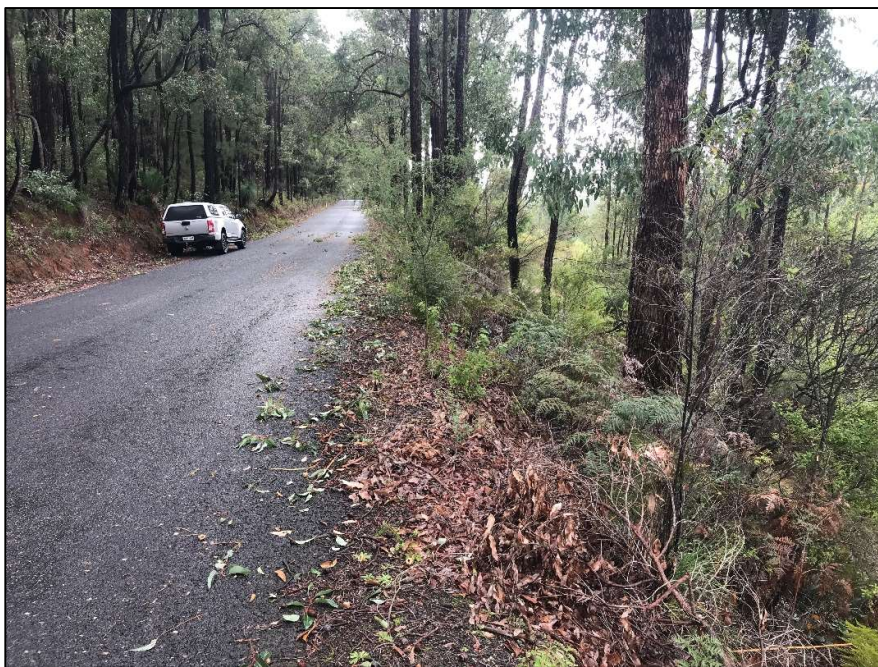
The batter from the gravel shoulder to the natural ground is too steep in several sections.

An errant vehicle may roll over when the batter of the verge is steeper than 3:1 for cars resulting in occupants being injured.

Finding 2.5 – Steep bank close to close to the traffic lane, a hazard to an errant vehicle.

Provide a suitable road safety barrier along the road section when verge batters trigger a high Network Roadside Risk Intervention Threshold.

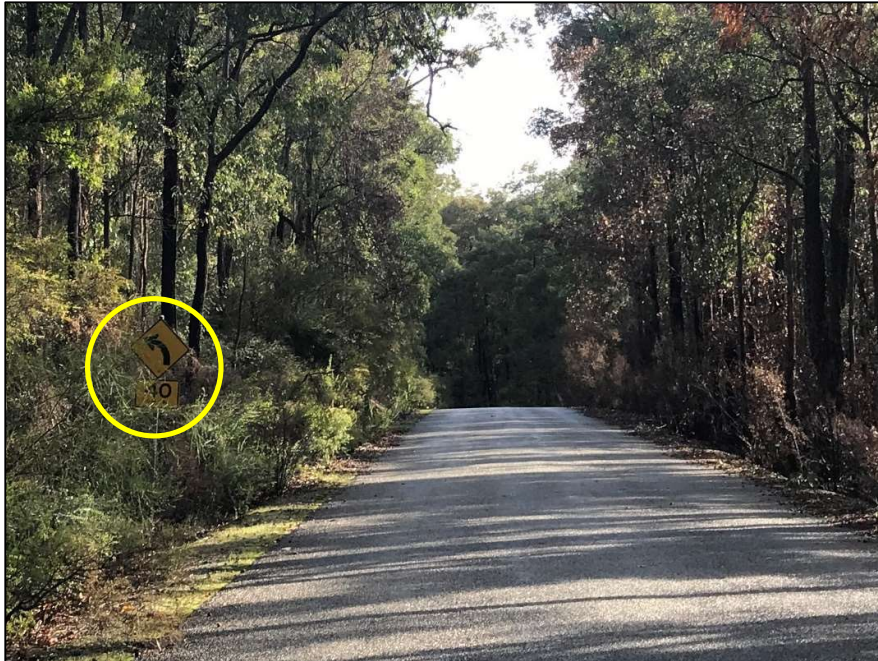
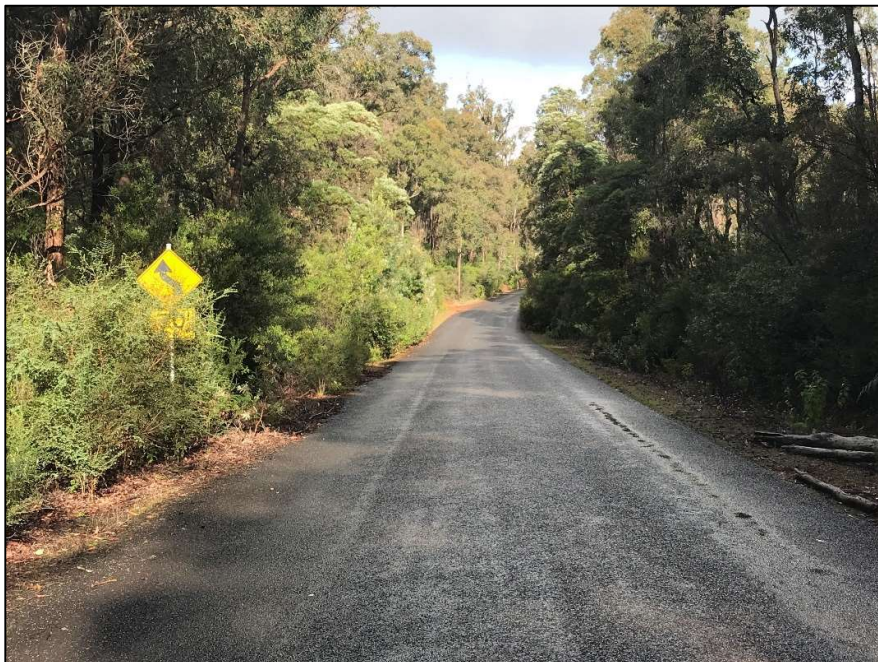
Vegetation close to the traffic lane obscures warning signs and guideposts.

Vegetation close to the traffic lane results in drivers shying away from the edge of the road and crossing the centreline into approaching traffic lane which could result in a head on crash. Vegetation that obscures warning signs and or guideposts may result in the road user traveling too fast for curves or crests or misjudge the road layout ahead.

Finding 2.6 – Advance warning sign obscured by vegetation could result in the road user approaching the curve too fast.

Remove vegetation that is close to the road and or obscures advance warning signs and guideposts.

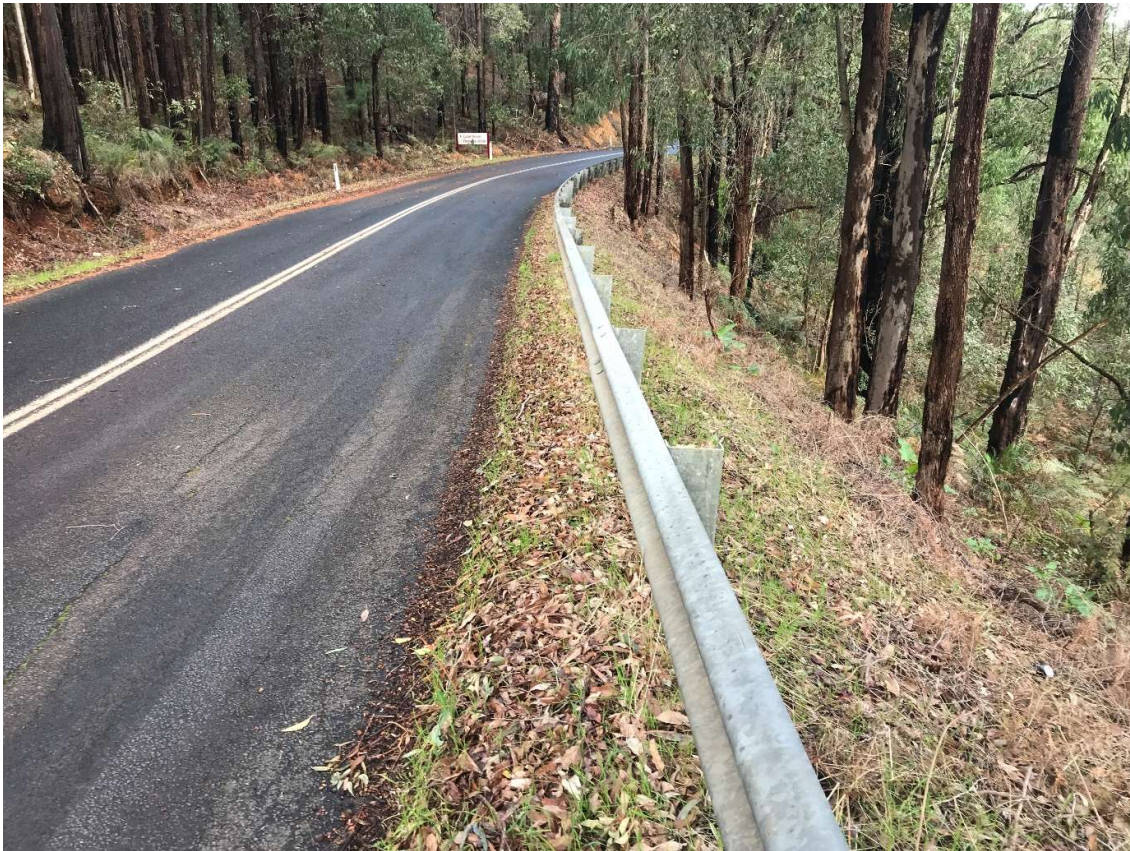
A visual inspection showed it seemed to have been side swiped a couple of times with minor damage not requiring repair. The ground being gravel appears to be suitable to instal the W beam without the full 600 mm to the hinge point.

This barrier is not to current standards as it does not have blockouts and looked a little low. It also has no delineation and the end treatment is a width marker sign.

Photo 1 – W Beam in Shire of Murray appears to be in good condition.

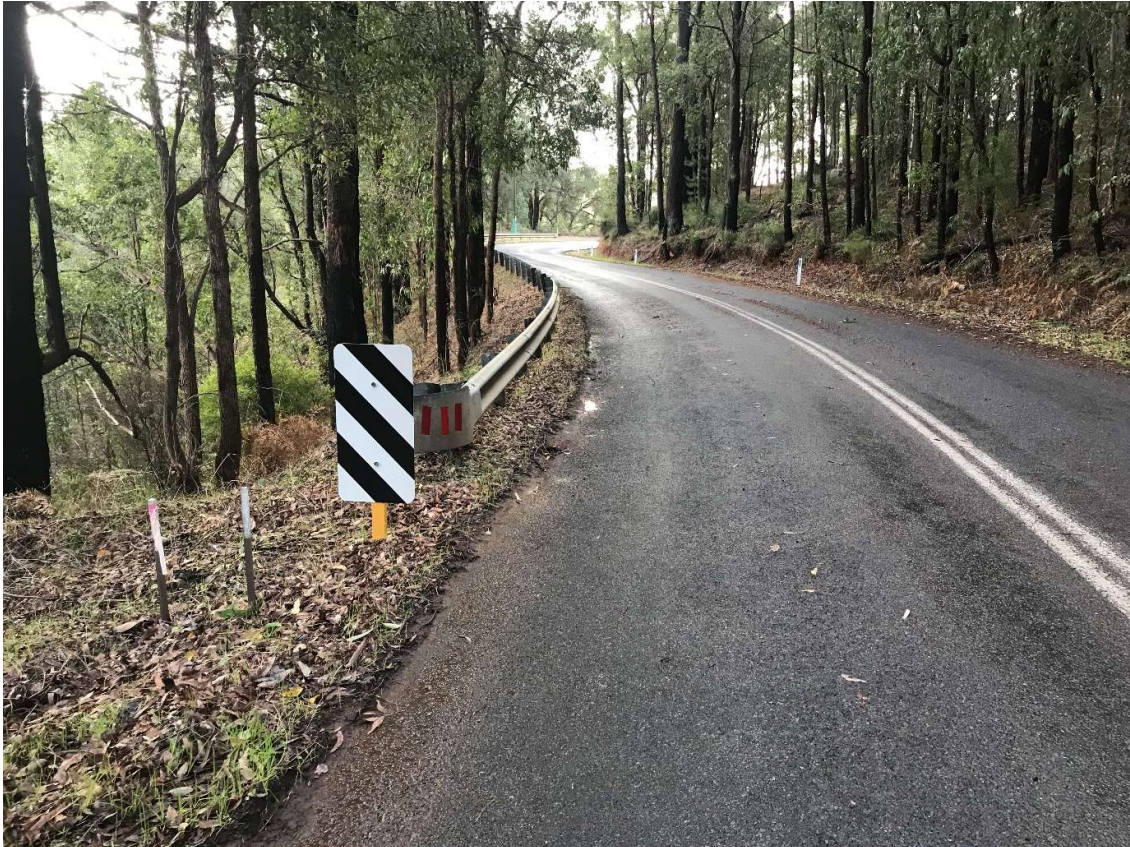
Photo 2 – W Beam in Shire of Murray with Width Marker signage and WA Melt end treatment.

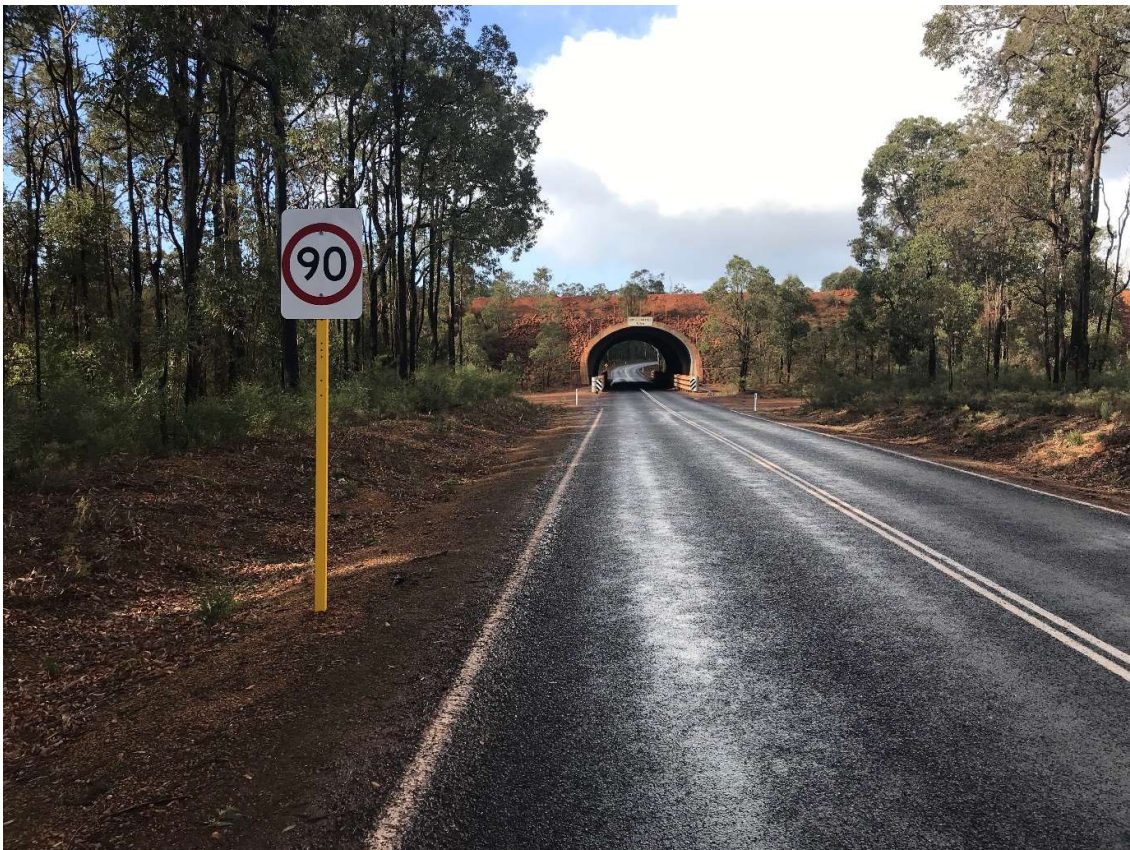
Photo 3 – 90 km/h repeater sign, poorly located placed just prior to the narrow tunnel.
