PRELIMINARY TREE ASSESSMENT LOT 9012 JAYES ROAD, PIARA WATERS (REV 1)

PREPARED FOR:
CELSIUS LAND
BRENTON DOWNING
MANAGING DIRECTOR

DATE ISSUED:- 25 JANUARY 2022

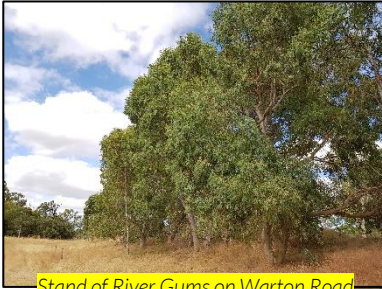
Stand of River Gums on Warton Road

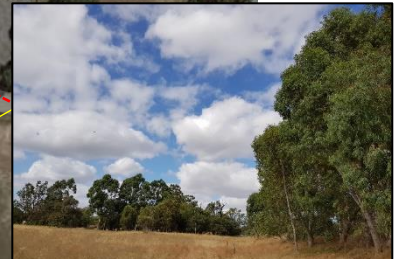
Stand of River Gums on Warton Road (right) looking toward Stand of natives in western sector

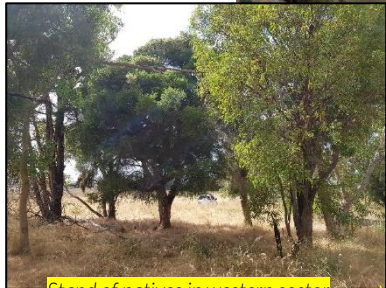
Stand of natives in western sector

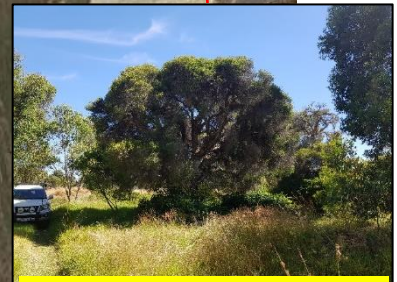
Tree 73 - Good example of Stout Paperbark

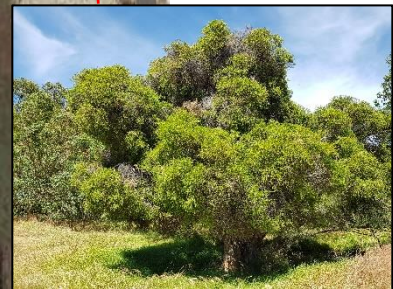
Tree 77 - Good example of Stout Paperbark

0077	<i>Melaleuca preissiana</i> (Stout Paperbark)	Mature	8	14	15 - 40 years	Good	Reasonable	0.550 + 0.500 + 0.500	10.80	1.200	3.57	Deadwood noted within canopy (150 mm to 300 mm dia.), Tree displays multi stemmed form, Tree is considered to be a good specimen of the species, Adjacent creek	Optimal (Well Placed &/or Good Specimen)	*Raise canopy *Remove major deadwood >30mm dia..
78	<i>Eucalyptus rudis</i> (Flooded Gum)	Early Mature	13	12	40 + years	Good	Good	0.350	4.20	0.450	2.37	Considered a good specimen of the species, friction stems to 50mm dia, situated adjacent creek	Optimal (Well Placed &/or Good Specimen)	*Raise canopy *Remove major deadwood >30mm dia. *Remove rubbing stems
0079	<i>Melaleuca preissiana</i> (Stout Paperbark)	Mature	8	13	15 - 40 years	Questionable	Questionable	1.500	15.00	1.500	3.92	Canopy indicates decline, Canopy noted to be sparse, Prior branch failures noted within canopy (150 mm to 300 mm dia.), Partial assessment only due to blackberry bramble surrounding tree (tree not tagged due to being inaccessible), Further assessment required, situated adjacent creek	Questionable (Modifications and inputs required for incorporation &/or may display Questionable health or structural issues)	*Raise canopy *Remove major deadwood >30mm dia. *Remove branch stubs

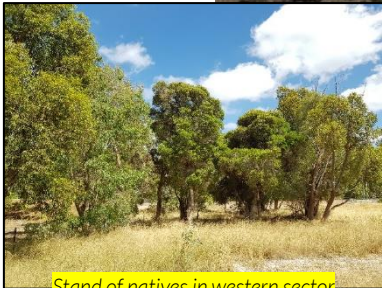
Stand of natives in western sector

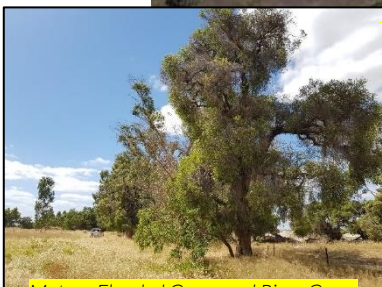
Mature Flooded Gums and River Gums along south western boundary

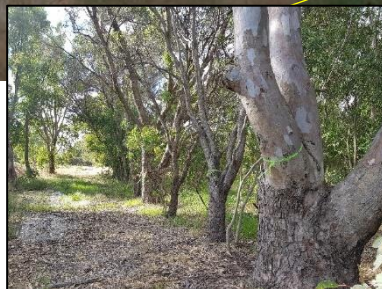
Mature Flooded Gums adjacent creek and dewatering overflow area

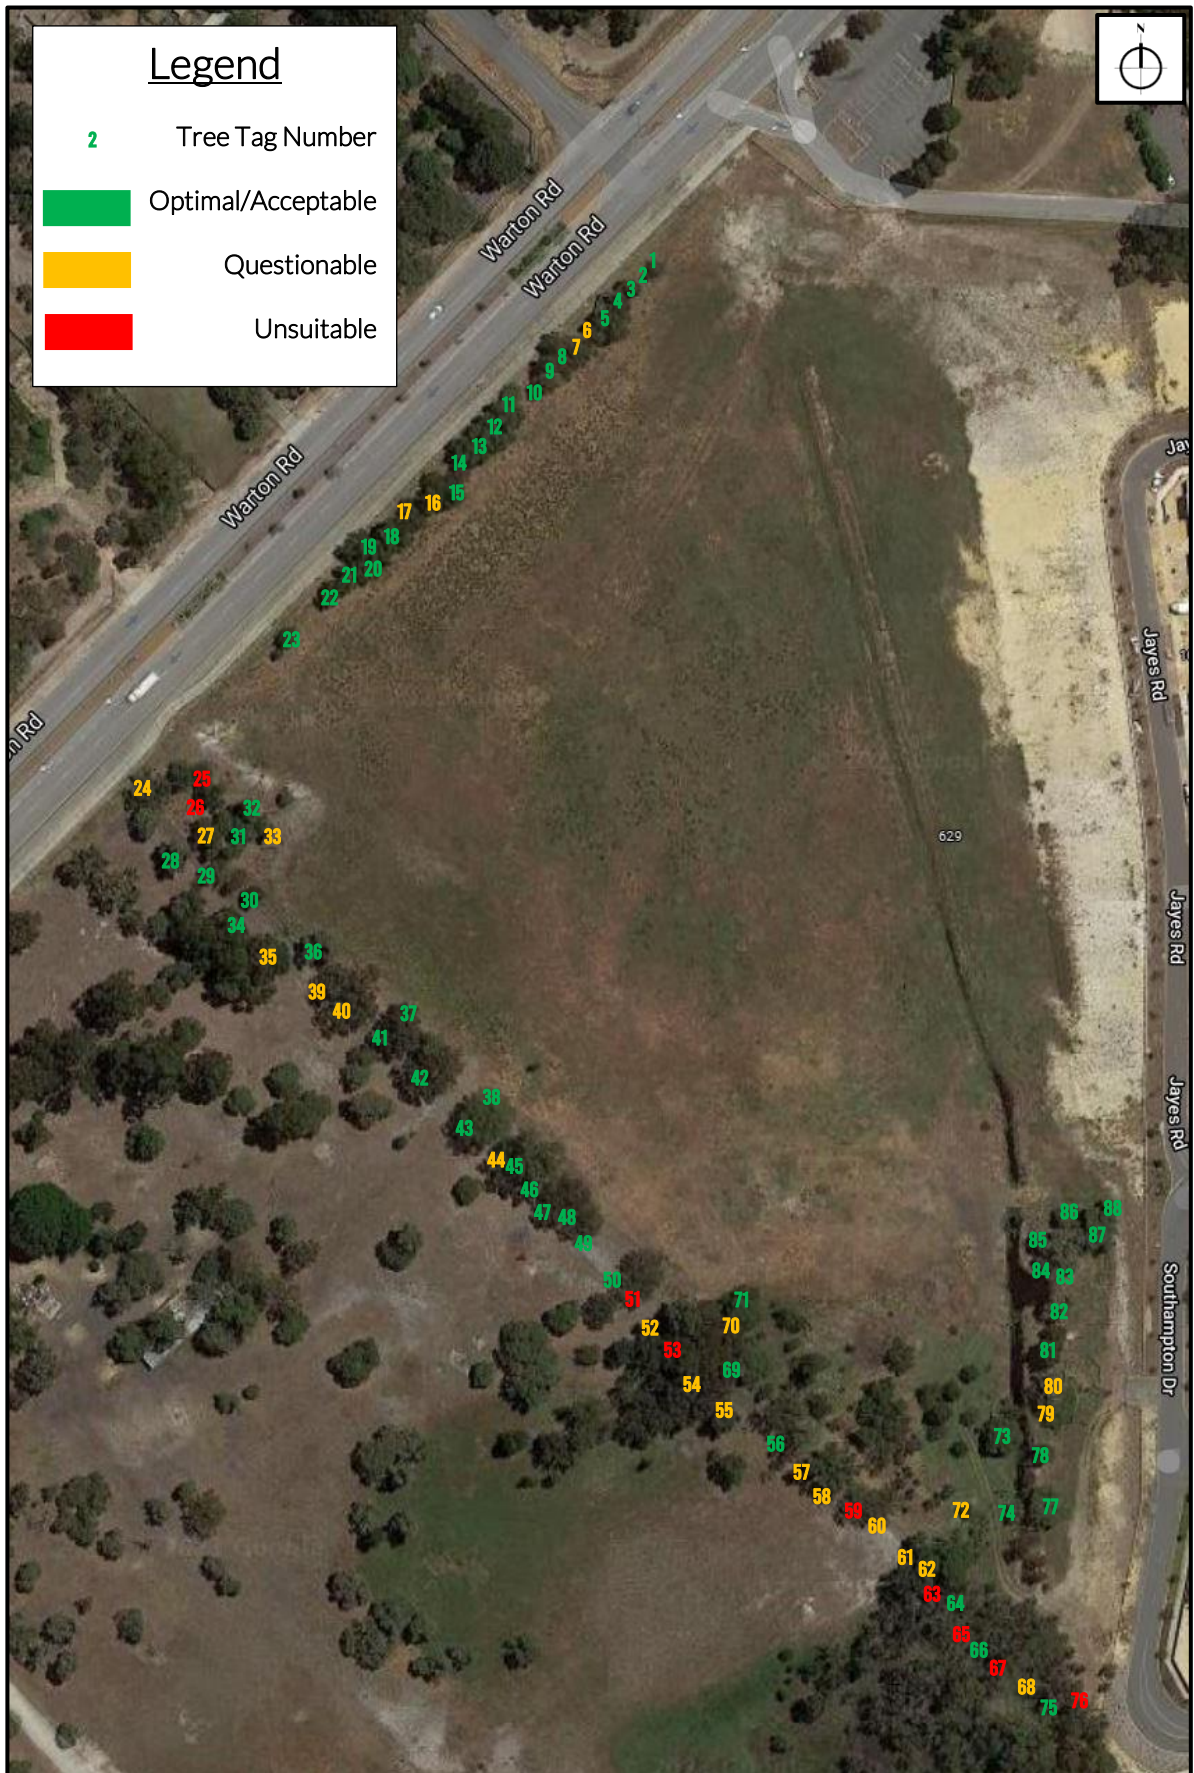
Figure 3 –Image showing indicative location, individual numbering and Suitability rating of the assessed trees
 Image Source Image source www.google.com.au/maps/ Please note that trees locations are indicative and for reference purposes only.
