Arboriculture Report

Pete's Treeworx

Shire of Waroona

The purpose of this report is to provide an independent Arboriculture report for the Town centre project and the health of the trees with the impact of the development. This report will outline health issues in the trees and recommended measures to put in place for the site.

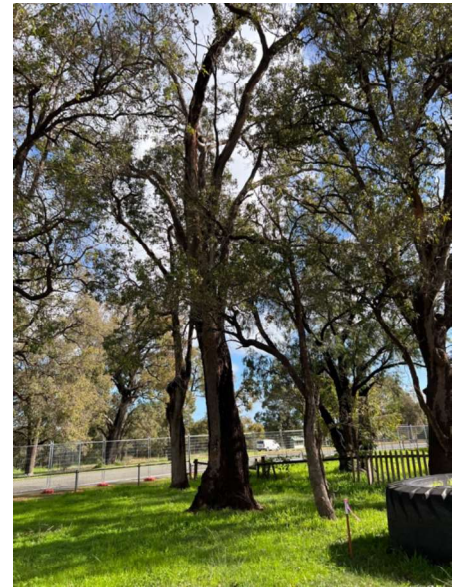
Trees 1, 2, 3, 4, 5

Health & Condition: Average

Risk rating post development: High

These marri's are in average health and poses a risk the future development with signs of severe canker within the canopy and trunk(this is outlined in the photos). Canker is an easily spread disease and the only way to stop the spread is to remove the canker. Tree 1 has also been pollarded which exposes huge risk to anyone around the park.

With close excavations to the tree about to be undertaken the root plate will be highly compromised and unbalancing the health and life expectancy.

Risk management – to monitor and manage the risk of this tree if it where to be kept will incur an expensive cost on an annual basis and with so many unknown variables once excavations are complete the trees will most likely have more value if it where to be removed and replaces with a healthy juvenile in its place away from the park

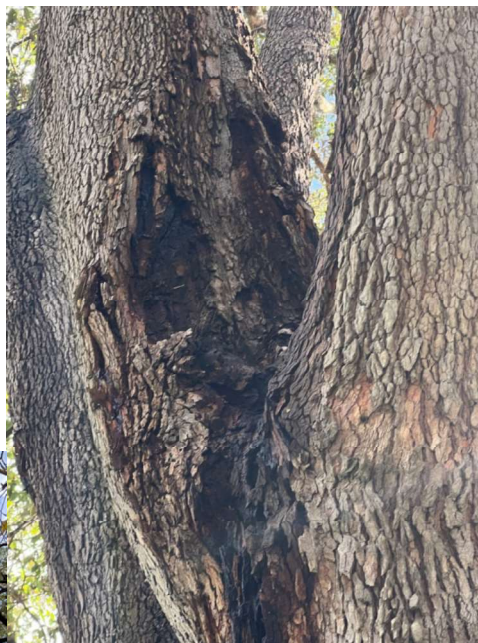
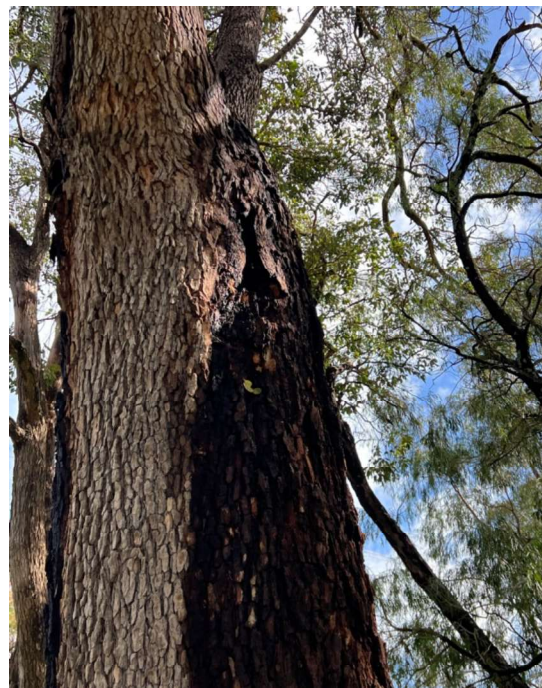
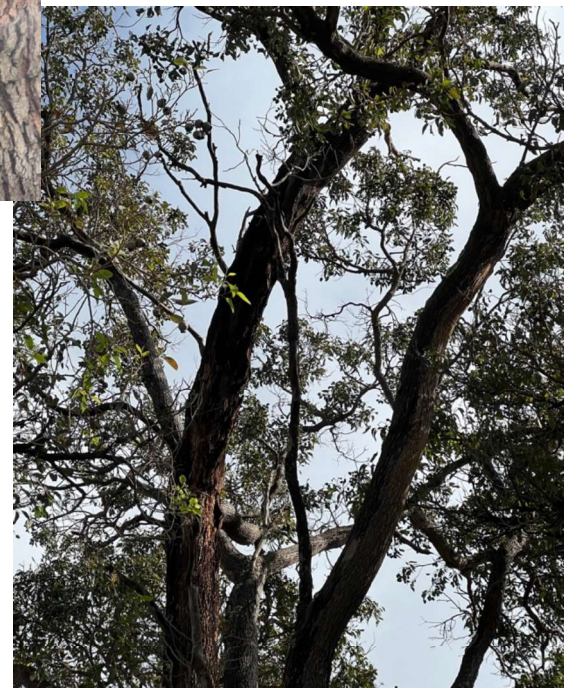
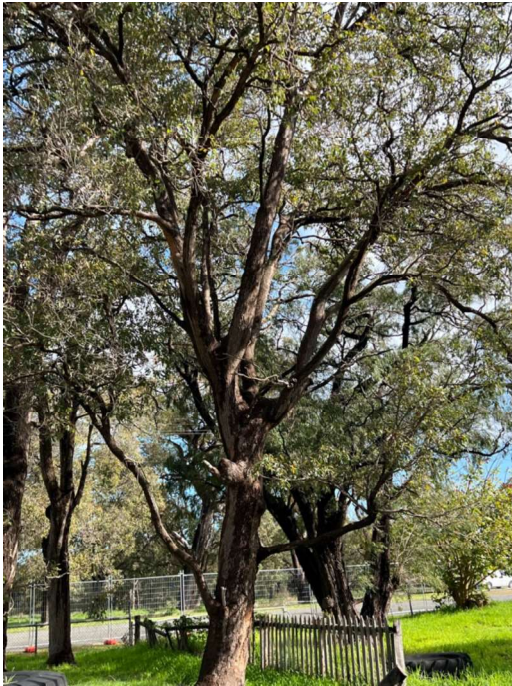
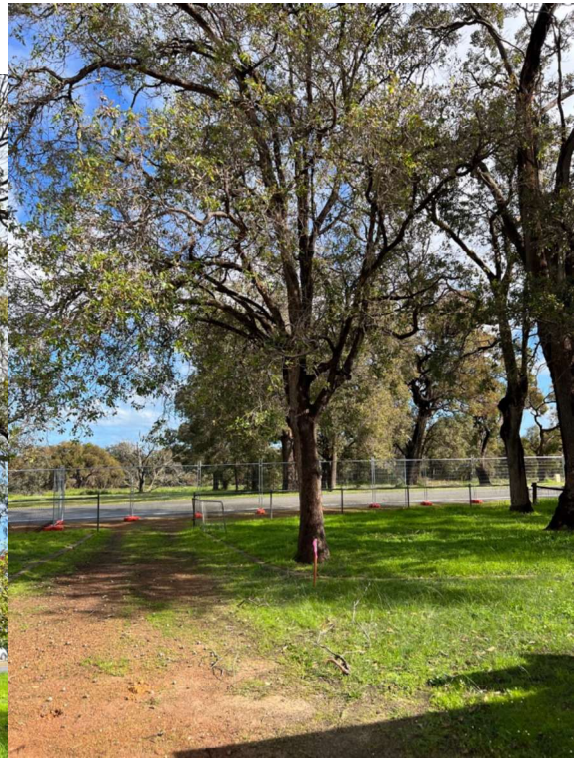
Tree 3 you will notice the excavations are going to be extremely close to the base of the tree and will be a huge detriment to the health of this tree.

Tree 4 is in close proximity from the powerlines and is also in extreme poor health due to being poorly pruned year on year.

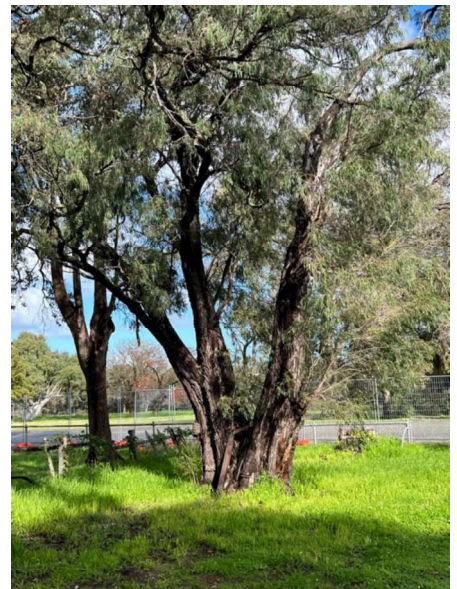
Tree 7
Scientific name: *Agonis Flexuosa*
Common name: WA Peppermint
Age class: semi mature
Health & Condition: Reasonable
Risk rating post development: Low

This Agonise is a semi mature tree with reasonable to good health and does not pose a big risk to anyone. A recommendation of doing soil tests and rejuvenating the soil to allow the tree the best health in the future and being able to preserve as many trees as we can. Installing a boundary around the tree prior to any works being undertaken is a high priority to stop any damage being made when earth works are being made.

Risk management - Once a soil test is undertaken the recommendations of the test is of high importance to keep the health of the tree.

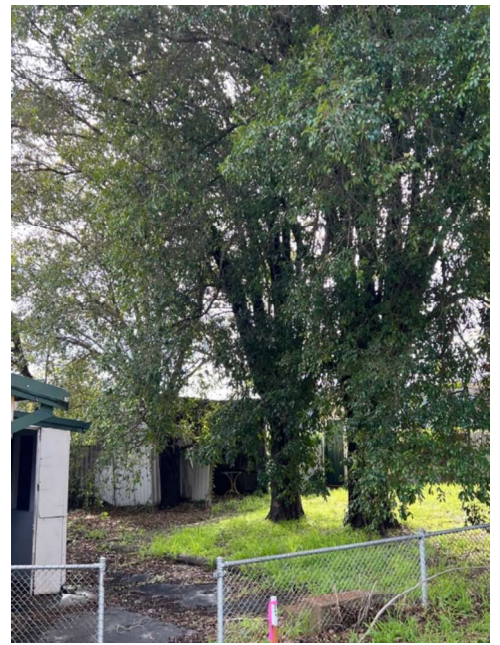
Trees 11, 12, 13, 14, 15

Health & Condition: Good health, poor condition

Risk rating post development: high

This clump of lilly pilly's have been poorly pruned in the past and pose a huge risk to the public in the event of a storm or high winds. Having a soft fruit will pose a risk through the blossom season dropping on the concrete and making a hazard on the track.

Risk Management – Removal of these trees is the only recommendation for the management due to the major risk they pose to those using the track being installed and to the public.

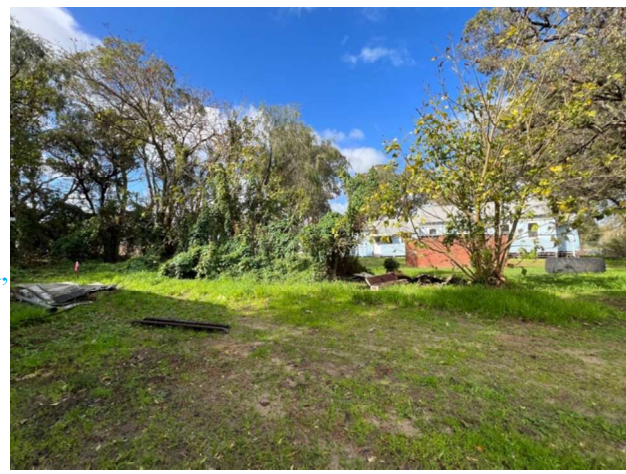
Trees 6, 8, 10

Health & Condition: Poor health, poor condition

Risk rating post development: low- medium

Although this clump of mixed trees is not a direct risk to anybody they are in poor health due to being poorly pruned in previous years and being over taken by vines. Excavations will be undertaken extremely close to the trees and direct effect the already poor health of the trees

Risk reduction – the only recommendations for these trees is to be removed and something else be put in their place.

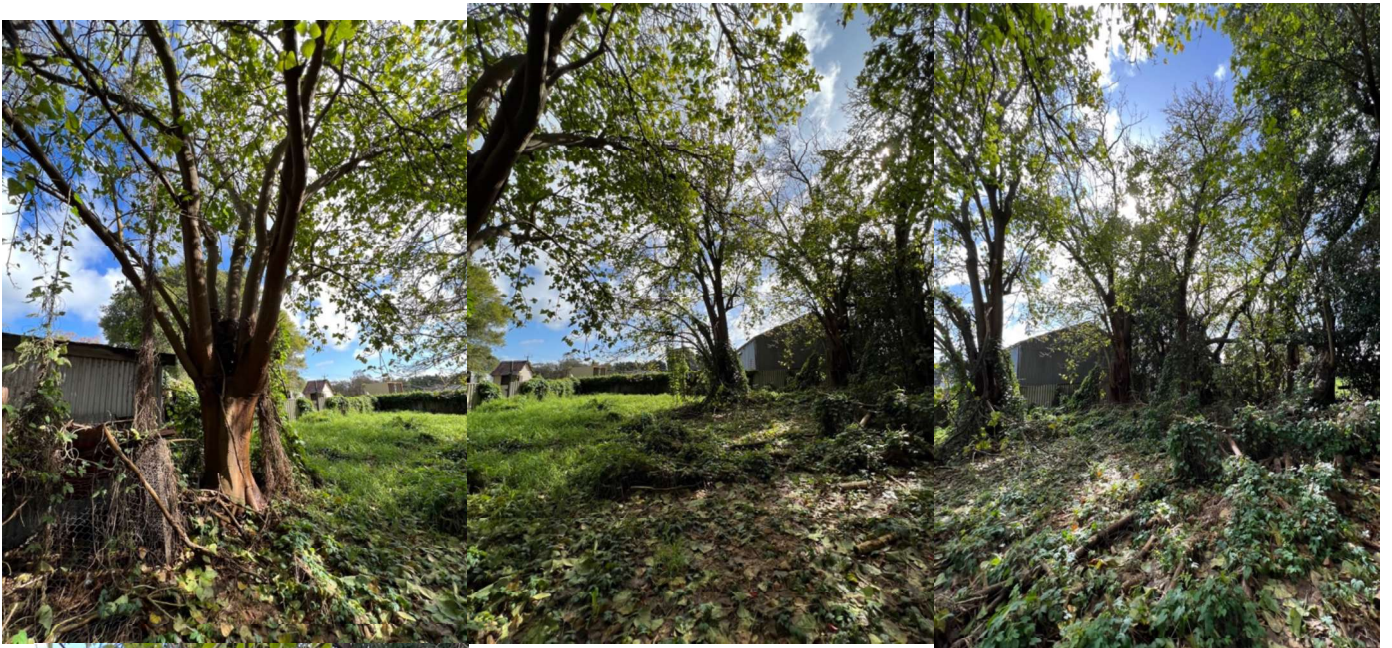
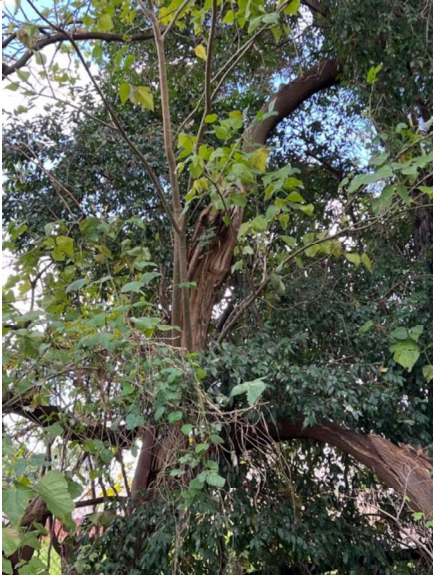
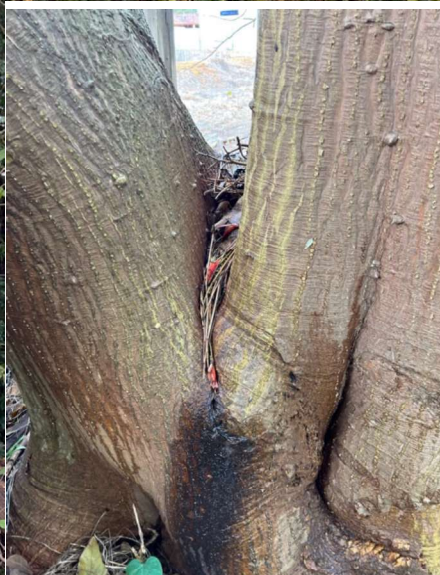
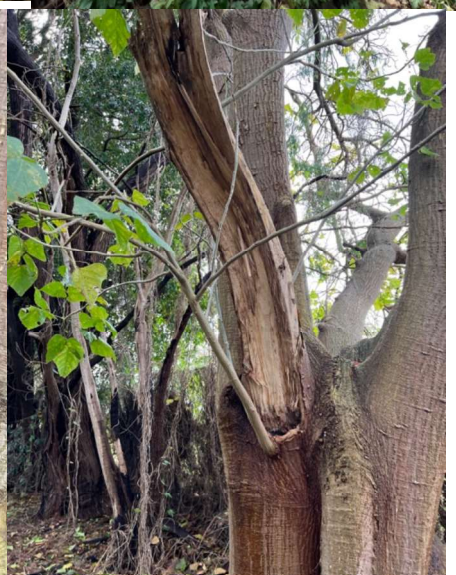
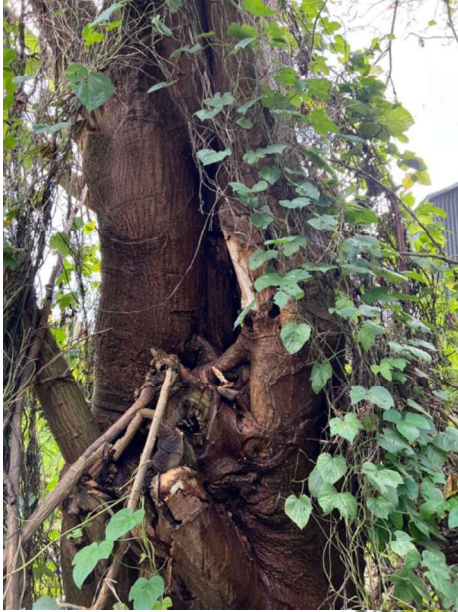
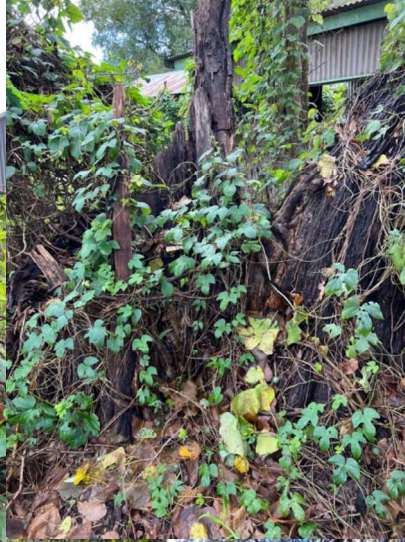
Trees 16, 17, 18, 19, 20, 21, 22, 23

Health & Condition: Average health, Poor condition

Risk rating post development: High

You will notice there are extreme defects throughout these trees and they pose a major risk to the public.

The defects consists of; Poor past pruning, major failures, included unions, failure to compartmentalise, pollards.

Corals trees are a deciduous and would pose an extreme risk in autumn once they loose their leaves and create a hazard on the track.

Risk management – The only risk management solution for these trees is for them to be removed and replace for a more suitable species.
