Our Ref: J22039

9 January 2023

**River Road, Boddington
Powerline Alignment Survey**

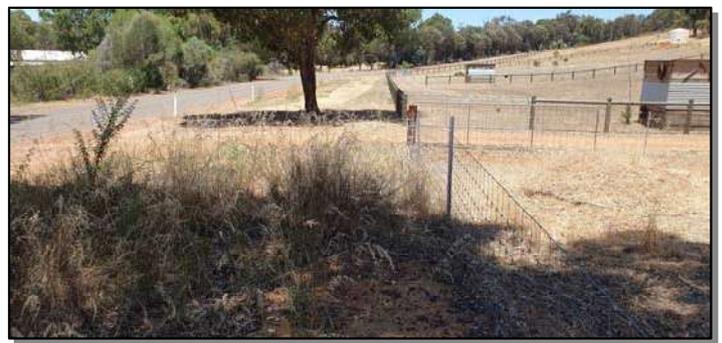
489 S

479	275	480. Root trimming may be required.
480	282	End of trees. Group of sheoaks, wattles & Wandoo on or inside boundary to Wpt 482. Should be passable but
481	315	root trimming required.
482	327	End of trees; also Telstra pit. Water pipe coming from across road. Centreline of driveway crossover. To north, boulder wall & landscaping inc planted trees to Wpt
483	332	484.
484	337	Gravel driveway & ug power to north.
485	345	Clear to north. Few small, apparently planted small Eucalypts, Acacias & Sheoaks, all <1m. 2 Eucalypt saplings 2.5m & <1m. Larger is on boundary, smaller ~1m out. 5m gate to north then
486	430	another planted Eucalypt sapling <1m.
487	465	Old electrical termination? 5m south is Telstra pit & road crossing. Mature Marri 3m off boundary, room between but root trimming required. 3m gravel driveway &
488	532	gate immediately north.
489	561	Marri 10m high, 3m off boundary, root trimming required.

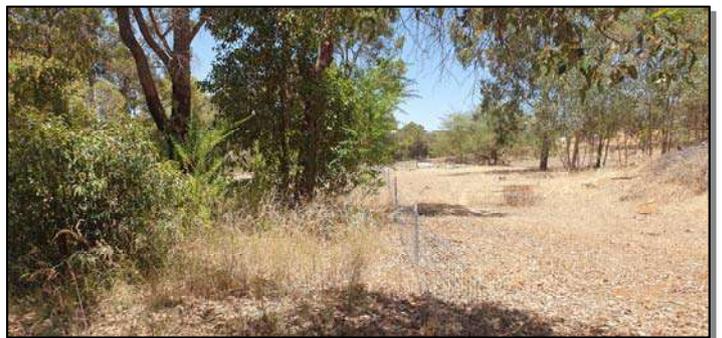
491 S

490	594	Marri mostly dead, substantial, 2m off boundary. Possible passable, root trimming required. Marri, mature, 3m off boundary, low overhanging branches might need trimming, root trimming required Next 20m north is messy, lots of dead fallen branches etc., 2 native shrubs ~2m off
491	602	boundary, replaceable. Blackboy, low 30cm high, 2m spike, Tagasaste, Marri 4m from boundary, also Jarrah ~5m from
492	625	boundary, should be trenchable. Jarrah 10m tall, 0.4-0.8m from boundary. Also blackboys & sedges, acacias 2m out. Drilling
493	634	recommended.
494	654	Large Jarrah 20m x 1.5m, mostly dead but significant, smaller Jarrahs for next 10m. Drilling recommended.

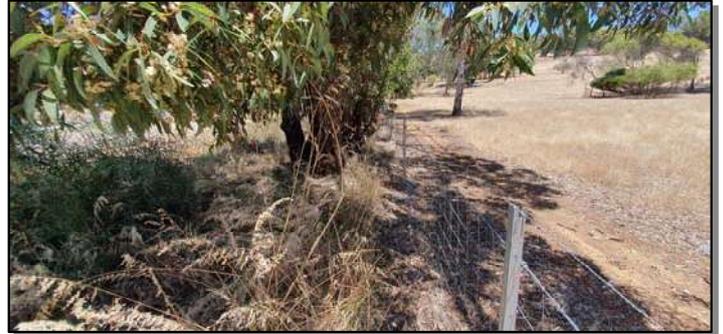
495 S

495	664	Clear. Driveway 10m north.
496	683	Centreline of intersecting road. Next 120m north is line of planted trees ~1m inside fence, no obstruction but may need root trimming.
497	695	WC retic valve. Immediately north is small (3m) dead Jarrah.
498	701	Dead Jarrah stump, large but no hollows, 2m high. Minimal value. Next 10m to Wpt 499 is thicket of Jarrah ~3m from boundary, room to trench but root trimming required.
499	713	End of thicket.
500	732	Bus shelter ~1m from boundary.
501	809	Large Jarrah 20m x 0.8m, needs drilling.
502	821	Water valve on standpipe, ownership unknown, just outside boundary.
503	830	Row of olive trees ~1-1.5m outside boundary, 1-4m high, continues for ~30m.
504	833	Telstra pit, also power pole 3m off boundary, reinforcing cable anchored in alignment.
505	843	Water pipe under road.
506	851	End of olives, very large stump 1m high possibly Jarrah, possibly value for residents.

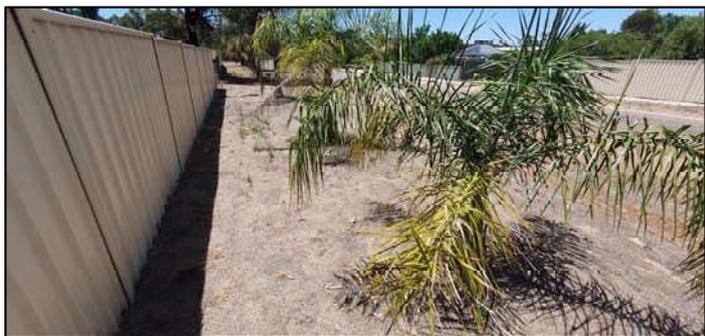
508 N

507	861	Centreline of gravel driveway.
508	867	Row of ornamental palms (dates?), 2m off boundary, varying sizes, continue to intersection.
509	876	WC stop valve, immediately north is 6m double gate, no driveway.
510	910	Centreline of 2m concrete driveway. Large date palm on corner, wattle possibly inside property boundary, spreading over verge, will need trimming.
511	943	
512	947	Telstra double pit.
513	963	Power pole 2m off boundary. Start of row of fruit trees ~3m off boundary, continues to end of alignment, could get through, roots require trimming.
514	966	
515	980	Centreline of 3m gravel driveway.
516	985	2 PVC pipes, poss, retic for fruit trees, poss disused. Power pole followed immediately by 3m gravel driveway; opposite power pole is Telstra pit. After driveway are gum trees, olives etc. on outside edge of verge interspersed with driveways & power poles.
517	992	
518	131	Mature Wandoo 15m tall, 6m boundary, on boundary of narrow CAD strip.
