# *Assessment of Trees at Creaney Primary School*

*Prepared For*

*Programmed Facility Management*

The information and opinions provided in this report are based on the observations made during the site assessment undertaken April 11, 2024

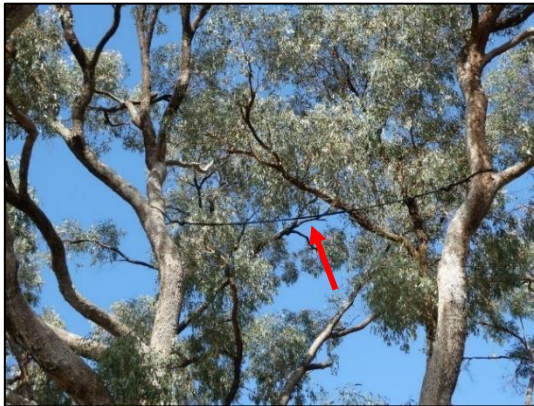
The cable does look slightly tauter than before; but doesn't necessarily look to be tight or under strain.

Image taken October 2022  
Note the cable is slightly slack in its appearance

Whilst not a major concern, this is one that will need to be monitored more closely than other Trees at this School for any signs of increased load on the cable, or separation at the union or the canopy of the two stems.

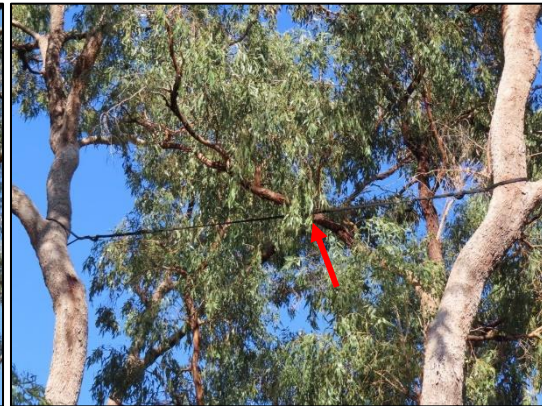
There are no visible signs of any separation at the union of its two main stems (and they may even be separate trees anyway).

Image taken April 2024  
Note the cable now looks slightly tauter compared to the Last Inspection

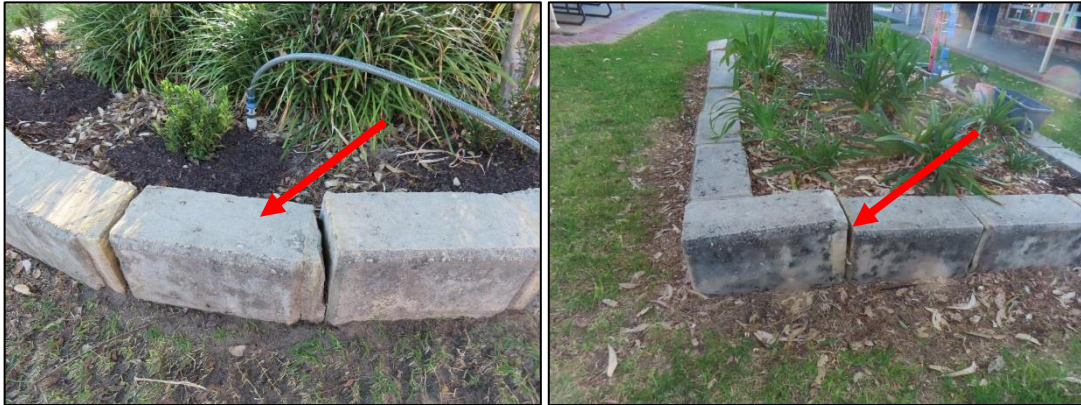
Disturbance to a number of small (single limestone block) retaining walls was again noted to be continuing to occur for the same reasons detailed in the report after the Last Inspection.

The Trees in the planter areas are all early mature Rosewood (*Tipuana tipu*) that show good health and structural form and look to be providing valuable amenity to the area in which they are situated in terms of shade and visual benefits. They all look to be 'early-mature' trees and can be expected to live for another 20-40 years or more, during which time they may double in size in terms of their height, trunk diameter and canopy extents. They are considered to be a very low risk, low maintenance species in terms of their pruning requirements so in many respects they are considered suitable for school situations, although their relatively surface orientated root system can cause issues with surrounding infrastructure if not taken into consideration at the design and construction stage of the development of the area where they are to be situated.

**In this instance the planter constructed around it does NOT appear to have taken into consideration the Trees, their roots, or their potential for future growth.**

At this time the damage was still considered to be more 'cosmetic' rather than a safety concern as no movement was noted in the walls during the inspection and they are only small/low header walls for low rise planter beds.

However further damage can be expected to occur in the future, and if repair was required, including a degree of arboricultural input in the process will be key to a successful outcome.

**At this time repair of the disturbed sections of garden bed wall doesn't look to be required from a risk management perspective.**

If repair was required, including a degree of arboricultural input in the process will be key to a successful outcome. Looking at the landscape there may be a number of options to address the issues without removing the Trees and achieving the desired results although further discussion will be required to table any potential options.

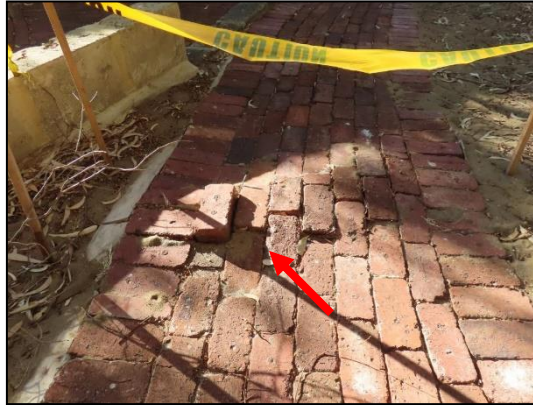
Disturbance to a few areas of paving was noted to be starting to occur; seen in the images below.

Although no pavers were removed, the disturbance looked to be typical of that caused by roots and assumed to a root (or roots) from the nearby Tree; a good mature Tuart.

Repair to the paving is suggested to mitigate the potential trip hazard. In this instance the disturbed sections of the paving would need to be removed to enable further assessment of the size and number of any roots present, and if so what impact their removal would have on the Tree of origin.

Removal of any roots larger than this would not be recommended without seeking further advice.

Once pruned, the paving can then be replaced as required.

Once pruned, the paving can then be replaced as required. However, expect to need to repeat the process every 5 or so years due to the generation of new roots back into the area under the paving.

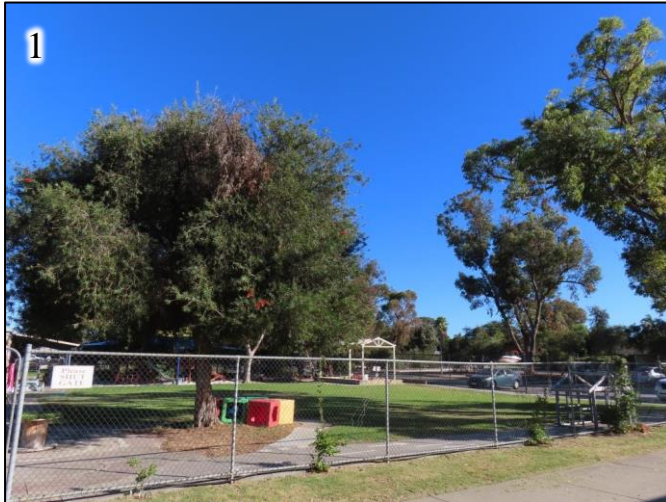
No major change visible since the Last Inspection.

All of the Trees in this area currently show good health and no visible change to their structural condition.

Decay noted in one old Coastal Moort. Ok for now but one to watch.

The dead section of a Jarrah looks to be retaining sufficient structural integrity at this time as well but is also one to watch.

**Area may benefit from some new trees being planted.**

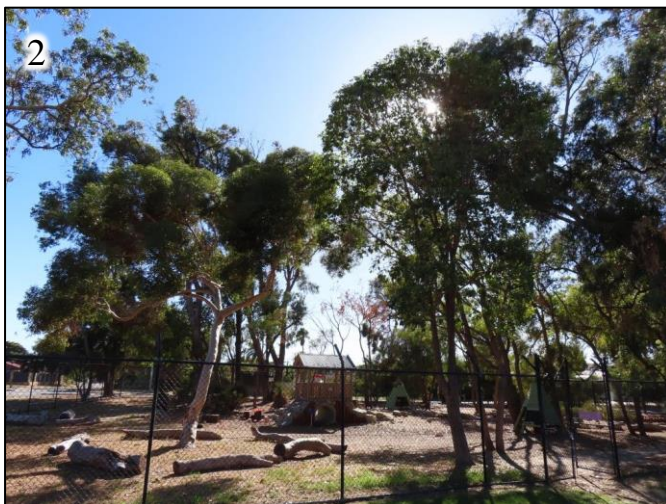
Nature playground area

No major change visible in most Trees since the Last Inspection.

Most look to be remaining in good health and no visible change to their structural condition.

Armoured Scale, borers and canker issues continue to affect smaller parts of some of the Tuart resulting in some smaller diameter (but noticeable) deadwood. Not necessarily a risk of harm in some but in others it is suggested to be removed.

Three small dead Jarrah noted and another looks to be mostly dead; all suggested to be removed before natural decay starts to affect their structural integrity.

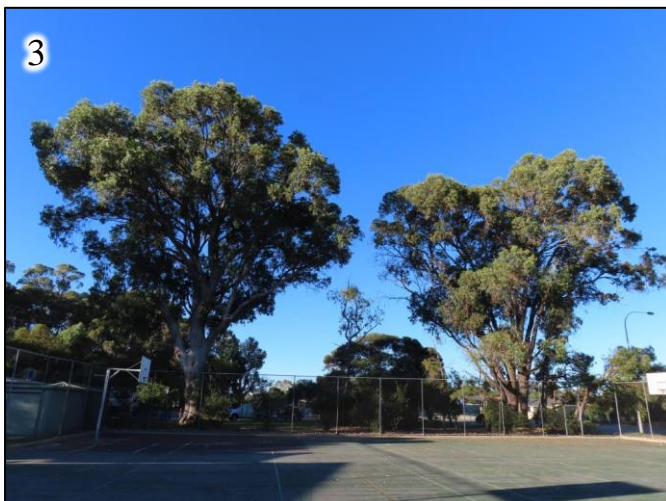
No major change visible since the Last Inspection.

All of the Trees in this area look to be remaining in good health and no major change visible in their structural condition.

Loading noted in parts of the canopy of both of the larger older Tuart trees and so some canopy works are recommended.

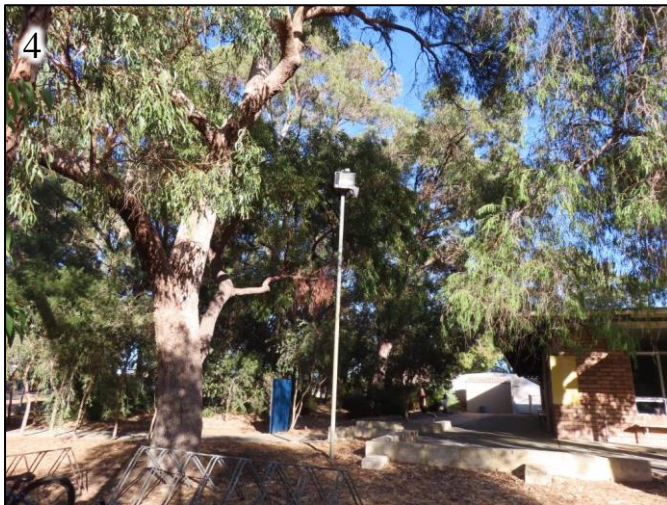
Densely treed area.

Predominantly Jarrah and Tuart and remnant trees for this area.

Looks to be a relatively low use area so whilst some trees have deadwood in their canopy for the most part it looks to represent a low RoH at this time.

Canopy works are however suggested for three Trees in this area and a dead Common Sheoak is suggested to be removed before natural decay starts to affect its structural integrity.

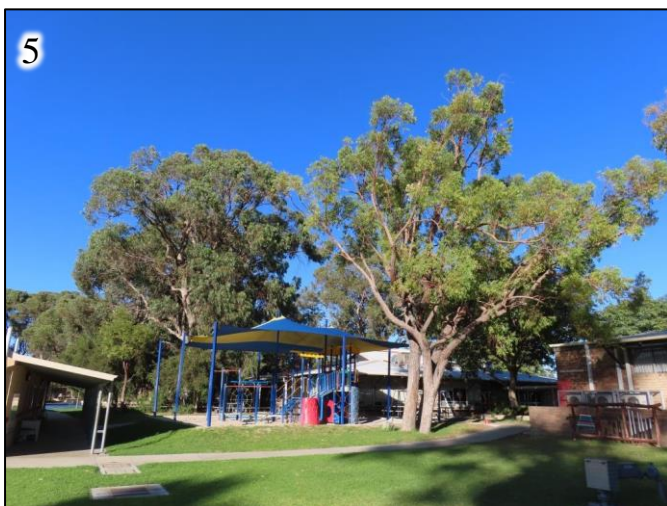
No major change visible since the Last Inspection.

All of the Trees currently show good health and no visible change to their structural condition.

Minor amounts of smaller diameter sized deadwood is visible in some of the Trees but doesn't look to represent a risk of harm due to its size. Marginal weight loading at this time.

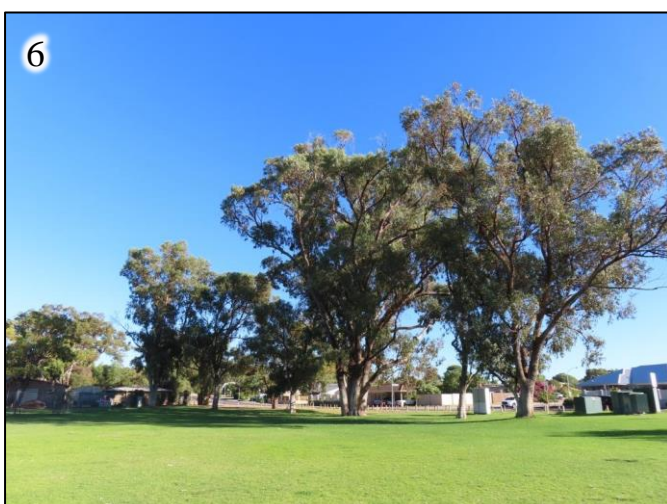
No major change visible since the Last Inspection.

Most of the Trees in this area currently show good health and structural form and no major issues visible at this time.

Some visible deadwood noted in the Tuart (looks to be a Canker and/or borer issue). For the most part it isn't a major concern at this time from a risk management point of view due to its size and the nature of the use of the area.

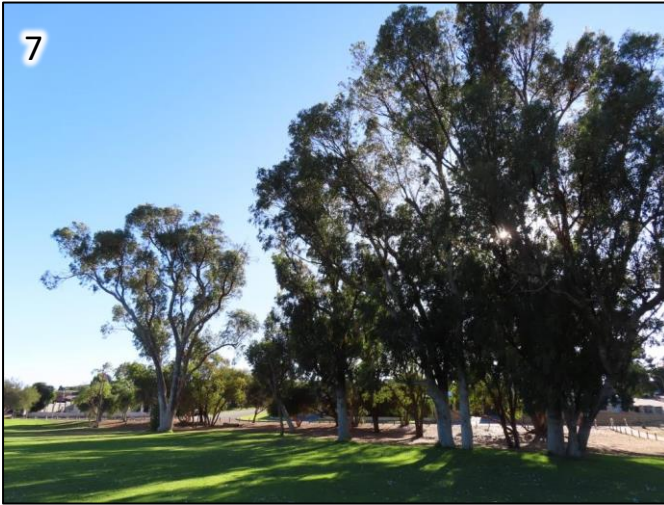
No major change visible since the Last Inspection.

Most of the Trees in this area currently show good health and structural form and no major issues visible at this time. Some smaller deadwood noted but looks to represent a low risk due to its size and the nature of the use of the area.

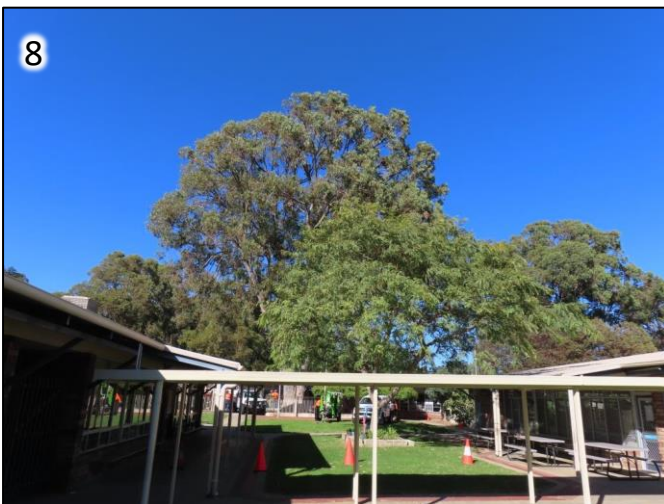
Special Education Area.

Large mature Tuart. Currently shows good health and no visible change to its structural condition. Armoured Scale noted but looks to be having marginal impact to its health at this time. Couple of branches have failed since the Last Inspection. Both around the 8-10cm diameter sized parts. Both mid-canopy northern side this time. Both look to have been force loading related causes.

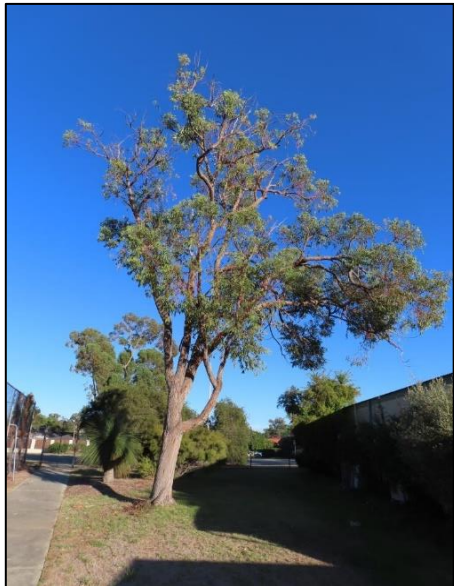
Canopy is slightly sparse but overall it looks to be remaining in good health and no major change looks to have occurred since the Last Inspection. Minor amount of smaller and moderate diameter sized deadwood present in its canopy	Deadwood over Target area	Low use/Target area	3	4	2	1/500,000	Low risk but suggest remove larger deadwood
2	Tuart (Eucalyptus gomphocephala)	23	180	Excellent	Acceptable	Mature

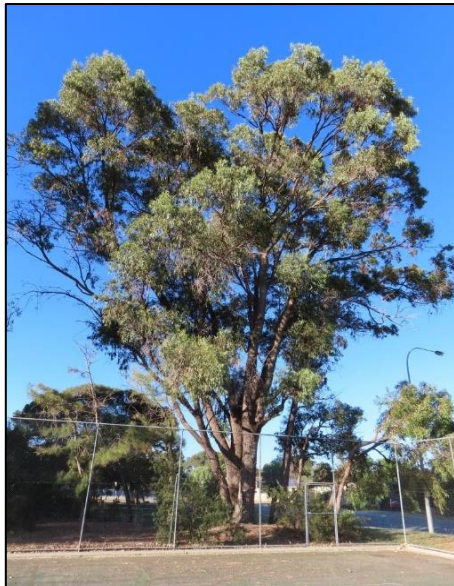
Large mature specimen. Currently shows good health and a good (typical) structural form. Armoured Scale noted but looks to be having marginal impact to its health at this time. Minor amount of smaller and moderate diameter sized deadwood present in its canopy. Weight loading noted in sections of canopy	Failure of live branches over Target area (110-250mm diameter-SoP 3)	Basketball Court	3	3	3	1/500,000	Remove the noticeable deadwood. Remove couple of branches extending over the courts and reduce end weight loading low branch west side

Remove the noticeable deadwood. Remove couple of branches extending over the courts and reduce end weight loading low branch west side

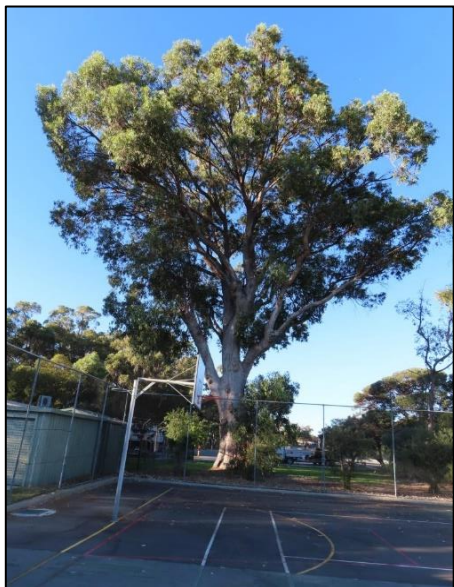
3	Tuart (Eucalyptus gomphocephala)	26	180	Excellent	Acceptable	Mature

Large old tree. Currently shows good health. Previously topped. Regrowth unions look ok at this time. Weight loading noted in sections of canopy	Failure of (live) branches over Target area (260-450mm diameter-SoP 2)	Footpath, Shed	2	2	4	1/50,000	Reduce weight loading NE area

Reduce end weight loading (and length where possible) NE and NW area of the canopy. Remove any larger deadwood from the canopy.

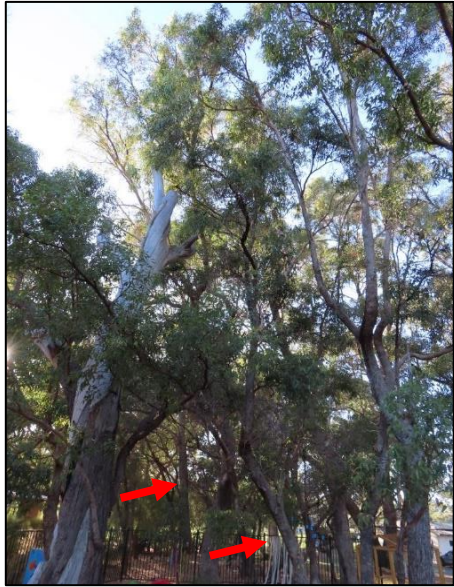
Two trees in close proximity that effectively form the one canopy. Minor amount of moderate and larger diameter sized deadwood	Deadwood over Target area	Nature play area	3	3	2	1/50,000	Remove the larger/moderate diameter sized deadwood. No canopy thinning required (Two trees in this area)
5	Tuart (Eucalyptus gomphocephala)	17	70, 45	Excellent	Good	Mature

Remove the larger/moderate diameter sized deadwood. No canopy thinning required (Two trees in this area)
5	Tuart (Eucalyptus gomphocephala)	17	70, 45

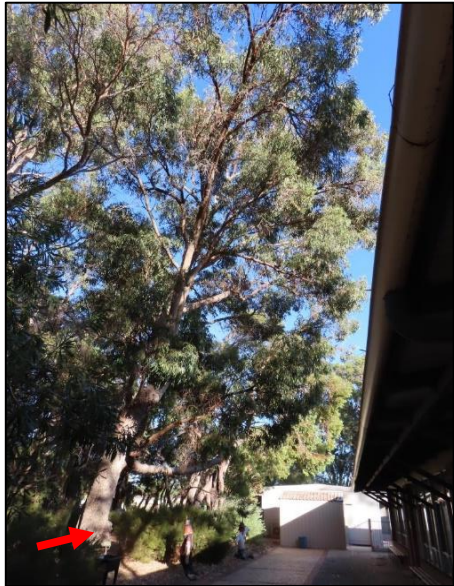
Large mature specimen. Part of a group of trees in close proximity that effectively form the one canopy. Currently shows good health and a good (typical) structural form. Weight loading noted in sections of canopy	Failure of live branches over Target area (110-250mm diameter-SoP 3)	Footpath	2	4	2	1/50,000	Reduce load upper canopy NE and NW areas. Remove the noticeable deadwood

Reduce load upper canopy areas north side. Remove the noticeable deadwood

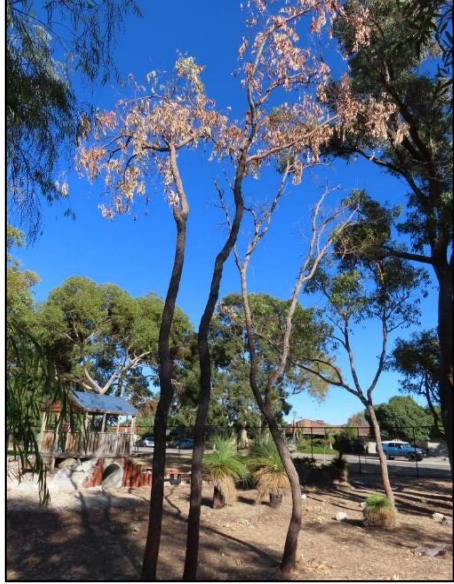
Three small trees that look to have recently died	Failure of upper dead sections/main stems	Nature play area	3	3	3	1/500,000	Suggest remove to ground level as it looks likely to have limited life span remaining. Grind the stump
11	Tuart (Eucalyptus gomphocephala)	24	65	Good	Good	Mature

Remove to ground level and grind the stumps; three small dead trees

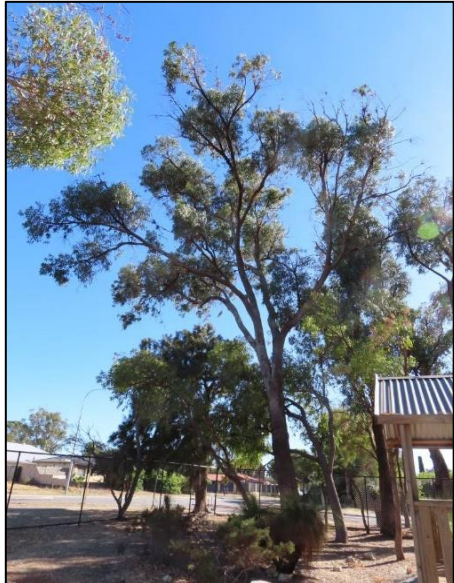
Large mature tree. Some larger deadwood and leggy extended branch structures	Deadwood over Target area	Nature play area	3	3	3	1/500,000	Remove the larger/moderate diameter sized deadwood. Reduce end weight loads SW, west and NW branch
12	Tuart (Eucalyptus gomphocephala)	24	Multiple	Good	Good	Mature

Remove the larger/moderate diameter sized deadwood. Reduce end weight loads SW, west and NW branch

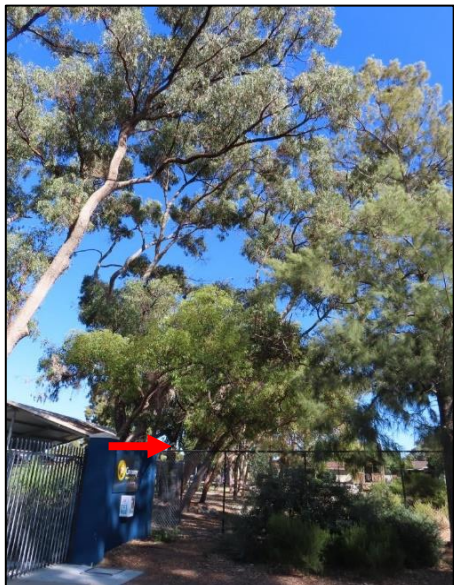
Large mature tree. Some larger deadwood but otherwise ok	Deadwood over Target area	Nature play area	3	3	3	1/500,000	Remove the larger/moderate diameter sized deadwood

Remove the larger/moderate diameter sized deadwood. No canopy thinning required	
13	Jarrah (Eucalyptus marginata)	7	20
