## **Application for referral to clear native vegetation - Infrastructure Areas Vegetation Assessment 2025**

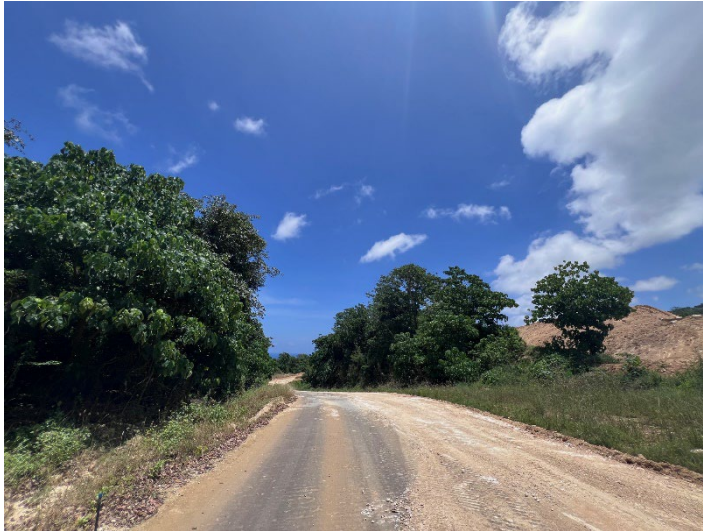
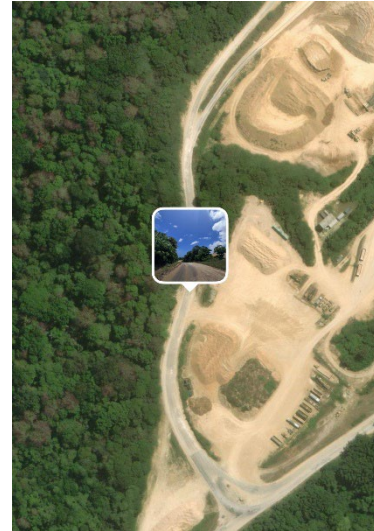
<b>Waypoint Reference</b>	3
<b>Site</b>	ROM
<b>Tenement</b>	MCI 70/1A
<b>GPS Coordinates</b>	N 8845353.6514, E 572712.3482
<b>Photo Direction</b>	344° N
<b>Native Vegetation</b>	<i>Macaranga tanarius</i> <i>Tristiropsis acutangula</i> <i>Arenga listeri</i>
<b>Weed Species</b>	<i>Leucaena leucocephala</i> <i>Musa acuminata</i> <i>Ricinus communis</i> <i>Carica papaya</i> <i>Colocasia esculenta</i> <i>Muntingia calabura</i> Other weed species
<b>Vegetation Rating (1=Pristine, 7=Cleared)</b>	5, 6, 7
<b>ESA</b>	Inside, exemptions do not apply
<b>Notes</b>	Vegetation along road. Road access to Tip-head.

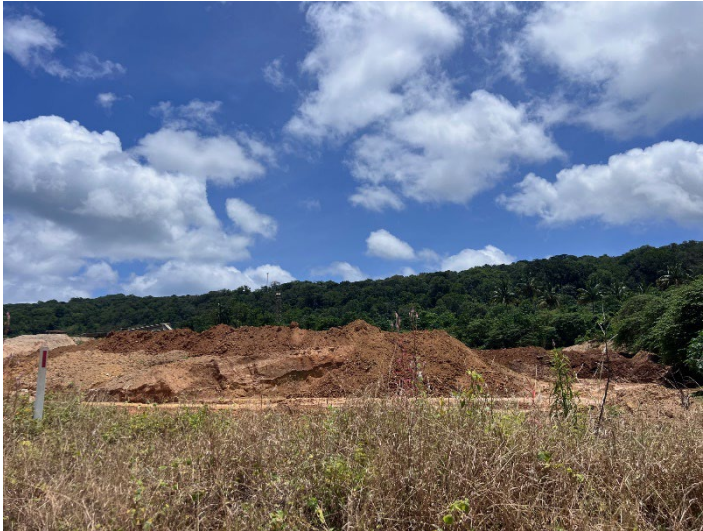
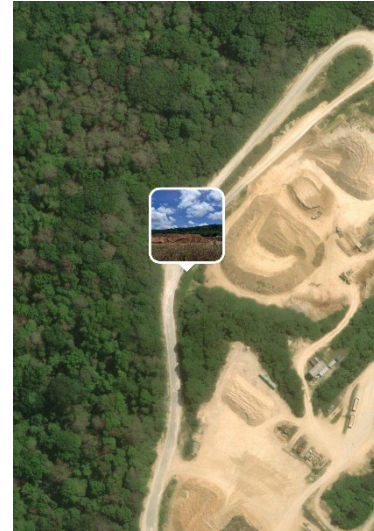
<b>Waypoint Reference</b>	4
<b>Site</b>	ROM
<b>Tenement</b>	MCI 70/1A
<b>GPS Coordinates</b>	N 8845492.0729, E 572720.7307
<b>Photo Direction</b>	68° E
<b>Native Vegetation</b>	-
<b>Weed Species</b>	<i>Muntingia calabura</i> Other weed species
<b>Vegetation Rating (1=Pristine, 7=Cleared)</b>	7
<b>ESA</b>	Inside, exemptions do not apply
<b>Notes</b>	Track / Laydown area. Stockpile of product hauled from mining field. Weed species on windrow.

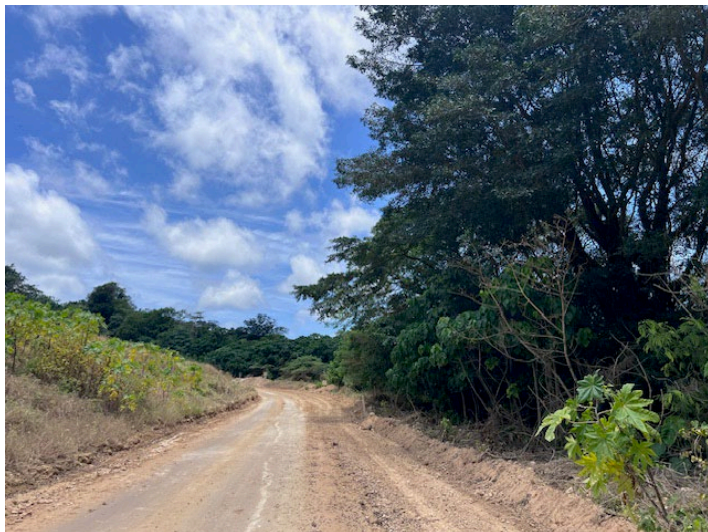
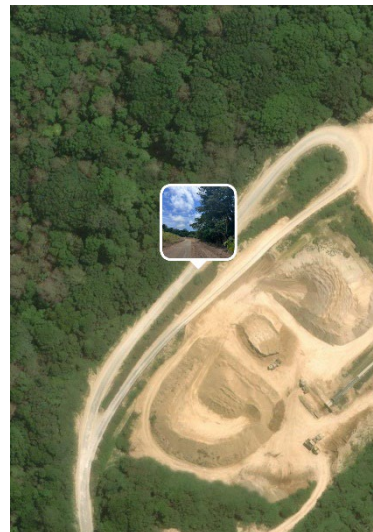
<b>Waypoint Reference</b>	5
<b>Site</b>	ROM
<b>Tenement</b>	GCI 70/2
<b>GPS Coordinates</b>	N 8845599.7664, E 572779.5155
<b>Photo Direction</b>	220° SW
<b>Native Vegetation</b>	<i>Macaranga tanarius</i> <i>Ficus macrocarpa</i>
<b>Weed Species</b>	<i>Leucaena leucocephala</i> <i>Ricinus communis</i> Other weed species
<b>Vegetation Rating (1=Pristine, 7=Cleared)</b>	6, 7
<b>ESA</b>	Inside, exemptions do not apply
<b>Notes</b>	Road exiting Tip-head. Vegetation along track, overhanging Ficus limbs.

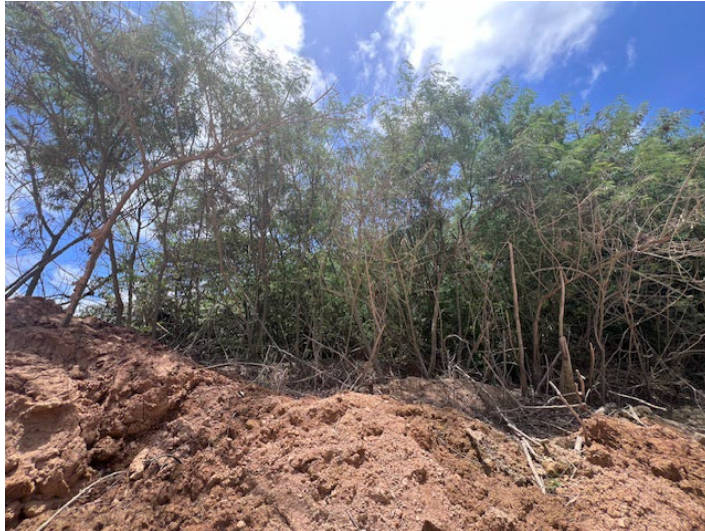
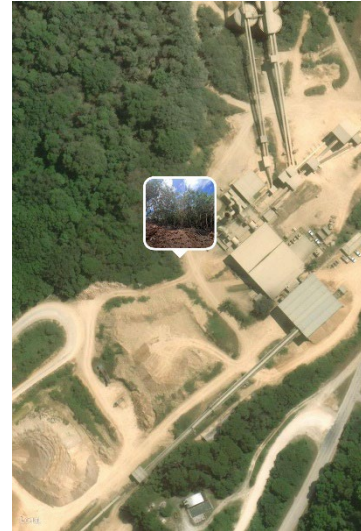
<b>Waypoint Reference</b>	10
<b>Site</b>	Dryers
<b>Tenement</b>	MCI 70/1A
<b>GPS Coordinates</b>	N 8845711.7506, E 572948.4177
<b>Photo Direction</b>	292° NW
<b>Native Vegetation</b>	<i>Maclura cochinchinensis</i>
<b>Weed Species</b>	<i>Leucaena leucocephala</i> <i>Muntingia calabura</i> Other weed species
<b>Vegetation Rating (1=Pristine, 7=Cleared)</b>	6, 7
<b>ESA</b>	Inside, exemptions do not apply
<b>Notes</b>	Disturbed - weed dominated. Between reject stockpile and Baghouse.

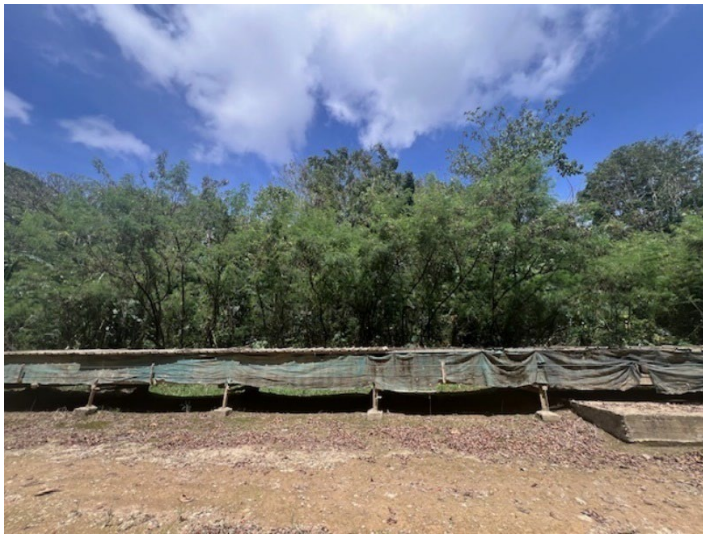
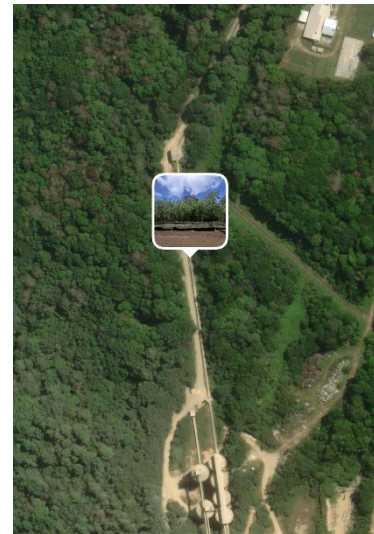
<b>Waypoint Reference</b>	17
<b>Site</b>	Cross Country Conveyors
<b>Tenement</b>	MCI 70/1A
<b>GPS Coordinates</b>	N 8846085.2137, E 572974.4892
<b>Photo Direction</b>	37° NE
<b>Native Vegetation</b>	<i>Macaranga tanarius</i> <i>Dysoxylum gaudichaudianum</i> <i>Leea angulata</i> <i>Arenga listeri</i> <i>Melochia umbellata</i> <i>Maclura cochinchinensis</i>
<b>Weed Species</b>	<i>Leucaena leucocephala</i> <i>Musa acuminata</i> <i>Muntingia calabura</i> Other weed species
<b>Vegetation Rating (1=Pristine, 7=Cleared)</b>	6, 7
<b>ESA</b>	Inside, exemptions do not apply
<b>Notes</b>	Along PS10 Conveyor. Operational area – Vegetation along track and overhanging limbs.

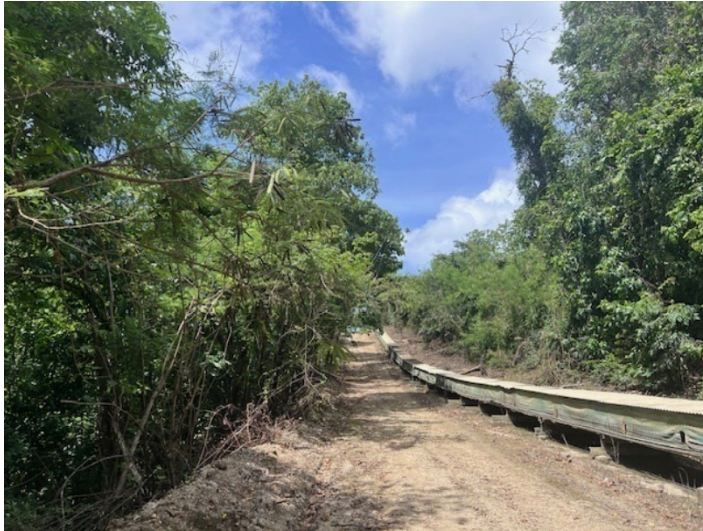
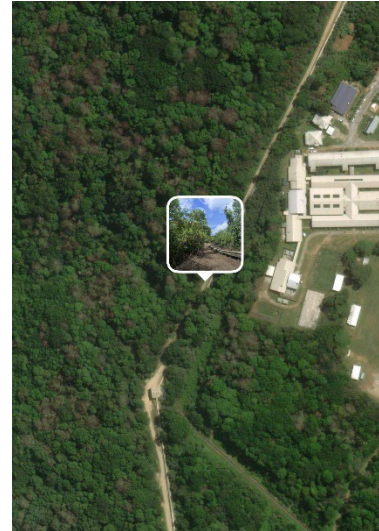
<b>Waypoint Reference</b>	18
<b>Site</b>	Cross Country Conveyors
<b>Tenement</b>	MCI 70/1A
<b>GPS Coordinates</b>	N 8846271.9901, E 573021.1856
<b>Photo Direction</b>	21° N
<b>Native Vegetation</b>	<i>Inocarpus fagifer</i> <i>Terminalia catappa</i> <i>Maclura cochinchinensis</i> <i>Macaranga tanarius</i> <i>Tristiropsis acutangula</i> <i>Gyrocarpus americanus</i> <i>Ficus microcarpa</i> <i>Barringtonia racemosa</i>
<b>Weed Species</b>	<i>Leucaena leucocephala</i> Other weed species
<b>Vegetation Rating (1=Pristine, 7=Cleared)</b>	5, 7
<b>ESA</b>	Inside, exemptions do not apply
<b>Notes</b>	Along C1 Conveyor (bottom of hill). Operational area – Vegetation along track and overhanging limbs.

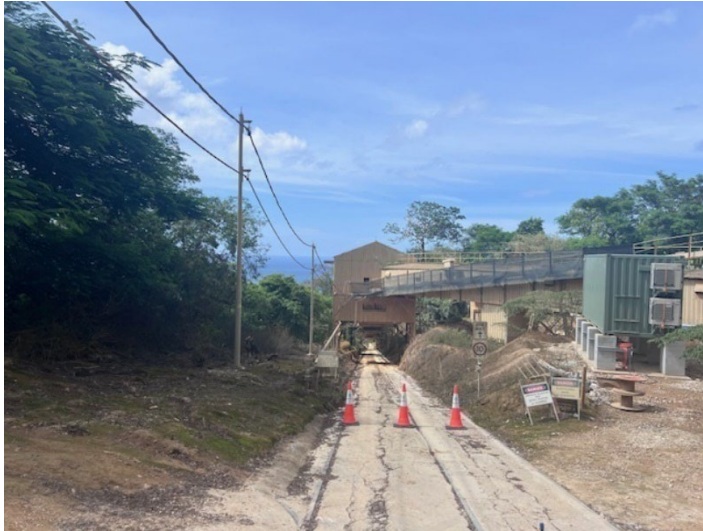
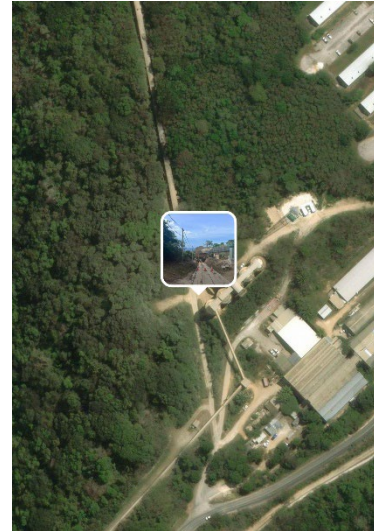
<b>Waypoint Reference</b>	25
<b>Site</b>	Downhill
<b>Tenement</b>	MCI 70/1A
<b>GPS Coordinates</b>	N 8847279.3830, E 573970.7220
<b>Photo Direction</b>	20° NE
<b>Native Vegetation</b>	<i>Macaranga tanarius</i>
<b>Weed Species</b>	<i>Muntingia calabura</i> <i>Leucaena leucocephala</i> <i>Delonix regia</i> Other weed species
<b>Vegetation Rating (1=Pristine, 7=Cleared)</b>	6, 7
<b>ESA</b>	Inside, exemptions do not apply
<b>Notes</b>	Incline. Operational area – vegetation along incline and overhanging limbs.

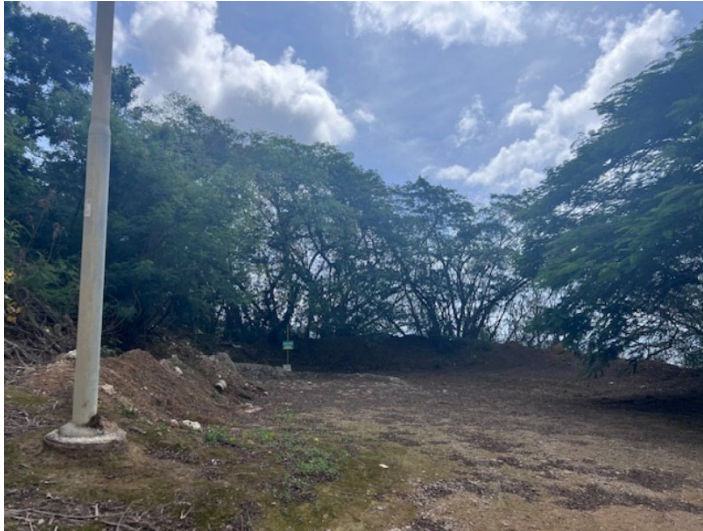
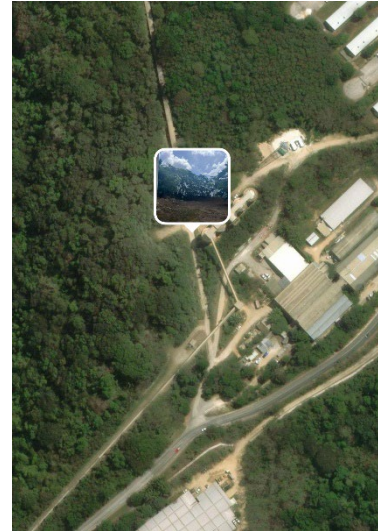
<b>Waypoint Reference</b>	25
<b>Site</b>	Downhill
<b>Tenement</b>	MCI 70/1A
<b>GPS Coordinates</b>	N 8847279.3830, E 573970.7220
<b>Photo Direction</b>	274° W
<b>Native Vegetation</b>	<i>Macaranga tanarius</i> <i>Dysoxylum gaudichaudianum</i>
<b>Weed Species</b>	<i>Delonix regia</i> <i>Muntingia calabura</i> <i>Leucaena leucocephala</i> Other weed species
<b>Vegetation Rating (1=Pristine, 7=Cleared)</b>	7
<b>ESA</b>	Inside, exemptions do not apply
<b>Notes</b>	Parking area outside of lease. Operational area - Parking Area, overhanging limbs.

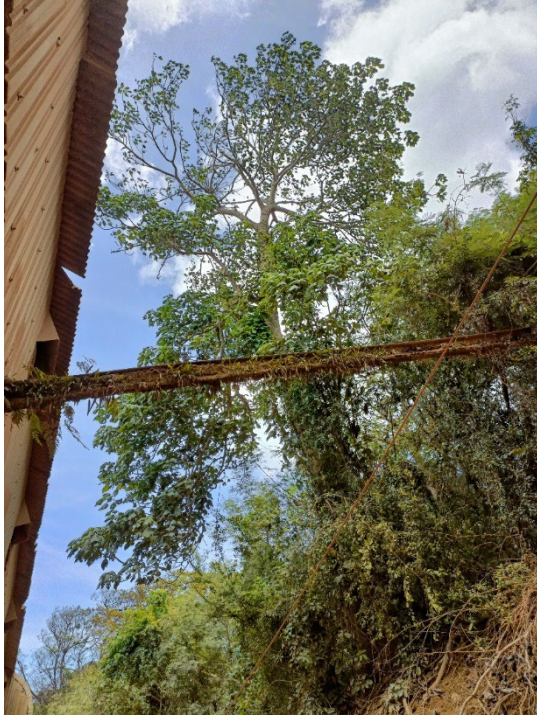
<b>Waypoint Reference</b>	29
<b>Site</b>	Downhill
<b>Tenement</b>	MCI 70/1A
<b>GPS Coordinates</b>	N 8847333.9822, E 573969.4663
<b>Photo Direction</b>	20° N
<b>Native Vegetation</b>	<i>Gyrocarpus americanus</i> <i>Maclura cochinchinensis</i> <i>Schefflera elliptica</i> <i>Dysoxylum gaudichaudianum</i> <i>Tristiropsis acutangula</i> <i>Tectaria dissecta</i>
<b>Weed Species</b>	<i>Leucaena leucocephala</i> Other weed species
<b>Vegetation Rating (1=Pristine, 7=Cleared)</b>	6, 7
<b>ESA</b>	Inside, exemptions do not apply
<b>Notes</b>	Outside of D10 conveyor. Operational area - vegetation along conveyor.

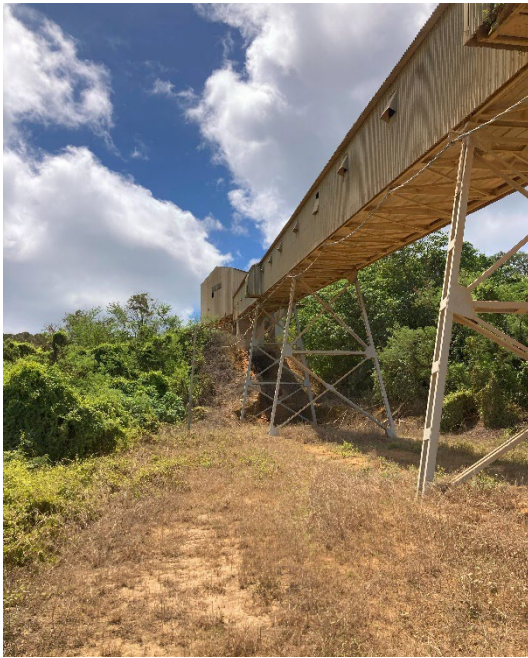
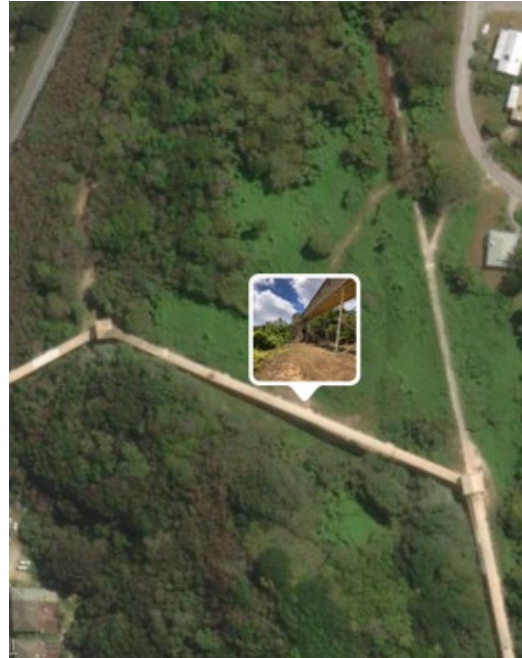
<b>Waypoint Reference</b>	30
<b>Site</b>	Downhill - D11
<b>Tenement</b>	MCI 70/1A
<b>GPS Coordinates</b>	N 8847639.0677, E 573850.9666
<b>Photo Direction</b>	110° E
<b>Native Vegetation</b>	<i>Maclura cochinchinensis</i> <i>Schefflera elliptica</i> <i>Ficus microcarpa</i>
<b>Weed Species</b>	<i>Leucaena leucocephala</i> <i>Antigonon leptopus</i> <i>Manihot esculenta</i> <i>Carica papaya</i> Other weed species
<b>Vegetation Rating (1=Pristine, 7=Cleared)</b>	6, 7
<b>ESA</b>	Inside, exemptions do not apply
<b>Notes</b>	Operational area - largely cleared or weeds with overhanging native limbs.

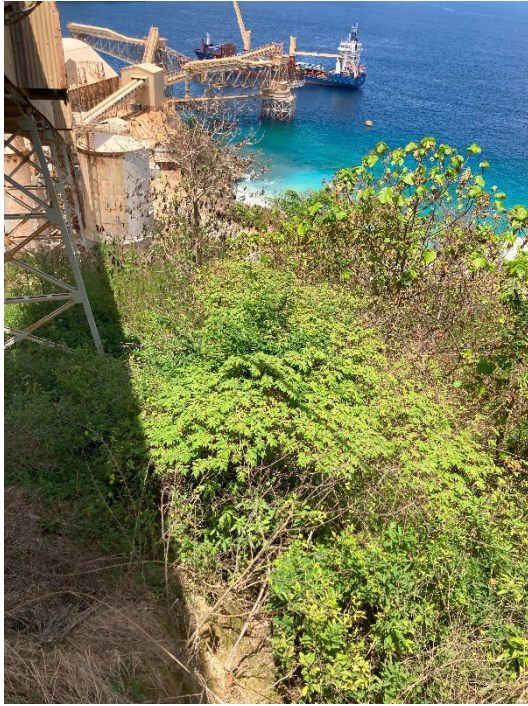
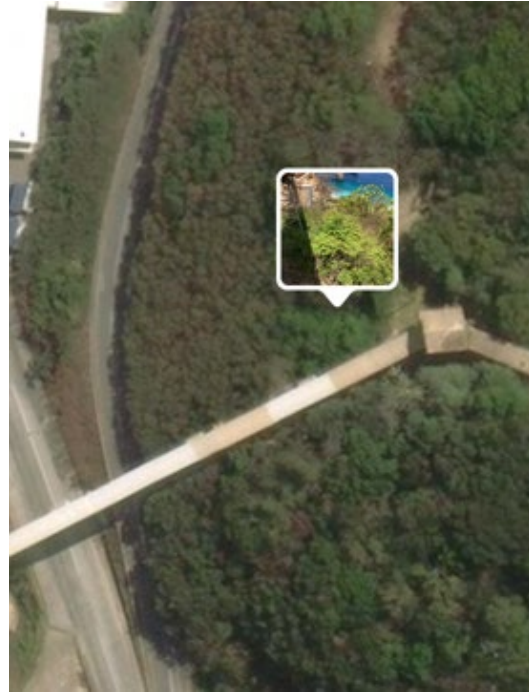
<b>Waypoint Reference</b>	31
<b>Site</b>	Downhill-D12
<b>Tenement</b>	MCI 70/1A
<b>GPS Coordinates</b>	N 8847671.0644, E 573737.4897
<b>Photo Direction</b>	230° SW
<b>Native Vegetation</b>	<i>Macaranga tanarius</i> <i>Maclura cochinchinensis</i> <i>Schefflera elliptica</i>
<b>Weed Species</b>	<i>Leucaena leucocephala</i> <i>Muntingia calabura</i> <i>Delonix regia</i> <i>Musa acuminata</i> <i>Manihot esculenta</i> Other weed species
<b>Vegetation Rating (1=Pristine, 7=Cleared)</b>	5, 6
<b>ESA</b>	Inside, exemptions do not apply
<b>Notes</b>	Operational area – weed dominated.
