## **Arboriculture Advice for the Shire of Harvey**

Date: 06/03/2025

Location: Seventh Street, Harvey WA

Tree Species: *Corymbia calophylla*

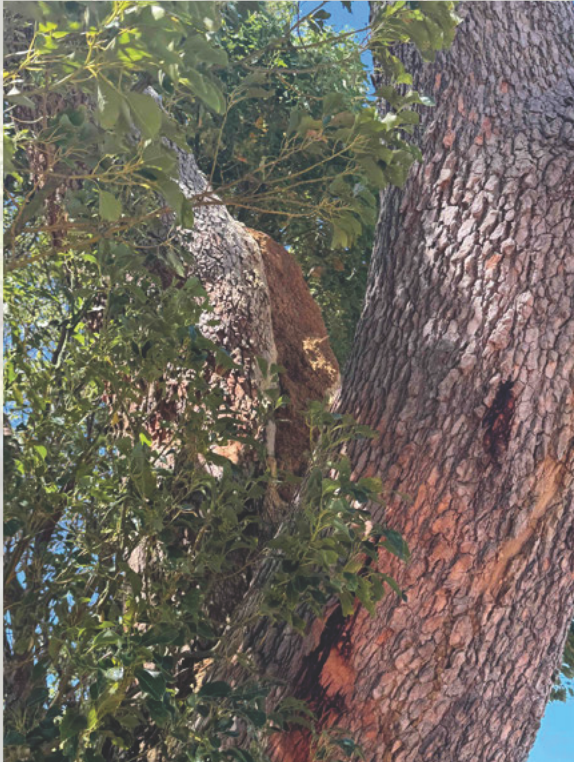
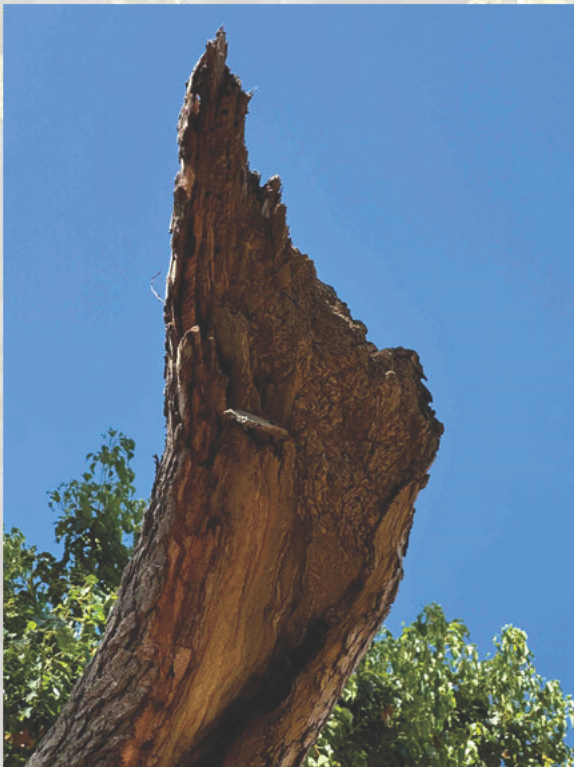
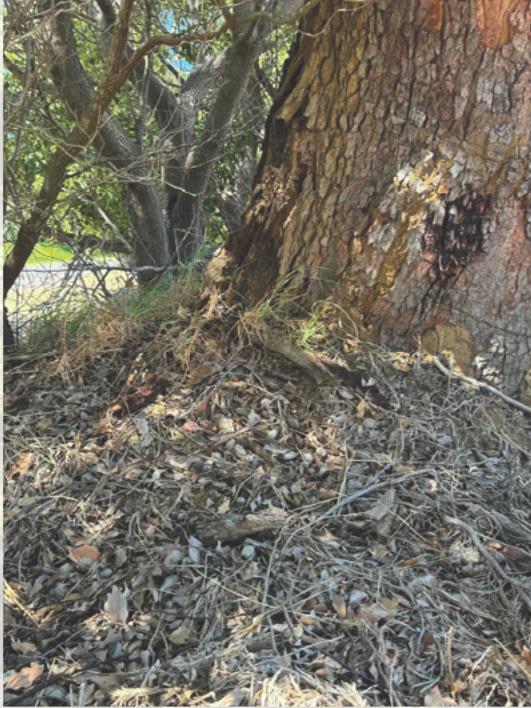
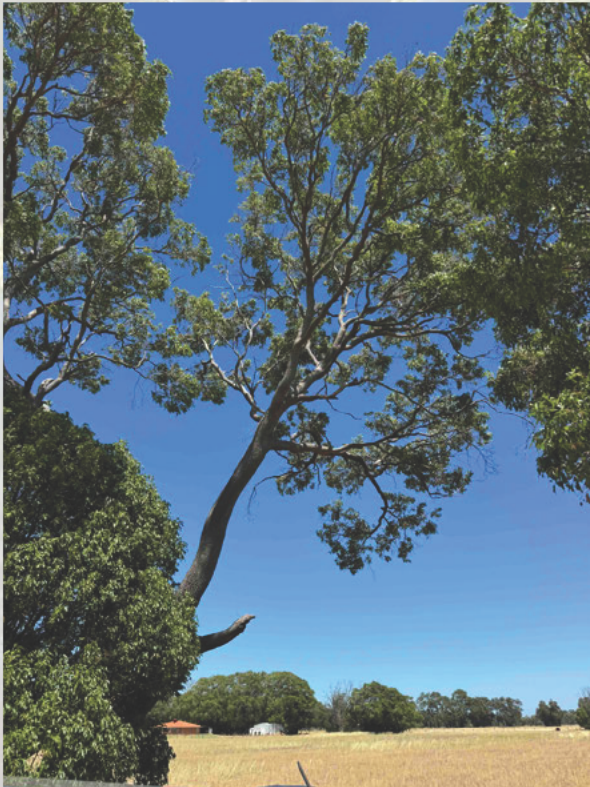
Tree #1:

- Signs of root plate movement due to prevailing winds. Heavy ground cover limits the consultant's ability to assess further.
- Drain of a smaller scale approximately 1m from base. No root cuts evident on this occasion. However, prone to waterlogged soil during winter months.

- Has a significant lean to the West.
- Multi-stemmed, no included bark present.
- Significant white ant damage.
- Some minor marri canker also present at the base of the trunk.

- Broad spreading canopy of 13m.
- Multi-stemmed.
- Poor structure
- Previous failures are evident (200mm).

- **White ant treatment prior to removal**
- **Full removal is recommended**

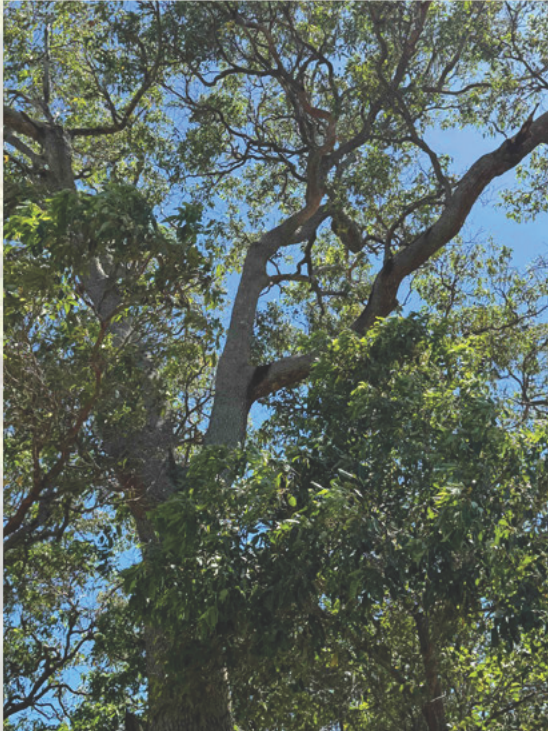
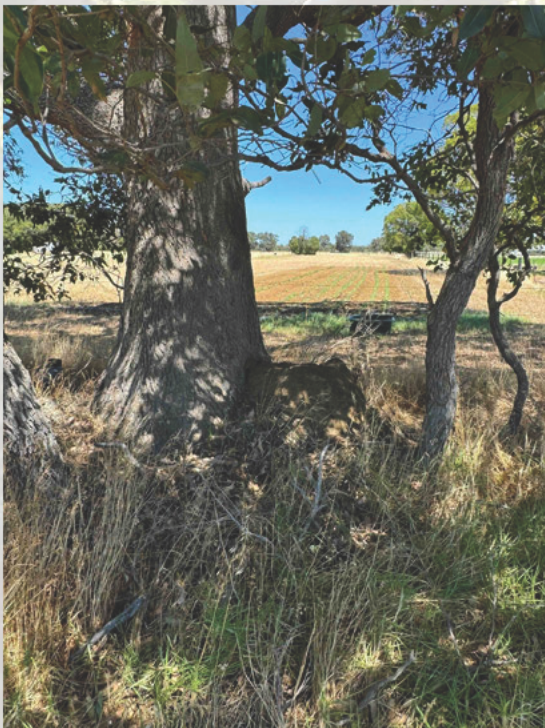
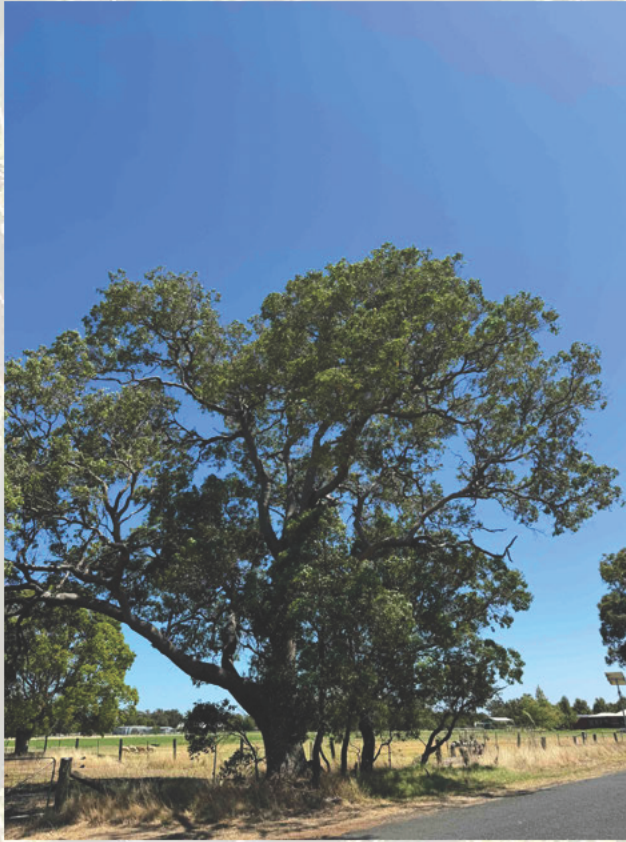
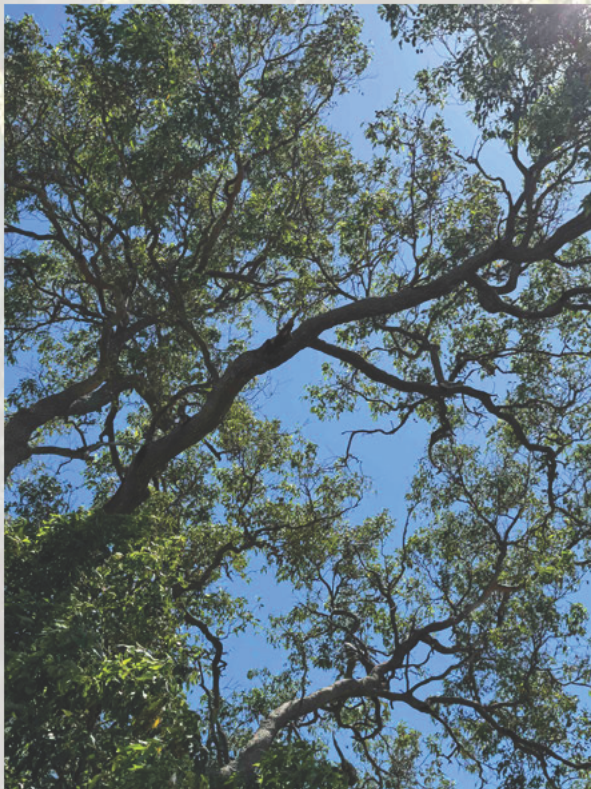
Tree #2:

- No signs of root plate movement. No root cuts evident. Termite mound at base of trunk at the root flare.

- White ant nest at base.
- Multi-stemmed.
- Slight lean to the West (very minor).
- Otherwise in good health.

- 19m canopy spread.
- Large first order limb to the West (slightly over-extended).
- Minor marri canker damage (insignificant)
- Minor deadwood
- No major evidence of previous failures.

- **Weight reduction on first order limb to the West**
- **Deadwood prune**
- **White ant treatment**
- **Minor thin out of canopy**
