#### Attachment 4 – Photos of Proposed Clearing Area

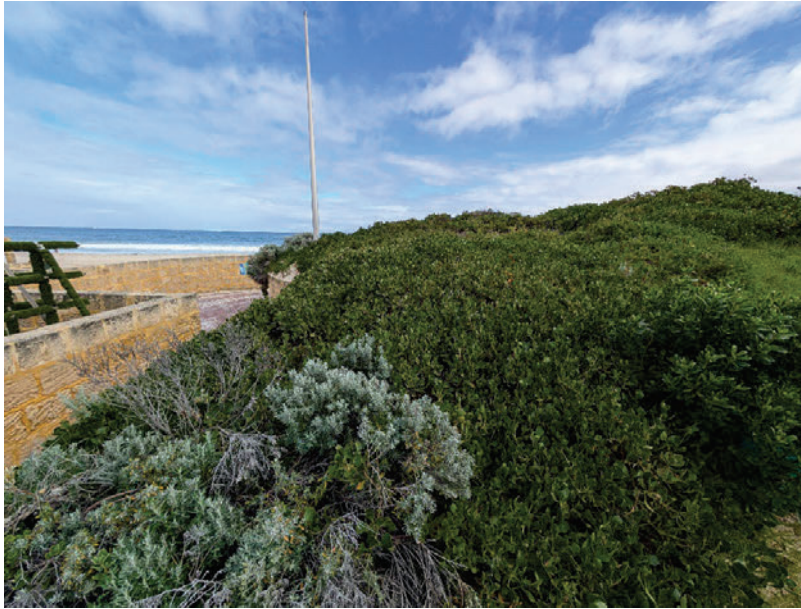
Plate 1: Proposed clearing area facing West towards Mullaloo Beach. *Scaevola crassifolia* and *Olearia axillaris* will need to be either removed or pruned back to allow space for works.

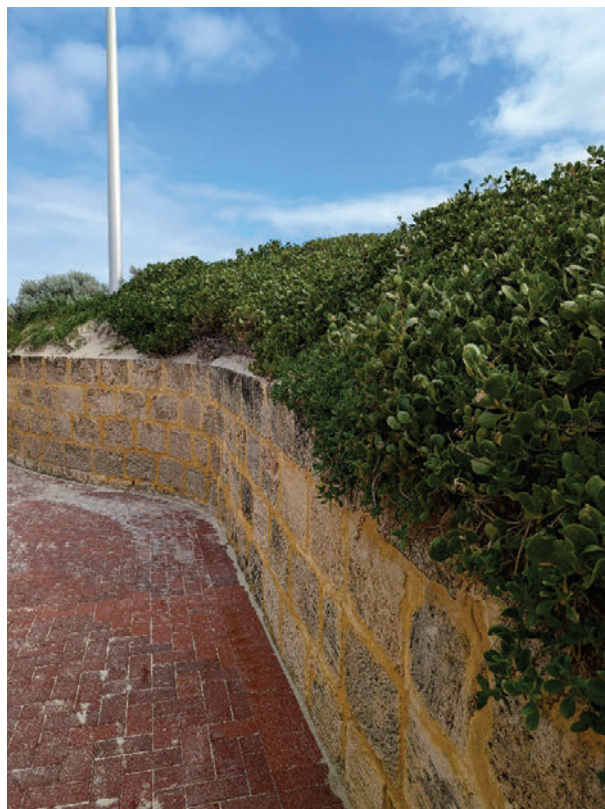
Plate 2: Proposed clearing area from ground level perspective, facing in the same direction as Plate 1.

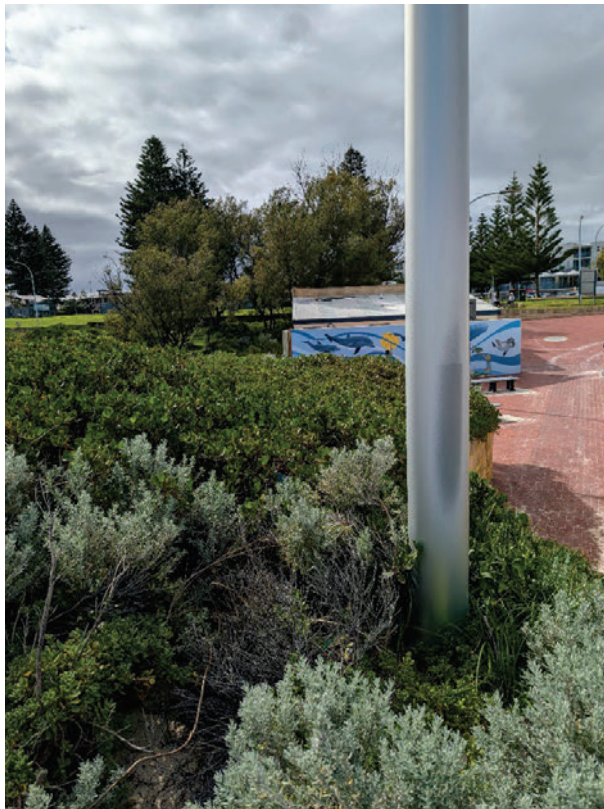
Plate 3: Proposed clearing area facing East towards Tom Simpson Park public toilets.

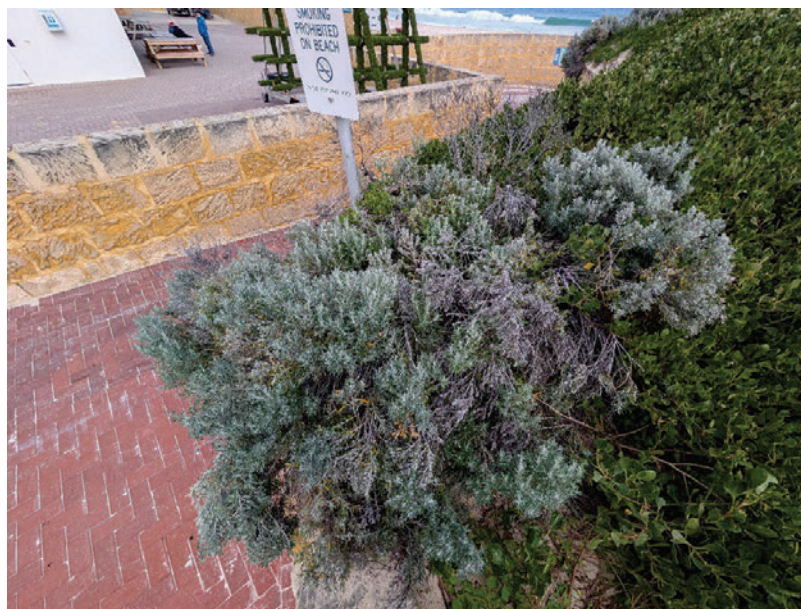
Plate 4: A large *Olearia axillaris* bush that will need to be removed to provide access for crew to conduct maintenance.

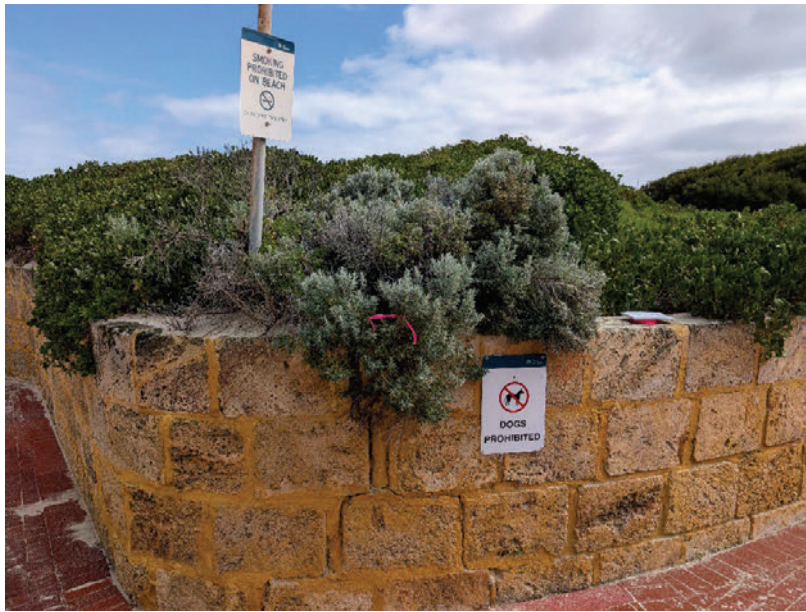
Plate 5: Frontal view of *Olearia axillaris* photographed in Plate 4.

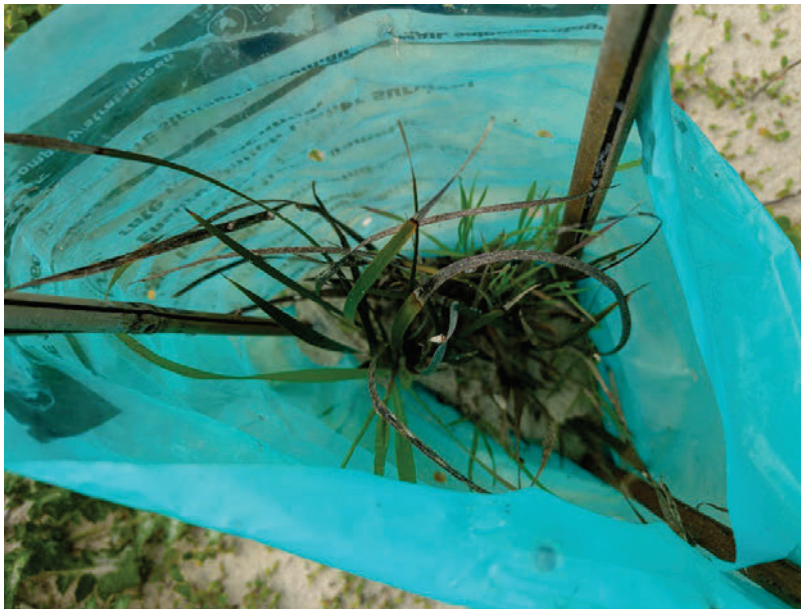
Plate 6: Planted *Lepidosperma gladiatum* within proposed clearing area.

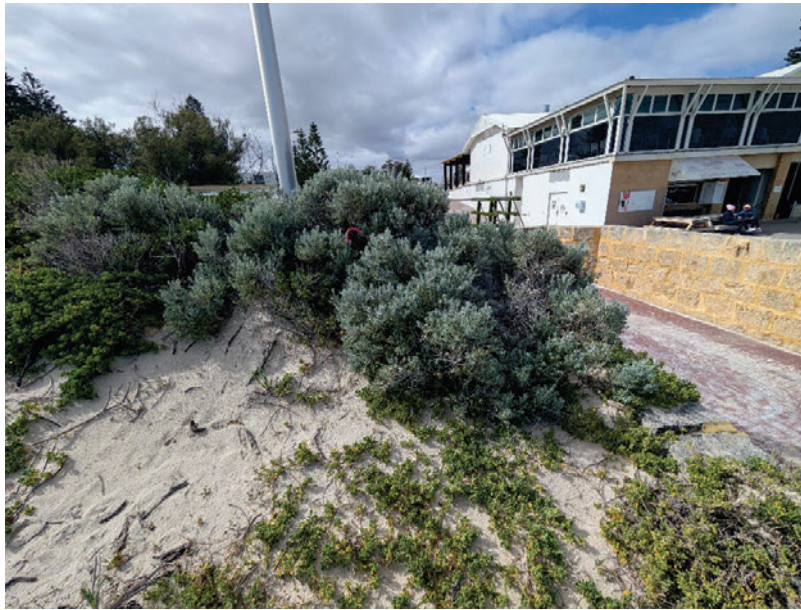
Plate 7: *Olearia axillaris* that will need to be cleared for access. Photographed on Western side of proposed clearing site, facing East towards Tom Simpson Park public toilets.

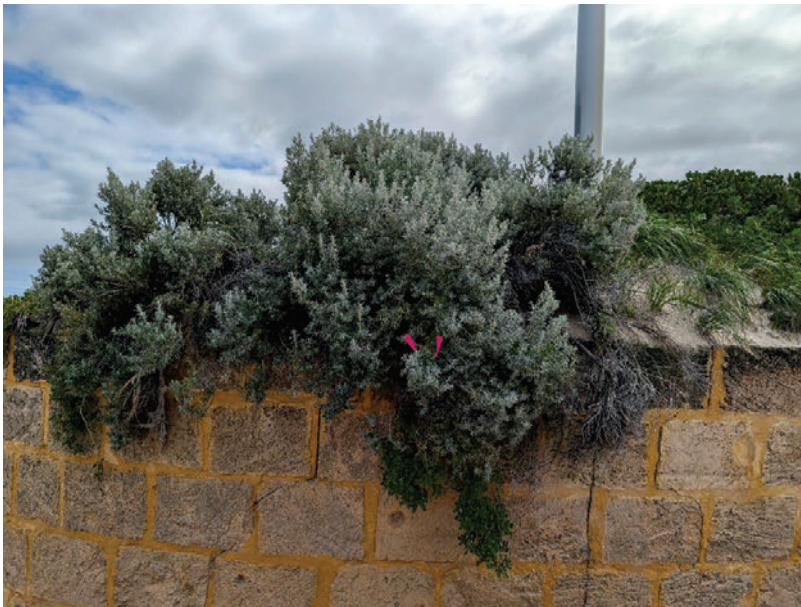
Plate 8: Photo of same *Olearia axillaris* taken in Plate 7, facing limestone wall.

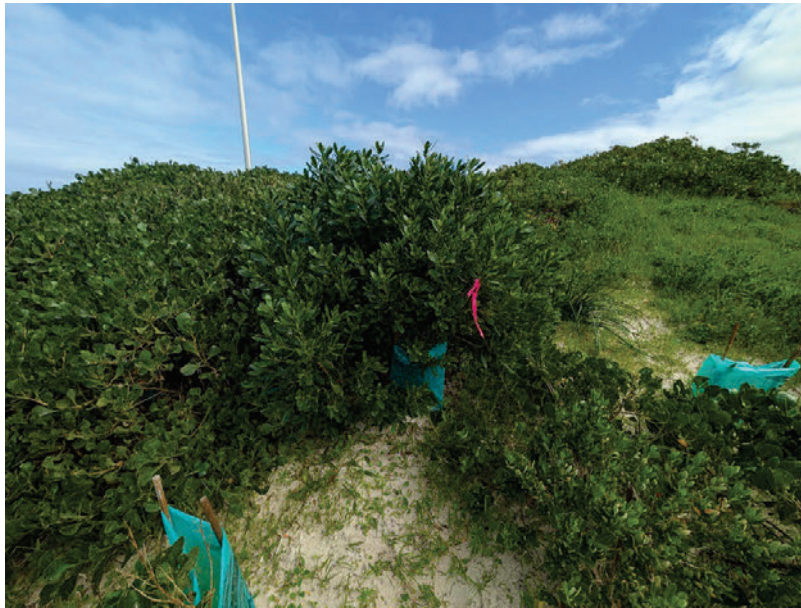
Plate 9: *Myoporum insulare* that will be pruned back to provide access for maintenance.

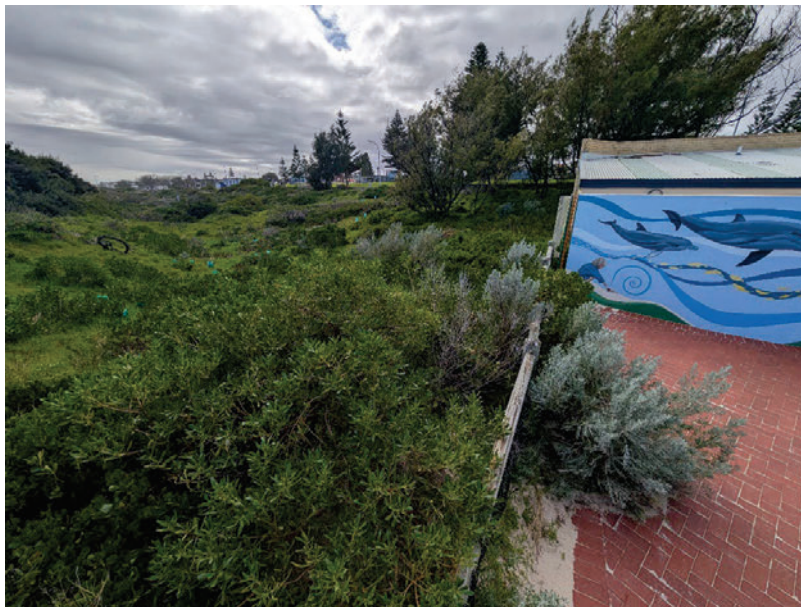
Plate 10: Eastern access point considered for access to limestone wall. This entry point was decided against, as the area contained a large coverage of established native plants that would need to be removed.

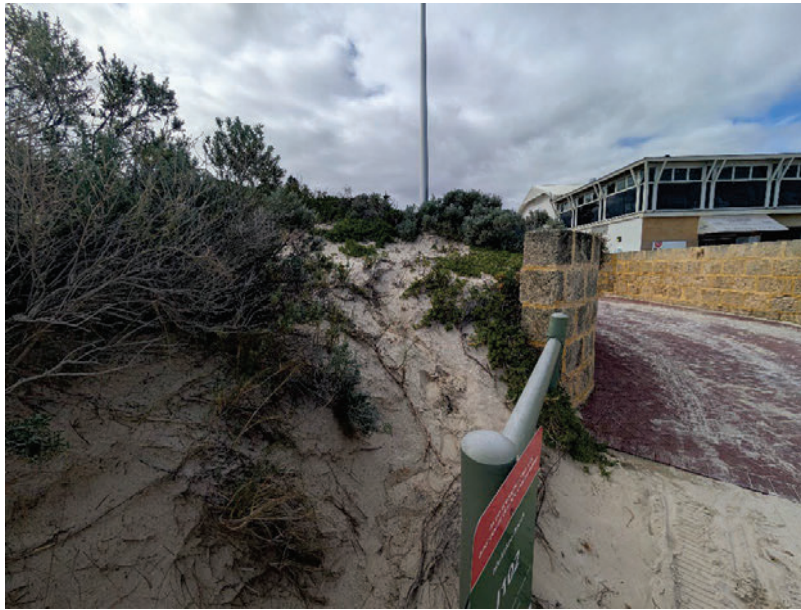
Plate 11: Western entry point that was considered as an entry point for contractors. This entry point was decided to be the most appropriate point, as the area is fairly degraded with little coverage of native vegetation.

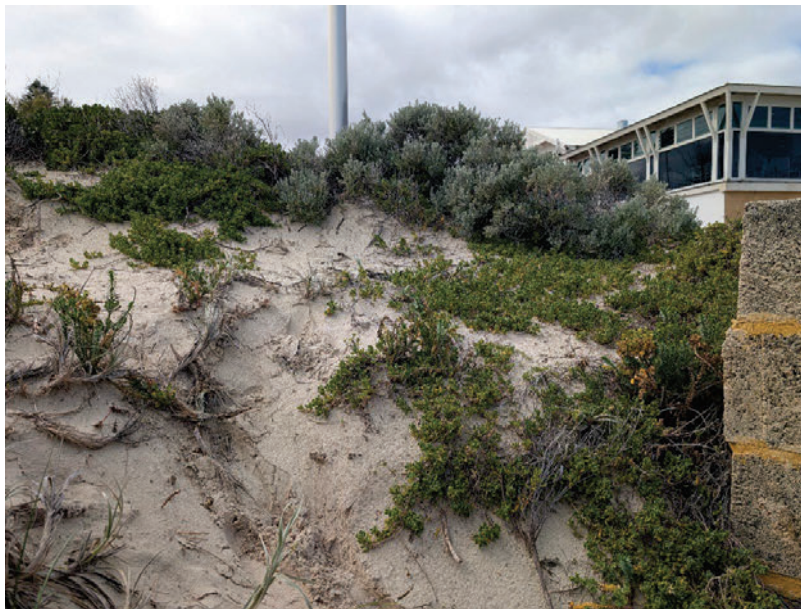
Plate 12: Close up photo of Western entry point with large barren patches of sand with established weeds, such as *Tetragonia decumbens*. *Olearia axillaris* seen in background is the same *Olearia axillaris* from Plates 7 and 8.

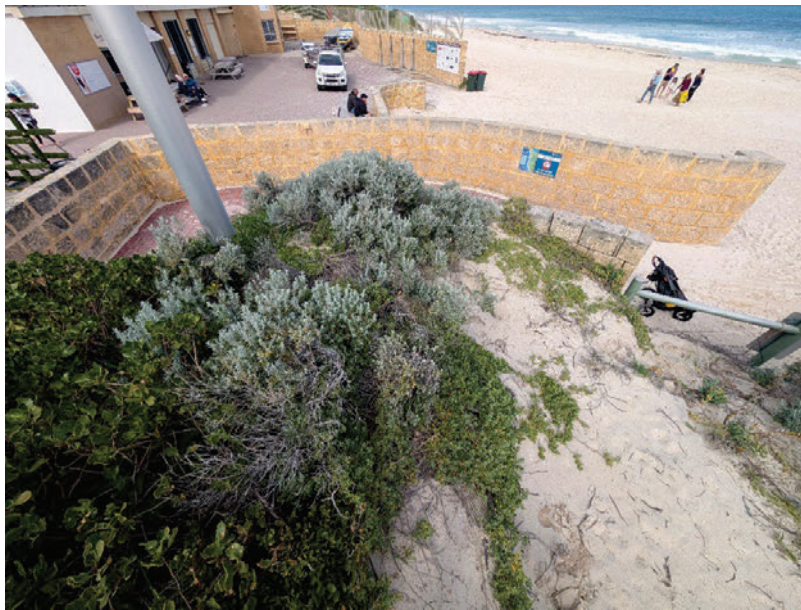
Plate 13: Aerial perspective of Plates 7, 8, 11 and 12.

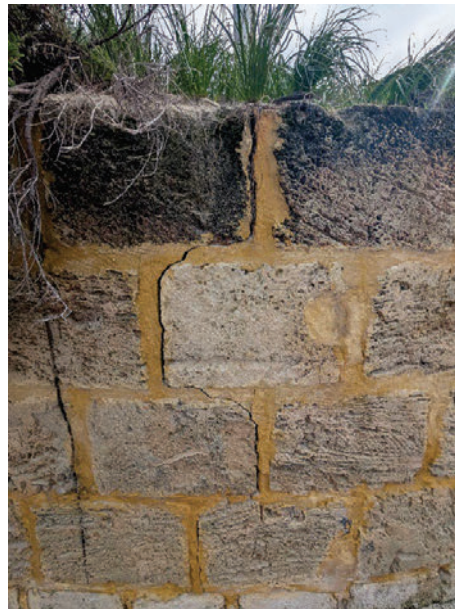
Plate 14: Example 1 of deterioration on limestone wall.

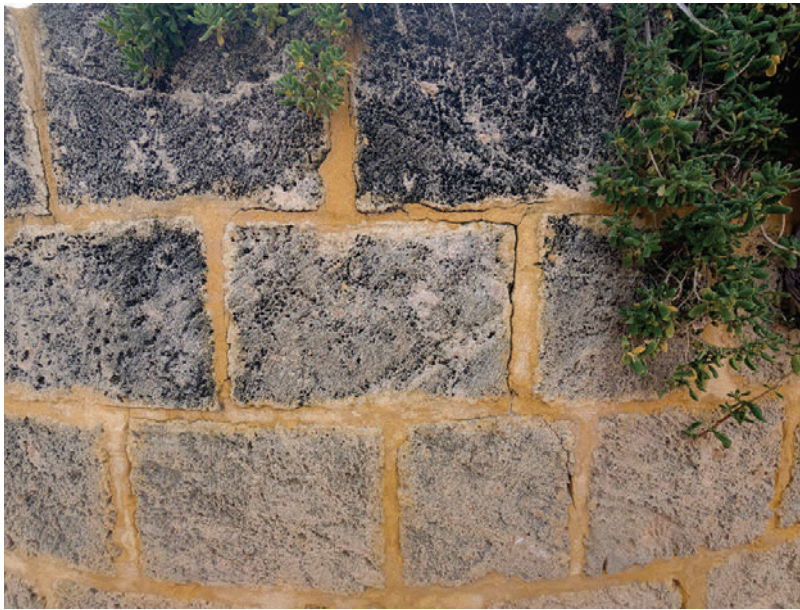
Plate 15: Example 2 of deterioration on limestone wall.

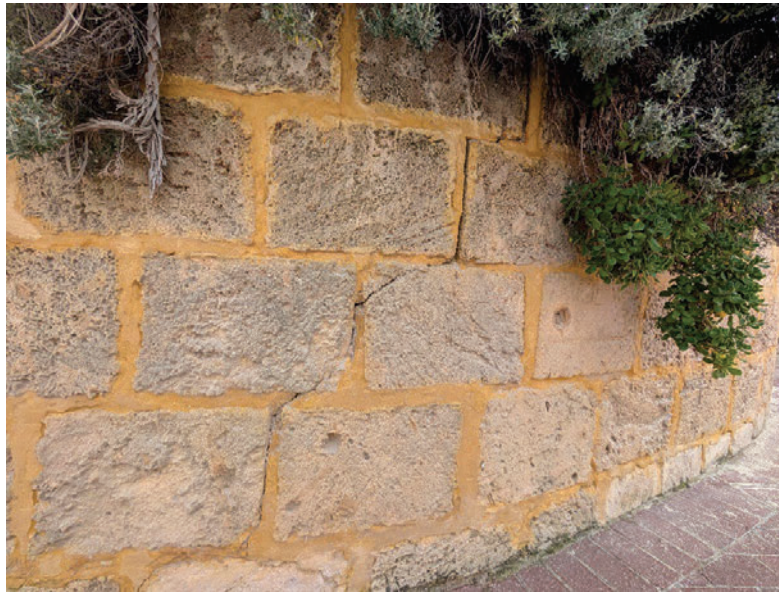
Plate 16: Example 3 of deterioration on limestone wall.

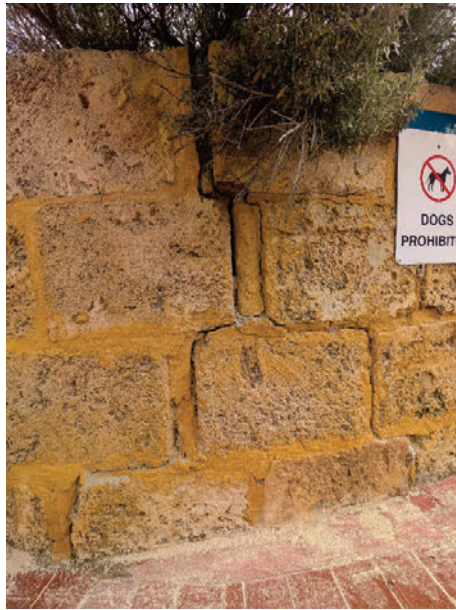
Plate 17: Example 4 of deterioration on limestone wall.

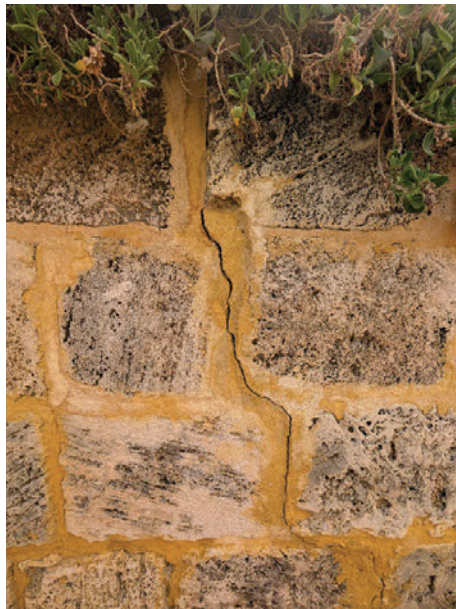
Plate 18: Example 5 of deterioration on limestone wall.

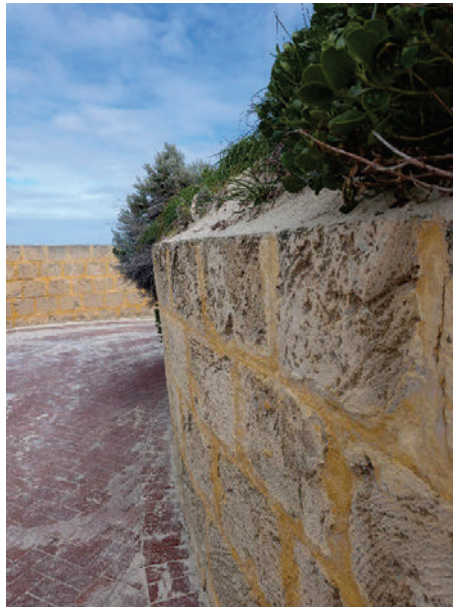
Plate 19: Example 1 of top end of limestone wall beginning to bend from the weight of the sand dunes.

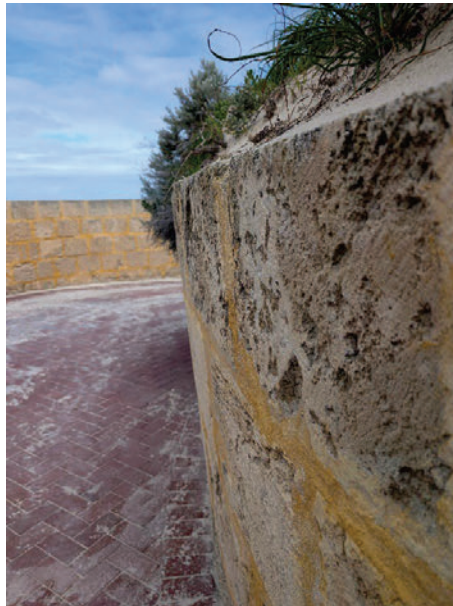
Plate 20: Example 2 of top of limestone wall beginning to bend from the weight of the sand dunes.
