Attachment 1: Ground level photographs of the conductor alignment and the vegetation located above the conductors.

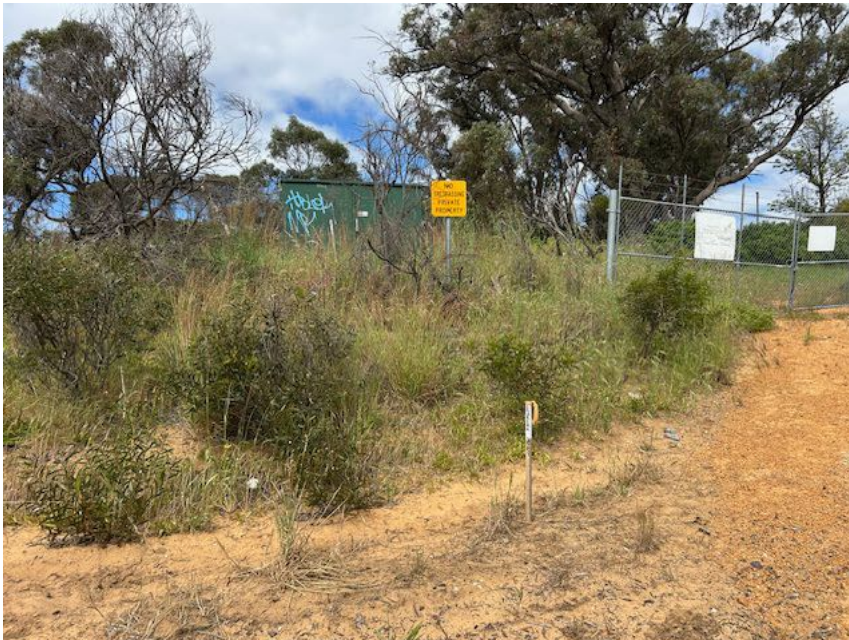
Plate 1. The vegetation at the northern end of the conductor route, looking east, with the wooden peg showing the edge of the drilling alignment, which continues to the left and right directions within this frame of view.

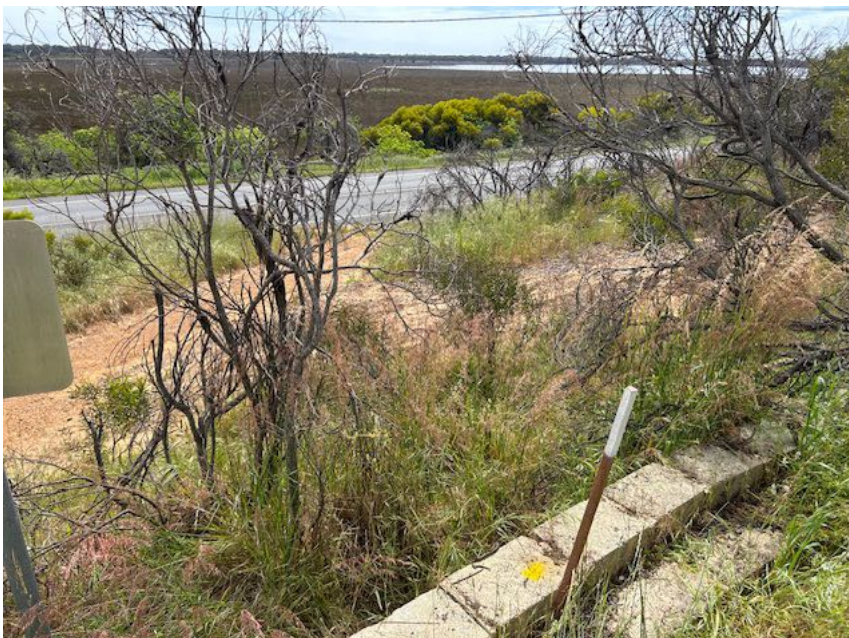
Plate 2. A view to the north-west looking over the conductor alignment as shown by the peg.

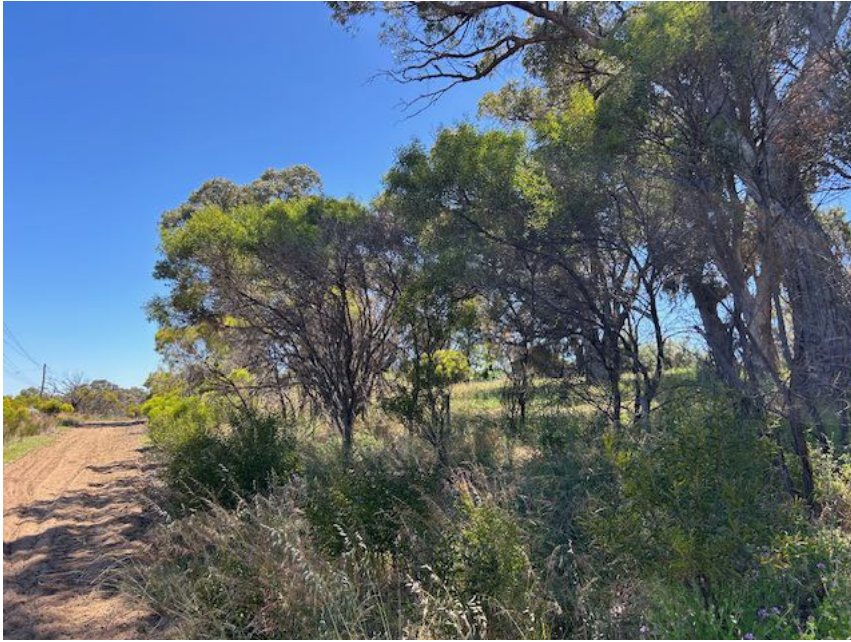
Plate 3. A view looking north over a central portion of the conductor alignment, showing some *Acacia saligna* shrubs growing in amongst weeds and grasses. In the north of the work area, the conductors will be located beneath the gravel track.

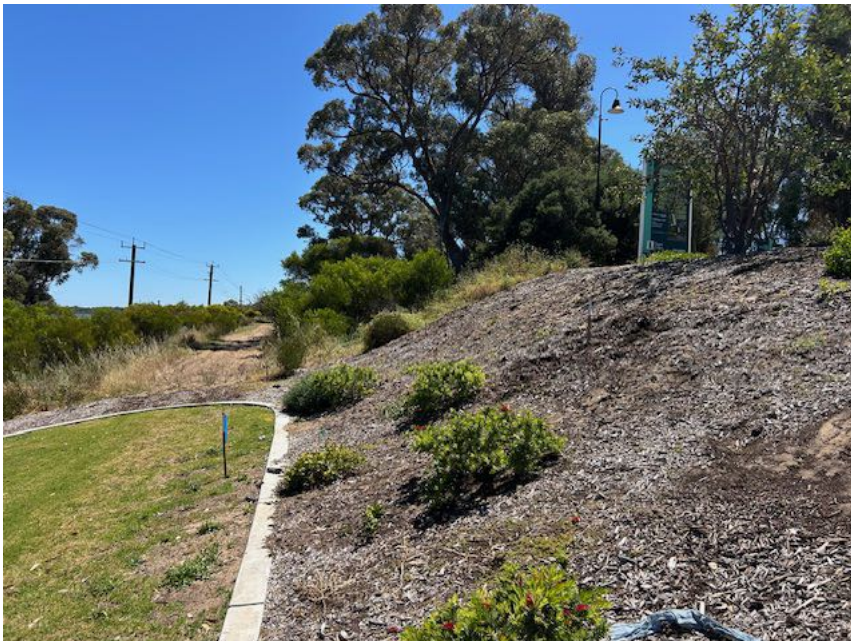
Plate 4. A view to the north, with the wooden pegs showing the corridor where the conductor will be established at 750mm below ground beneath the Tuart Lakes Lifestyle Village entry statement landscaping.

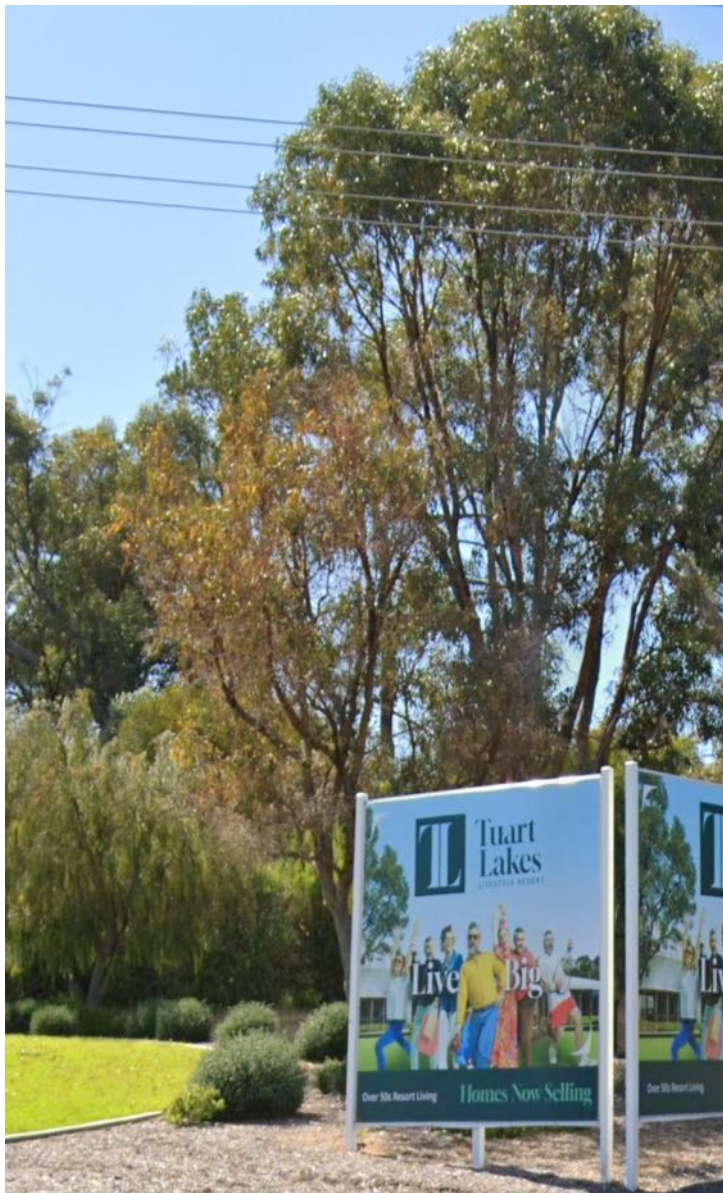
Plate 5. The single tuart tree located along the edge of the conductor corridor is located behind this screen on the left. The larger tree to the right of this is not within the work area. It is a young mature tree with no hollows. The conductor will pass close to or through the root zone of this tree, but at a depth (750mm) which indicates there will be little or no interference to the root system of the tree – which research indicates will be focussed in the shallow surface soils.

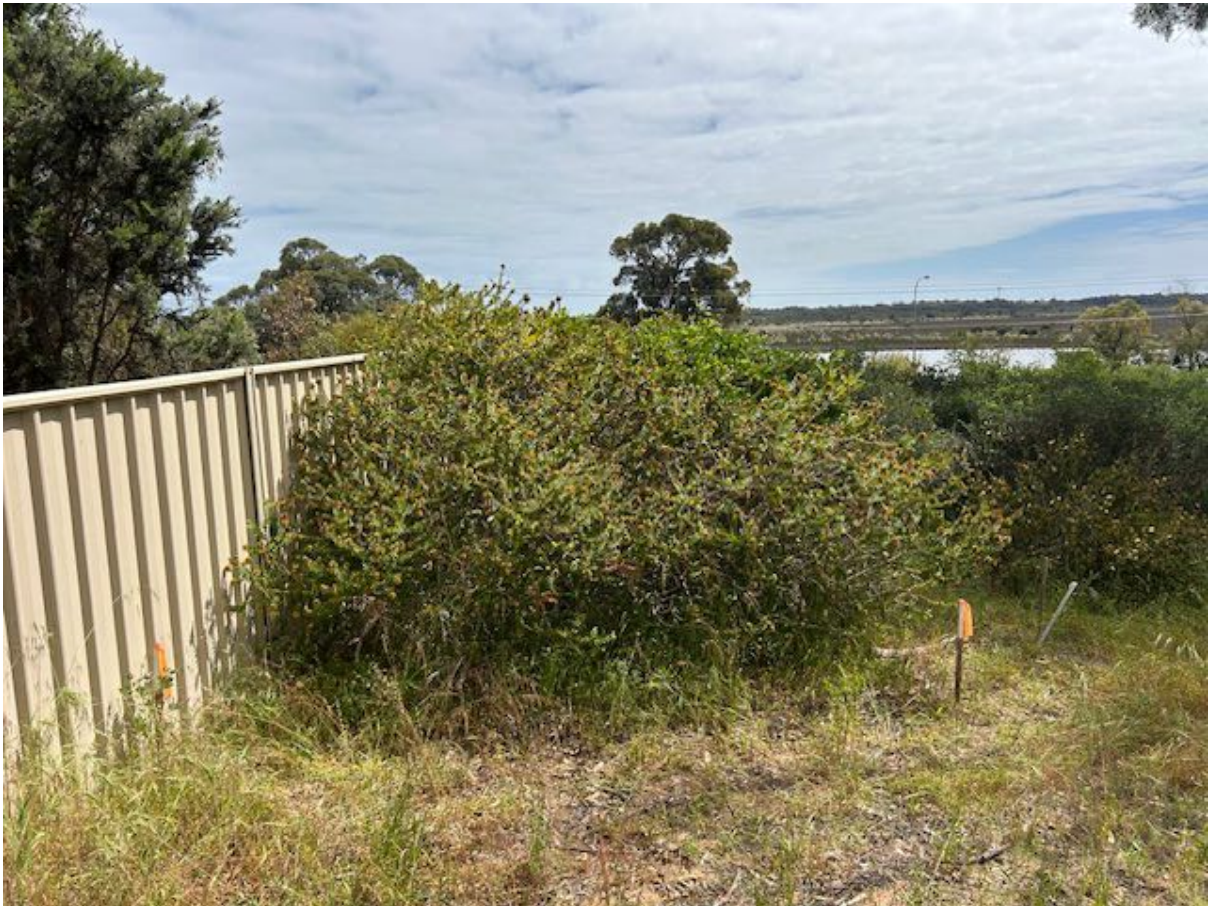
Plate 6. A view at the southern boundary of Lot 1 looking east, and showing planted landscaping with species being non-endemic flora. The drilling will pass under this shrub beneath the wooden peg with the red tape attached, at a depth of 750mm below ground level.
