## **Henty Road, Burekup WA**

### **Road Improvements between 0.04 - 11.61 Sk.**

## **Road Safety Audit**

### **Stage 3 - Detailed Design**

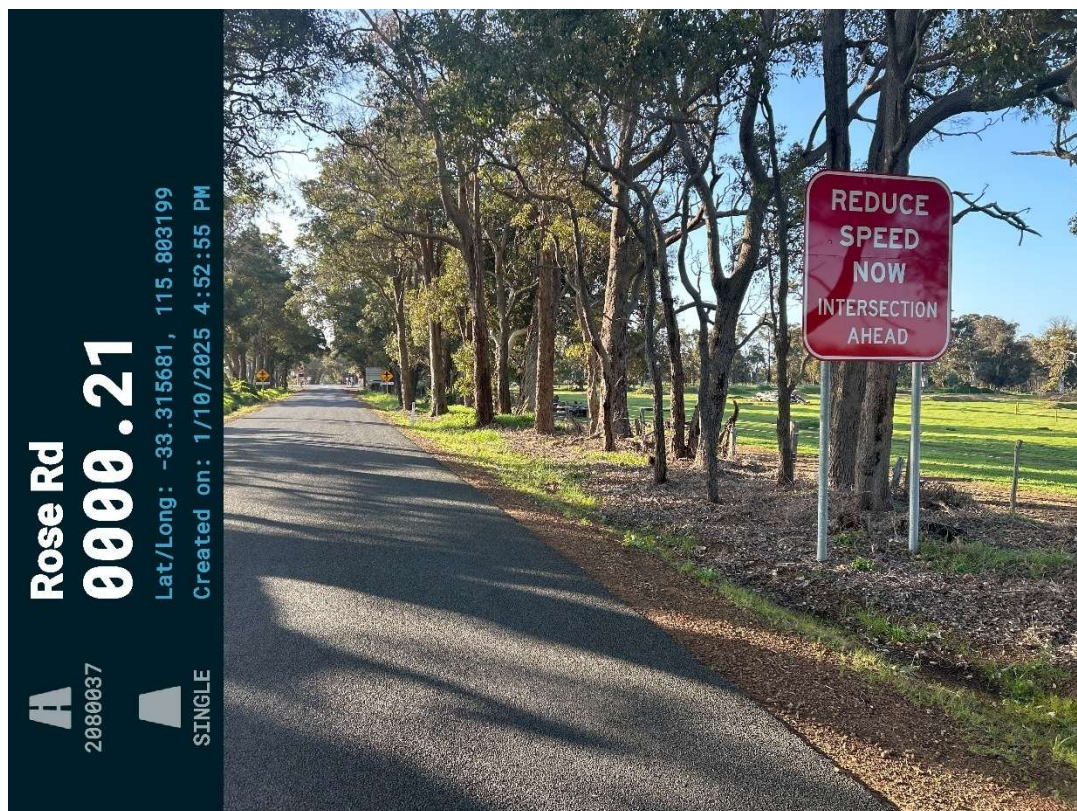
The advance signage “Reduce Speed Now – Intersection Ahead” would indicate that road users have previously approached the railway crossing and intersection too fast, resulting in signage being placed as a mitigation.

Photo 1 – Advance warning signage installed at the approach to the intersection.

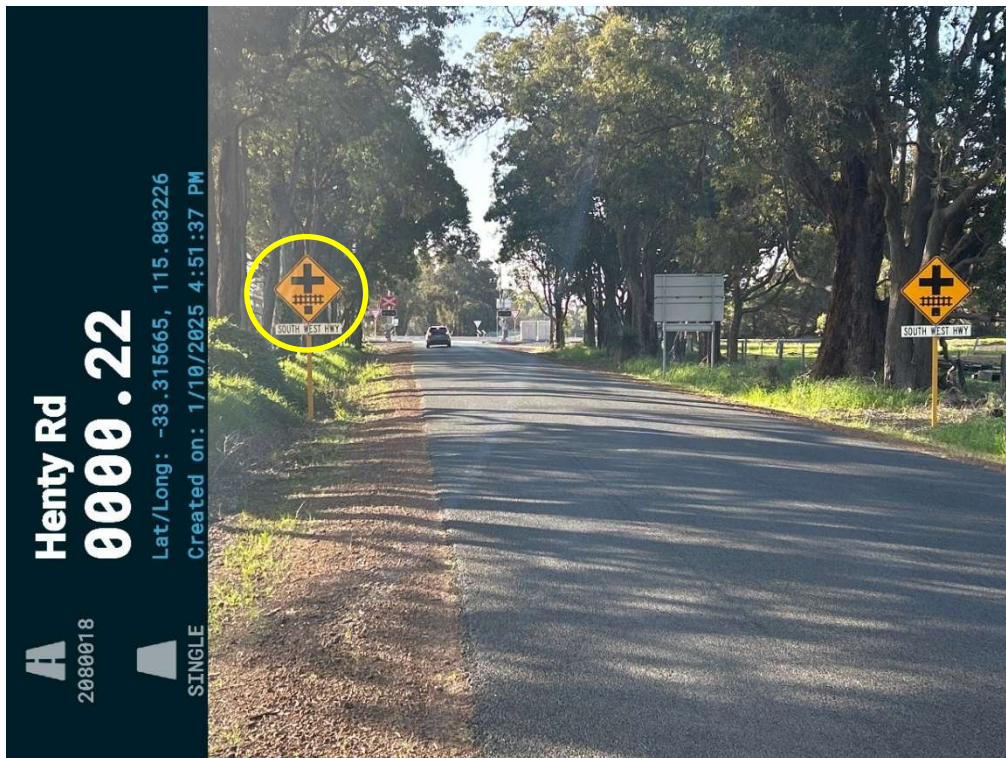
Advance warning signage has also been installed for the rail crossing. Side Road signs have been used which are not technically correct, but do provide the road user a clear guide of the crossing and crossroad ahead. Crossroad signs are not to be used on the approach to a Give way or Stop sign (AS 1742.2).

**Photo 2 – Advance warning signage using Side Road signage installed at the approach to the railway crossing and intersection.**

Width markers could be installed to alert road users of the narrow road pavement at the railway crossing. It was also noted at the site inspection, that the road pavement has undulations at the culvert crossing close to the railway crossing. This could result in loads on vehicles moving, making the vehicle unstable.

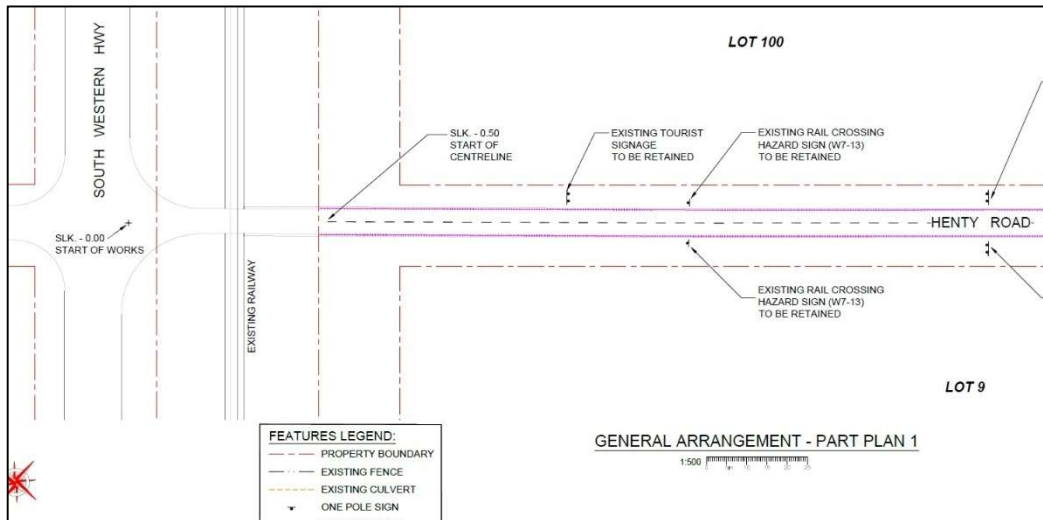
The centre line marking on the approach to the railway crossing is shown as a broken line. The AS 1742.7 suggests that the centre line should be solid on approach from the first warning sign, approximately 0.29 SLK.

Figure 7 - Part of the design drawing.

The design drawings do not show the horizontal alignment of the road, so determining where barrier line marking should start and stop is challenging. Prior to the centre line marking being installed, the start and stop points of barrier line marking should be confirmed.

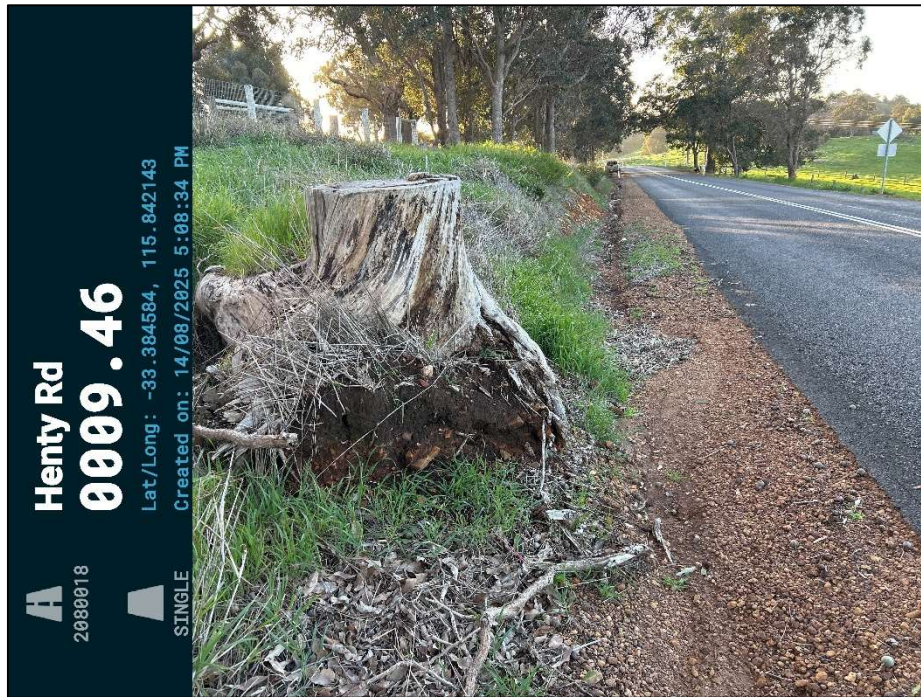
**Finding 2.2 – The large tree stump is close to the traffic lane and should be removed.**

The closest trees should be removed and hazards that cannot be removed should be delineated.

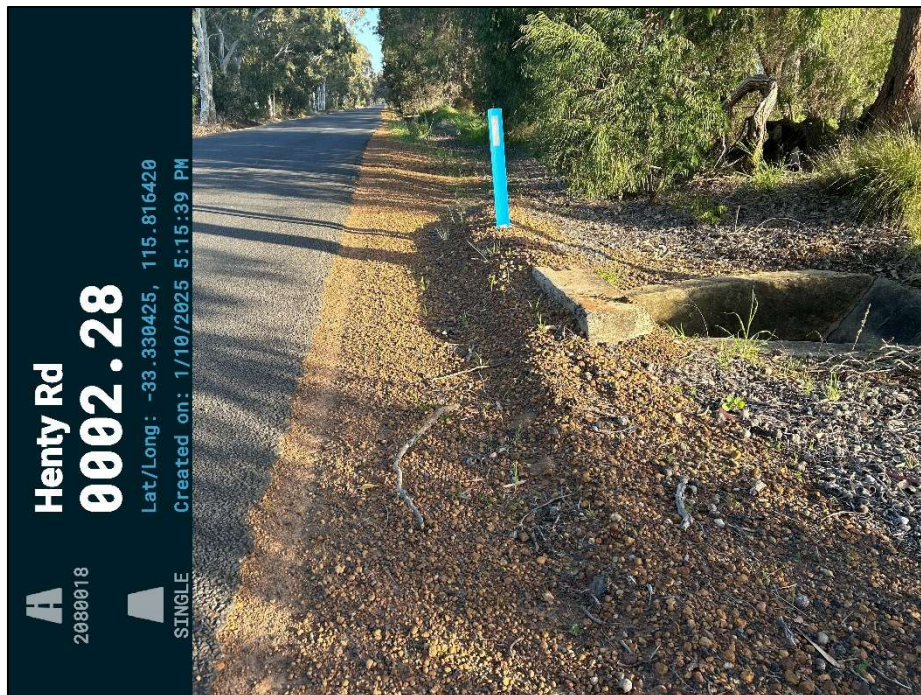
**Finding 2.2 – The culvert headwall will be close to the traffic lane and should be delineated if not relocated.**

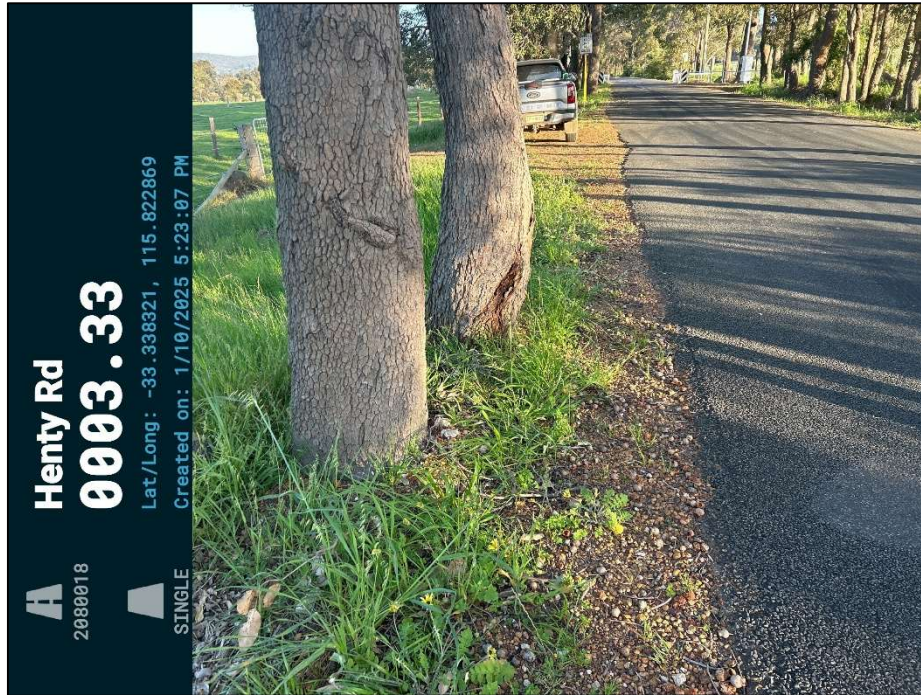
Finding 2.2 – The large trees are close to the traffic lane and should be removed.

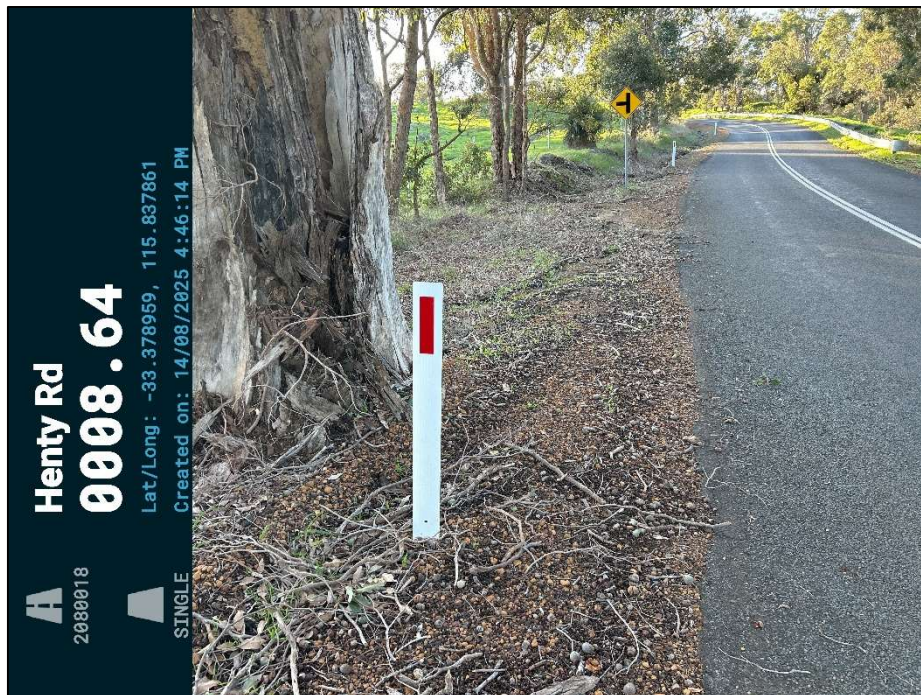
Finding 2.2 – The large tree stump is close to the traffic lane and should be removed.

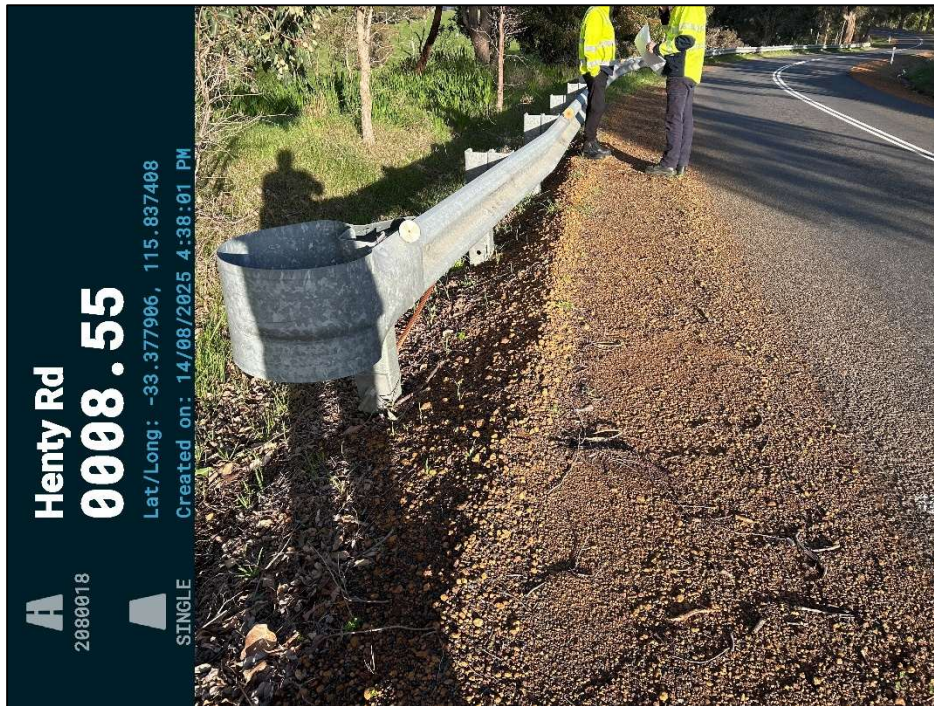
**Finding 2.2 – The existing W Beam road safety barrier is not compliant to current standards (particularly the end treatments), however with new delineation provides a suitable treatment. If the barrier was damaged, then a new barrier to the current standard should be installed.**

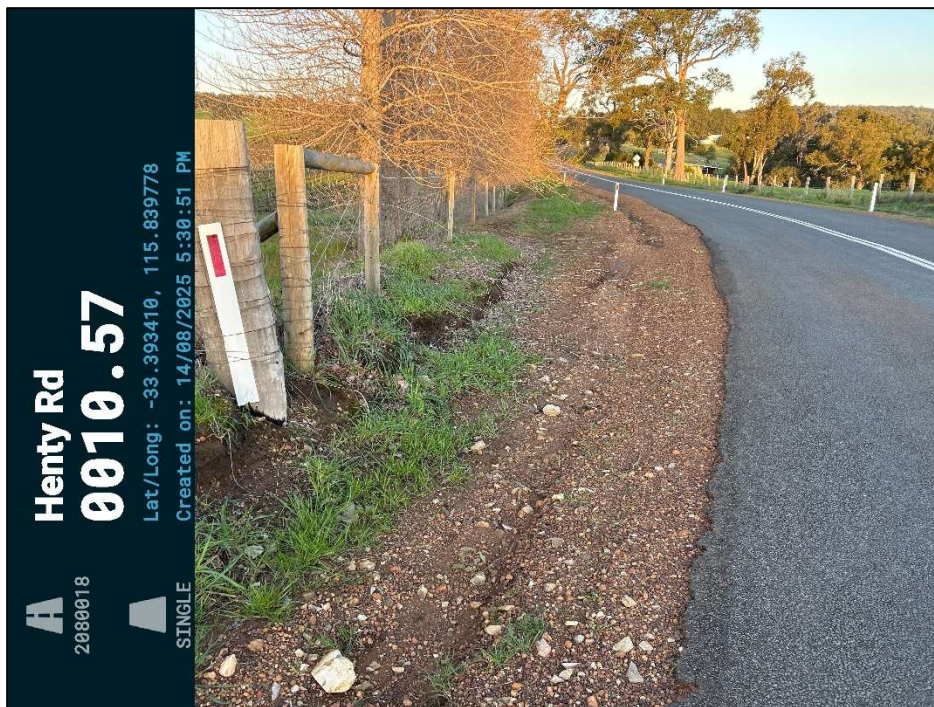
Numerous guide posts were missing, damaged or bent over. Guide posts assist the road user by indicating the alignment of the road ahead. The normal spacing of guide posts is 150 m in pairs, one on each side of the formation. This distance should be reduced when hazards cannot be removed, such as steep batters, steep table drains or non-frangible objects are close to the traffic lane.

**Finding 2.3 – Guide posts should be installed at a consistent distance from the edge of the road and be straight.**

Additional guide posts should be installed where hazards cannot be removed.

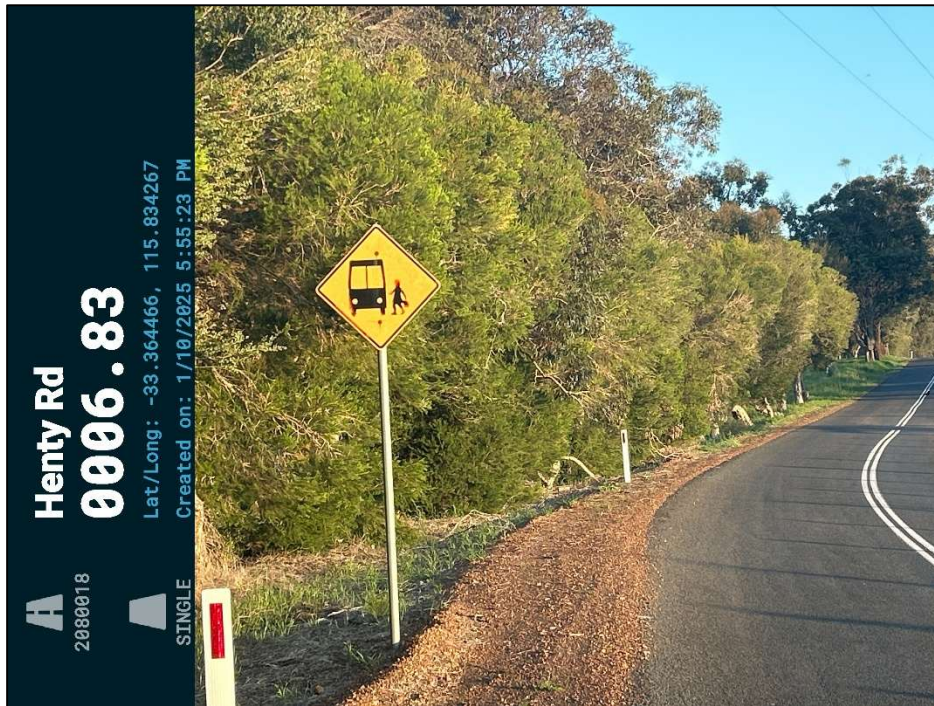
The School Bus sign at 6.83 Slk is not detailed on the drawing, the sign is old and may not need to be replaced.

**Finding 2.3 – The Bus Stop sign is old and may not be warranted. This sign is not detailed on the design drawings.**

The signage should be replaced and corrected.

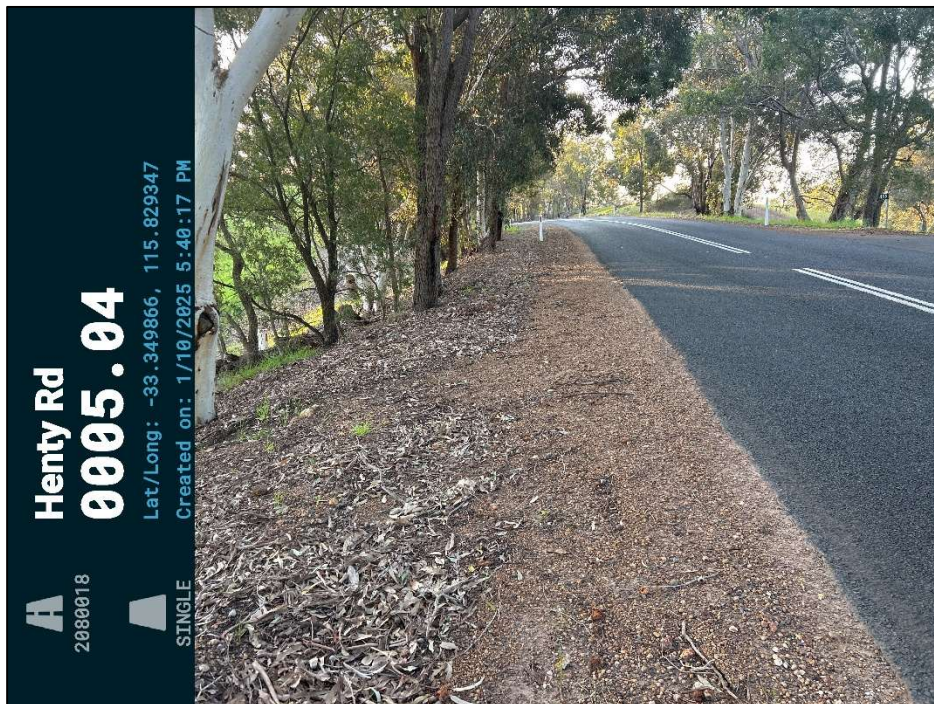
**Finding 2.3 – Where the verge is steep, or objects are close to the traffic lane, additional guide posts should be installed at closer spacing to assist guiding the road user past the hazard.**

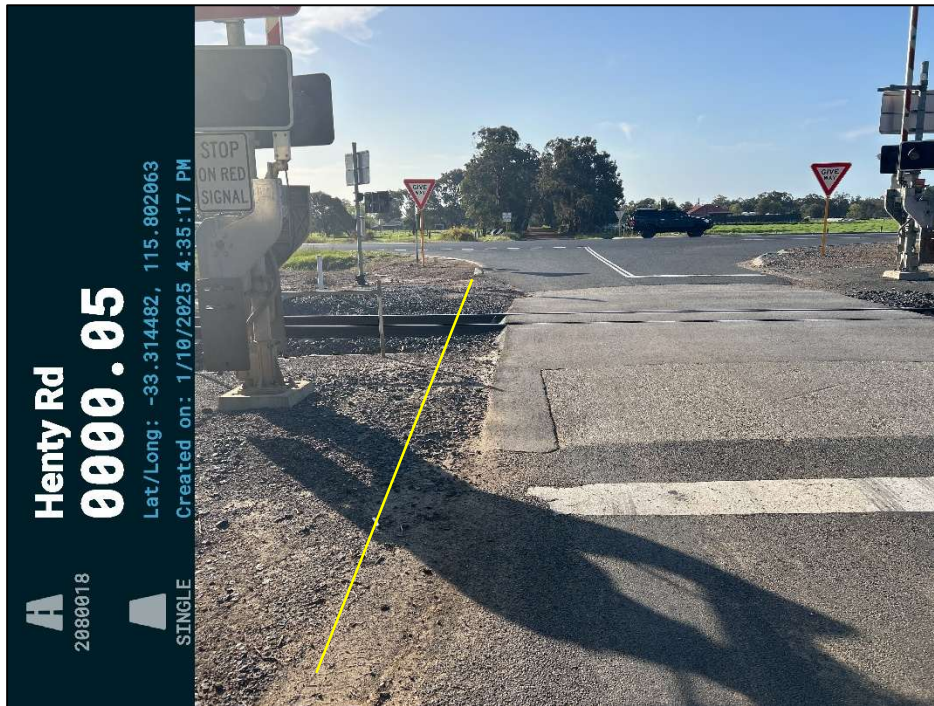
At the site inspection, it was noted that the road pavement narrows at the railway crossing. There is no guidance for road users and tyre marks could be seen crossing the rail where there was no road pavement. Normally width markers would be positioned to guide road users.

The proposed widening of the road seal and traffic lane may increase the risk of road users running off the edge of the road pavement at the railway crossing.

**Finding 2.4 – The railway crossing is narrower than the sealed road pavement. Drivers may not realise the narrow section and drive over the rails.**

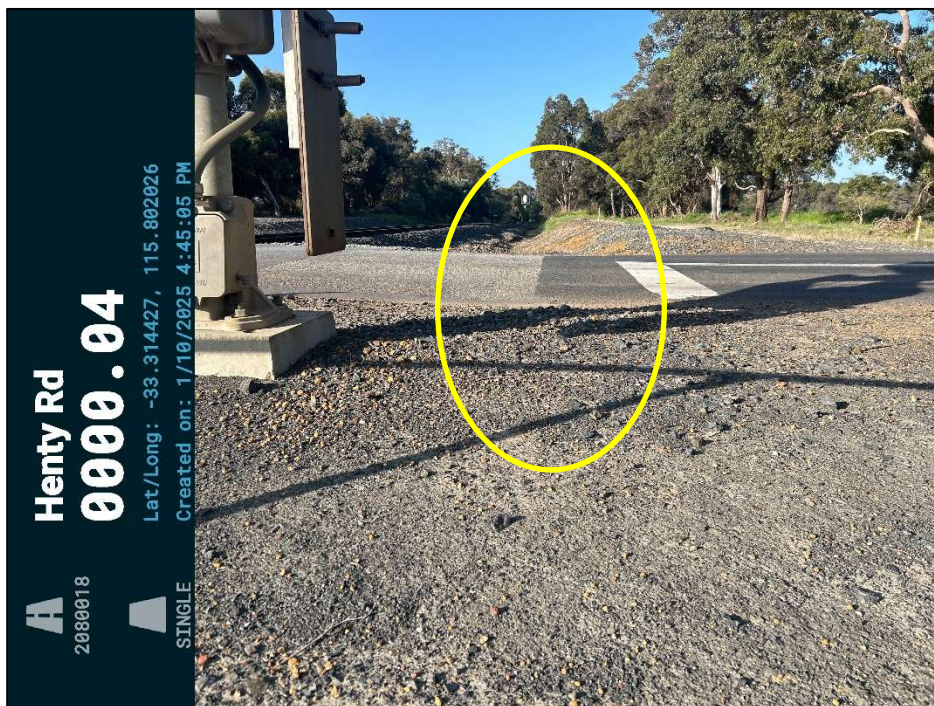
**Finding 2.4 – The railway crossing has a dip where the culvert is located, this should be made smooth.**

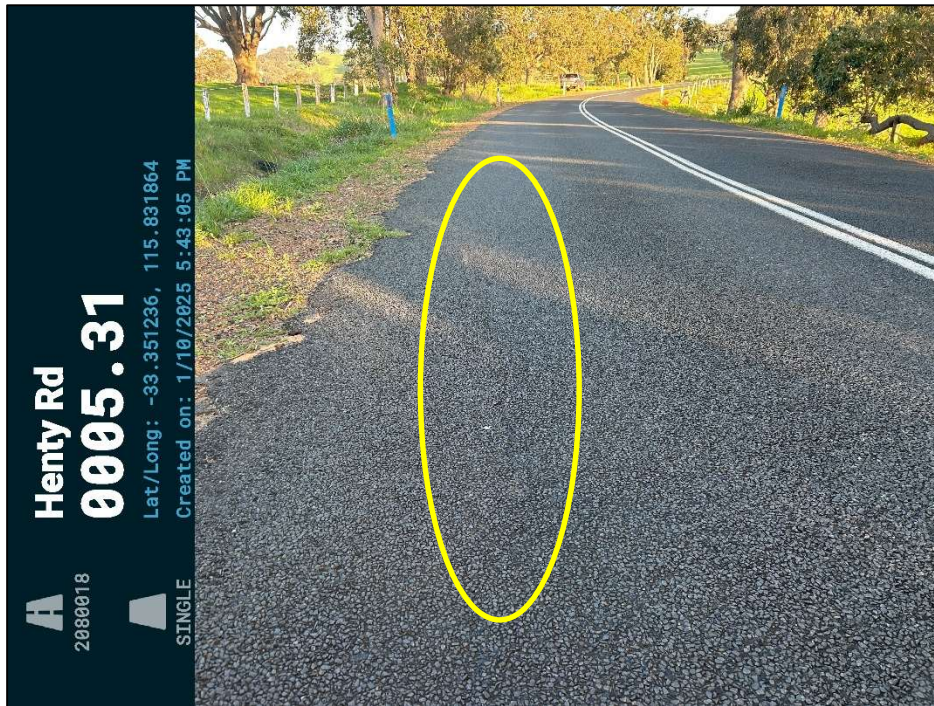
The water crossing the road surface may cause vehicles to aquaplane, resulting in a loss of grip and an off path crash.

**Finding 2.5 – The sealed pavement undulates resulting in stormwater running down the road rather than off the road towards the shoulder. This can result in excessive water on the sealed pavement and vehicles aquaplaning on the sealed surface.**

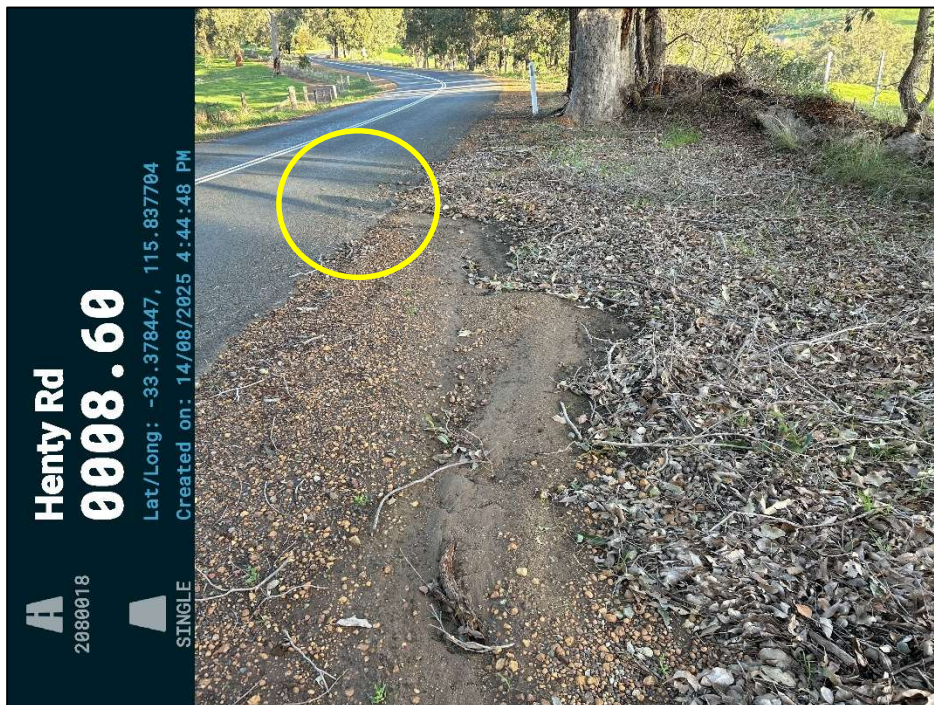
At approximately 8.40 Slk, there is a dead tree stump and a log which has blocked the natural table drain. The stormwater now flows across the road pavement near the curve. This could result in loss of grip between the tyre and the sealed surface in wet conditions, the driver losing control of the vehicle and running off the road.

**Finding 2.5 – The table drain is blocked, causing the water to flow over the road.**

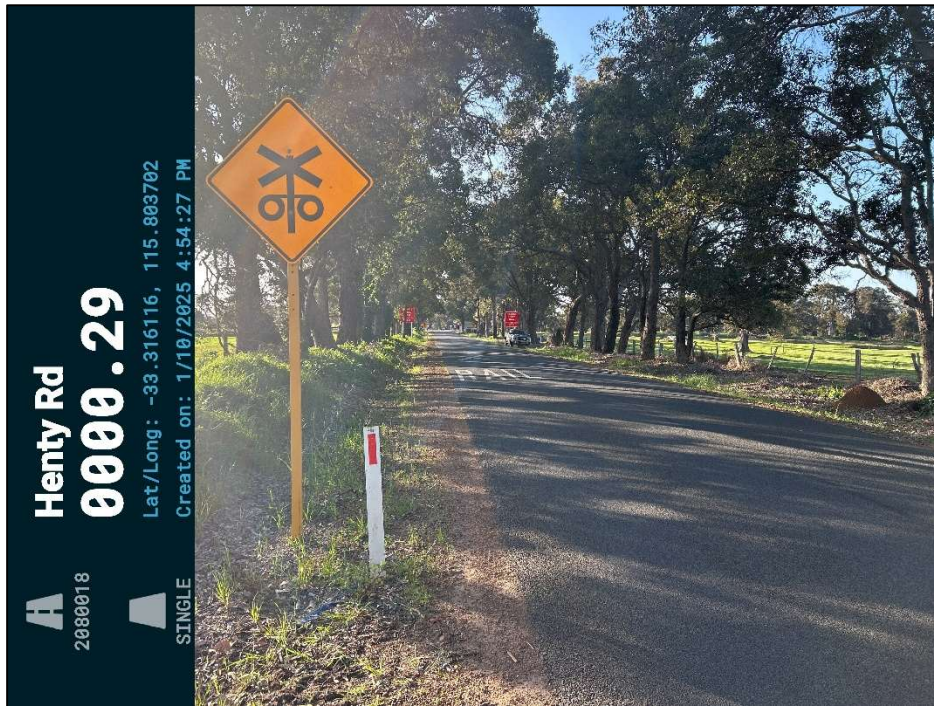
**Finding 2.6 – On approach to the rail crossing, a solid painted centre line should be installed from the first warning sign of the rail crossing. The design drawings show a dashed centre line to be installed, this should be corrected to Main Roads requirements.**

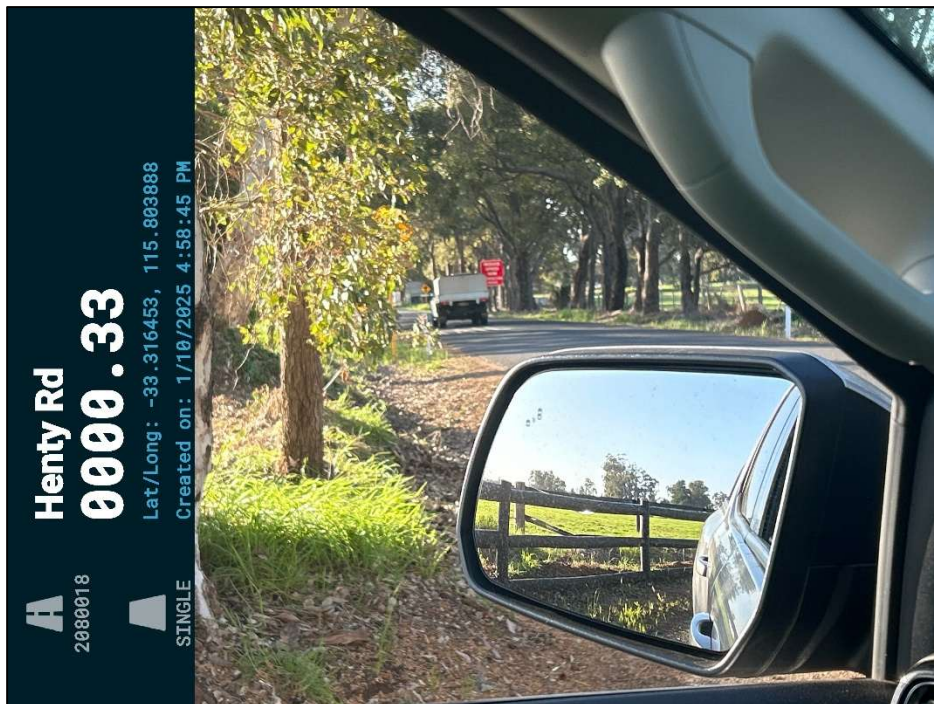
**Finding 2.7 – The access at this location has a restricted sight distance due to the vegetation. The vegetation should be trimmed to provide suitable sight distance.**

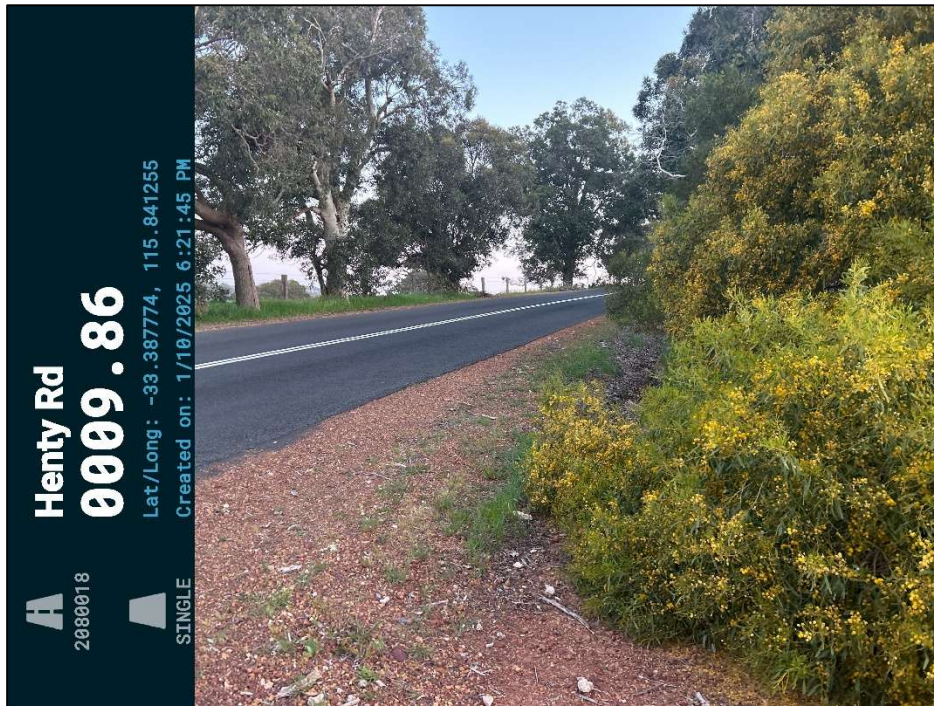
**Finding 2.7 – The access at this location has a restricted sight distance due to the vegetation. The vegetation should be trimmed to provide suitable sight distance.**

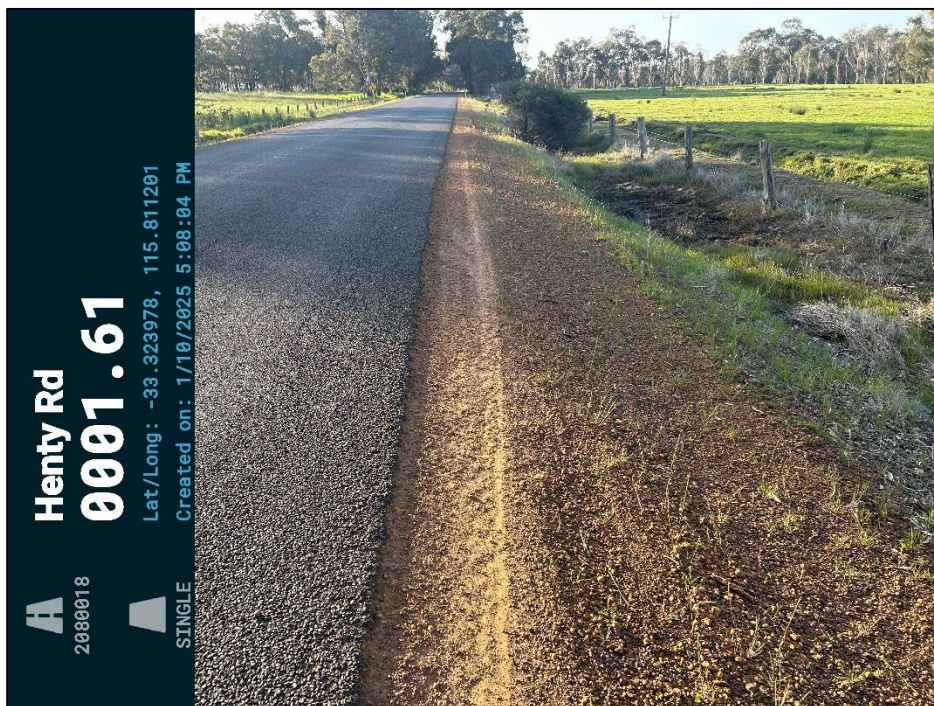
**Finding 2.8 – High vehicles are veering away from overhanging branches resulting in them travelling on the existing gravel shoulder. The design will provide additional sealed pavement, but the removal of the overhanging branches would allow drivers to remain lane correct.**

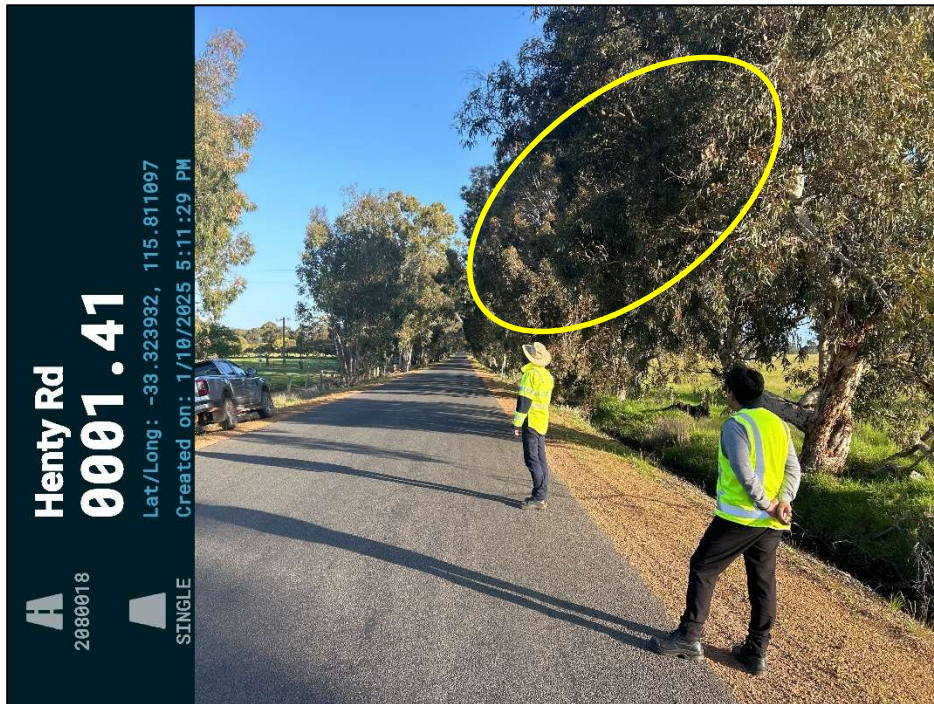
**Finding 2.8 – High vehicles are veering away from overhanging branches highlighted on the photo, results in them travelling on the existing gravel shoulder.**

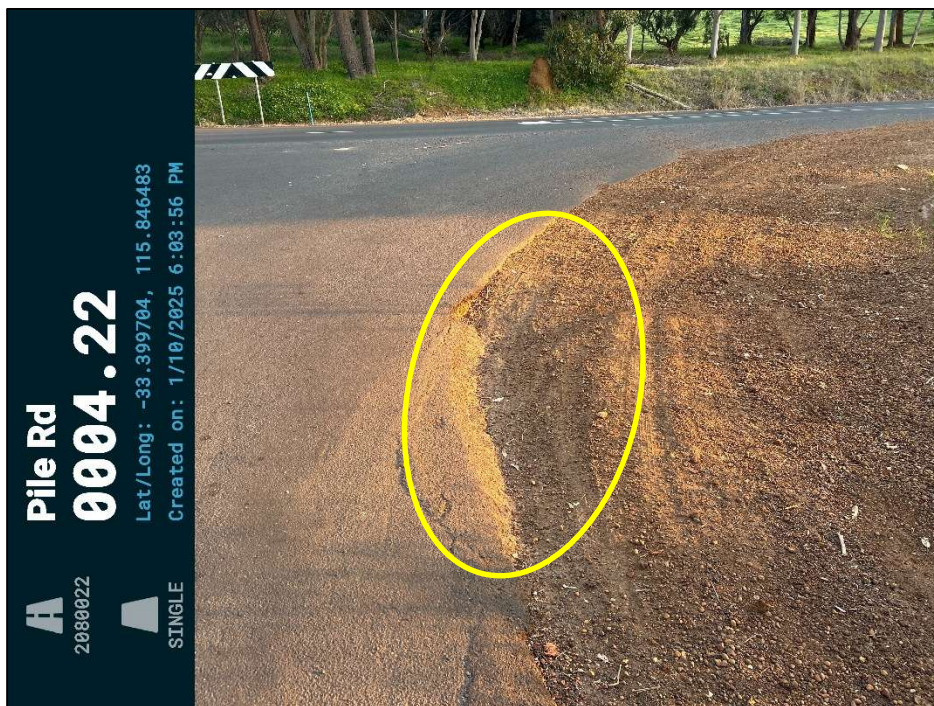
**Finding 2.9 – A section of the existing shoulder has deteriorated due to vehicles cutting the corner. The swept path for the design vehicle should be confirmed and widened if required. If vehicles are using the gravel shoulder to travel faster through the curve, then kerbing should be considered to keep the vehicles on the correct alignment. Note, drivers may be travelling too fast from Pile Road into Henty Road due to other vehicles following them and the lack of a deacceleration lane on Pile Road.**
