Friday 30th September 2022

Arboricultural Assessment – Reserve 48279 Old Broadwater Farm

Prepared for: The City of Busselton

Prepared by: Brett Moir

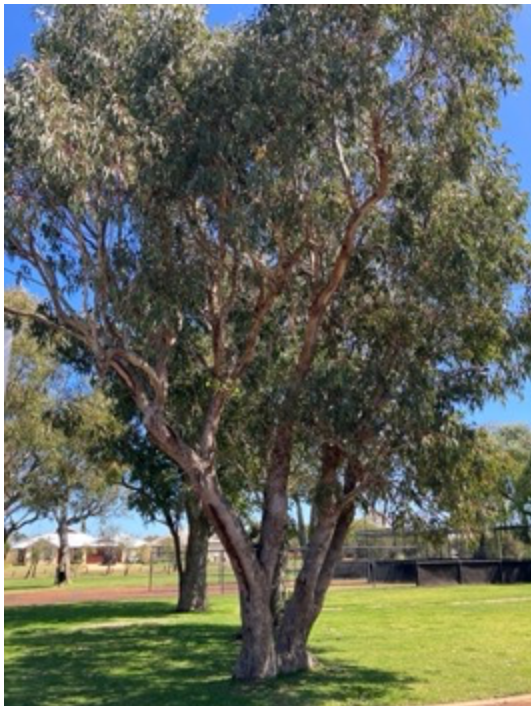
The subject tree is identified as a *Eucalyptus rudis* (Flooded Gum) – a species endemic to Western Australia. The tree has an approximate height of 10m and a trunk diameter at 1.4m above ground (dbh) of 0.8m (2 x 400mm stems).

Figure 2: Looking west at the subject tree from the adjacent Basketball Court

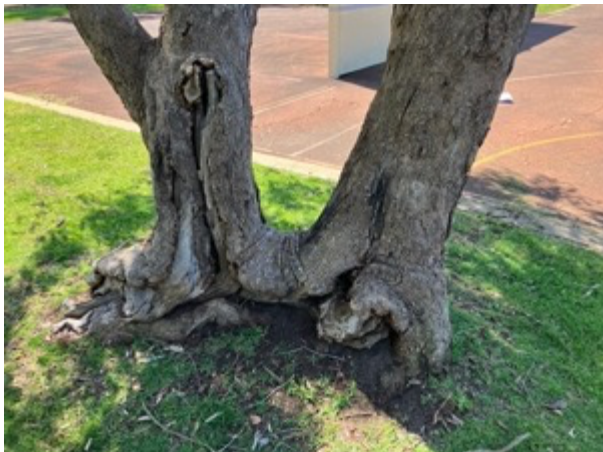
This tree has quite unusual form from ground level which may be a result of it being an old coppice stump or having root heaved in the past and a new crown having emerged from the fallen trunk. There is quite significant decay within the root buttress and lower trunk but given the relatively small crown area and good reactive growth, there appears to be adequate sound wood for structural support.

Figure 3: The unusual form of the base of the tree

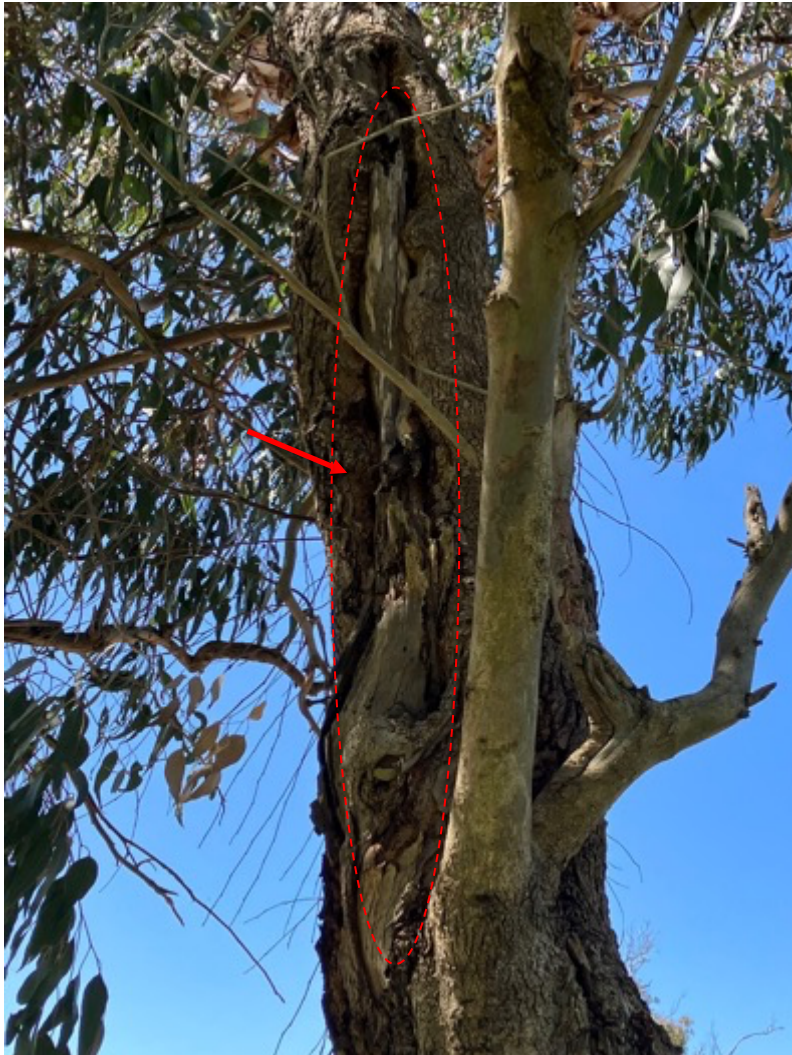
The tree is twin stemmed from ground level and has quite poor structural form with decay in the trunk and scaffold branches. There is also a fair amount of dead wood present throughout the crown.

Figure 4: Decay within one of the main stems

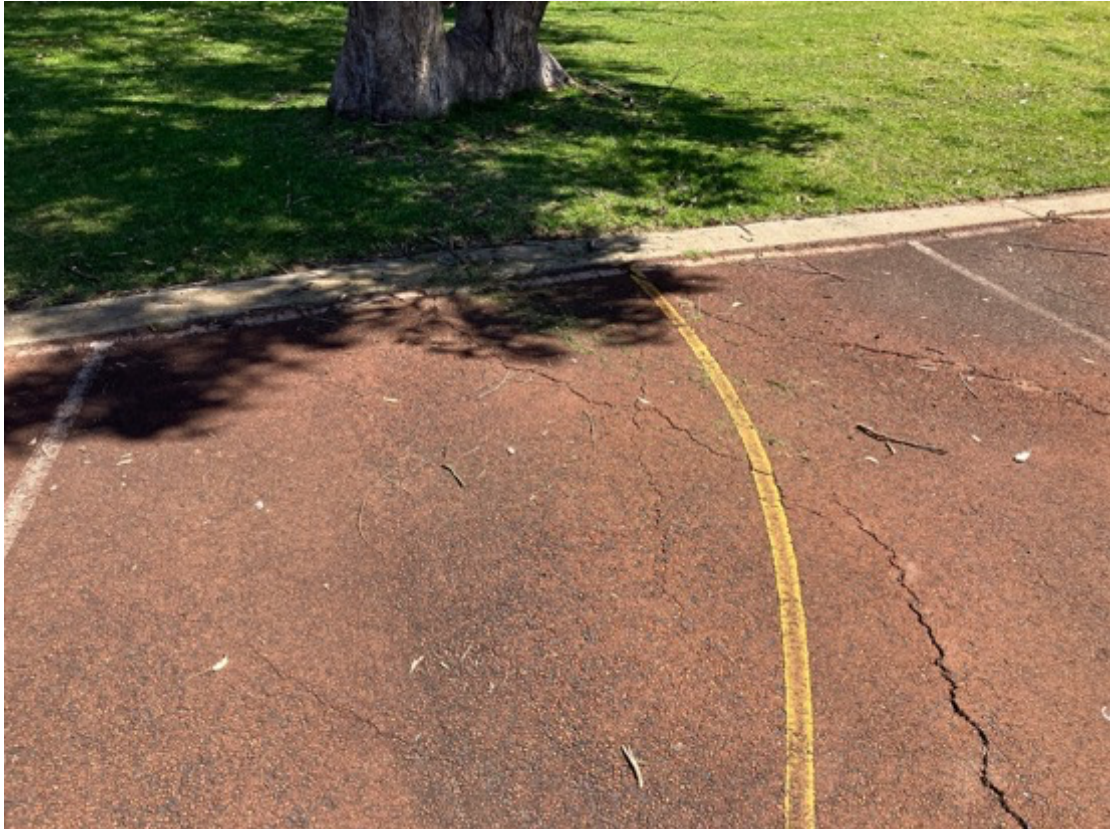
This tree is located 1.2m from the edge of the asphalt Basketball Court. There is significant mounding and cracking of the surface of the court.

Figure 5: Mounding and cracking of the Basketball Court surface.

The location of this tree in close proximity to the Basketball Court and the observed damage to the court surface presents a conflict with regard to the safety of users of the facility.

With the closest point of the basketball court being 1.2m from the tree, the grinding of the offending roots is not feasible as it would mean the removal of structural roots required for the trees stability. Similarly, the installation of a root barrier is not feasible for the same reason – it would require the severance of roots within the SRZ.

Given that these structural roots need to be removed in order to repair the damage to the court surface, the subject tree will need to be removed completely in order not to leave it in a structurally compromised state.
