Attachment 5: Photos of Mullaloo revegetation offset site for proposed amendment to Clearing Permit CPS 10219/1

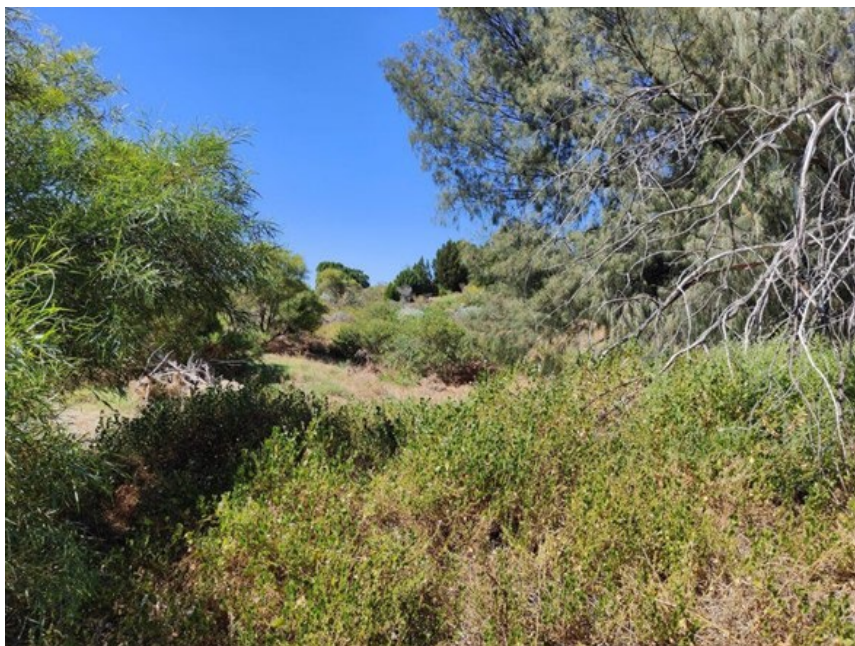
Coordinates: S31°47.274, 1E15°44.135

Plate 1: Mullaloo Foreshore Reserve revegetation site classified as degraded condition in 2021. Site was noted to contain evidence of rabbits. Photograph taken from the northern extent along fence line.

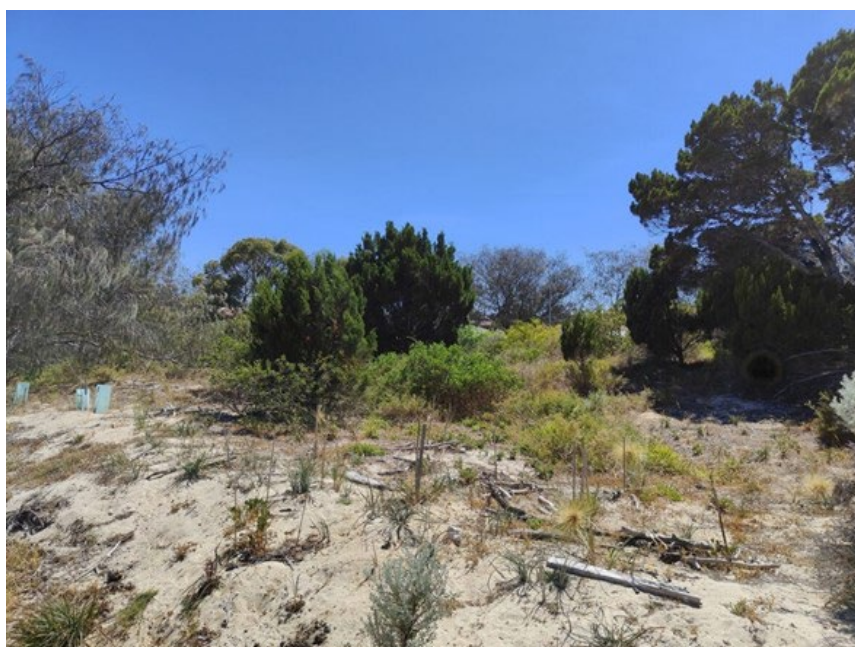
Coordinates: S31°47.309, E115°44.119

Plate 2: Mullaloo Foreshore Reserve revegetation site classified as degraded condition in 2021. Site was noted to contain evidence of rabbits. Photograph taken from the southern extent along western fence line.

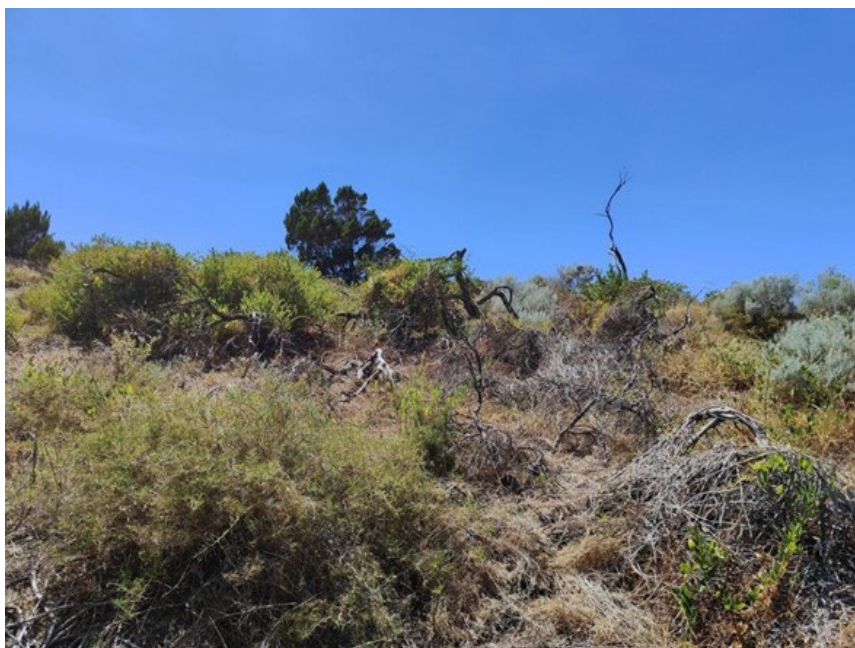
Coordinates: S31°47.319, S115°44.116

Plate 3: Mullaloo Foreshore Reserve revegetation reference site coastal shrubland vegetation community classified as good condition in 2021. Photograph taken from along the western fence line.

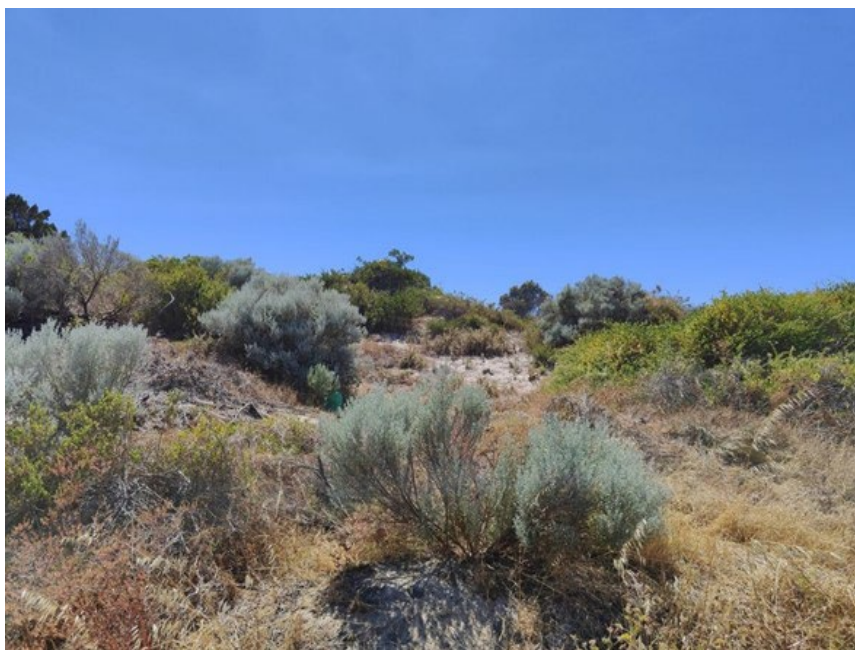
Coordinates: S31°47.333, E115°44.113

Plate 4: Mullaloo Foreshore Reserve revegetation reference site coastal shrubland vegetation community classified as good condition in 2021. Photograph taken from along the western fence line.

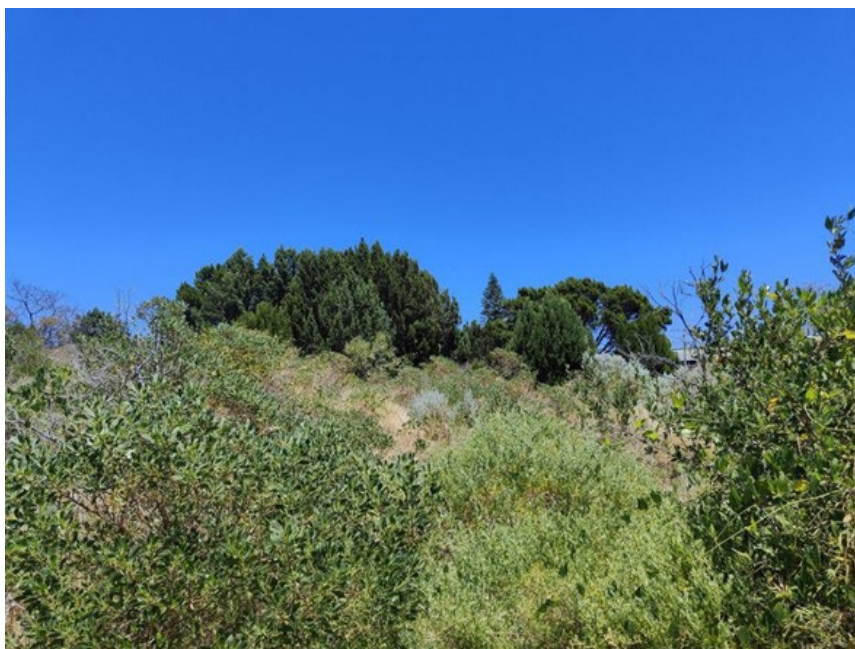
Coordinates: S31°47.310, E115°44.149

Plate 5: Mullaloo Foreshore Reserve revegetation reference site coastal shrubland vegetation community classified as very good condition in 2021. Photograph taken from along the eastern fence line.

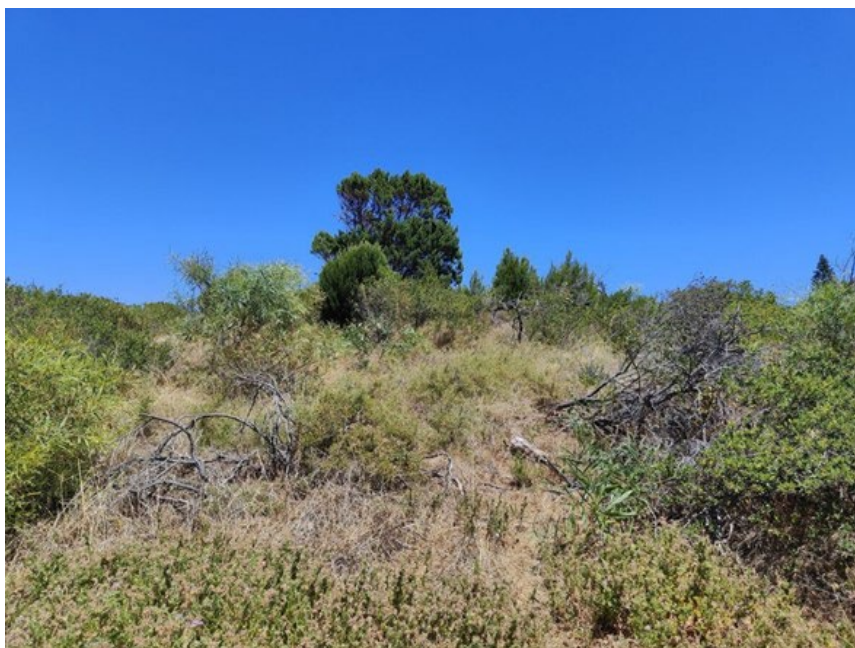
Coordinates: S31°47.342, E115°44.159

Plate 6: Mullaloo Foreshore Reserve revegetation reference site coastal shrubland vegetation community classified as very good condition in 2021. Photograph taken from along the eastern fence line.
