Black Cockatoo Habitat Tree Review

Donnington's Quarry Great Northern Highway Chittering

January 2024

Version 2

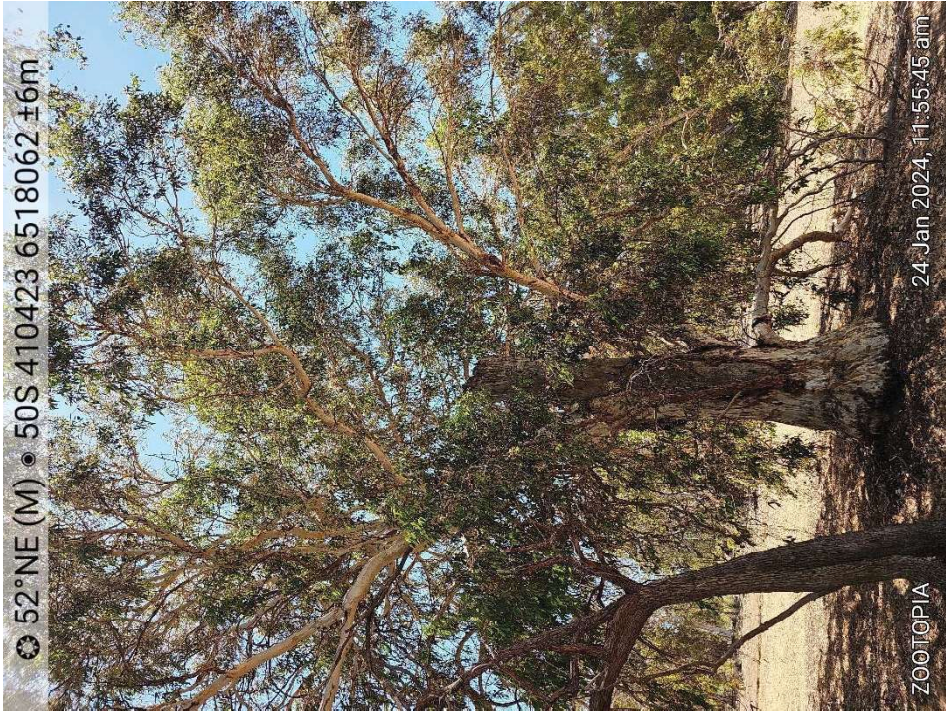
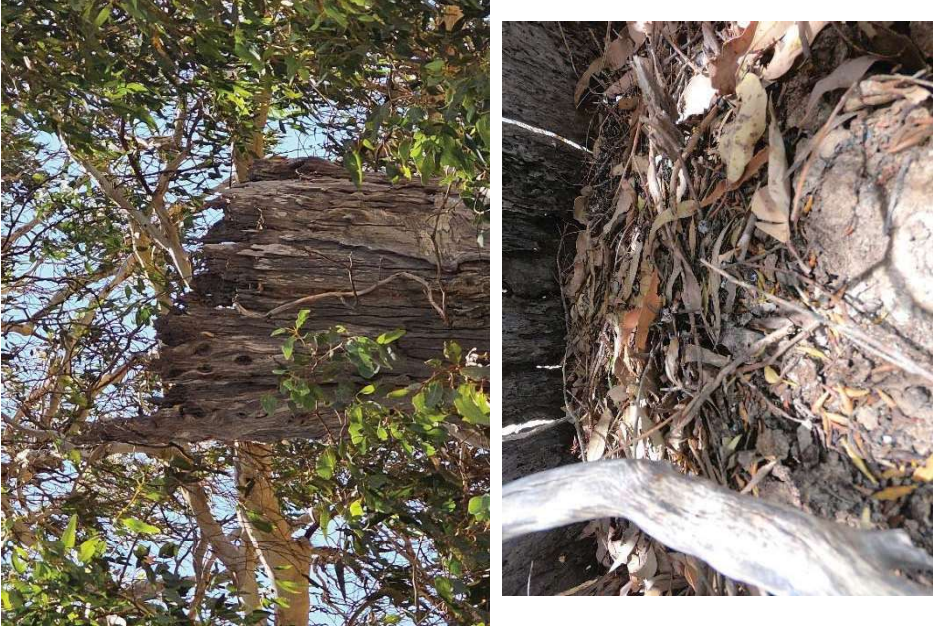
ID	Coordinates (MGA 94/Z50)	410432 mE	6518065 mN	Tree Species	Wandoo	Survey Date	24/01/2024
B018	Comments	Wandoo with a potential large chimney style hollow. When examined with a pole mounted camera the hollow was found to be very shallow (base visible a few centimetres from rim of hollow – picture below right). This hollow would not be suitable for black cockatoos to use for nesting purposes. No signs of use by any fauna.				Classification	Unsuitable Hollow

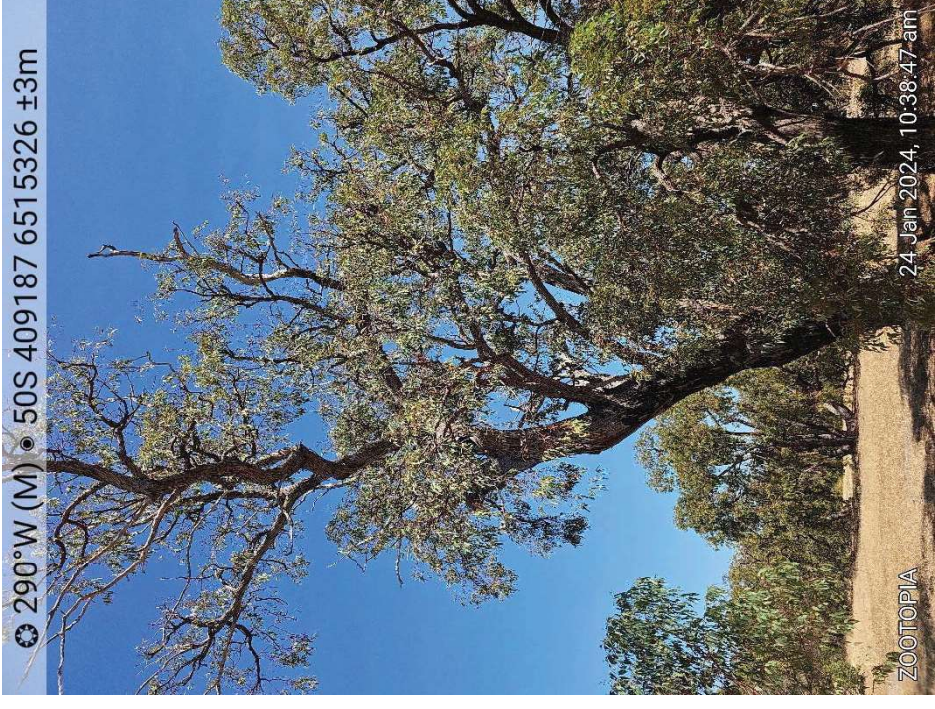
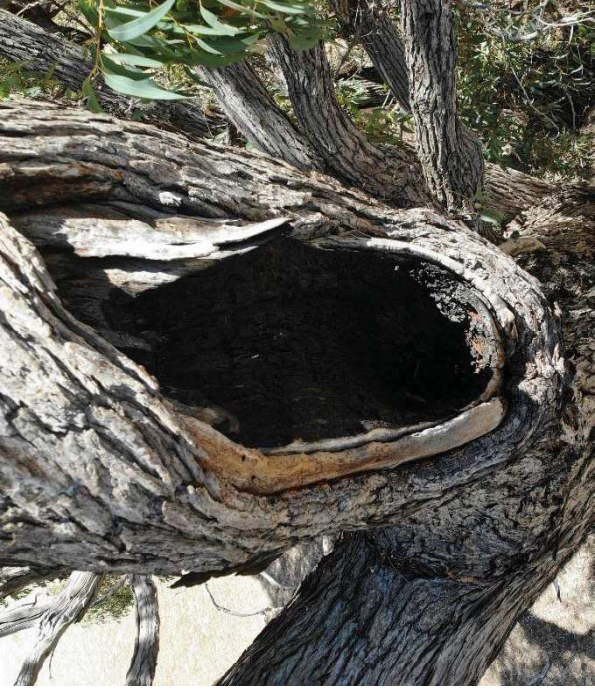
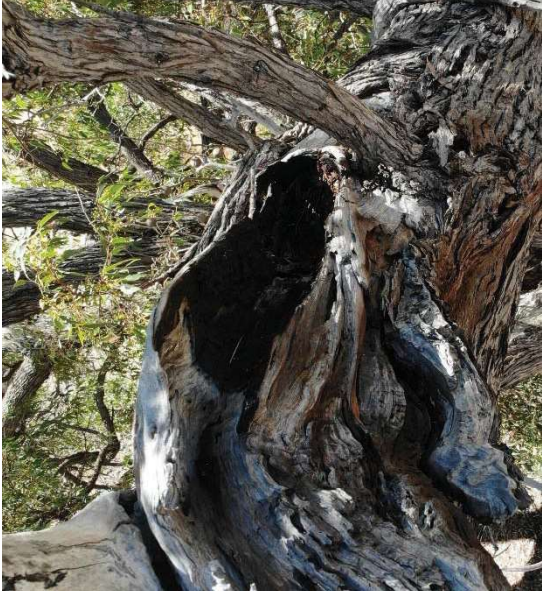
ID	Coordinates (MGA 94/Z50)	409178 mE	6515334 mN	Tree Species	Jarrah	Survey Date	24/01/2024	
D046	Comments	Jarrah with a potential large side entry hollow (centre picture) and spout (right picture). When examined with drone both hollows were found to have little depth (base visible in both cases). These hollows would be unsuitable for black cockatoos to use for nesting purposes. No signs of use by any fauna.						Unsuitable Hollows.

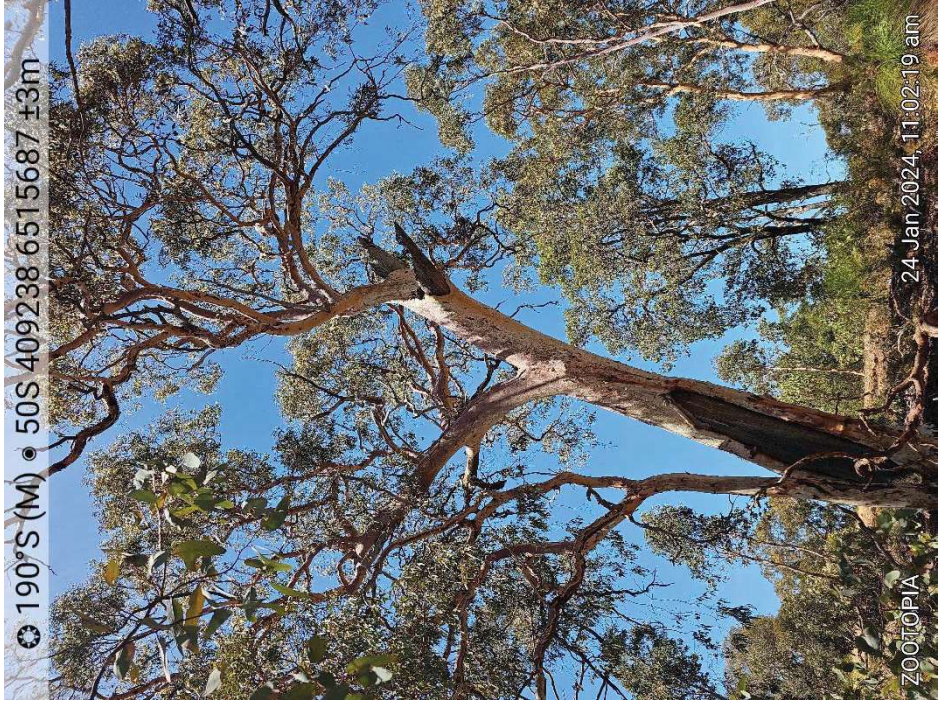
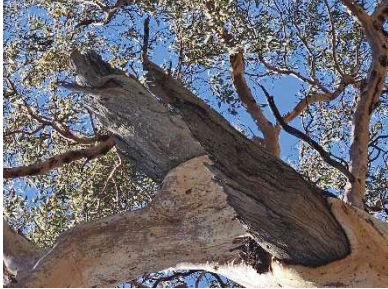
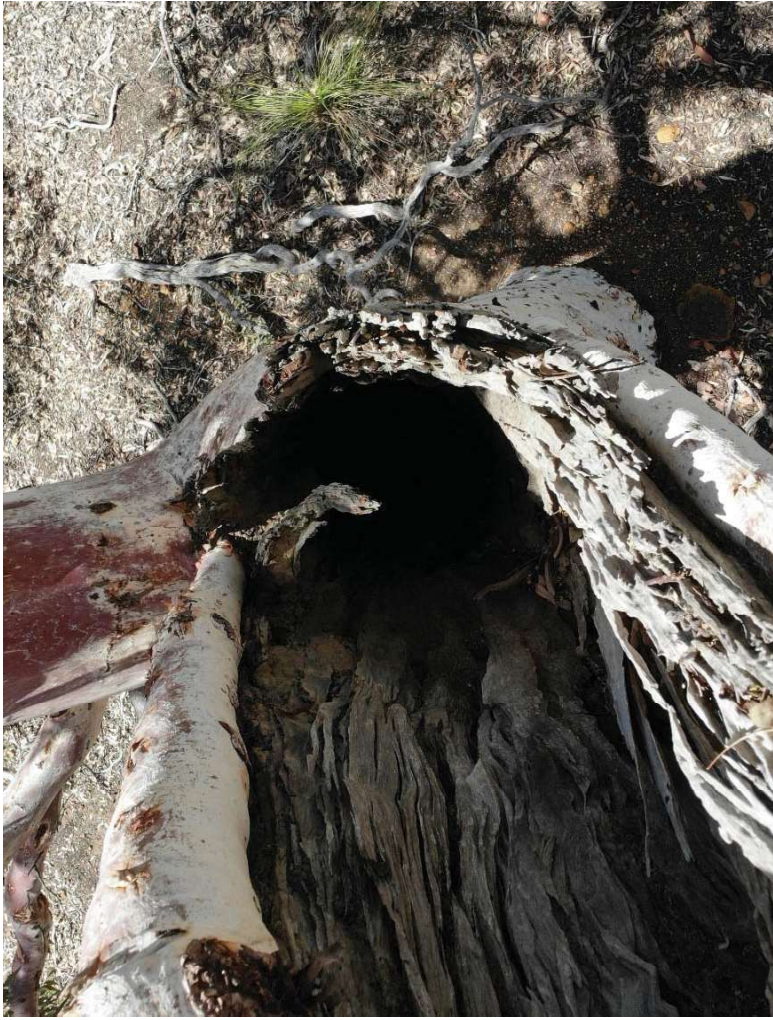
Tree D108 contains a large chimney style hollow that was found to have considerable depth and large internal dimensions. The hollow rim also has some minor chipping (chew marks) possibly caused by black cockatoos. This evidence suggests this hollow maybe suitable for black cockatoos to use for nesting purposes.

ID	Coordinates (MGA 94/Z50)	409241 mE	6515677 mN	Tree Species	Wandoo	Survey Date	24/01/2024	
D108	Comments	Wandoo with one large chimney type hollow and semi horizontal spout. When examined with a drone the chimney type hollow was found to have considerable depth (base not visible) and large internal dimensions. The hollow rim also has some minor chipping (chew marks) possibly caused by black cockatoos. Evidence observed suggest this hollow may be suitable for black cockatoos to use for nesting purposes. Semi horizontal spout was found to pass through to other side of tree and therefore unsuitable .						Classification Chewed Hollow.

If these two trees cannot be avoided, it is recommended they be reinspected for occupancy immediately prior to clearing.

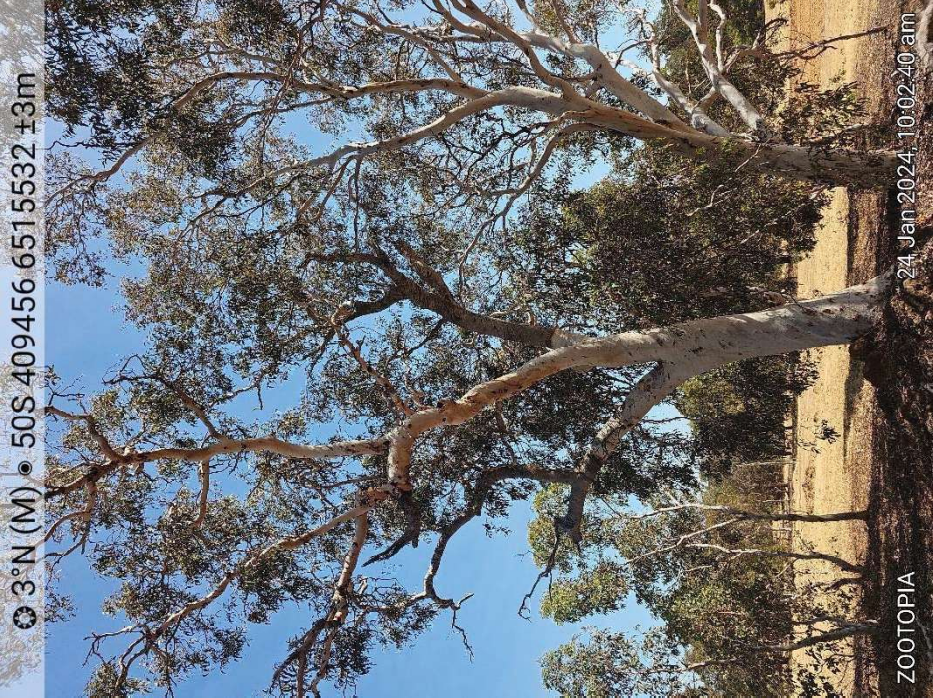
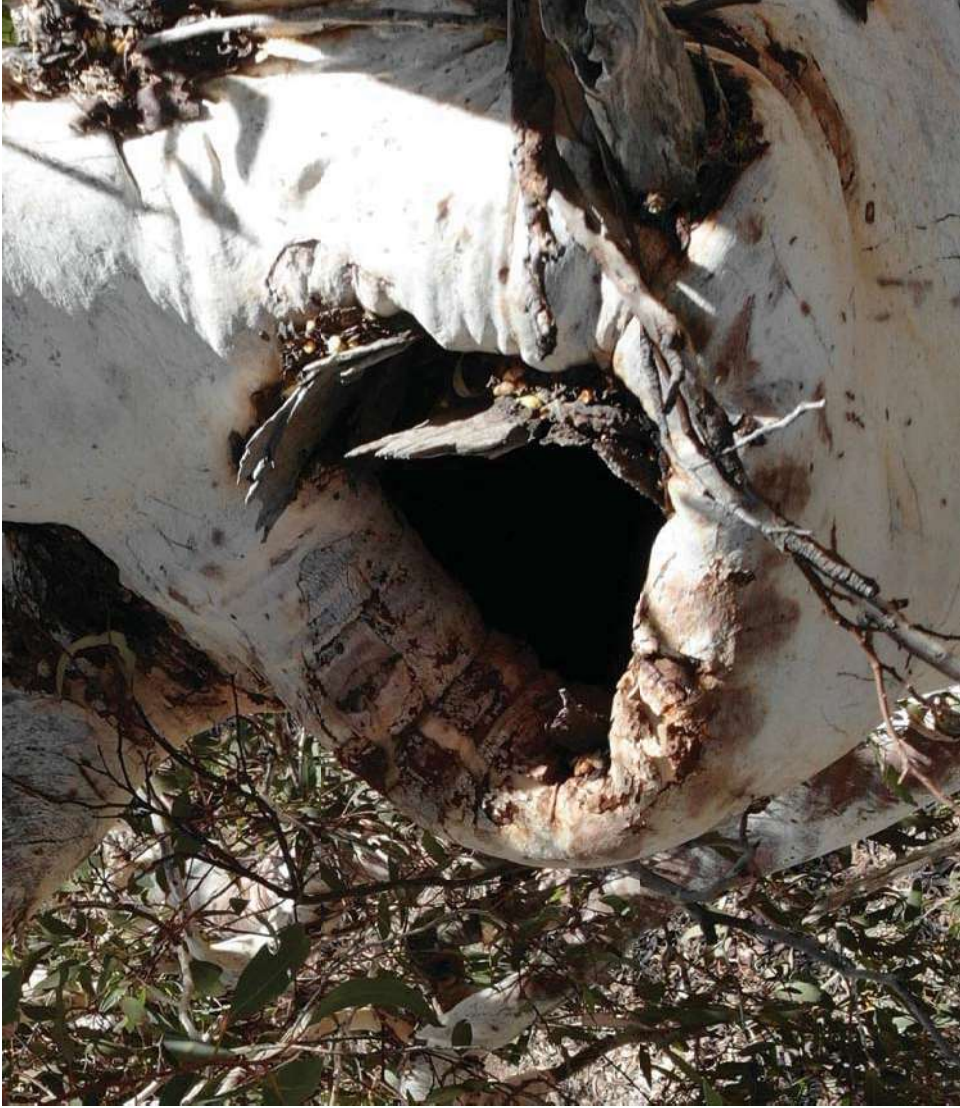
Tree D472 contains a large upward facing side entry hollow with some depth (base not visible). The hollow showed no signs of past or present use. The evidence observed suggests this hollow maybe suitable for black cockatoos to use for nesting purposes but it appears not to have been used for this purpose.

ID	Coordinates (MGA 94/Z50)	409454 mE	6515542 mN	Tree Species	Wandoo	Survey Date	24/01/2024
D472	Comments	Wandoo with a large upward facing side entry hollow and several small/medium sized spout type hollows. When examined with a drone the side entry type hollow was found to have some depth (base not visible). The hollow showed no signs of past or present use. Evidence observed suggests this hollow maybe suitable for black cockatoos to use for nesting purposes but it appears not to have been used for this purpose. Other hollows all too small.				Classification	Unused Hollow.

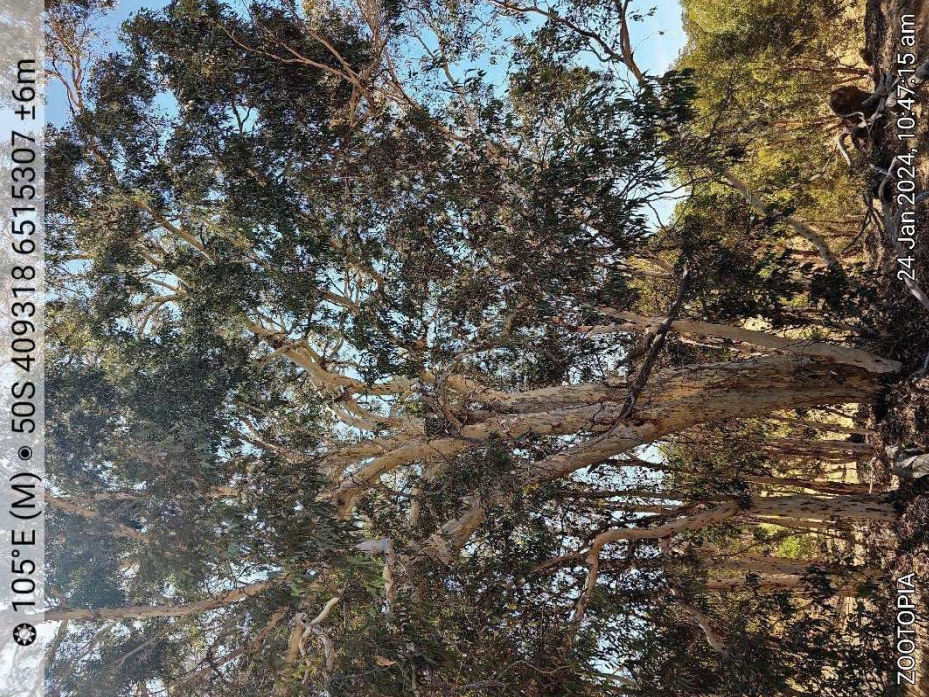
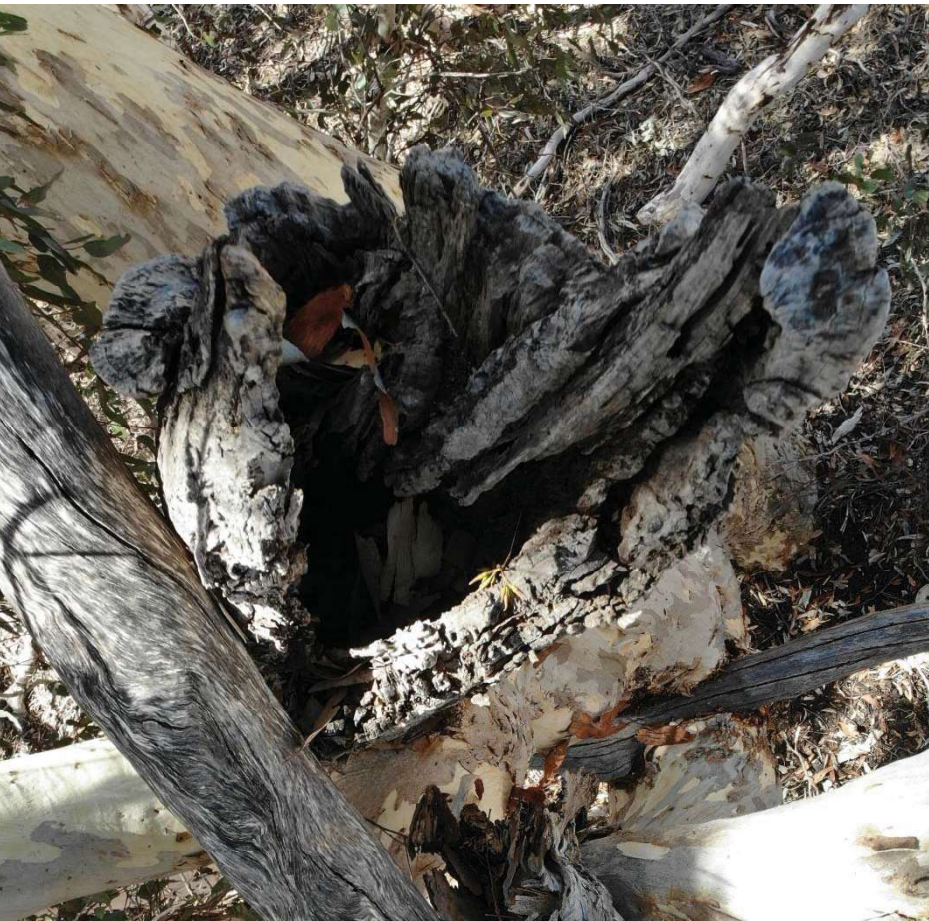
ID	Coordinates (MGA 94/Z50)	409334 mE	6515304 mN	Tree Species	Wandoo	Survey Date	24/01/2024
D507	Comments	Wandoo with upward facing spout. When examined with drone a shallow, medium size potential hollow was found (photo below right). In the Authors opinion this possible hollow would be unsuitable for black cockatoos to use for nesting purposes because it is too small. Two fissure type hollows in main trunk too small.				Classification	Unsuitable Hollow.

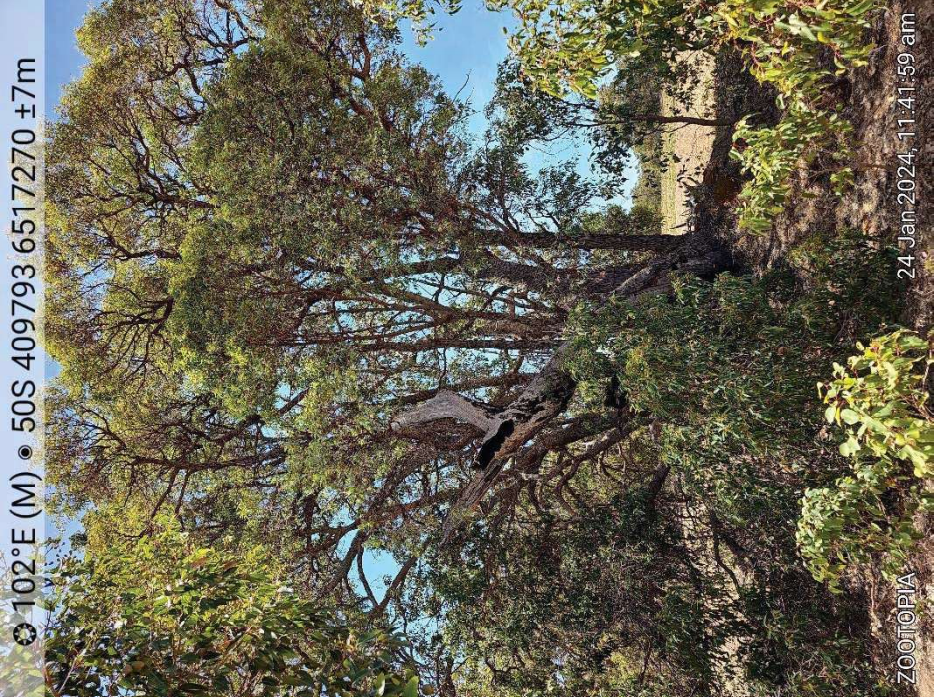
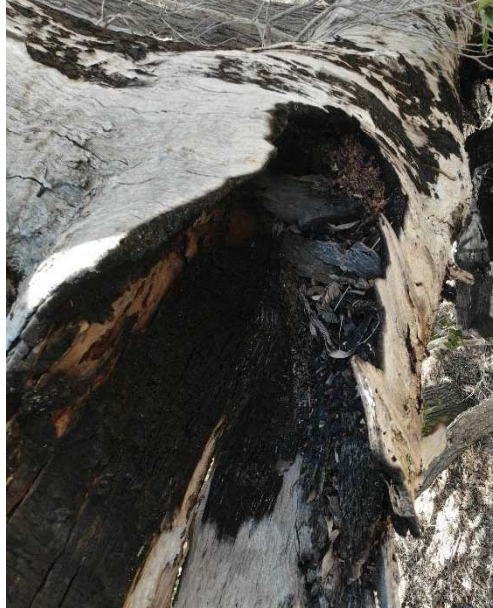
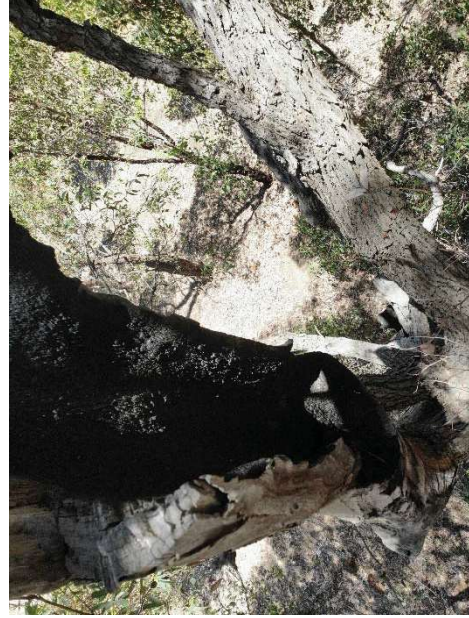
ID	Coordinates (MGA 94/Z50)	409806 mE	6517274 mN	Tree Species	Jarrah	Survey Date	24/01/2024	
D566	Comments	Jarrah with two potential spout type hollows, one at an angle (centre picture) and the other vertical (right picture). When examined with drone both hollows were found to have little or no depth (base visible in both cases). These hollows would be unsuitable for black cockatoos to use for nesting purposes. No signs of use by any fauna.						Unsuitable Hollows.
<div style="display: flex; justify-content: space-around; align-items: center;"> <div style="text-align: center;">

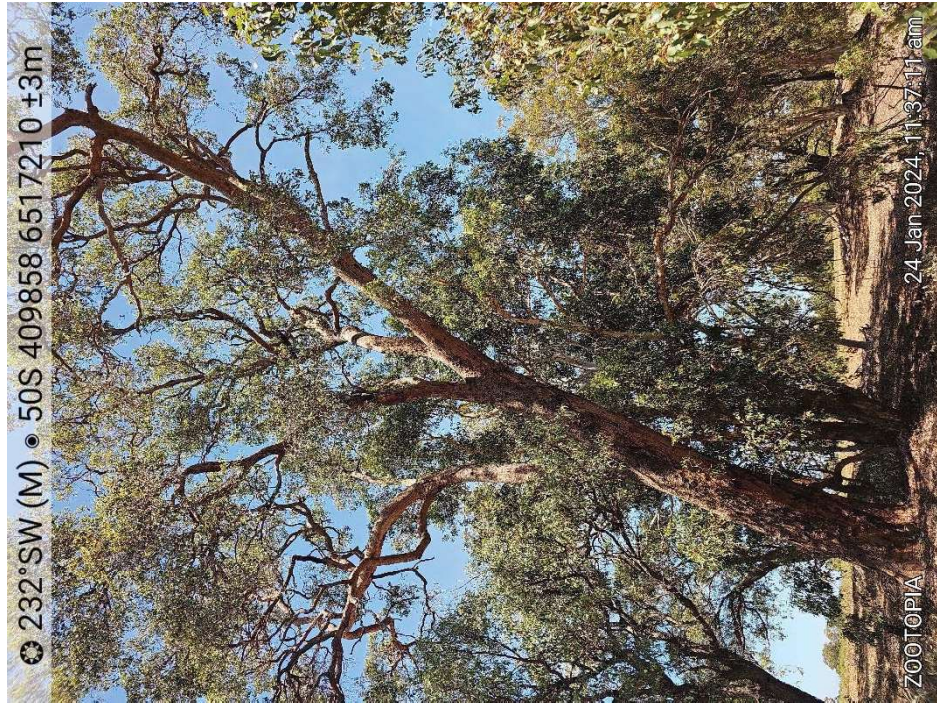
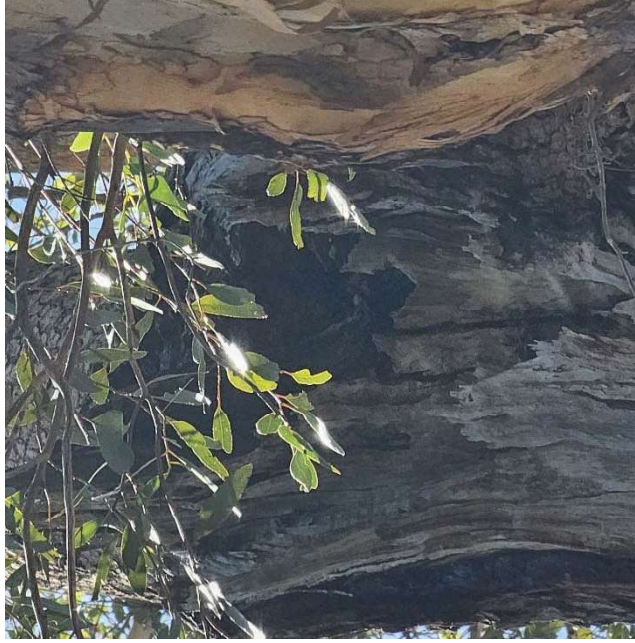
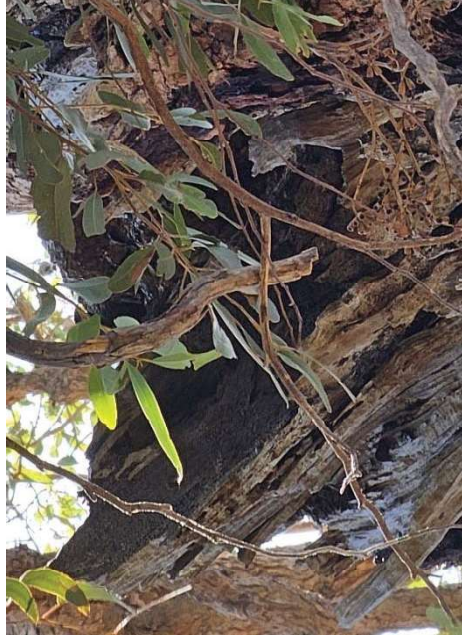
ID	Coordinates (MGA 94/Z50)	409854 mE	6517199 mN	Tree Species	Marri	Survey Date	24/01/2024	
D576	Comments	<p>Marri with a potential chimney type hollow. Because of surrounding branches it could not be examined with a drone and was too high for the pole camera, however when examined using binoculars the hollow appeared to be shallow/non-existent. In the Authors opinion this possible hollow would be unsuitable for black cockatoos to use for nesting purposes because it is too small. This hollow was also occupied by bees.</p>						<p>Unsuitable Hollow.</p>

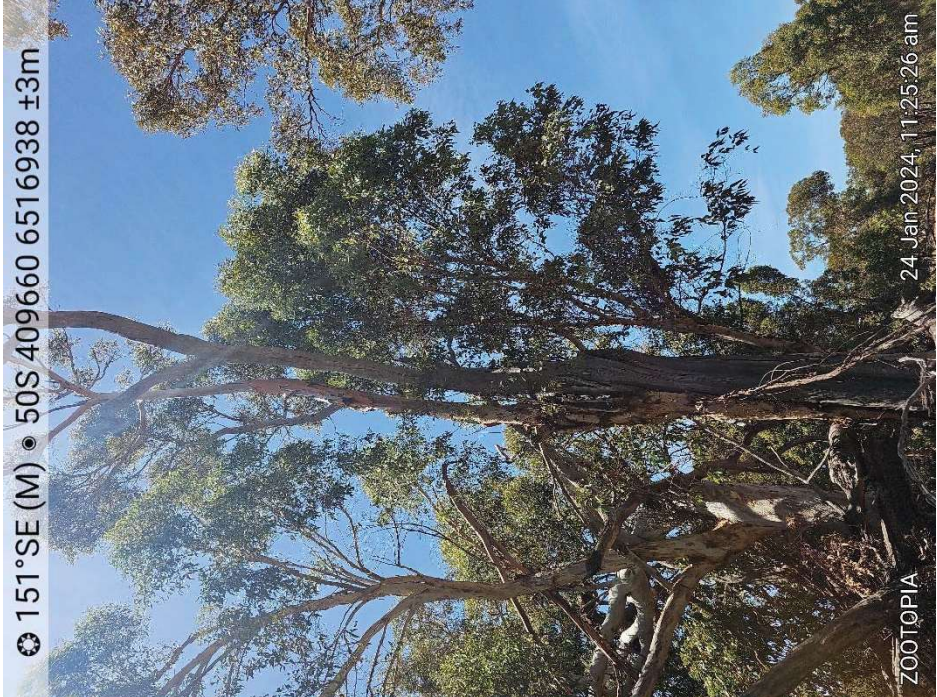
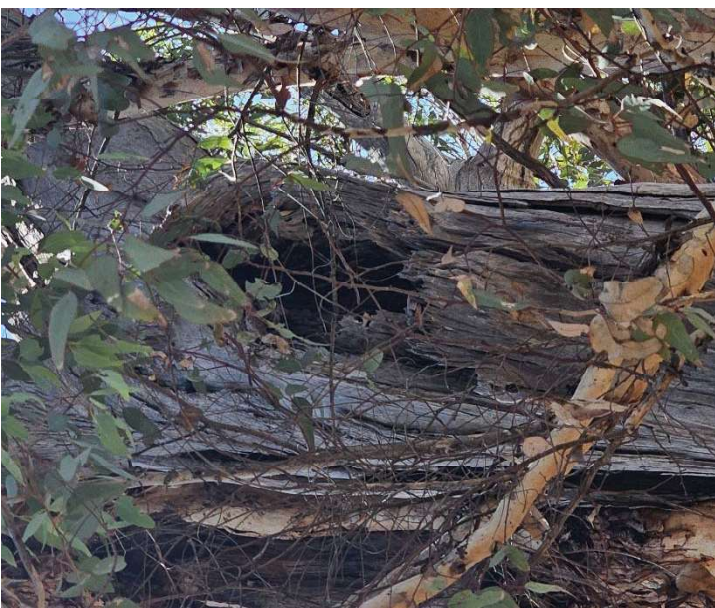
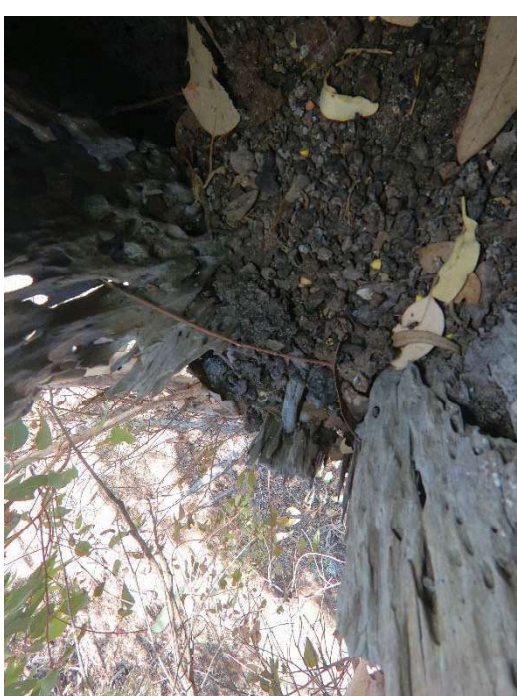
ID	Coordinates (MGA 94/Z50)	409854 mE	6516933 mN	Tree Species	Wandoo	Survey Date	24/01/2024	
D636	Comments	Wandoo with a potential large chimney style hollow. When examined with a pole mounted camera the hollow was found to be very shallow (base visible a few centimetres from rim of hollow – picture below right). This hollow would not be suitable for black cockatoos to use for nesting purposes. No signs of use by any fauna.						Unsuitable Hollow.

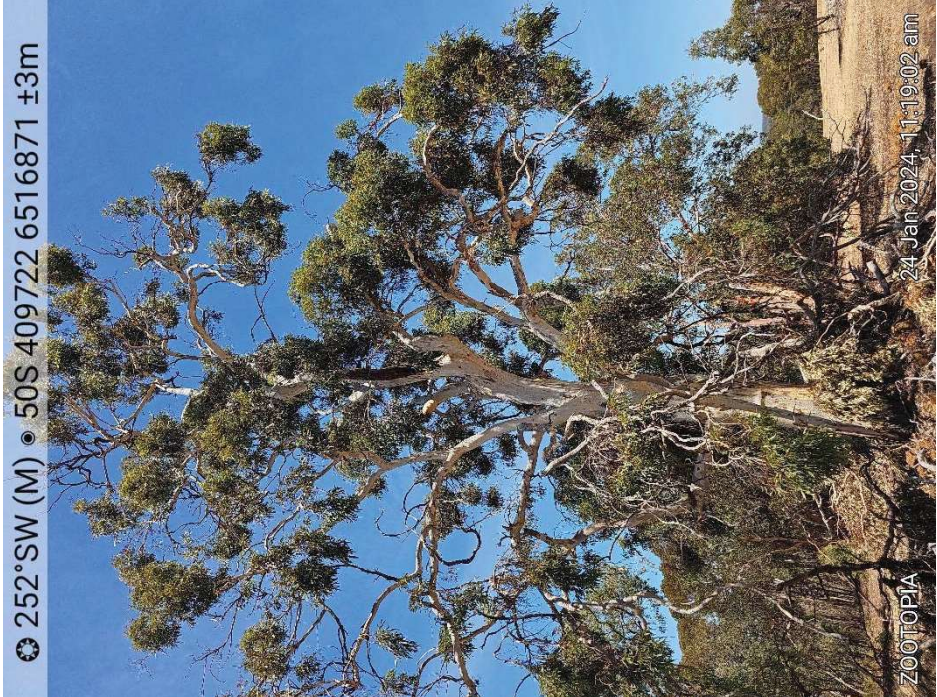
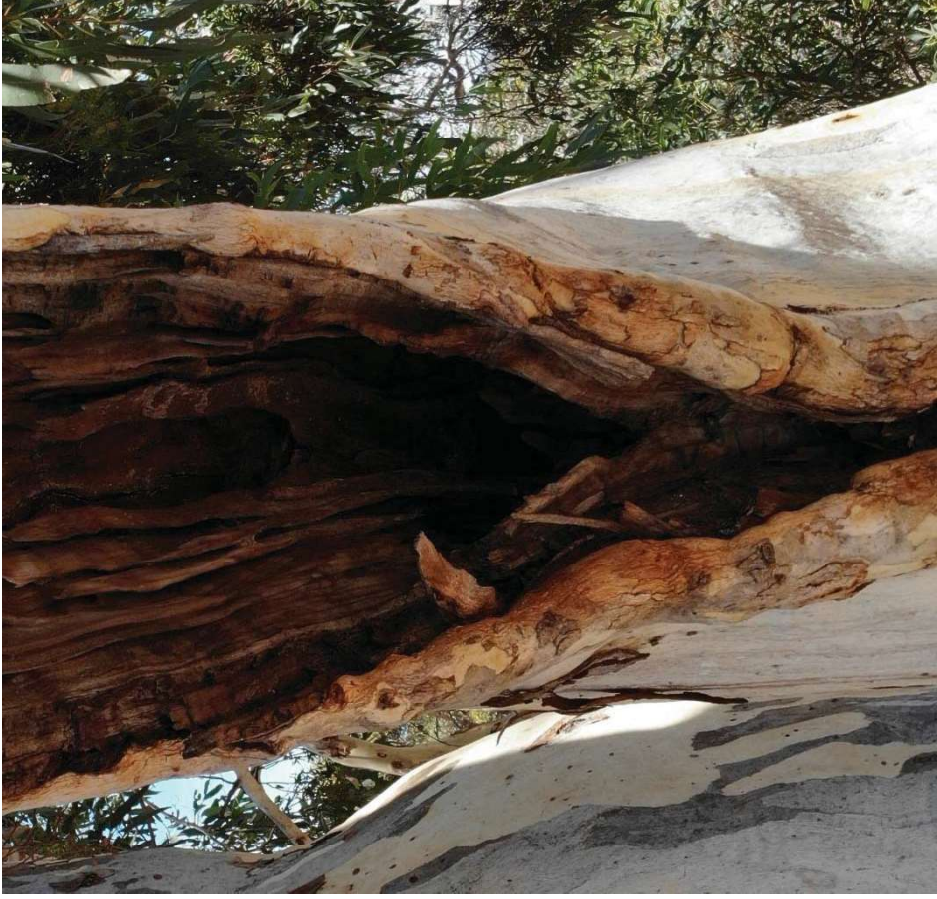
ID	Coordinates (MGA 94/Z50)	409712 mE	6516870 mN	Tree Species	Wandoo	Survey Date	24/01/2024
D639	Comments	Wandoo with upward facing spout. When examined with drone a shallow, medium size potential hollow was found (photo below right). In the Authors opinion this possible hollow would be unsuitable for black cockatoos to use for nesting purposes because it is too shallow and small. No signs of use by any fauna.				Classification	Unsuitable Hollow.
