Environmental Services Site visit notes

Site visit 28 September 2023

Proposed road upgrade – Honeyeater Glade Chidlow

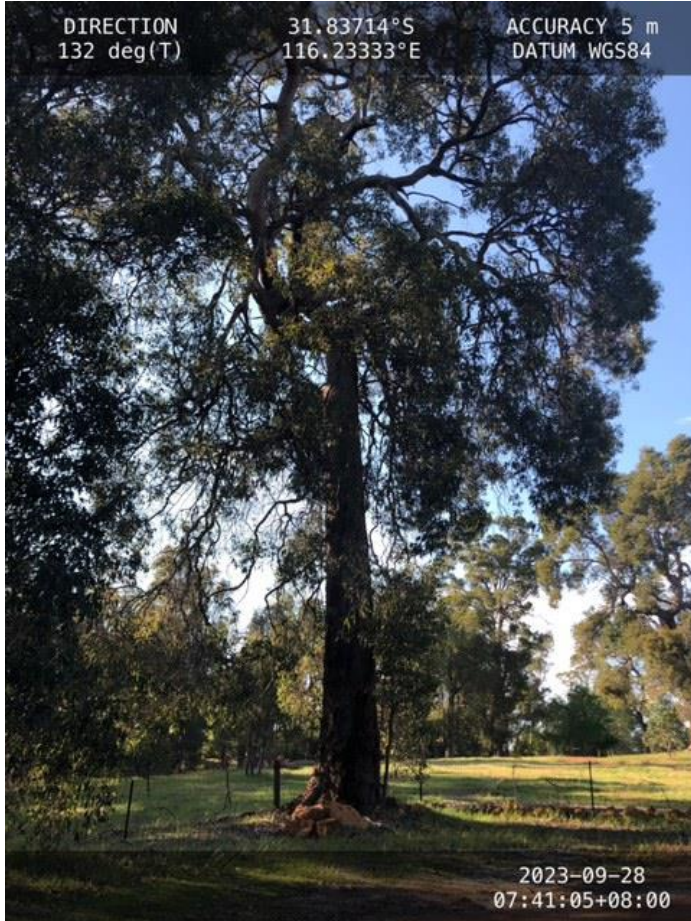
Photo 1 (left): Habitat tree, *Corymbia calophylla*. Approximately 150cm diameter at breast height (DBH). Tree is in good condition, one small hollow visible, possibly others. No impact with proposed road upgrades however Environmental Services recommends measures are taken to protect the habitat tree during construction with an area fenced off as a tree protection zone to create a physical barrier from construction works.

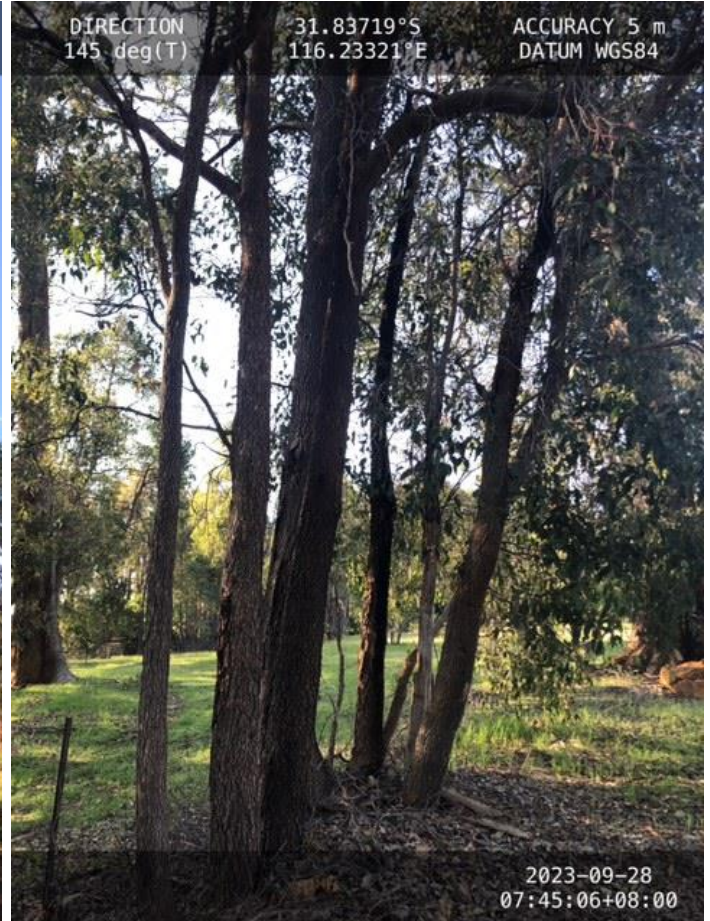
Photo 2 (right): Native vegetation that will be impacted on the northern side of the cul-de-sac. There are 7 native trees, all *Corymbia calophylla* (Marri) and under 30cm DBH.

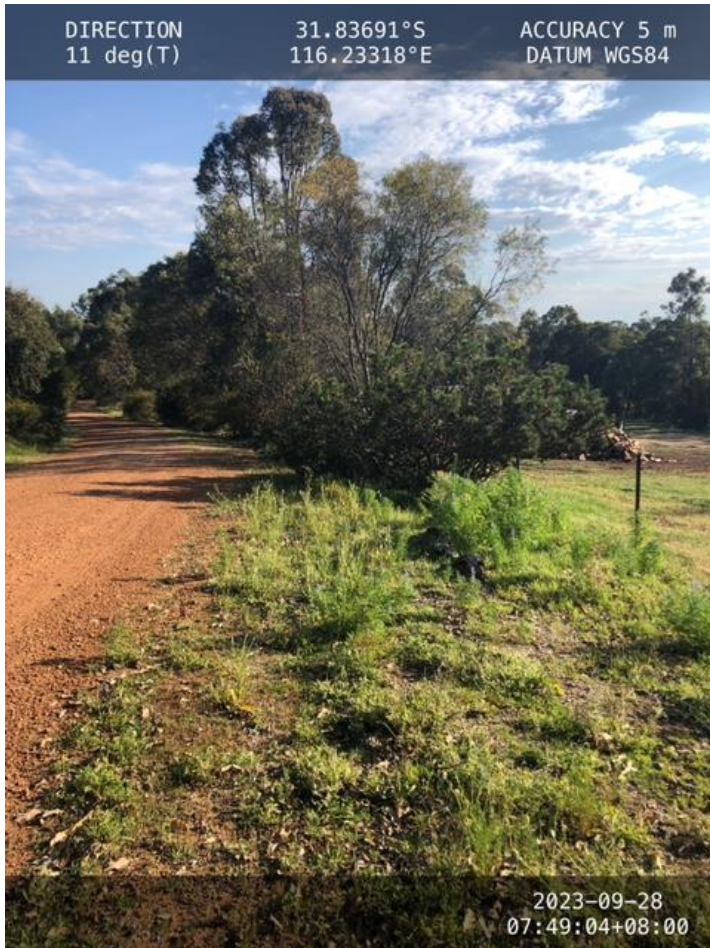
Photo 3 (above left): Weeds along the verge. No concerns with clearing however, follow up weed control after the completion of the road works is recommended.

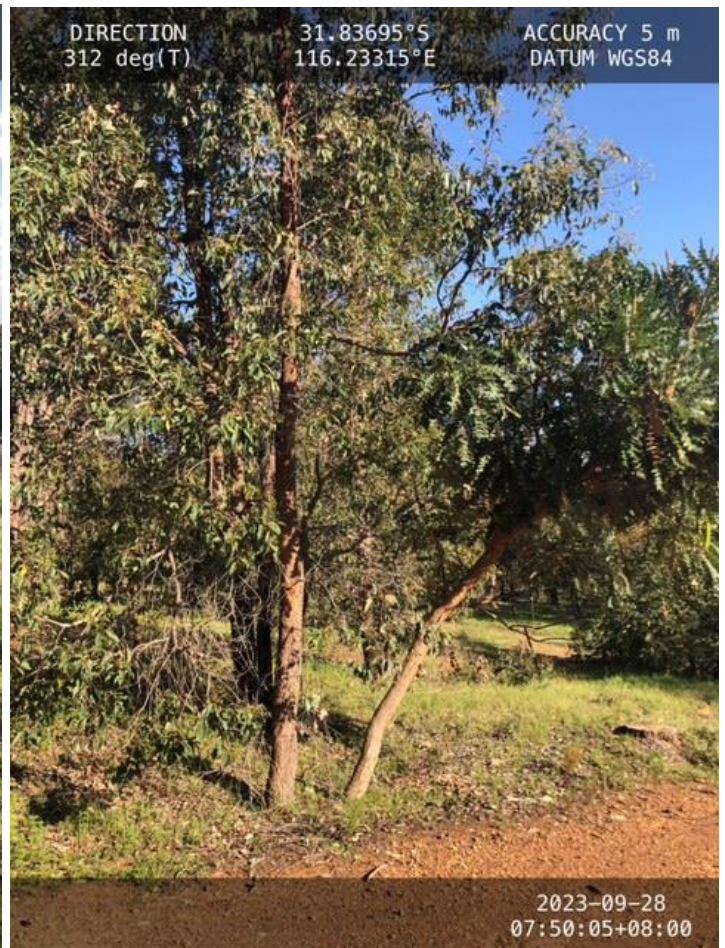
Photo 4 (above right): Native vegetation on the south side of the road verge that may be impacted. This includes a small *Corymbia calophylla* (Marri) under 30cm DBH and 1 x *Banksia grandis*.

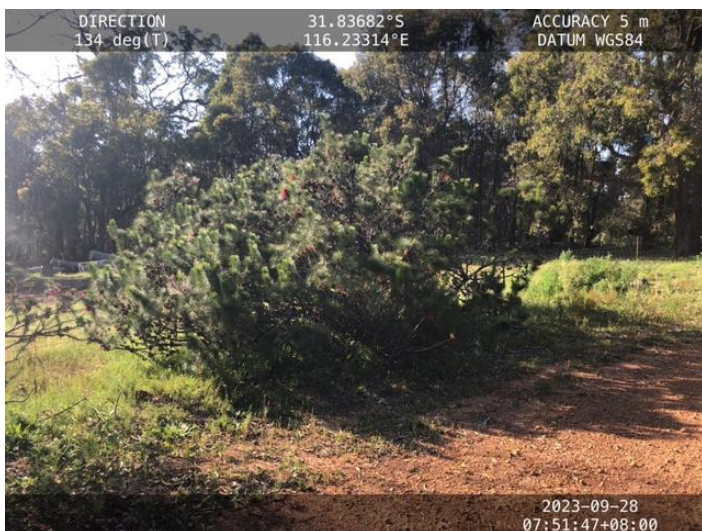
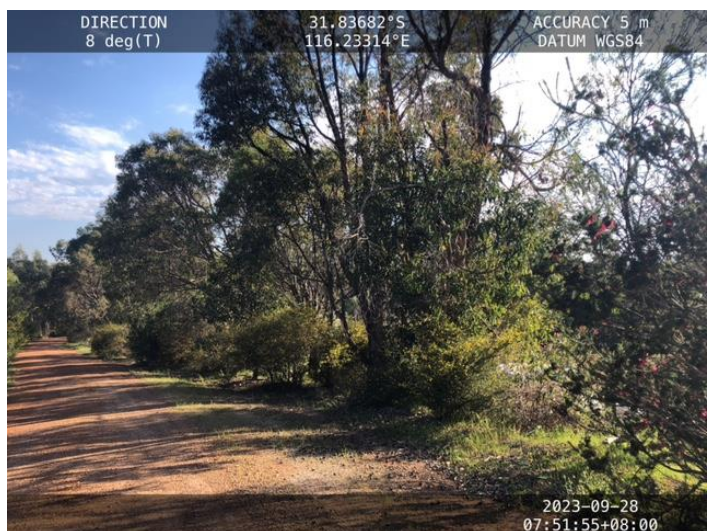
Photo 5 & 6 (above): Planted native vegetation, *Calothamnus rupestris* and *Acacia saligna*. Proposed to trim the vegetation in the first instance however may need to be removed for the proposed road upgrades. If cleared the area measures 420sqm (or 0.042ha) in total.

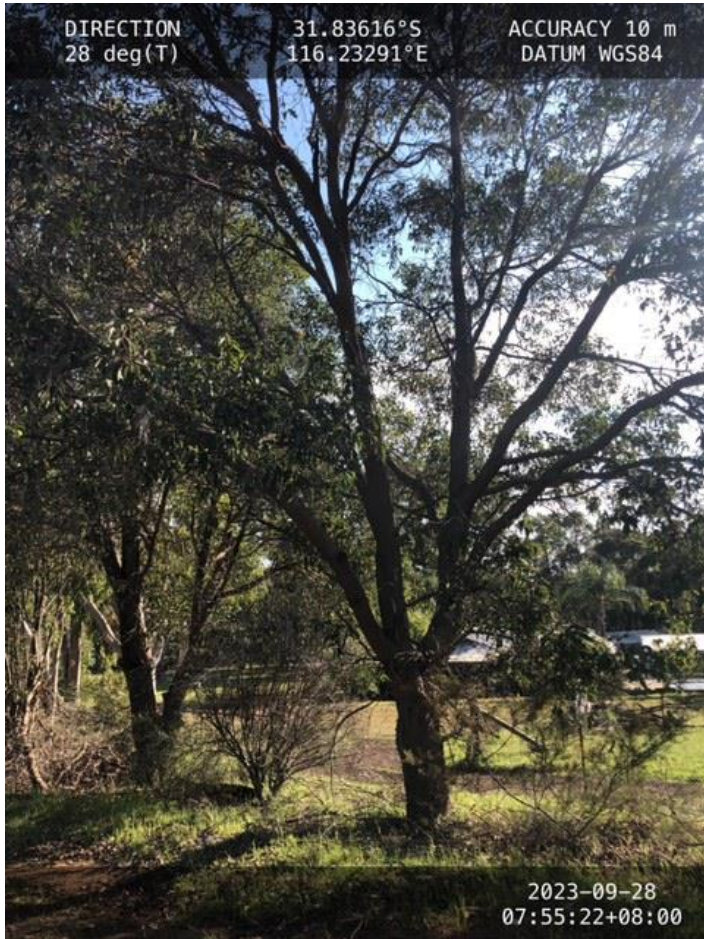
Photo 7 (above left): Native trees, such as the one in this photo will require pruning of lower branches only.

Recommend that removal of vegetation is done with a forestry mulcher. This will minimise ground disturbance and retain the native seed bank. Post construction it is also recommended to reinstate the verge with revegetation of low lying native species.

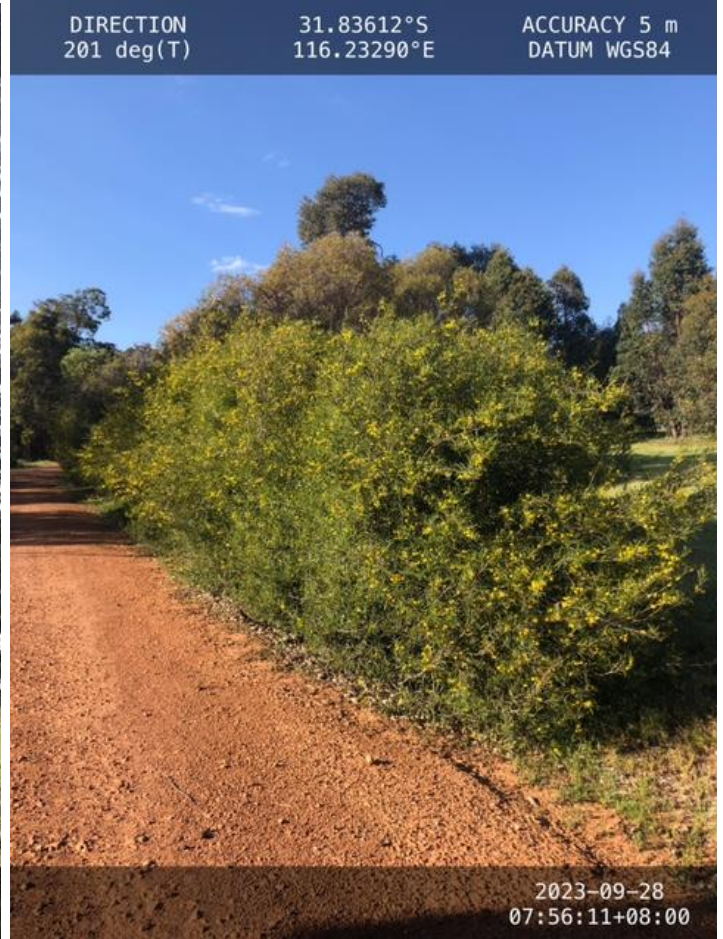
Photo 8 (above right): Planted native vegetation. Proposed to trim the vegetation in the first instance however may need to be removed for the proposed road upgrades.

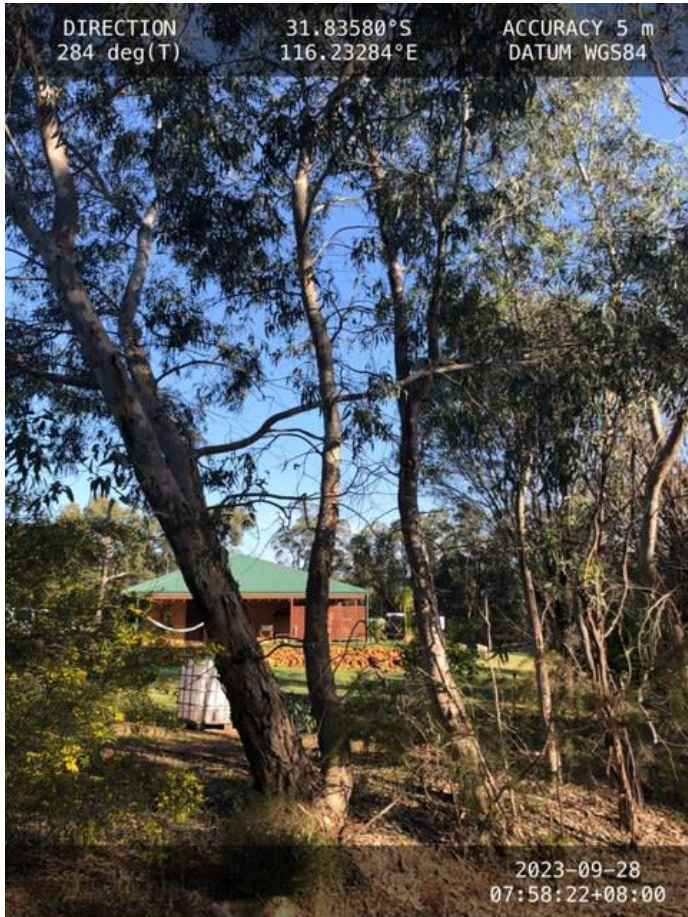
Photo 9 (above left): *Corymbia maculata* growing near in the road drainage. These species are introduced eucalyptus and removal is supported. Environmental services recommends follow up weed control after the completion of the road works to control saplings and replanting with native seedlings to assist with erosion.

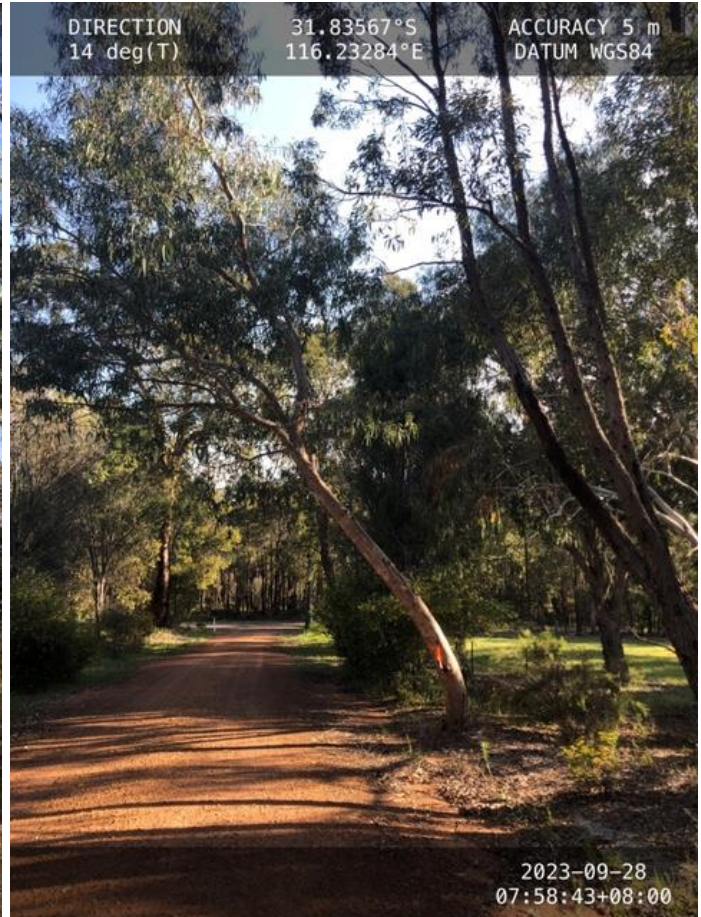
Photo 10 (above right): Non-native eucalyptus on a lean. As it is not native and weedy, there are no issues with removing this species or trimming back the overhanging branch.

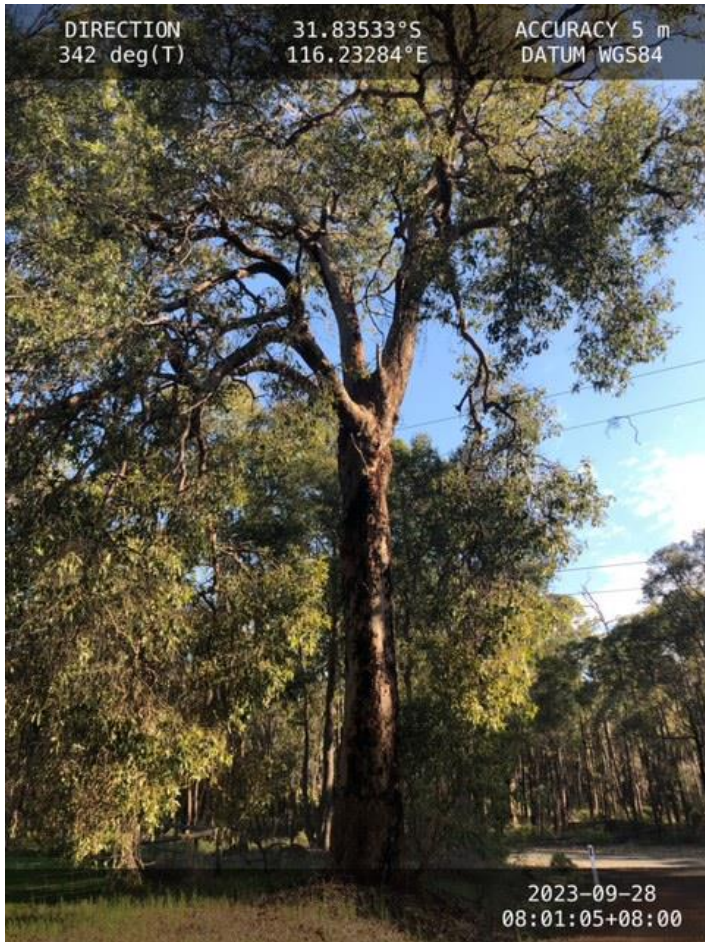
Photo 11 (above left): Habitat tree *Corymbia calophylla* (Marri) located near the south west corner of Honeyeater Glade. No impact to this tree with the proposed works. However there is some decline in the canopy which may be Marri Canker and would benefit from removal of dead and lower hanging branches. Environmental Services recommends measures are taken to protect the habitat tree during construction works.

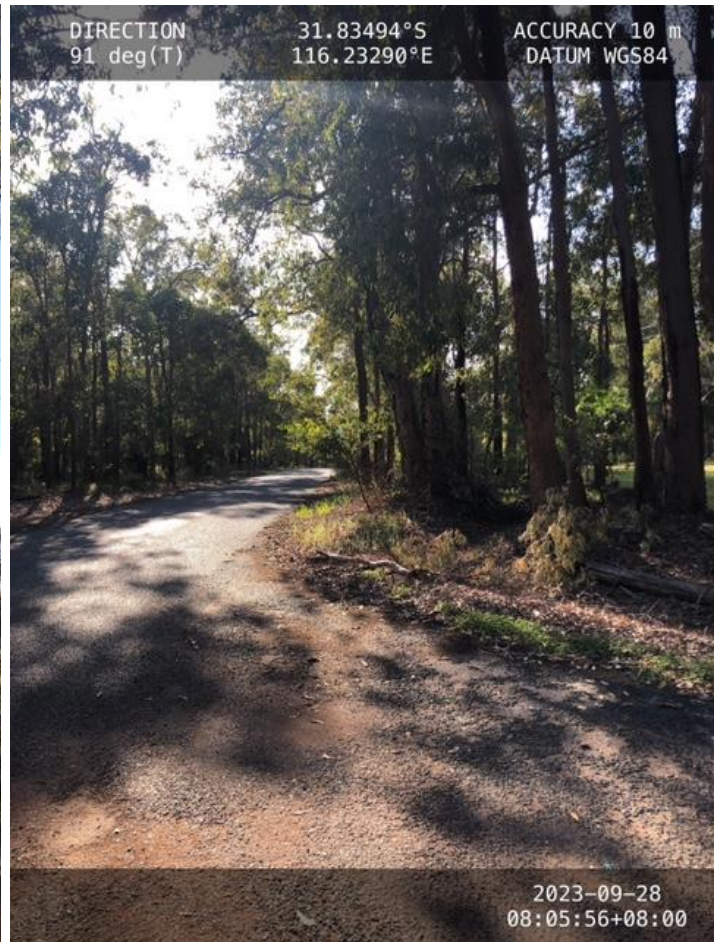
Photo 12 (above right): View of sight lines looking east towards Keenan Road. Some minor trimming only is proposed.
