RE: (SW546): Habitat Tree Re-assessment Results, 19.38 SLK Harvey-Quindanning Road, Harvey

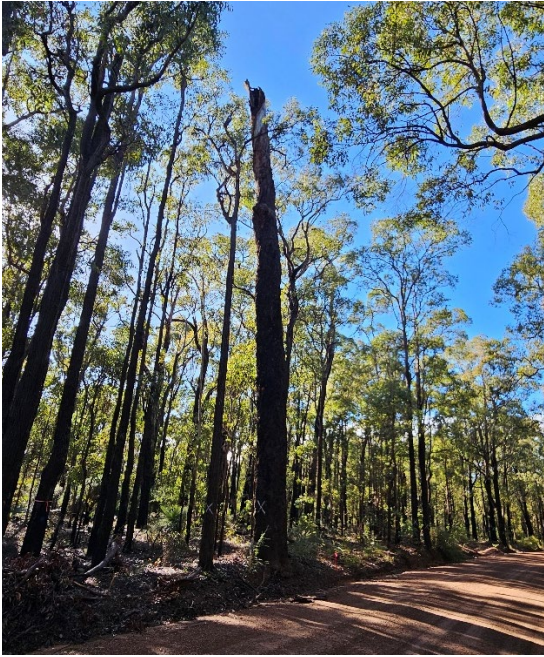
The tree was found to be snapped high on the main trunk at a significant height (~17m high). The snapped limb on the ground contained a large hollow that had potential to be used for black cockatoo breeding, had the limb remained intact. There was no evidence of previous black cockatoo use. The remaining intact main stem had one large knot hollow, but was too shallow for animal use, offering no protection, and the main trunk was filled with termite castings.

Photo 1 Tree at 19.38 SLK with undeveloped knot hollow

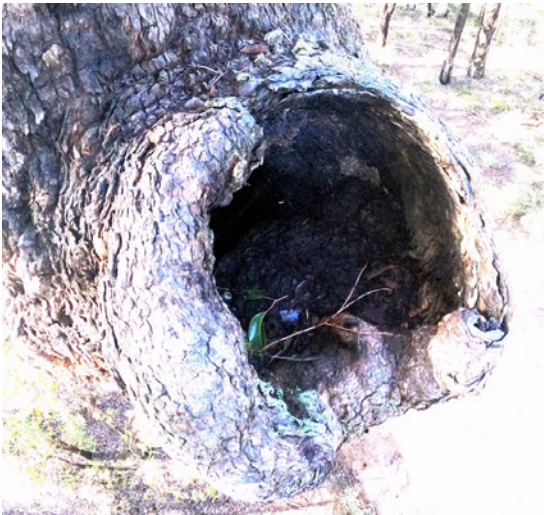
The remaining tree hollows are not considered suitable for black cockatoo breeding in their current form. No black cockatoos or any other fauna were found to be inhabiting the hollows. No signs of recent black cockatoo use were observed on the hollows.

Photo 2 Close up and enhanced photo of the knot in Photo 1

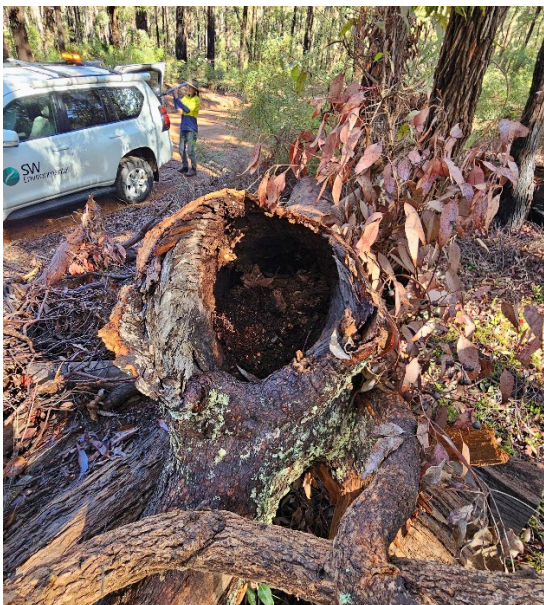
Photo 3 Snapped section of tree with large hollow
