Structural Vegetation and Condition Assessment

19.0 – 24.2 SLK Harvey-Quindanning Road, Harvey

SEPTEMBER 2024

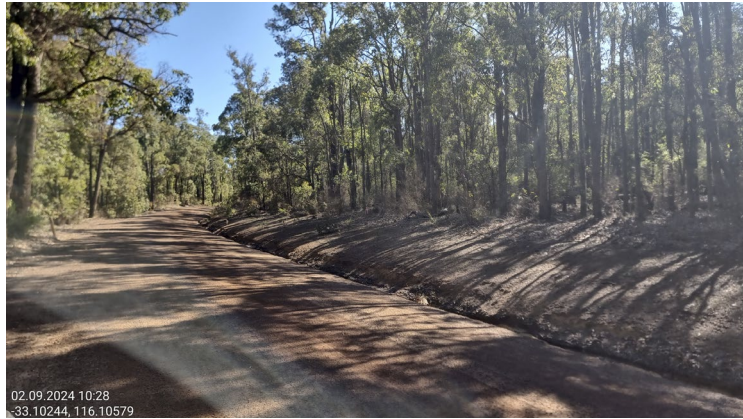
Blue Gum plantation vegetation (VU 5) was considered to be Completely Degraded, due to the complete alteration in vegetation structure. Degraded areas occurred on cleared cut batters where no regrowth vegetation was observed (Photo 1). Vegetation within the transmission line easement (VU 4) was also considered to be Degraded, as basic vegetation structure had been severely impacted by previous disturbances (likely widescale clearing). No dominant tree species that were characteristic of the surrounding vegetation were evident regenerating within this VU. In roadside vegetation described as 'Good' condition, regenerative native species that were representative of adjacent, intact areas existed (Photo 2). These areas were deemed as 'able to regenerate basic vegetation structure', as stated in the condition scale presented in EPA Technical Guidance (EPA, 2016).

Photo 1 Degraded roadside cut batter surrounded by VU 1 vegetation, severely impacted by clearing disturbance with no regrowth species currently present.

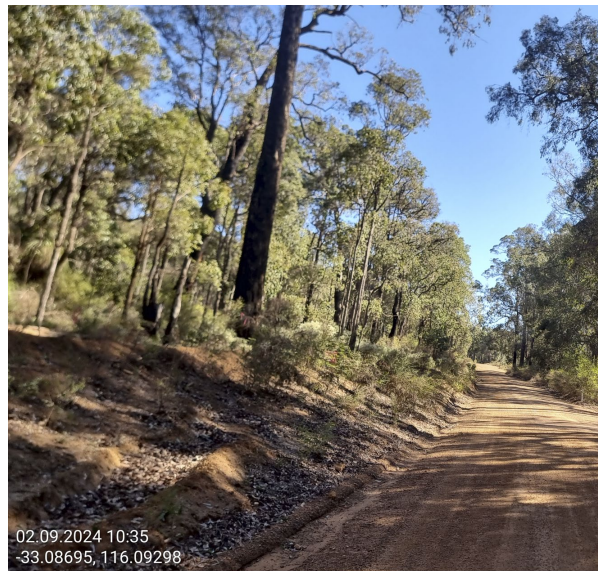
Photo 2 Roadside vegetation, subject to significant alteration by previous, clearing disturbance, native regrowth evident with ability to regenerate to surrounding VU 1 vegetation, considered as Good condition.

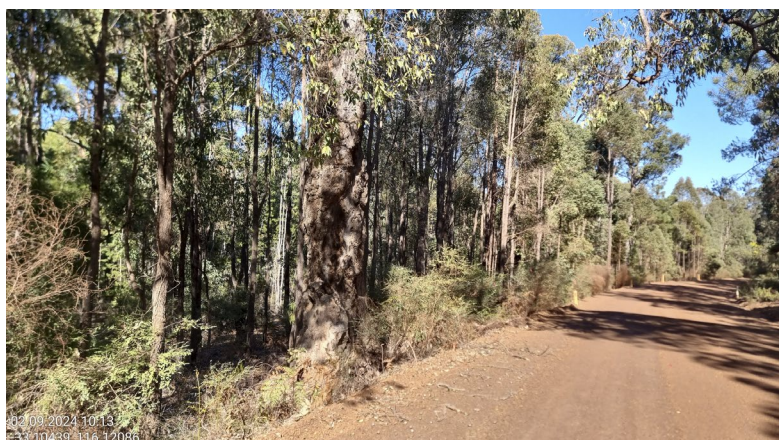
Outside of the clearing envelope, vegetation was in generally Very Good to Excellent condition (Photo 3). None of the vegetation to be cleared was observed to be in Excellent condition due to edge effects, however a proportion of the Survey Area was mapped as Very Good, particularly on the downslopes of the RHS SLK road verge, where cut batters had not been constructed (Photo 3).

Photo 3 Roadside vegetation (VU 1) with obvious signs of disturbance (edge effects) that is intact and uncleared within clearance envelope, considered as Very Good condition
