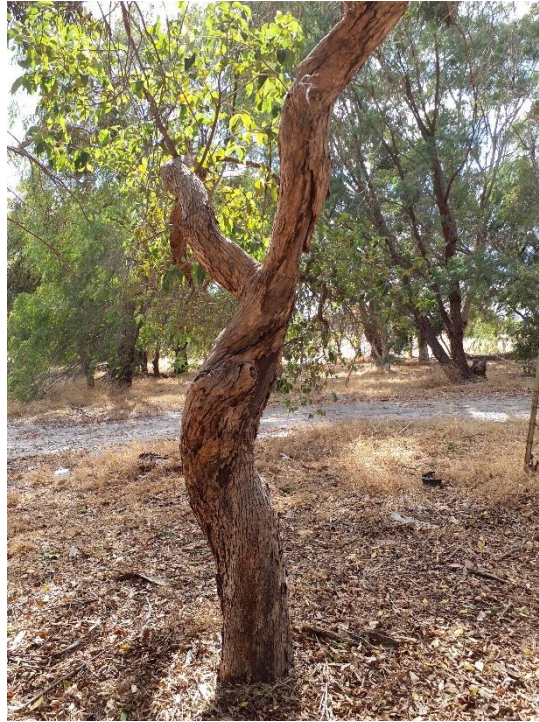
**Photo: 1**

Description: Marri within clearing extent, assessed as unhealthy

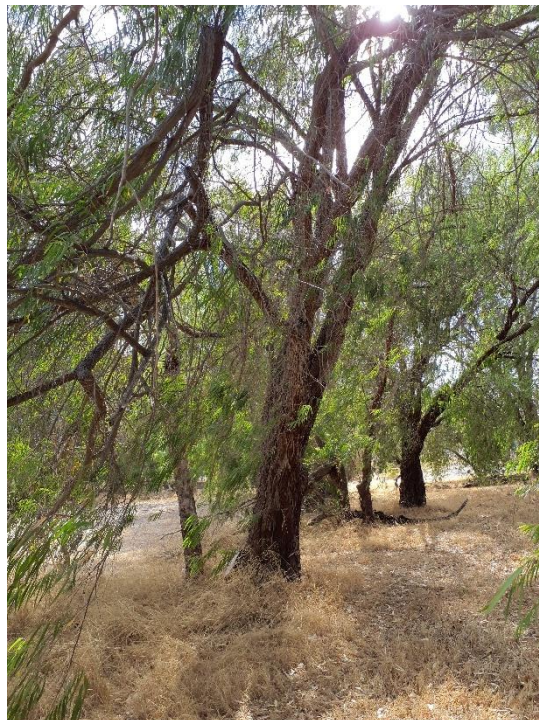
**Photo: 2**

Description: Row of peppermint trees within clearing extent

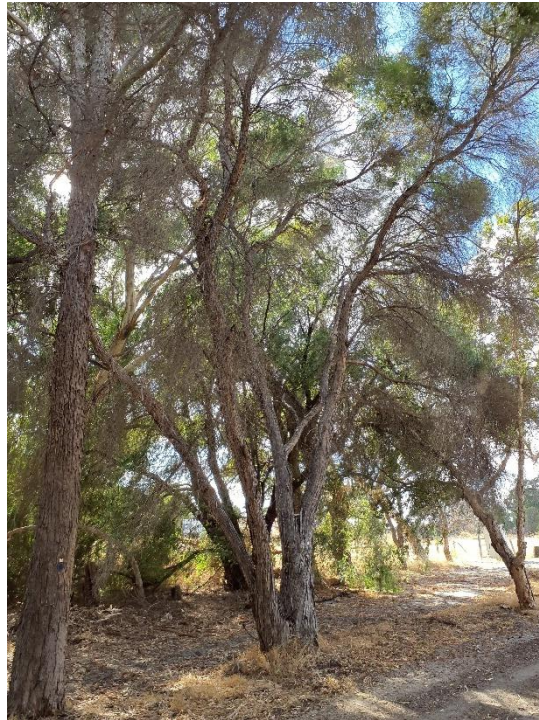
**Photo: 3**

Description: Vegetation along eastern boundary within clearing extent

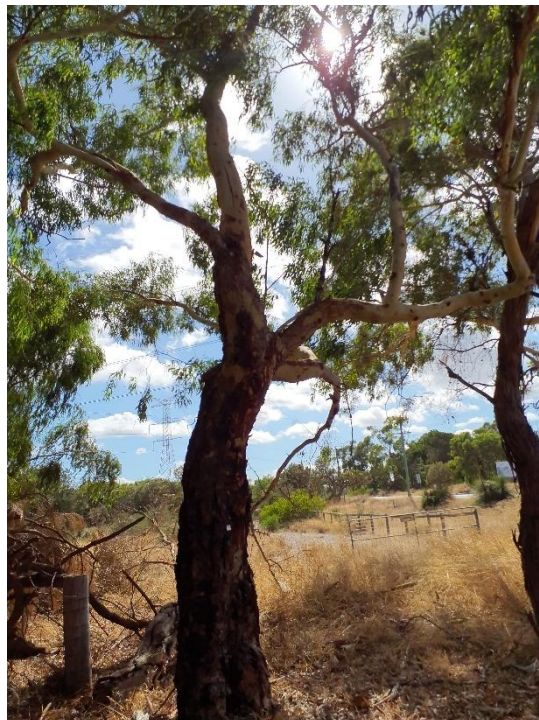
**Photo: 4**

Description: Vegetation along eastern boundary within clearing extent

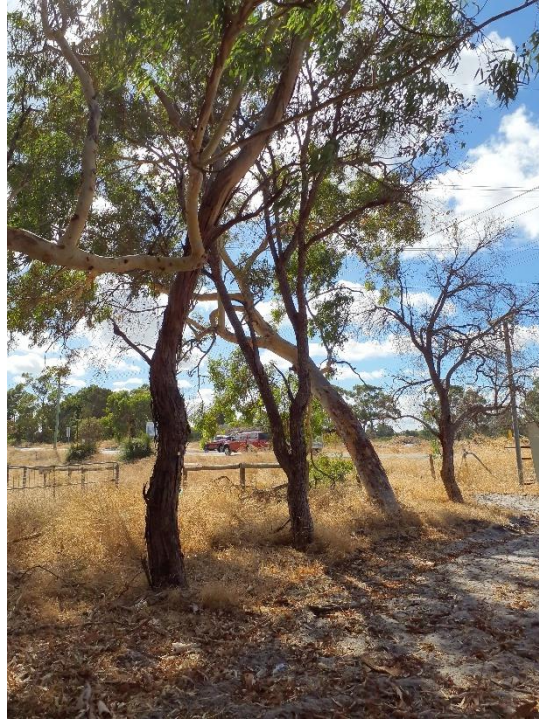
**Photo: 5**

Description: Vegetation along eastern boundary within clearing extent

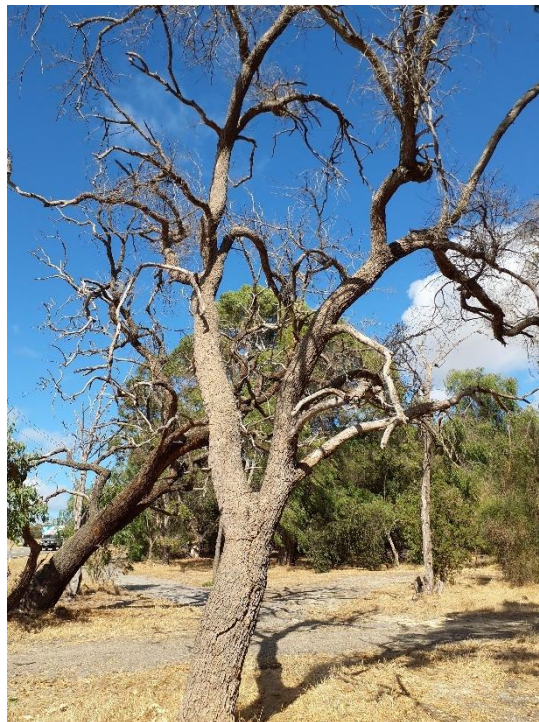
**Photo: 6**

Description: Dead tree within clearing extent

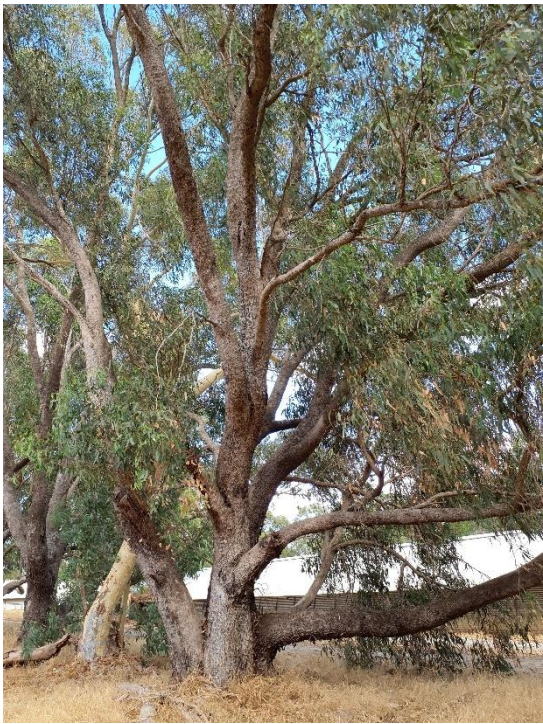
<b>Photo: 7</b>
Description: Two tuarts to be cleared

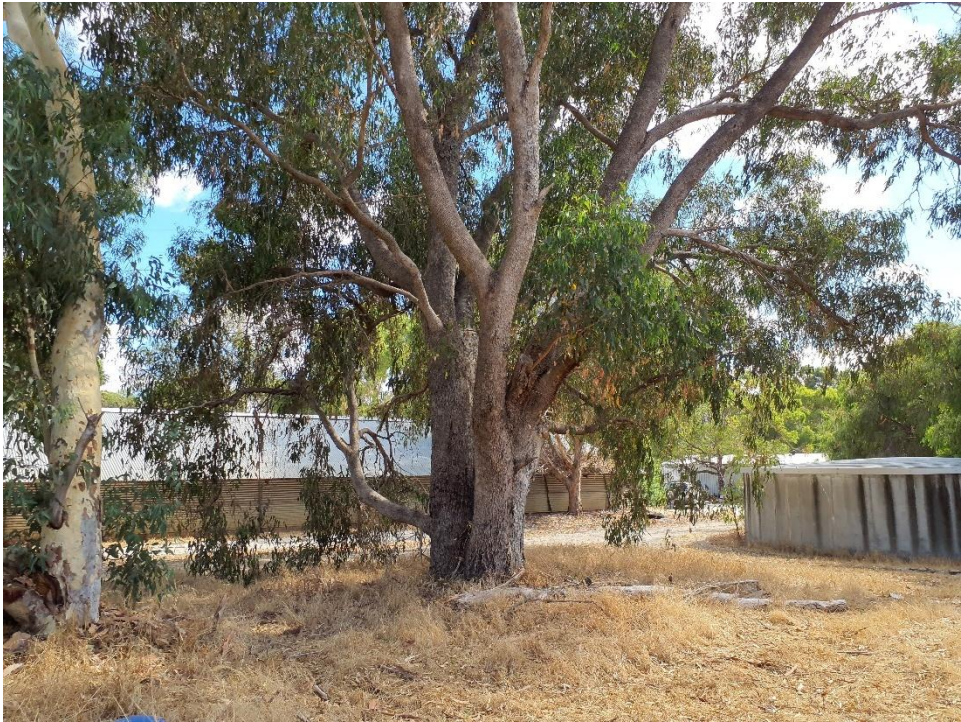
<b>Photo: 8</b>
Description: Western Tuart

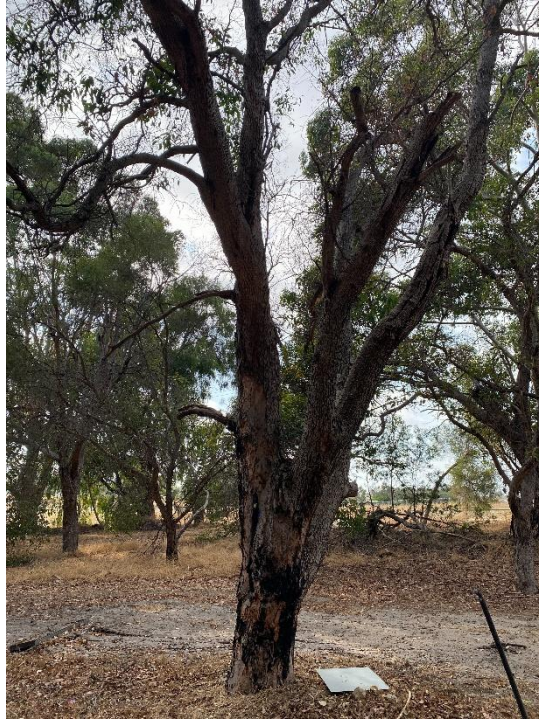
**Photo: 9**

Description: Unhealthy damaged marri within clearing extent
