2 December 2018

This letter outlines the results of a survey of vegetation condition undertaken by myself on the 30th November 2018 over part of Lot 3 Buller Rd, Waroona (herein referred to as the subject area). The purpose of the survey was to assess whether the vegetation condition within the subject area had returned, or was returning, to that which existed prior to the fire of January 2016 that also burnt large parts of the surrounding region.

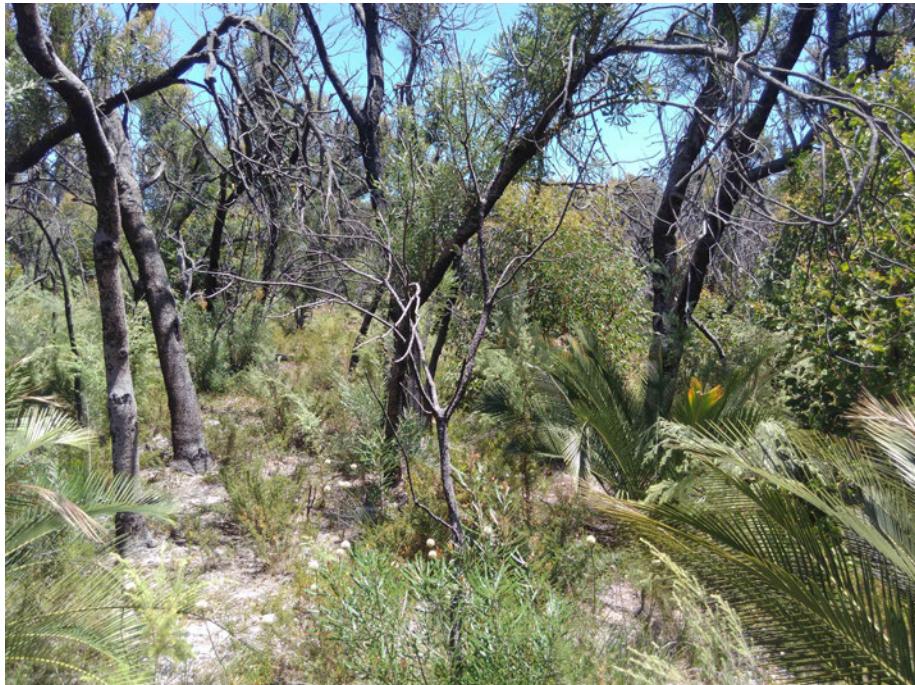
The condition of the vegetation in the southern half of the subject area was rated as 'Very Good', which is the same category as previously assigned by Woodman Environmental (2015) (Figures 1 and 2). The vegetation in this area is recovering its structure and diversity following the fire with a minor infestation of mainly non-aggressive weeds. Many native plants were observed to be resprouting and seedlings of *Banksia attenuata* were common. This area is a *Eucalyptus marginata* – *Banksia attenuata* woodland, and the vegetation condition meets the criterion for inclusion as part of the Commonwealth-listed Threatened Ecological Community (TEC) 'Banksia Dominated Woodlands of the Swan Coastal Plain IBRA Region' (Banksia Woodlands TEC).

Plate 1: 'Very Good' vegetation showing native understorey with mid- and upper strata regenerating following fire (32.8634 S, 115.8229 E).

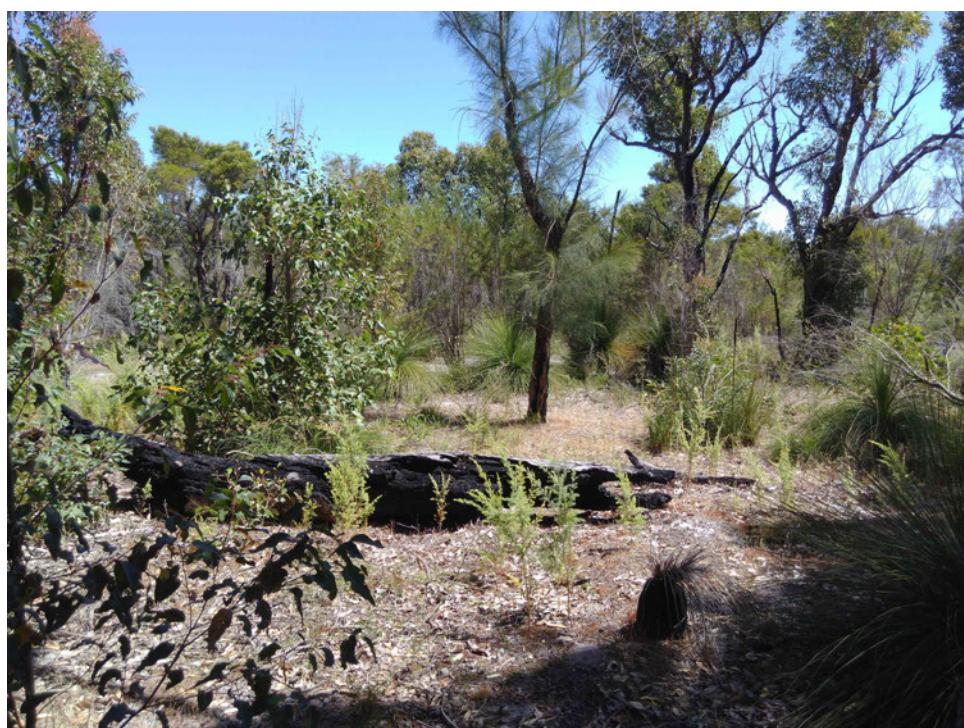
Plate 2: 'Very Good' vegetation, showing more open understorey but few weeds and intact vertical structure (32.8954 S, 115.8299 E).

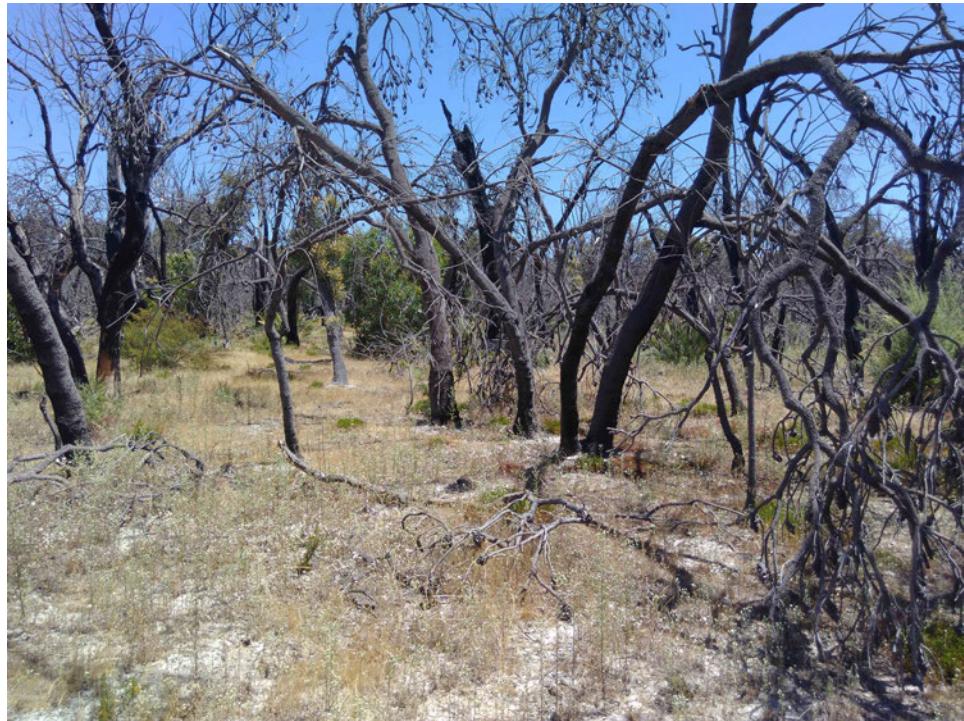
The vegetation of the northern half of the site was mostly in a 'Completely Degraded' to 'Degraded' condition. The original vegetation structure has been largely lost and the understorey is dominated by weed species (Figure 3). This area had been rated as 'Degraded' by Woodman Environmental (2015) and the fire may have adversely affected the vegetation even further. As such, the northern part of the subject area does not meet the criteria to be considered part of the Banksia Woodlands TEC. There were some small parts of the northern section that could be rated as 'Good', as the basic vertical structure is still intact but weeds dominated the understorey (Figure 4). The 'Good' areas mostly coincided with those mapped in the same category by Woodman Environmental (2015). While there is a degree of subjectivity in the rating of vegetation condition and may vary between observers, it is clear the vegetation condition in most of the northern part of the subject area has not improved since the fire and may have declined further.

Plate 3: 'Completely Degraded' vegetation with almost no ground layer and very open upper canopy (32.8553 S, 115.8233 E).

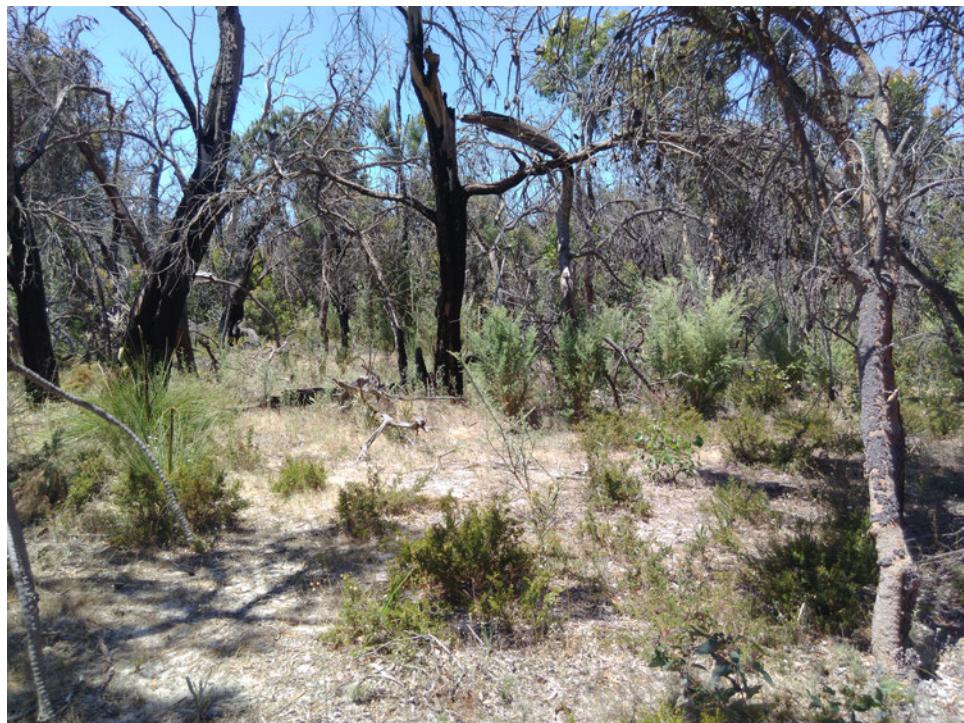
Plate 4: 'Good' vegetation with a weedy understorey and some native species, but vertical structure is still present (32.8589 S, 115.8227 E).
