# Flora and Vegetation Assessment Acker Quarry (MCI 70/2), Christmas Island

Prepared for: Acker Pty Ltd

Prepared by: Christmas Island Environmental Services

## June 2025 Survey Report

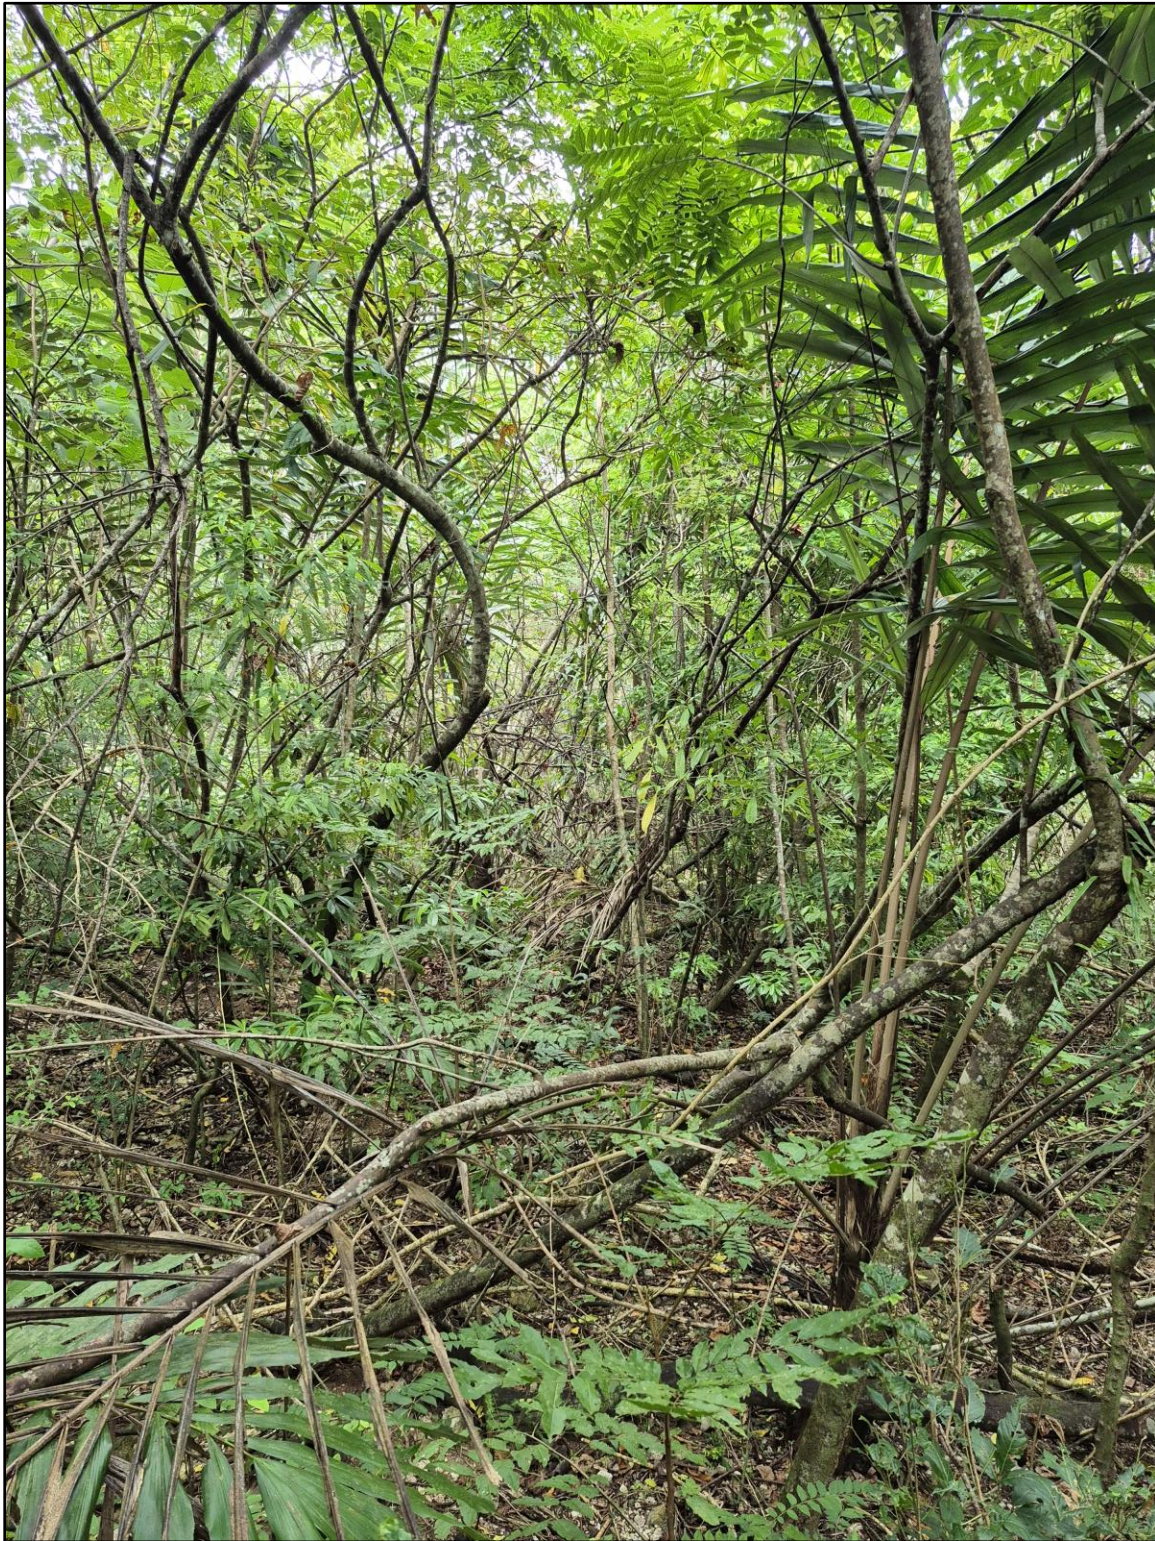
Christmas Island Environmental Services  
Waypoint 1 Photograph

| Flora Survey | | | | | | | |
|---|---|---|---|---|---|---|---|
| Topography/Slope: Gentle, NW | | | | Disturbance: Soil pushed up into windrows | | | |
| Photo ID: 20250625_092731 | | | | Vegetation Condition: Good | | | |

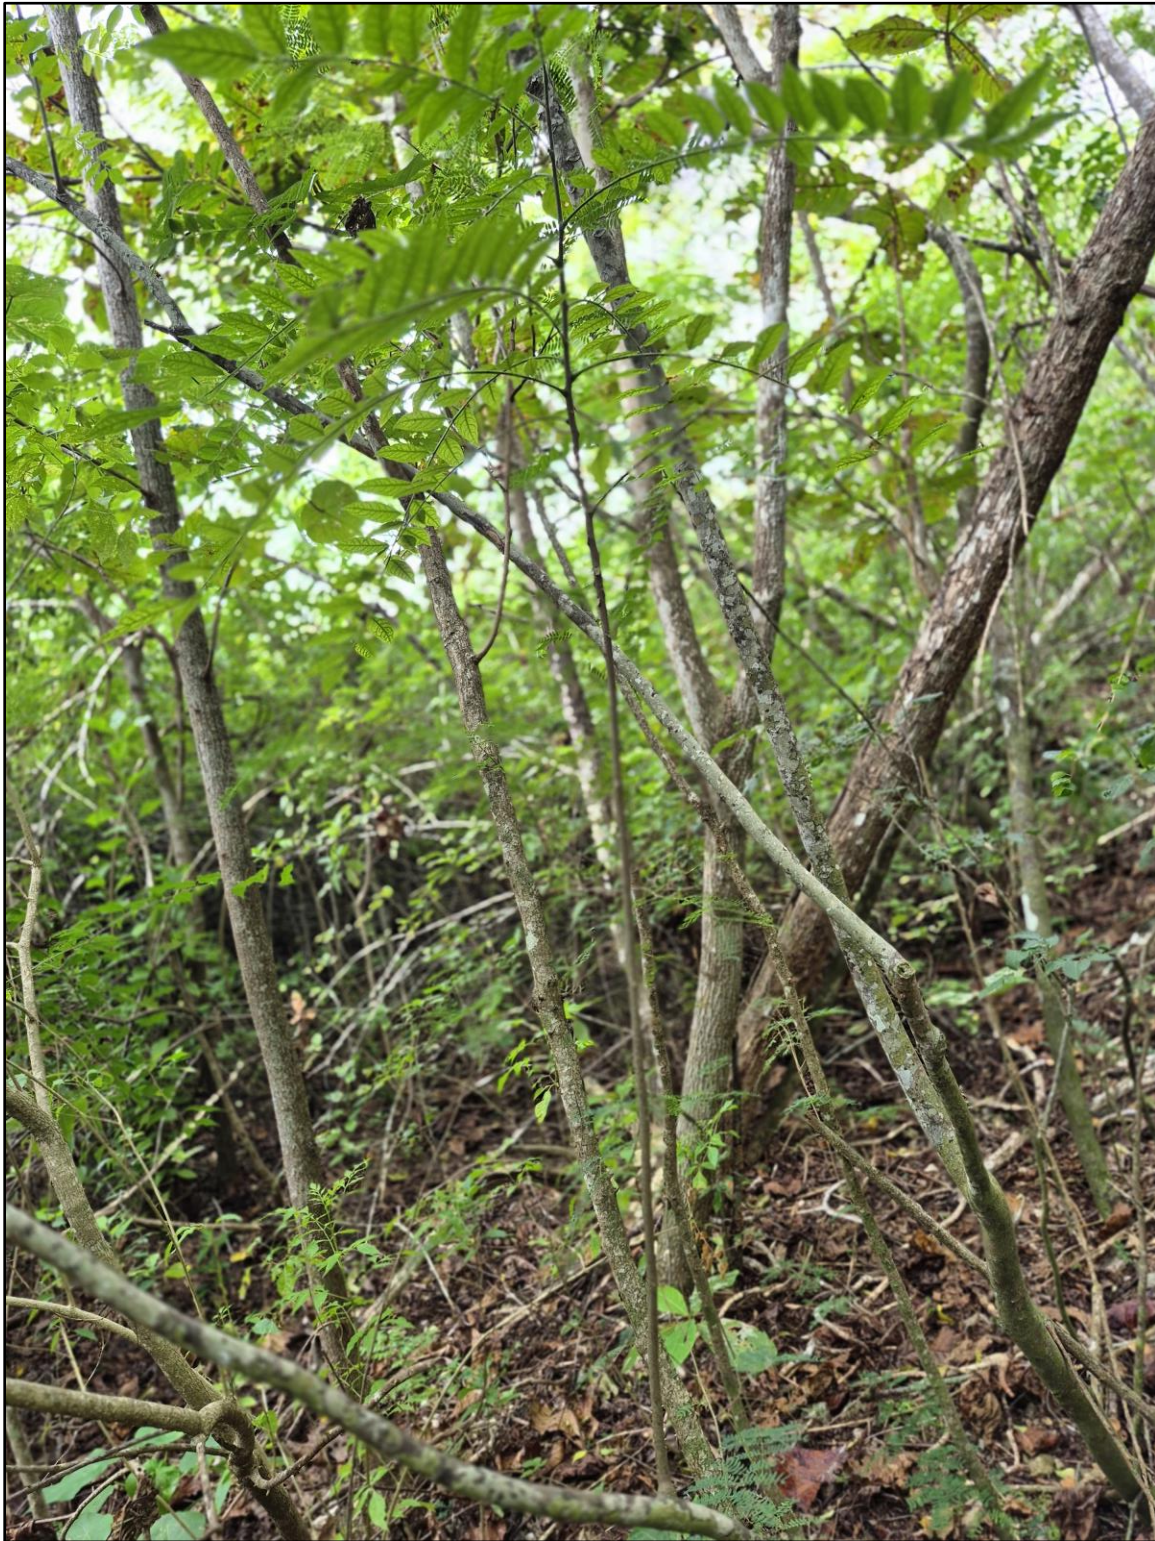
Christmas Island Environmental Services  
Waypoint 2 Photograph

| <b>Topography/Slope:</b> Moderate, NNW | | | <b>Disturbance:</b> Cleared previously, mounds pushed up | | | | |
| <b>Photo ID:</b> 20250625_100408 | | | <b>Vegetation Condition:</b> Good | | | | |

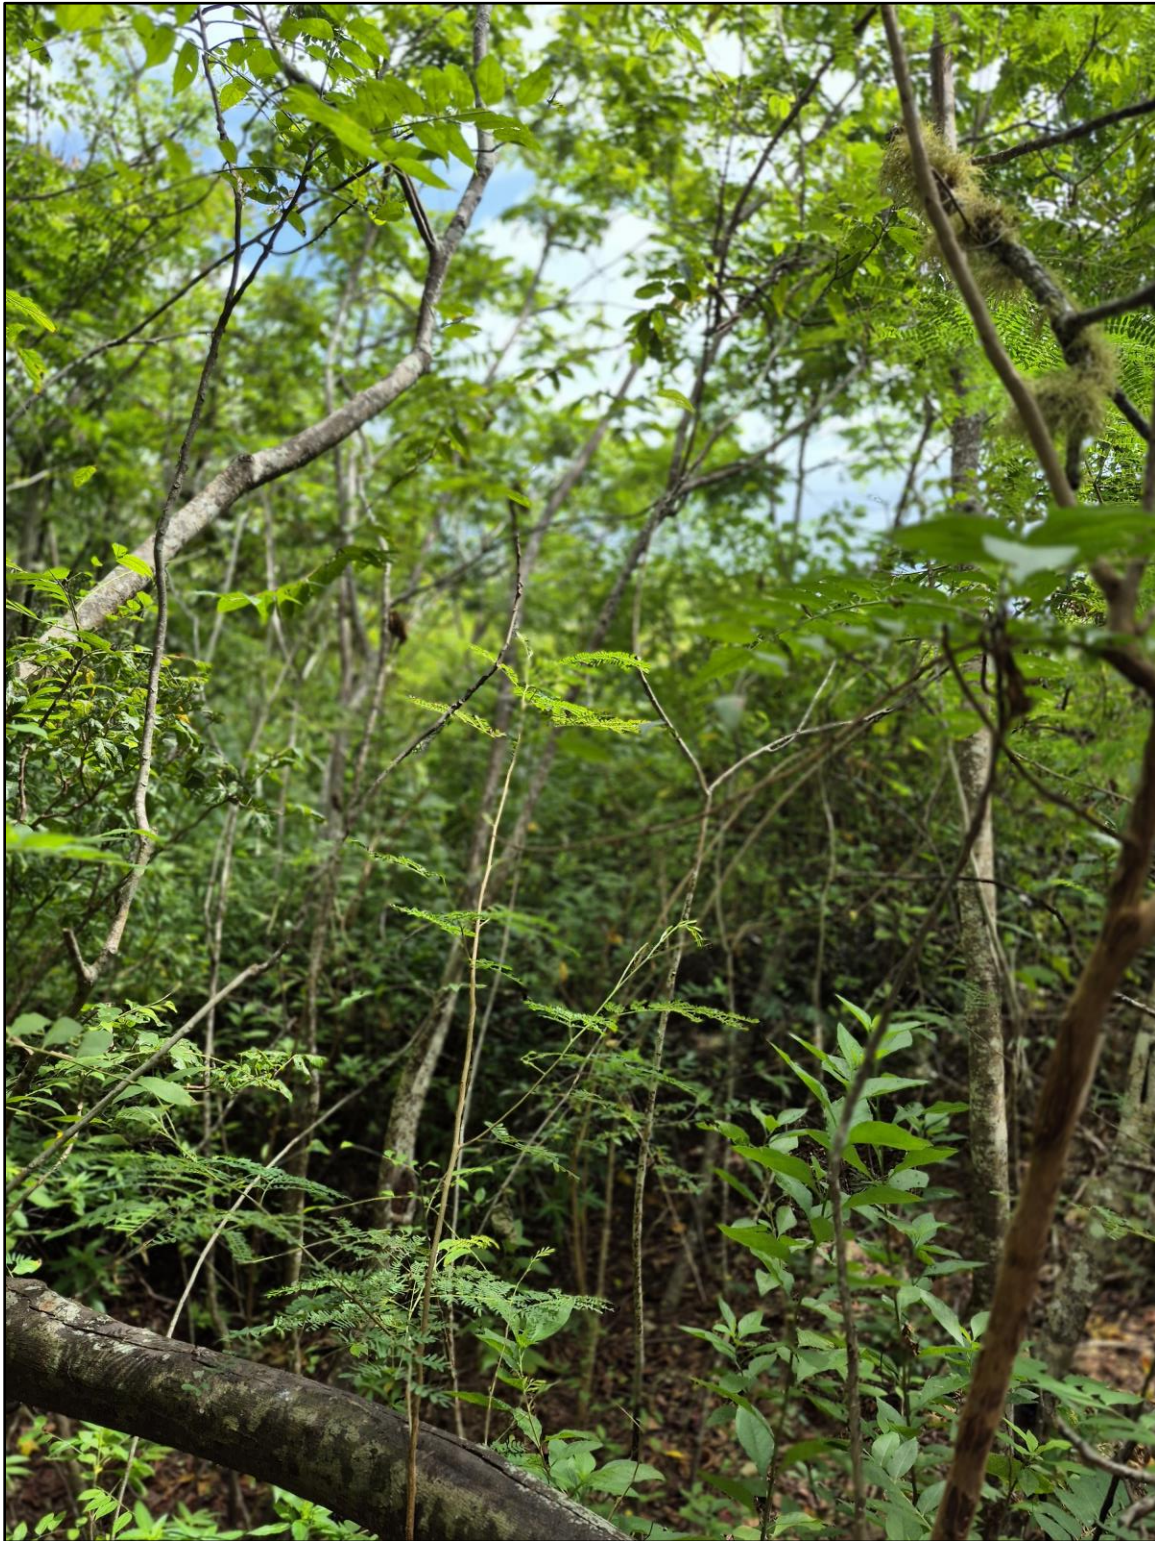
Christmas Island Environmental Services  
Waypoint 3 Photograph

| Flora Survey | | | | | | | |
|---|---|---|---|---|---|---|---|
| Topography/Slope: Moderate, N | | | | Disturbance: Soil pushed up into mounds | | | |
| Photo ID: 20250625_102602 | | | | Vegetation Condition: Good | | | |

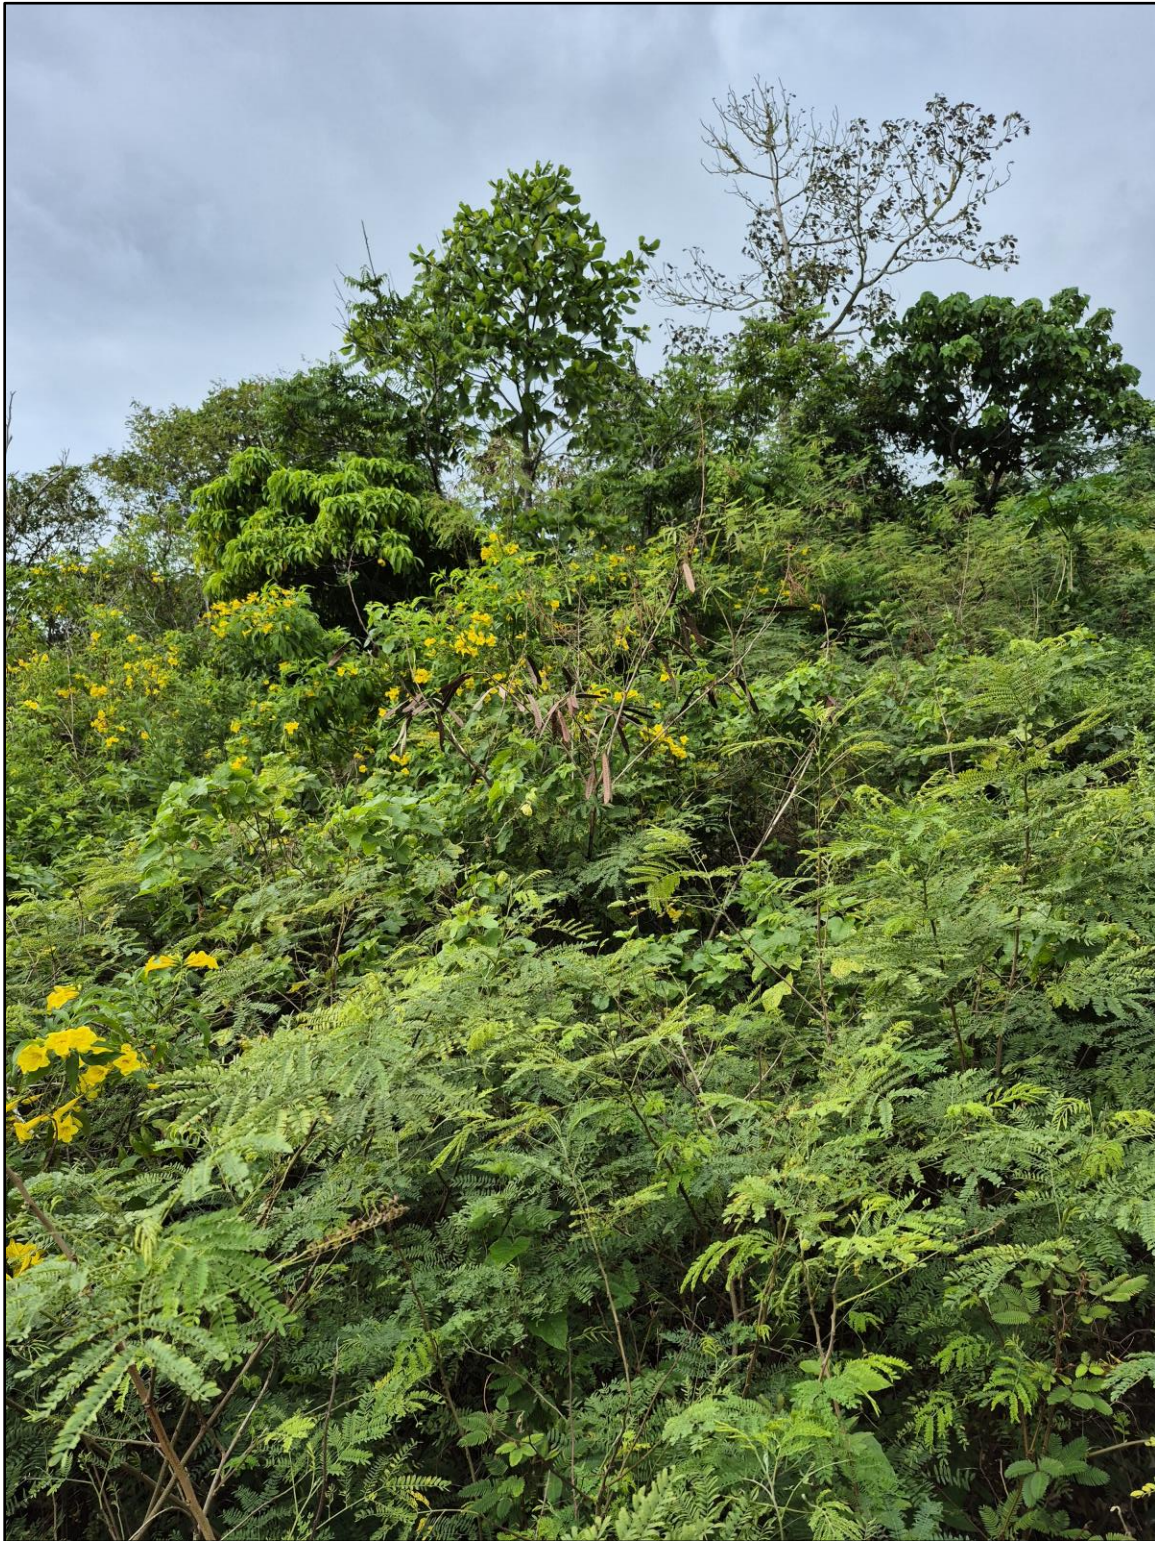
Christmas Island Environmental Services  
Waypoint 4 Photograph

| Flora Survey | | | | | | | |
|---|---|---|---|---|---|---|---|
| Topography/Slope: Moderate, N | | | | Disturbance: Prior cleared with weedy regrowth | | | |
| Photo ID: 20250625_104745 | | | | Vegetation Condition: Completely degraded | | | |

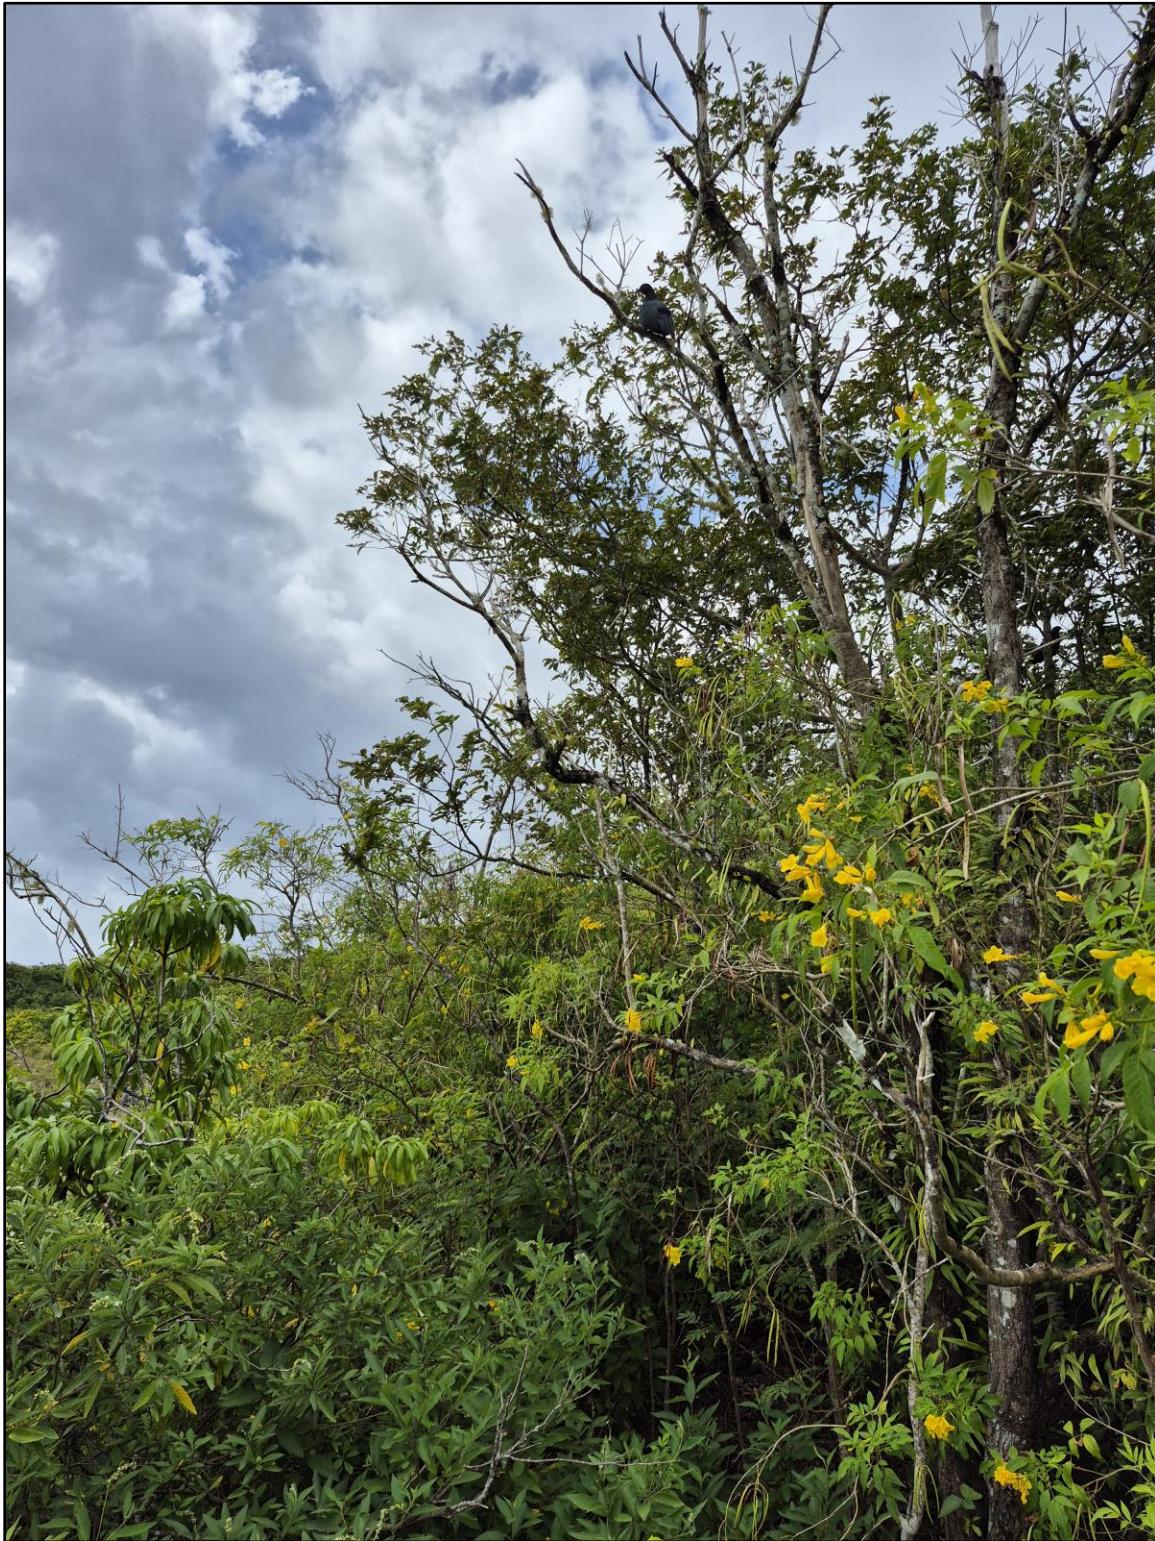
Christmas Island Environmental Services  
Waypoint 5 Photograph

| Flora Survey | | | | | | | |
|---|---|---|---|---|---|---|---|
| <b>Topography/Slope:</b> Moderate, NNW | | | | <b>Disturbance:</b> Prior cleared with weedy regrowth | | | |
| <b>Photo ID:</b> 20250625_110909 | | | | <b>Vegetation Condition:</b> Completely degraded | | | |

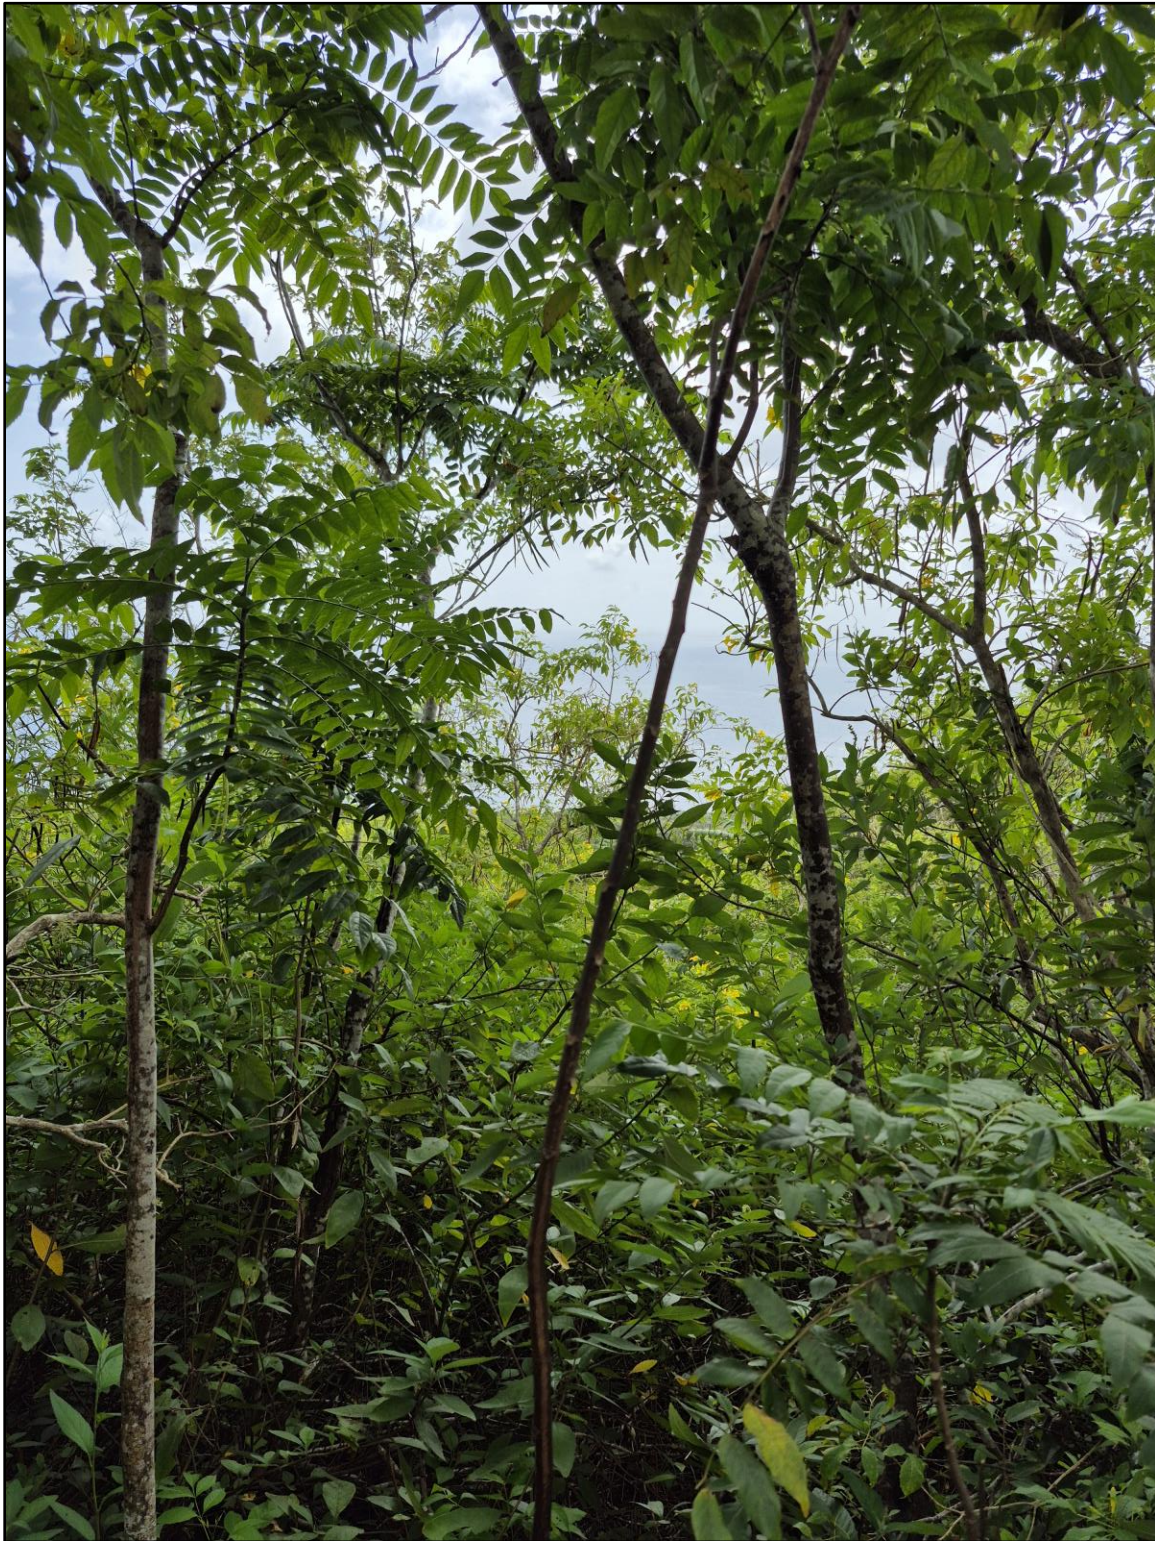
Christmas Island Environmental Services  
Waypoint 6 Photograph

| Flora Survey | | | | | | | |
|---|---|---|---|---|---|---|---|
| <b>Topography/Slope:</b> Moderate, NNW | | | | <b>Disturbance:</b> Prior cleared with weedy regrowth | | | |
| <b>Photo ID:</b> 20250625_112458 | | | | <b>Vegetation Condition:</b> Completely degraded | | | |

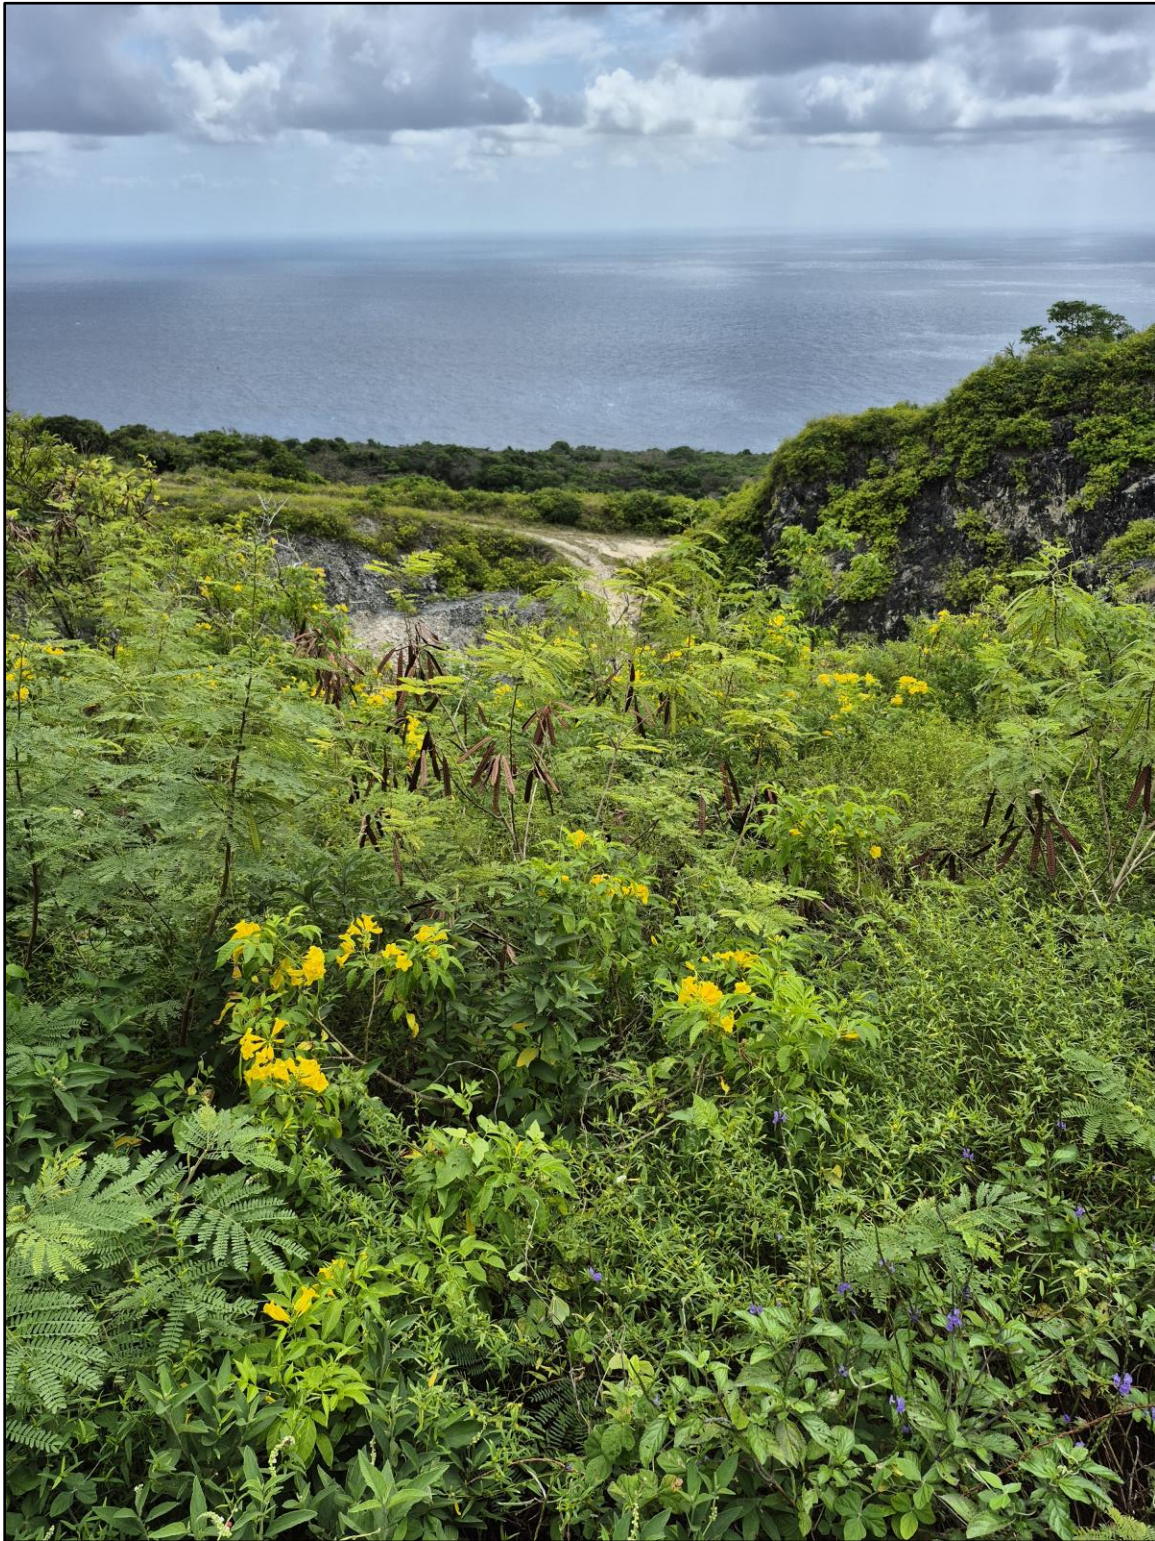
Christmas Island Environmental Services  
Waypoint 7 Photograph

| <b>Topography/Slope:</b> Moderate, NNW | | | | <b>Disturbance:</b> Prior cleared with weedy regrowth | | | |
| <b>Photo ID:</b> 20250625_114612 | | | | <b>Vegetation Condition:</b> Completely degraded | | | |

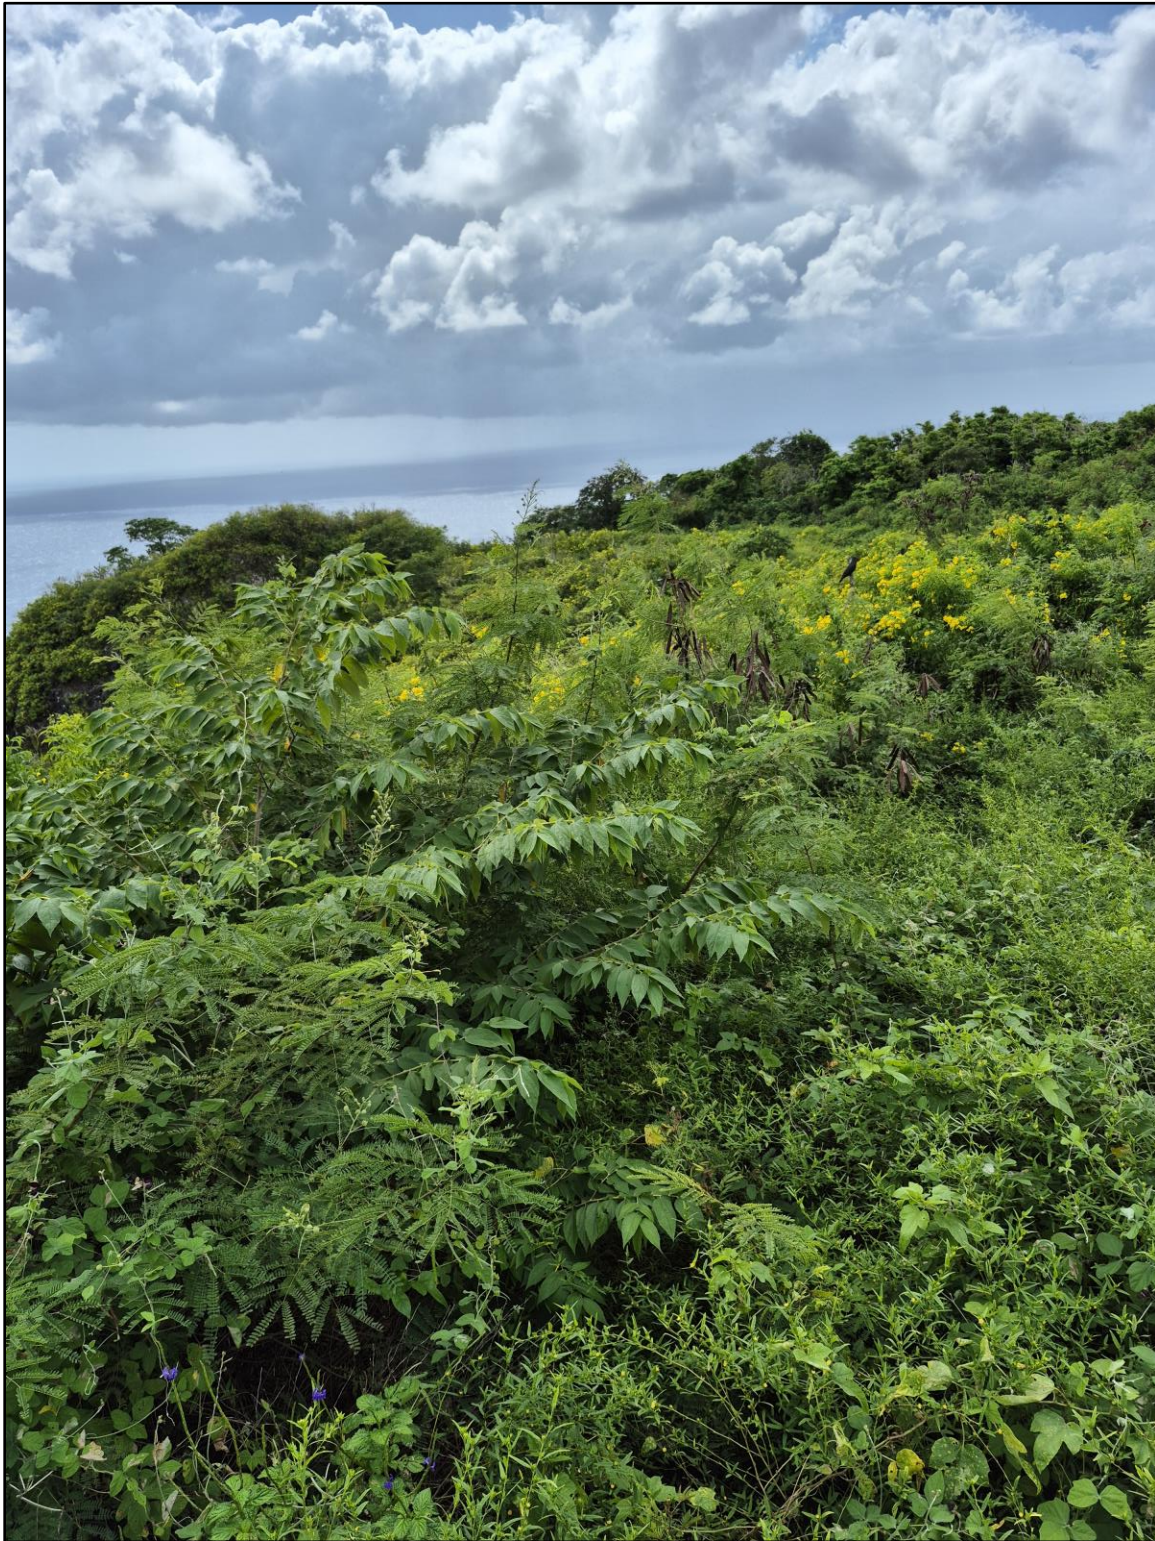
Christmas Island Environmental Services  
Waypoint 8 Photograph

| <b>Topography/Slope:</b> Moderate, NW | | | | <b>Disturbance:</b> Prior cleared with weedy regrowth | | | |
| <b>Photo ID:</b> 20250625_115650 | | | | <b>Vegetation Condition:</b> Completely degraded | | | |

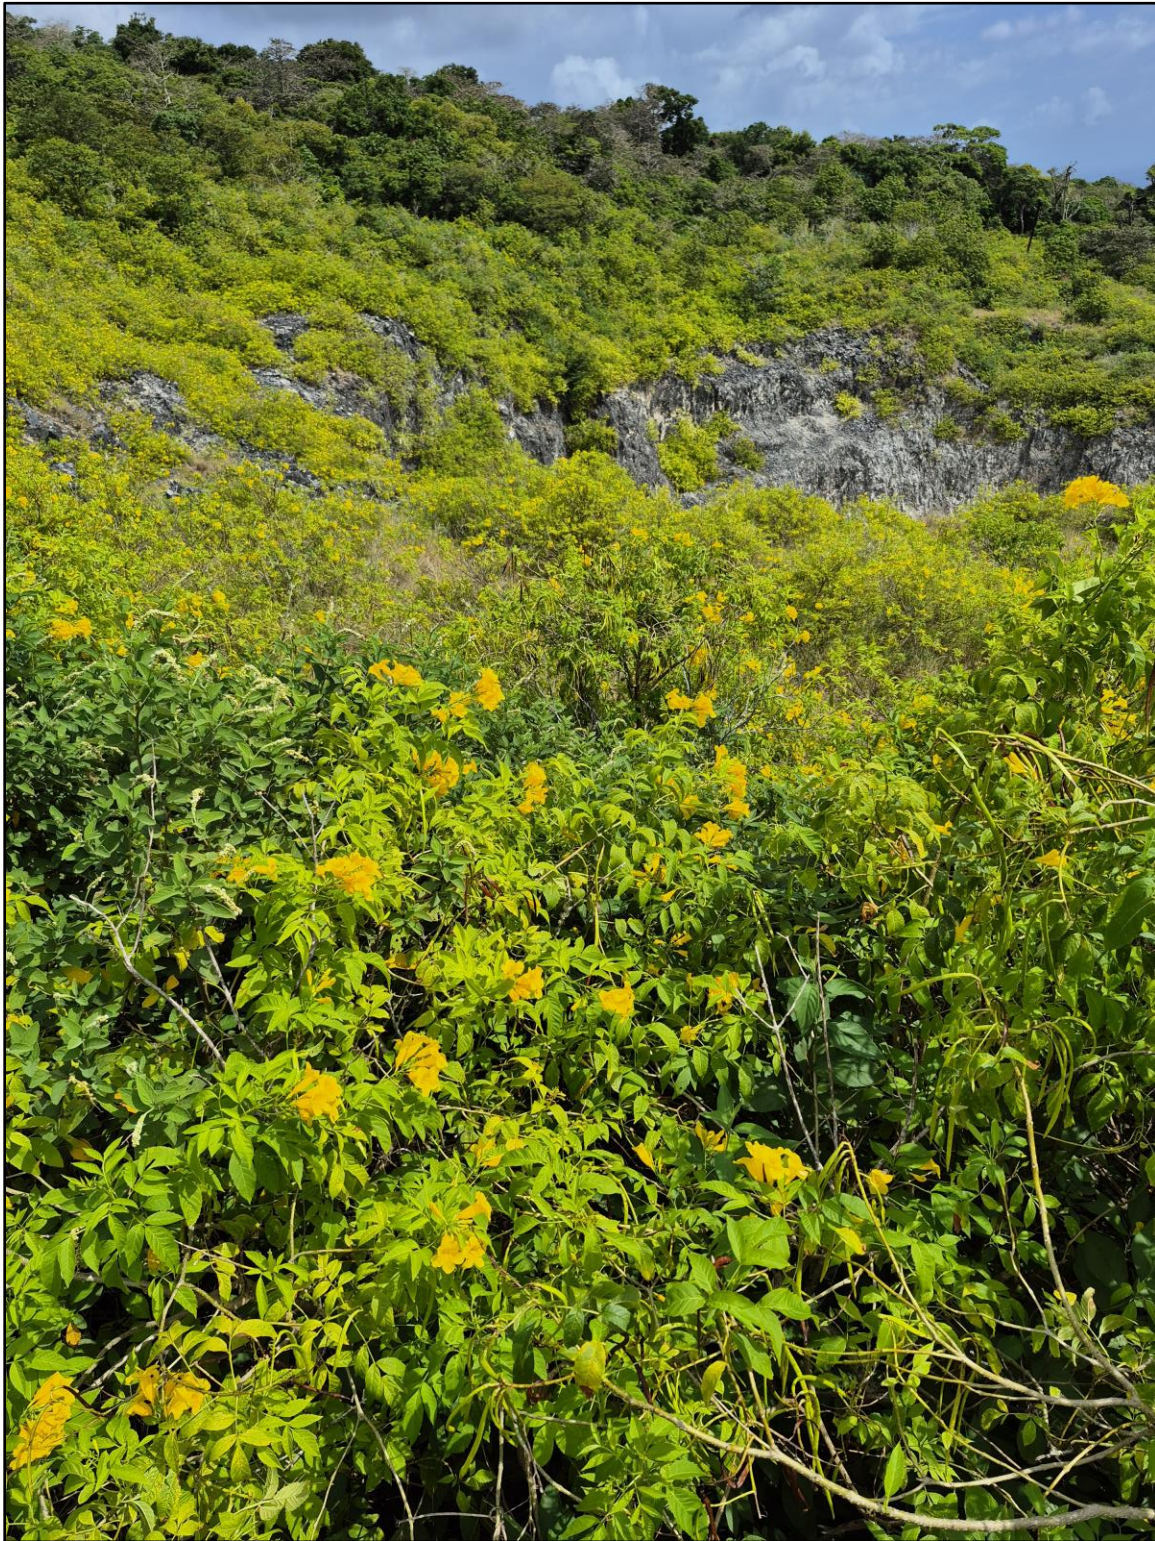
Christmas Island Environmental Services  
Waypoint 9 Photograph

| <b>Photo ID:</b> 20250625_120803 | | | | <b>Vegetation Condition:</b> Completely degraded | | | |

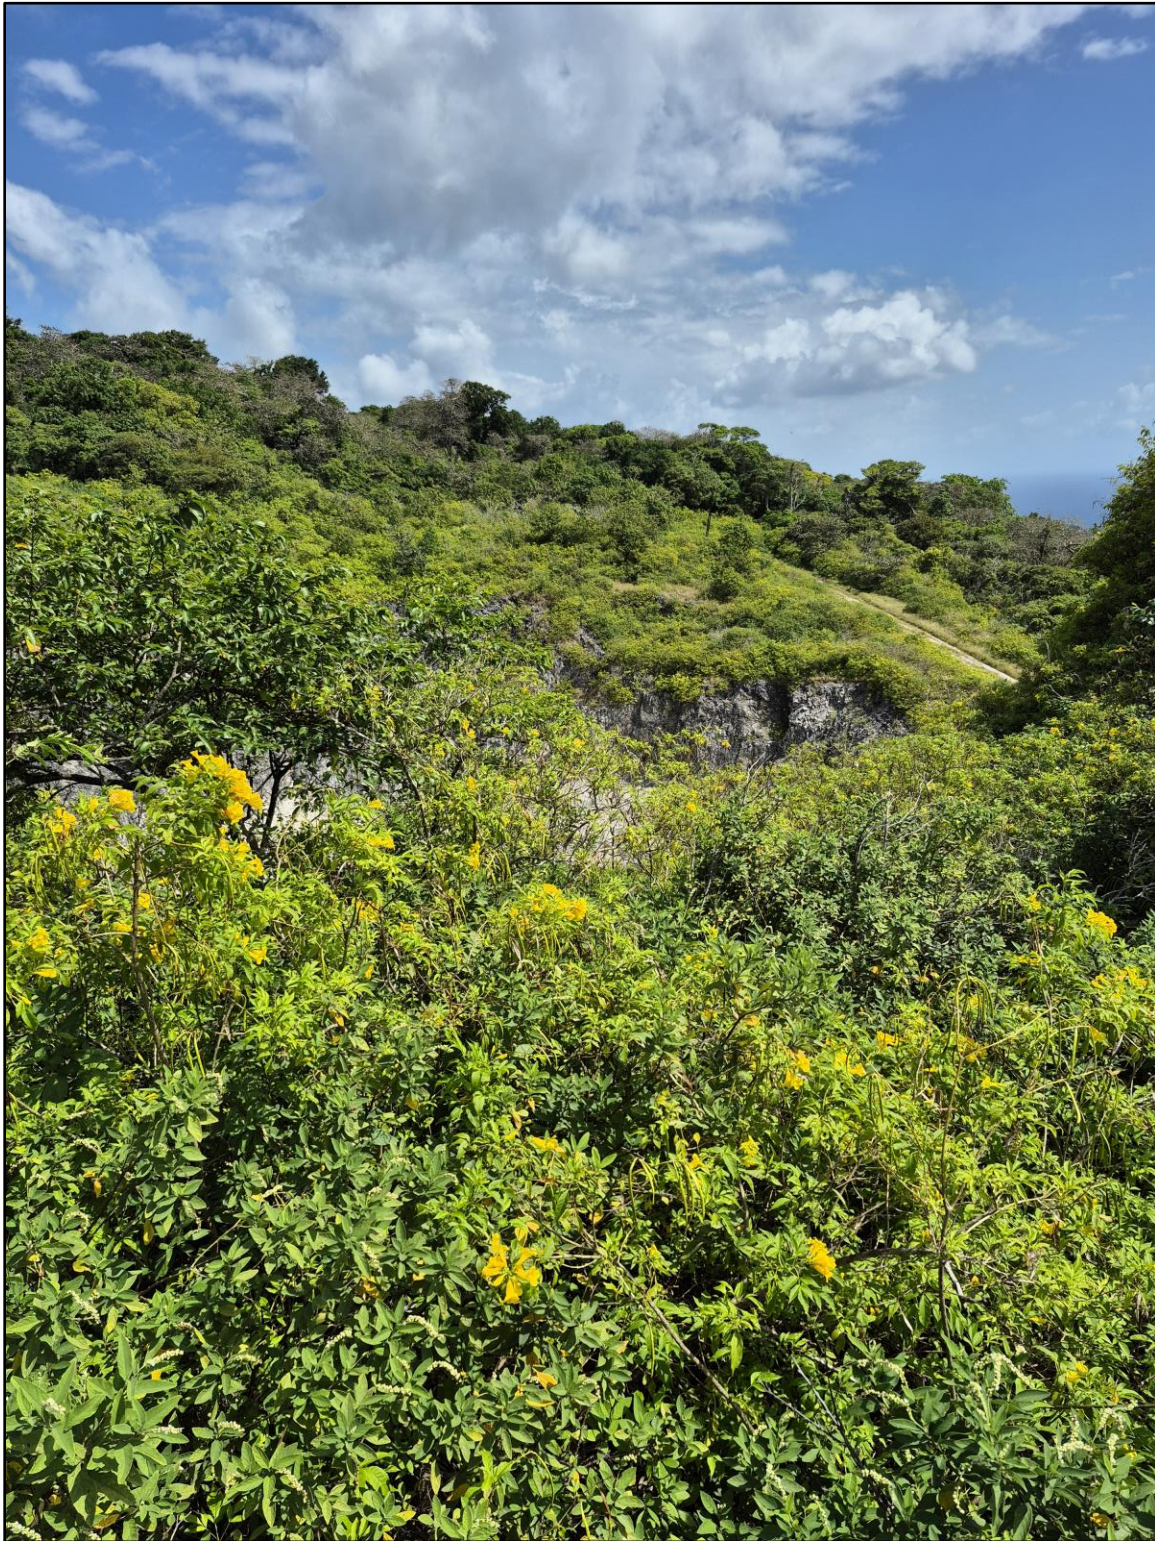
Christmas Island Environmental Services  
Waypoint 10 Photograph

| <b>Photo ID:</b> 20250625_121807 | | | | <b>Vegetation Condition:</b> Completely degraded | | | |
