Environment Survey

Proposed Emergency Access Way (EAW)

Marshwood Place, Lot 11099 and Lot 12394 Lance St, Sawyers Valley

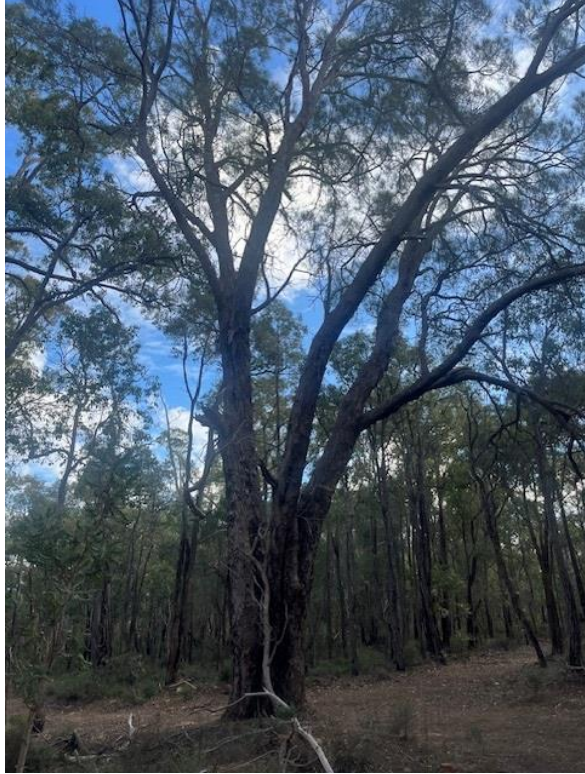
Photo 1: *Allocasuarina fraseriana* (Sheoak), bifurcated, in average condition with some decline noted in the canopy. No hollows visible with a diameter at breast height over 100cm. This tree is in the middle of the EAW.

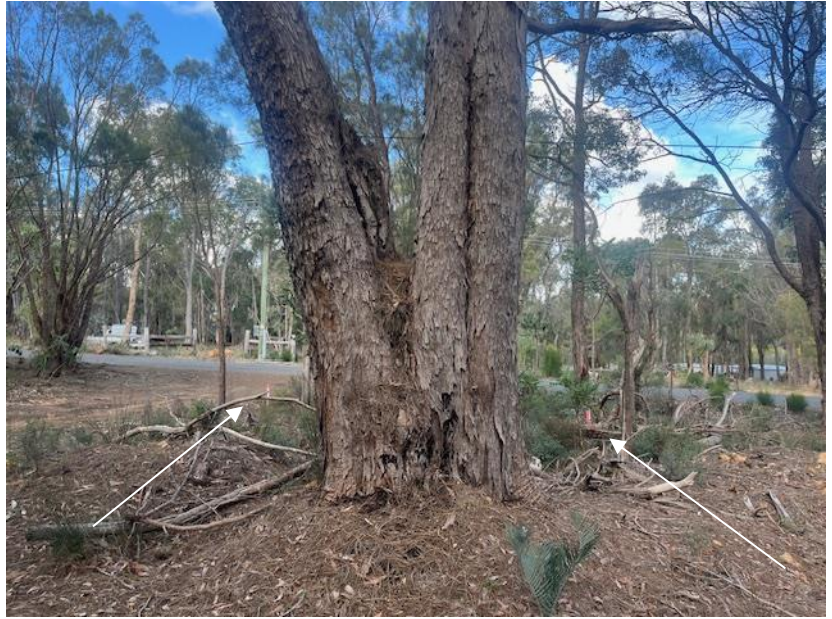
Photo 2: Another view of the Sheoak. Surveyed pegs (seen in the background) indicate the boundary of the EAW. All options were explored to consider retaining the tree however due to the location, removal is considered unavoidable.

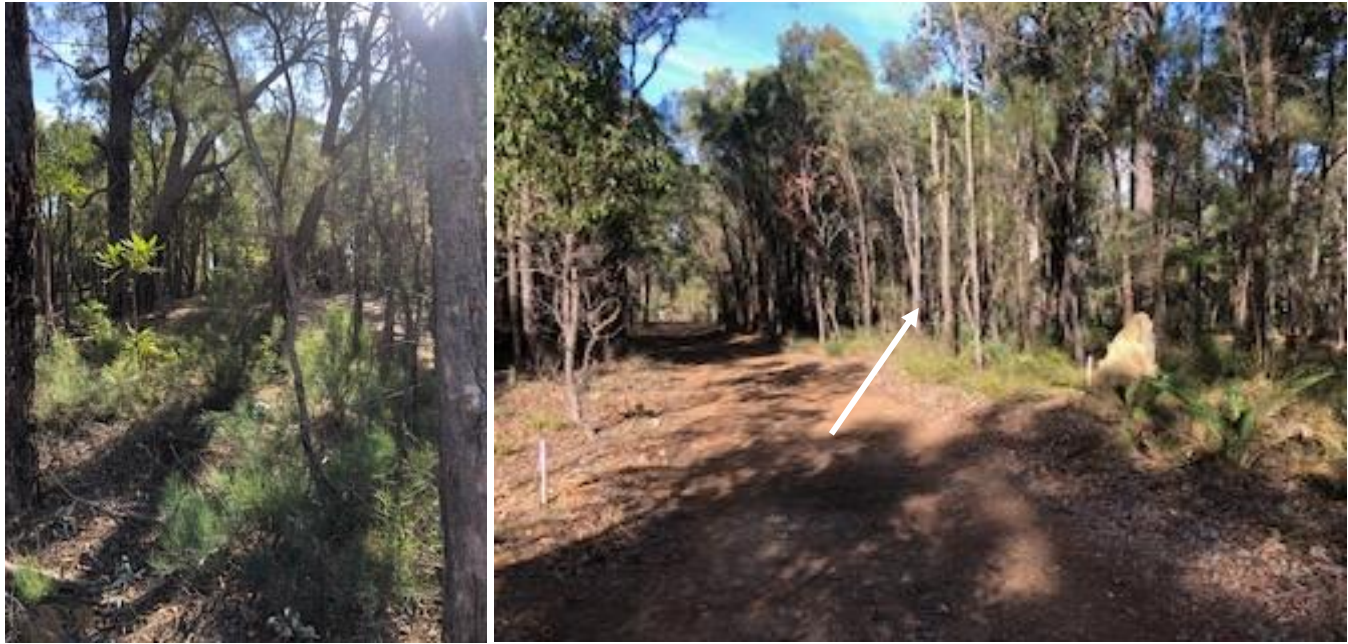
Photo 3 (above): Vegetation in the southern section of the Shire ROW. There is a mix of canopy of *Eucalyptus marginata* (Jarrah), *Corymbia calophylla* (Marri), *Allocasuarina fraseriana* (Sheoak), *Banksia grandis* (Bull Banksia) along with a diverse understorey (including *Bossiaea* sp, *Banksia dallanneyi*, native grasses and sedges) and midstory (mainly *Xanthorrhoea preissii* and *X. gracillis*).

Photo 4 (above right): EAW impacts vegetation as seen in the right of photo 2. The cleared area shown (existing track) is on private property.

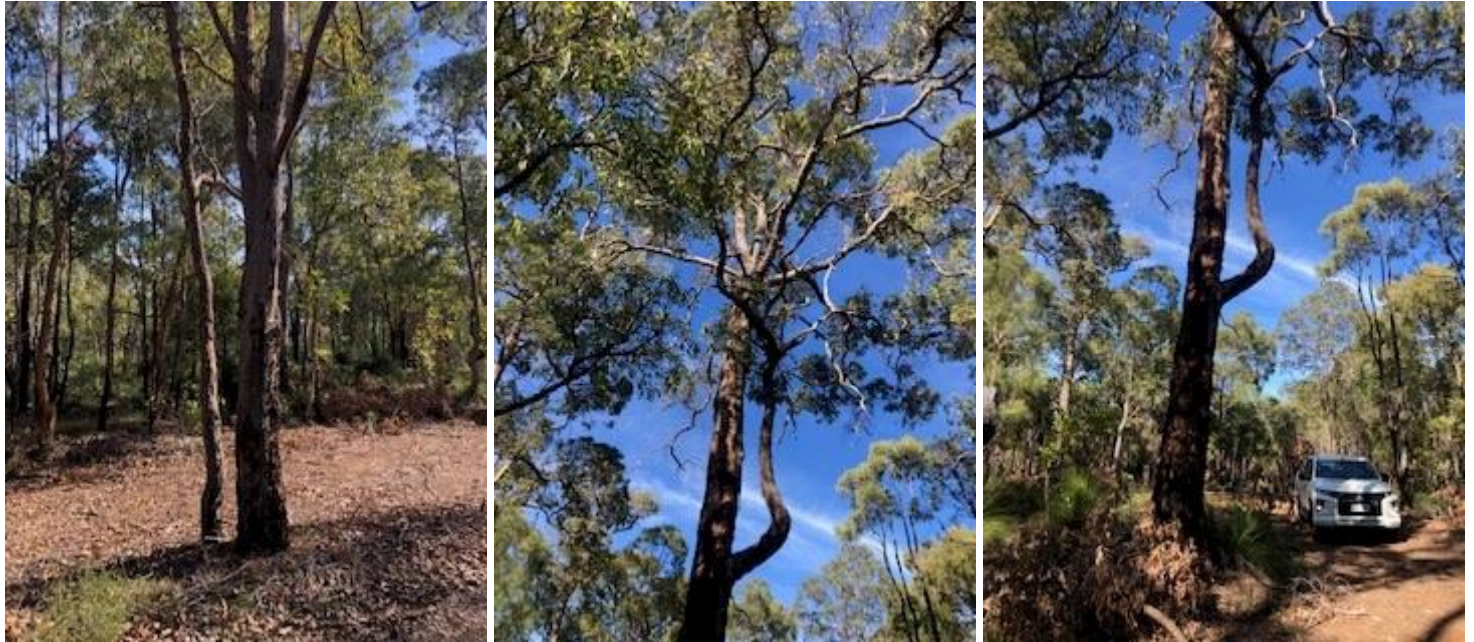
Photo 5 (left): Two (2) *Corymbia calophylla* (Marri) in the EAW. Diameter at breast height (DBH) measurements of approximately 10cm and 30cm. No hollows in either tree.

Photos 6 and 7 (above right): *Corymbia calophylla* (Marri) within the EAW. Average condition, showing decline in the canopy. DBH of approximate 80cm. No hollows are visible.

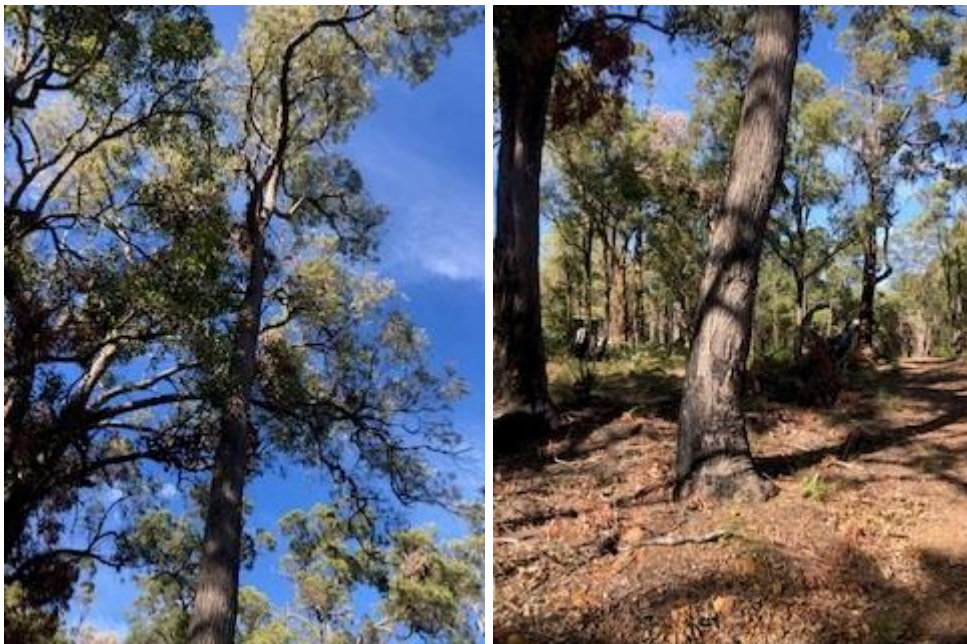
Photo 8 and 9: *Eucalyptus marginata* (Jarrah) tree with a DBH of approximately 60cm. It is on the edge of the EAW and all efforts will be made to retain this tree.

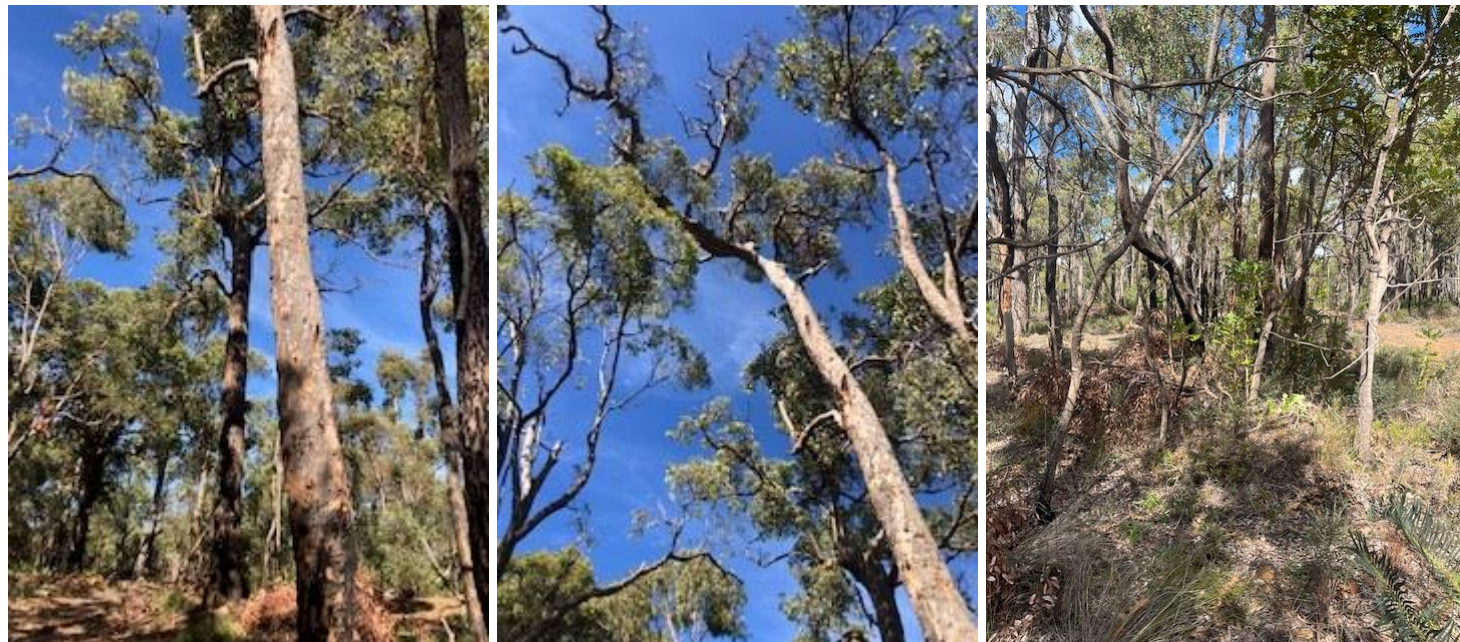
Photos 9 and 10: Two (2) *Corymbia calophylla* (Marri) trees in the EAW. Both are in poor condition, with a declining canopy. Both with a DBH that measures approximately 90cm. No hollows visible. Nearby *Banksia grandis* was observed to be in decline or already dead. Phytophthora dieback may be present.

Photo 11: Another view of the vegetation within area C.

Recommend the following actions are in place prior to construction:

- Prepare a Dieback Management Plan outlining hygiene measures to prevent the spread of dieback
- Prior to construction, the Shire's Tree Supervisor to inspect habitat and significant trees to ensure no hollows or fauna are present.
- Any viable hollows placed in nearby bushland for ground dwelling animals.

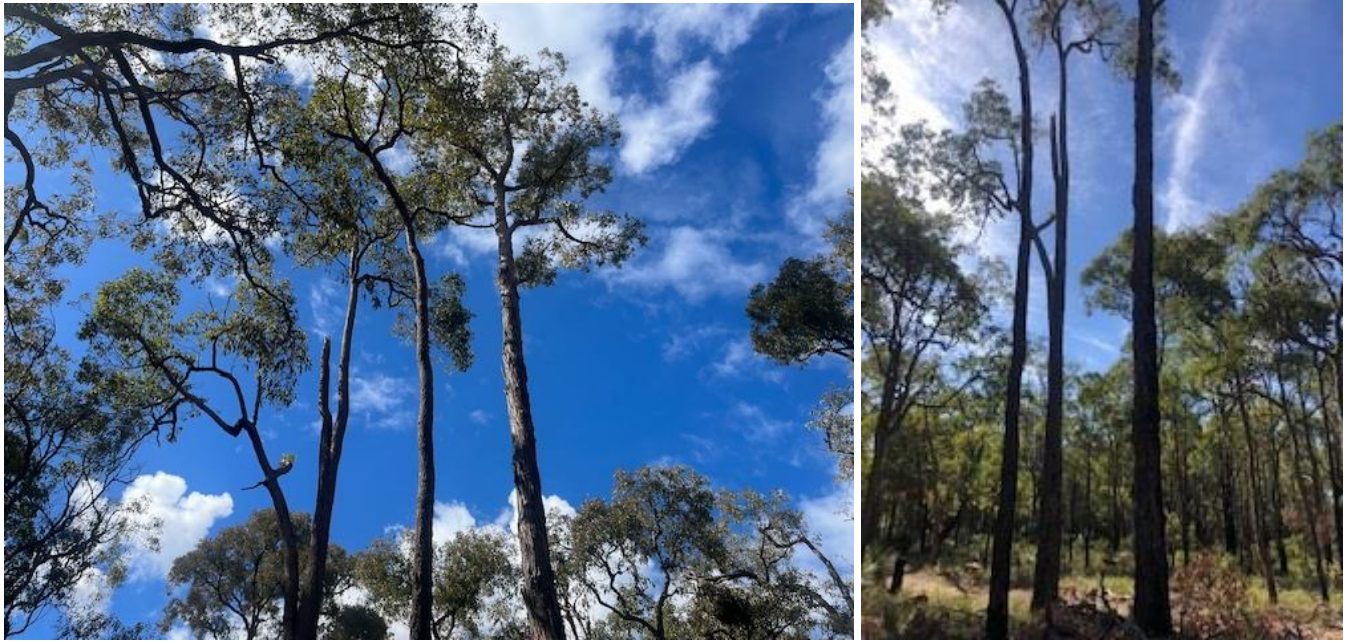
Photo 12 and 13: Three (3) trees within the EAW. Left to right – *Corymbia calophylla* (Marri) 20cm DBH, *Corymbia calophylla* (Marri) 60cm DBH and *Eucalyptus marginata* (Jarrah) 80cm DBH. No hollows visible.

View of the tops of the tree shows they have been heavily pruned in the past.

Trees are in the middle of the EAW and removal is unavoidable.

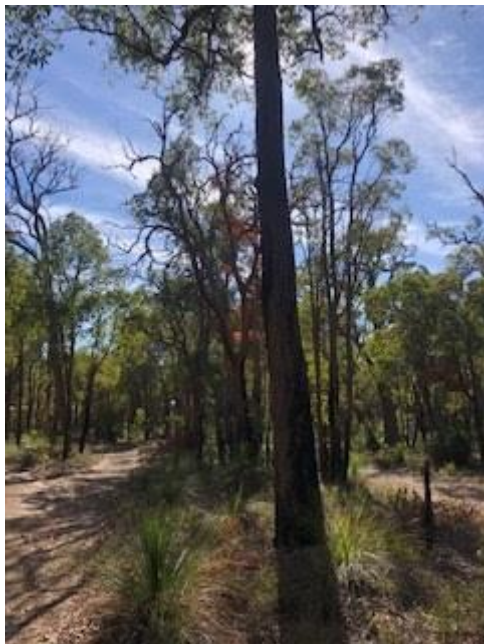
Photo 14: *Corymbia calophylla* (Marri) trees near the northern edge of Area C. Efforts will be made to retain this tree as it is on the edge of the EAW boundary.

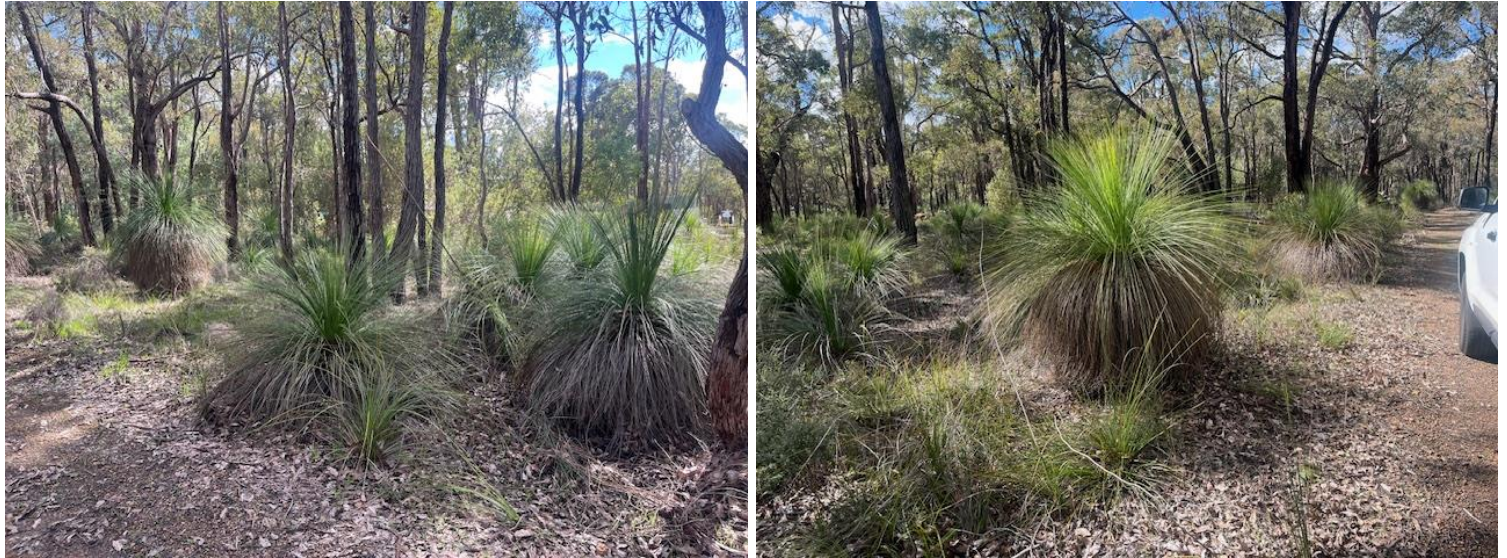
Photo 15 (above left): Several grass trees along the edge of the existing track. Efforts will be made to retain where possible and the EAW has been designed for least impact. However, there are several that will be removed for the proposed works

Photo 16 (above right): Alternative view of the grass trees.

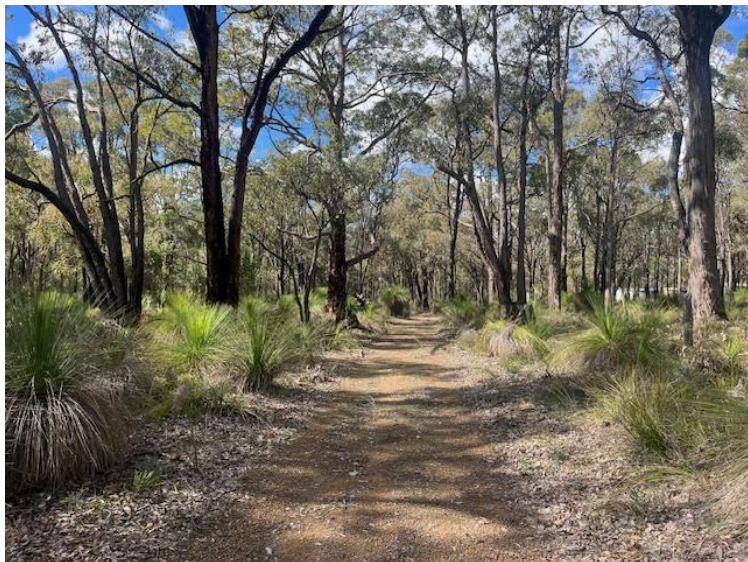
Photo 17: View of the existing track that the EAW will be constructed through. Trees can be retained in this location as seen above, however, some pruning of lower hanging branches is expected.

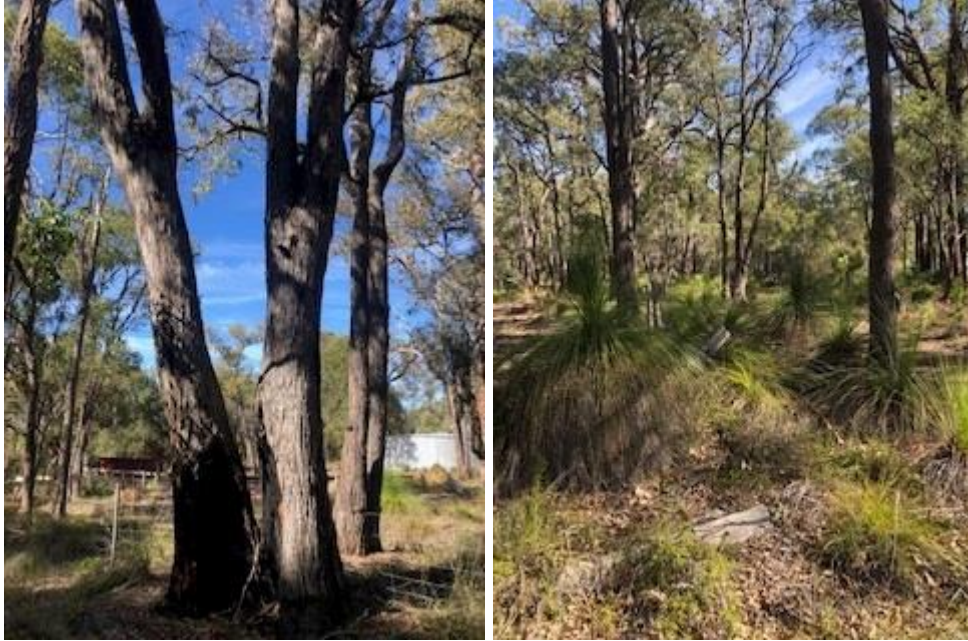
Photo 18: *Eucalyptus marginata* (Jarrah) trees that can be retained.

Photo 19 (above right): *Xanthorrhoea preissii* (Grass trees) in the road reserve. Alignment of the EAW has been designed to retain as many grass trees as possible. However, there will be instances where this is unavoidable.

Recommend the following actions are in place prior to construction:

- Grass Trees Australia is contacted to investigate if it is viable to relocate the grass trees that will be removed for the proposed works.
- Prior to works it is recommended that grass trees are visually inspected for any nests and signs of Quenda activity (i.e. under the skirts).
- Works proceed in a single direction to allow fauna the opportunity to move away from machinery.

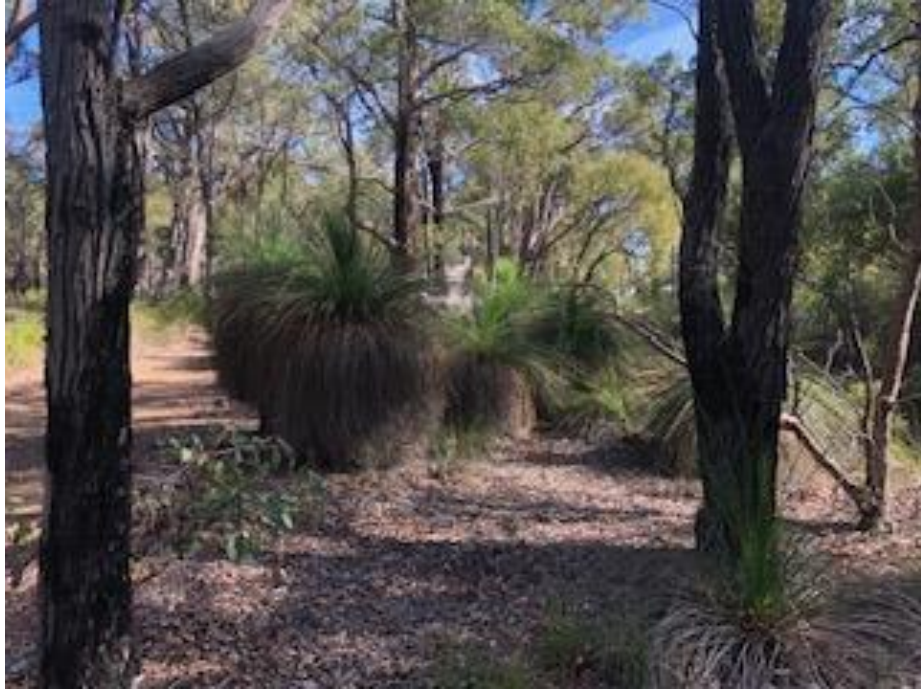
Photo 20 (above left): Cluster of grass trees that will be retained, as road will curve around to avoid them.

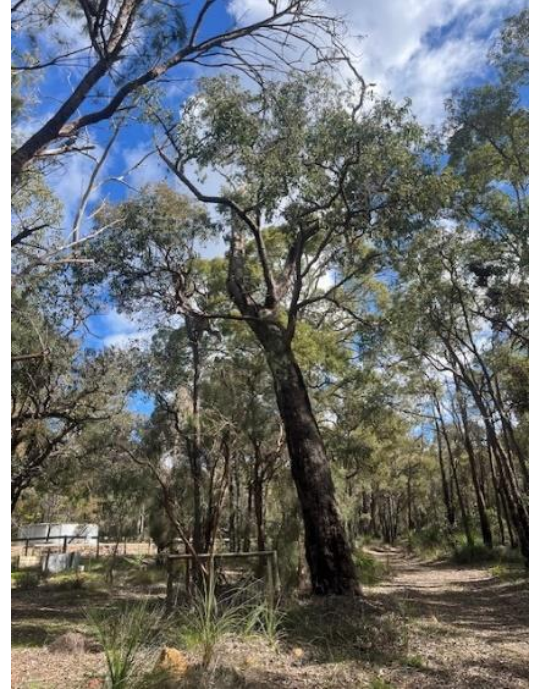
Photo 21: large tree as seen in the photo (left hand side) can be retained as road alignment can be constructed to avoid this tree. Marri tree 1100 DBH

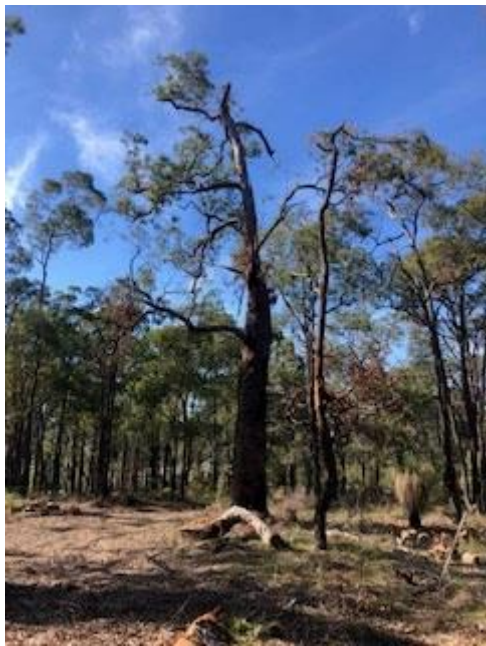
Photo 22 (above right): Recent branch failure has occurred in this tree, creating a potential hollow at the fracture point. Removal is likely, as the road alignment is designed to avoid another significant tree. Shire's Tree Supervisor to inspect the hollow prior to work, to ensure no hollows or fauna present.

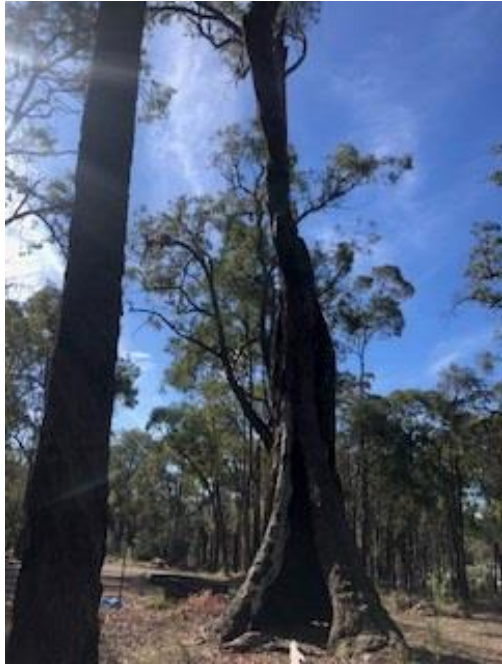
Photo 23 (above left): Shire's Tree Supervisor to assess the structure and health of the habitat tree. Efforts made to retain this tree if considered structurally sound. Jarrah DBH over 200cm

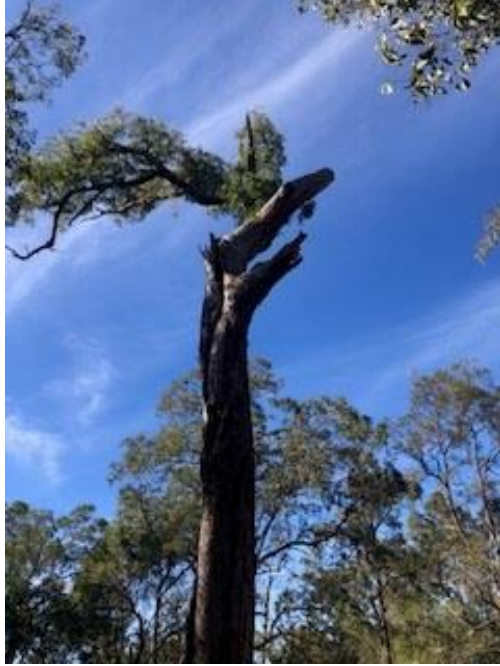
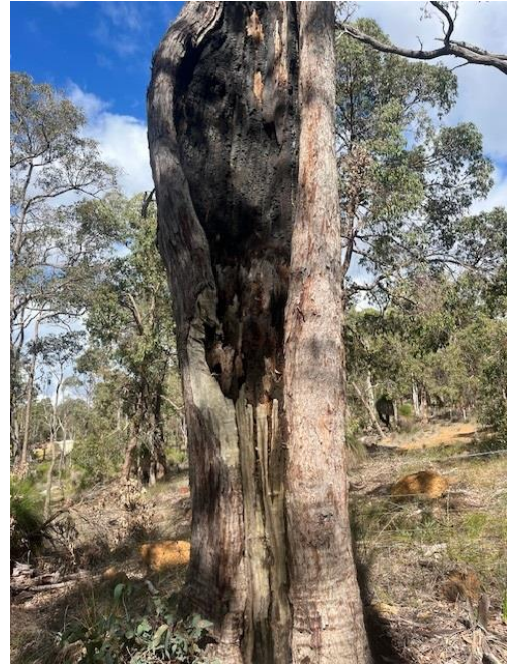
Photo 24 and 25: Tree to be removed. Hollow is currently occupied by European bees. Tree is not structurally sound. Bees at top and severe termite activity from the base to the top. Photo 25 shows the base of the tree and termite activity.

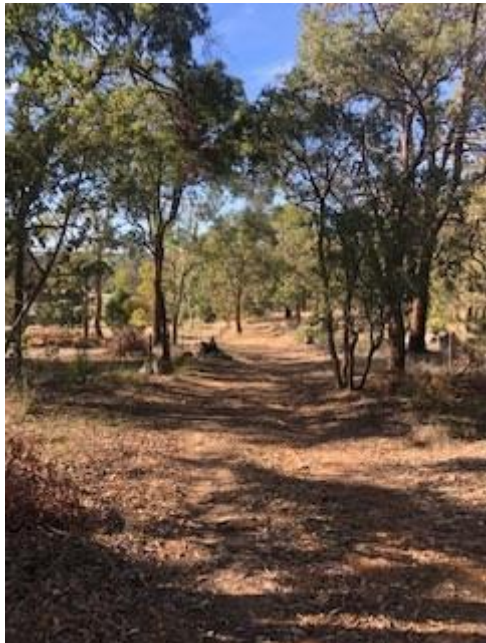
Photo 26 (above right): The EAW will follow the already constructed track and has been designed to retain and reduce overall impact to surrounding vegetation. There is potential for offset planting to the left; however, any planting must have trees spaced at 20-metre intervals and set back sufficiently from the EAW to ensure they are not impacting the road at maturity.

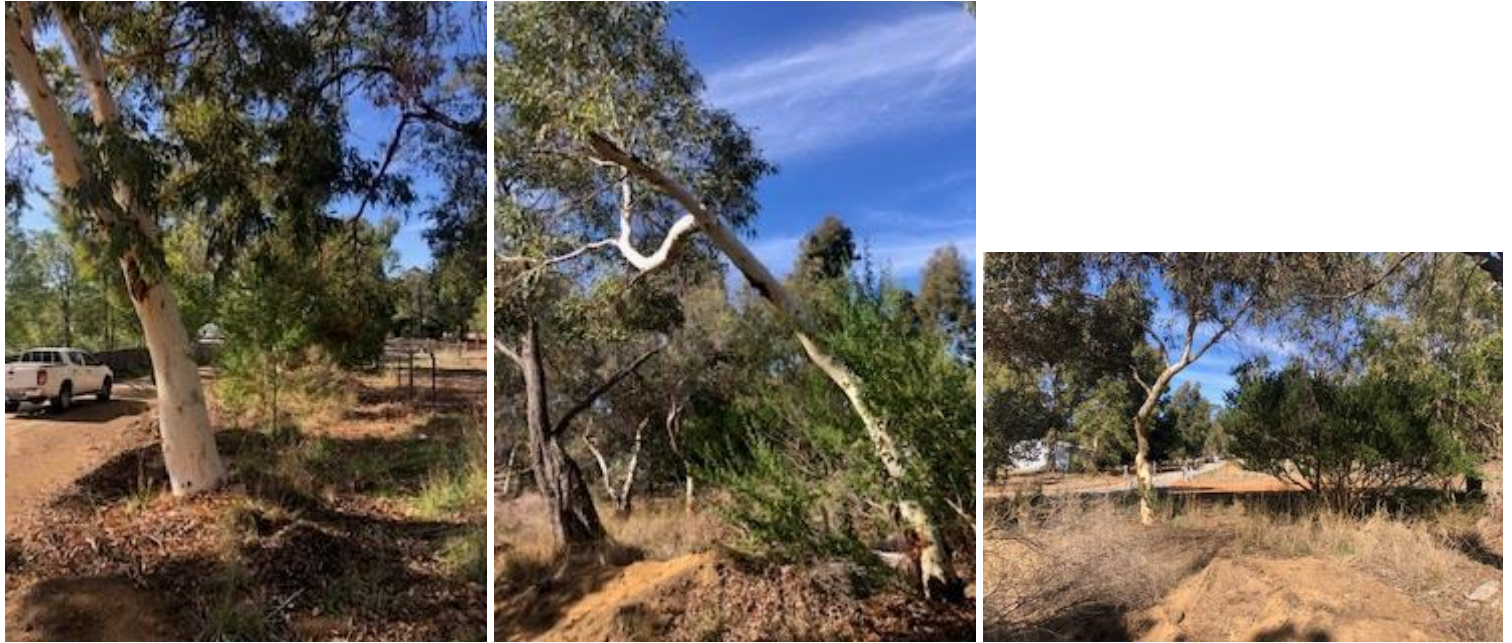
Photo 27 and 28: Planted vegetation with evidence of past pruning. Many specimens are in poor condition. The midsection is dominated by *Calothamnus rupestris* (Mouse Ears) likely planted as part of the Shire Tree Canopy and Understorey Program.

Photo 29 (above right): The EAW will provide connection to Jamroz Court, and linkage through to Lion Street. Vegetation is mainly weedy with tagasaste and weedy grasses and a few planted natives.
