Tree Protection Plan (TPP) and Tree Protection Specifications (TPS)

Prepared for Christopher & Jessica Coles
95 Paini Way, Jandabup WA 6077
City of Wanneroo

Prepared by Rowan Barkey – Consulting Arborist (AQF Level 5, *Dip. Arboriculture*)
Sorbus Arbor Consulting | ABN 98 356 184 454
Date: 13 November 2025

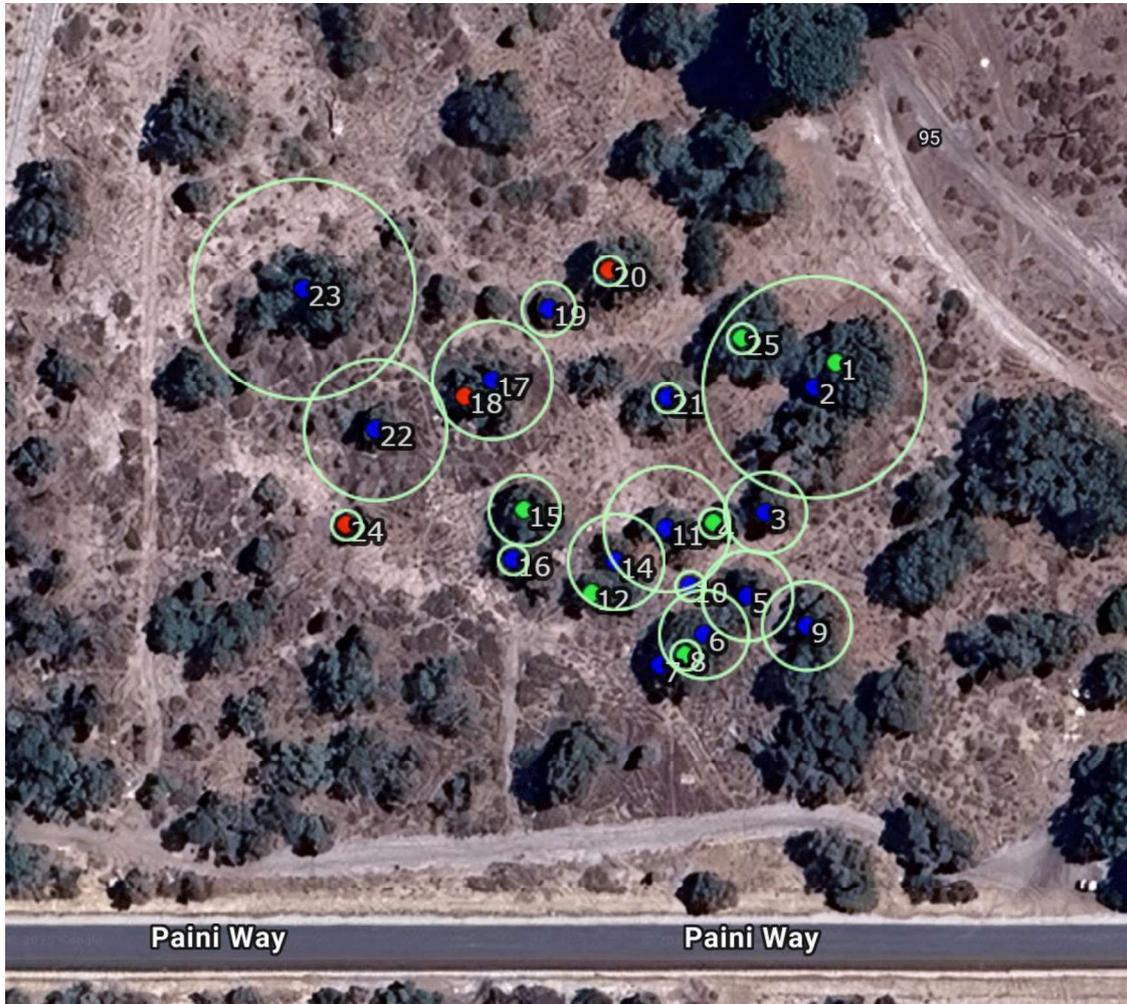
Trees surveyed within proposed build envelope with TPZs indicated with green circles

The site is located at 95 Paini Way, Jandabup (City of Wanneroo). Existing firebreaks and vegetated areas influence siting. Envelope 2 positions the dwelling approximately 21 m from the firebreak; the original envelope would be fewer than 5 m from the firebreak.

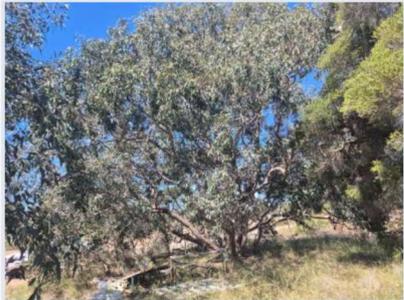
Flooded Gum Tree ID #1 95 Paini Way	
Tree Details	Tree Location
Tree Id: 1	Longitude: 115.866937
Botanical Name: Eucalyptus rudis subsp. rudis	Latitude: -31.746467
Common Name: Flooded Gum	Address: 95 Paini Way
Genus:	City: Jandabup
Health: Fair	Photos Street View Map View
Status: Alive

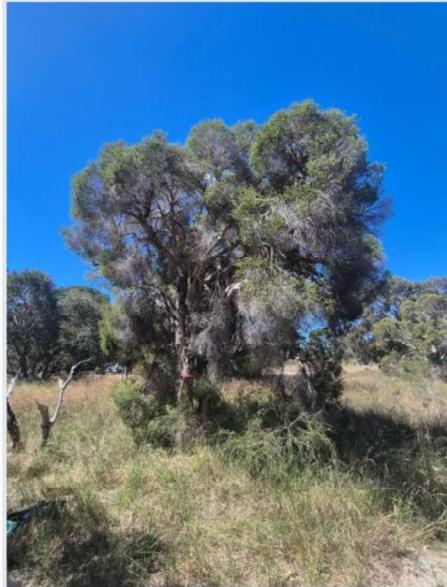
<u>Moonah, Dryland Tea-tree Tree ID #3</u> 95 Paini Way	
Tree Details	Tree Location
Tree Id: 3	Longitude: 115.866837
Botanical Name: Melaleuca lanceolata	Latitude: -31.746650
Common Name: Moonah, Dryland Tea-tree	Address: 95 Paini Way
Genus:	City: Jandabup
Health: Good	Photos Street View Map View
Status: Alive

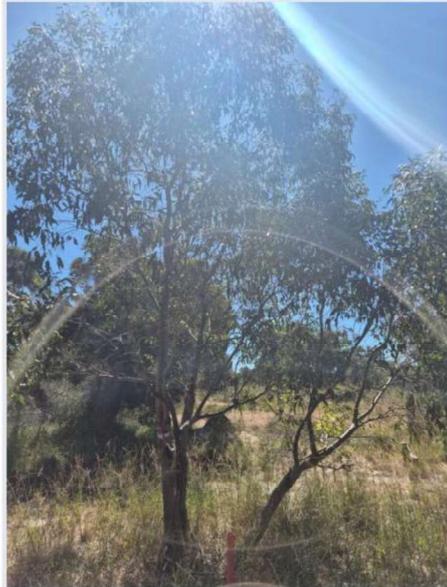
<u>Flooded Gum Tree ID #4</u> 95 Paini Way	
Tree Details	Tree Location
Tree Id: 4	Longitude: 115.866763
Botanical Name: Eucalyptus rudis subsp. rudis	Latitude: -31.746663
Common Name: Flooded Gum	Address: 95 Paini Way
Genus:	City: Jandabup
Health: Good	Photos Street View Map View
Status: Alive

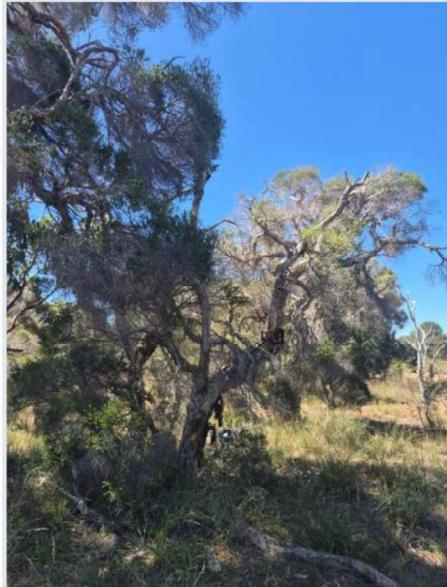
<u>Moonah, Dryland Tea-tree Tree ID #6</u> 95 Paini Way	
Tree Details	Tree Location
Tree Id: 6	Longitude: 115.866749
Botanical Name: Melaleuca lanceolata	Latitude: -31.746798
Common Name: Moonah, Dryland Tea-tree	Address: 95 Paini Way
Genus:	City: Jandabup
Health: Poor	Photos Street View Map View
Status: Alive

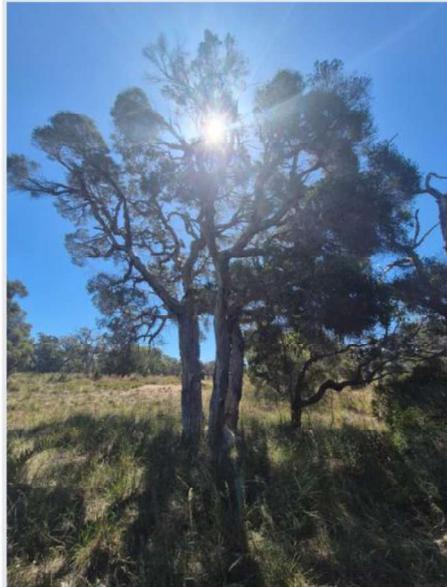
<u>Moonah, Dryland Tea-tree Tree ID #7</u> 95 Paini Way	
Tree Details	Tree Location
Tree Id: 7	Longitude: 115.866686
Botanical Name: Melaleuca lanceolata	Latitude: -31.746837
Common Name: Moonah, Dryland Tea-tree	Address: 95 Paini Way
Genus:	City: Jandabup
Health: Good	Photos Street View Map View
Status: Alive

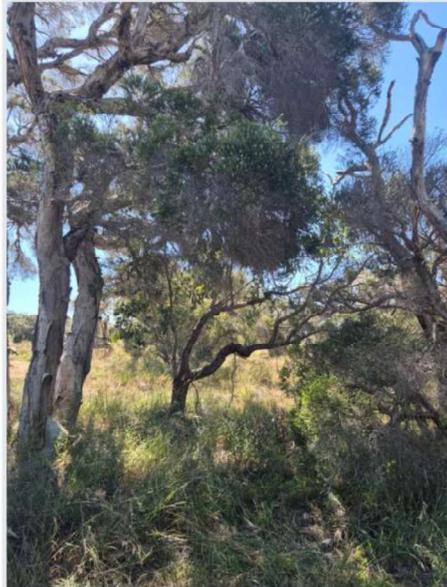
<u>Flooded Gum Tree ID #8</u> 95 Paini Way	
Tree Details	Tree Location
Tree Id: 8	Longitude: 115.866723
Botanical Name: Eucalyptus rudis subsp. rudis	Latitude: -31.746824
Common Name: Flooded Gum	Address: 95 Paini Way
Genus:	City: Jandabup
Health: Good	Photos Street View Map View
Status: Alive

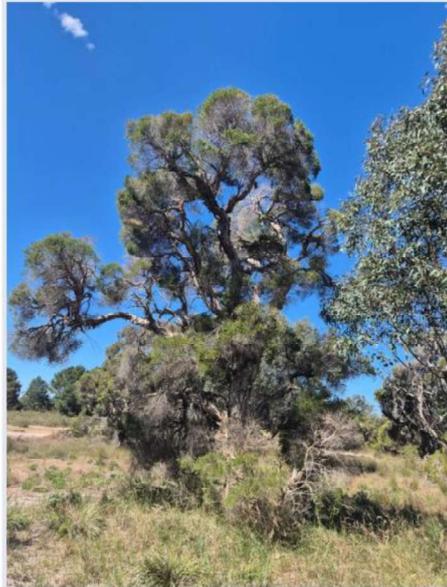
<p>17625834490431355861173963533415.jpg 08/11/2025</p>

<u>Moonah, Dryland Tea-tree Tree ID #9</u> 95 Paini Way	
Tree Details	
Tree Id:	9
Botanical Name:	Melaleuca lanceolata
Common Name:	Moonah, Dryland Tea-tree
Genus:	
Health:	Good
Status:	Alive
Number of Stems (Multi Calc):	1
DBH [cm]:	50
DBH Range:	46-60cm
Height Range:	5-10 Metres
Priority of Works:	Moderate
Canopy Spread [m]:	6
Useful Life Expectancy:	11-20 years
Observation Comments:	Remove prior to construction
Recommended Works:	Removal
Last Modified:	08/11/2025
Last Modified User:	Rowan
QTRA Risk Category:

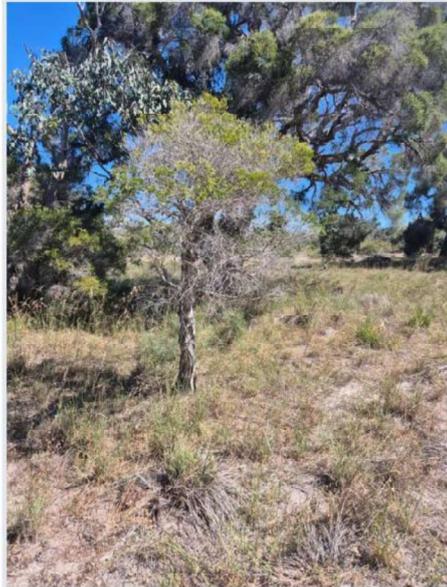
<p>17625837561895254879701219809328.jpg 08/11/2025</p>

<u>Moonah, Dryland Tea-tree Tree ID #10</u> 95 Paini Way	
Tree Details	
Tree Id:	10
Botanical Name:	Melaleuca lanceolata
Common Name:	Moonah, Dryland Tea-tree
Genus:	
Health:	Good
Status:	Alive
Number of Stems (Multi Calc):	1
DBH [cm]:	5
DBH Range:	0-8cm
Height Range:	<5 Metres
Priority of Works:	
Canopy Spread [m]:	1.5
Useful Life Expectancy:	40+ years
Observation Comments:	Protection not required
Recommended Works:	
Last Modified:	08/11/2025
Last Modified User:	Rowan
QTRA Risk Category:	
Tree Location	
Longitude:	115.866730
Latitude:	-31.746739
Address:	95 Paini Way
City:	Jandabup
Photos Street View Map View

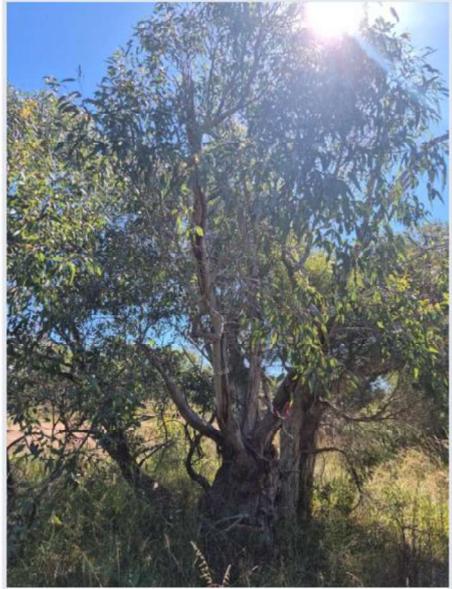
17625840615487896463309385460248.jpg 08/11/2025

Flooded Gum Tree ID #12 95 Paini Way	
Tree Details	
Tree Id:	12
Botanical Name:	Eucalyptus rudis subsp. rudis
Common Name:	Flooded Gum
Genus:	
Health:	Poor
Status:	Alive
Number of Stems (Multi Calc):	1
DBH [cm]:	
DBH Range:	N/A
Height Range:	N/A
Priority of Works:	
Canopy Spread [m]:	
Useful Life Expectancy:	0 years
Observation Comments:	Suckering stump - remove
Recommended Works:	Removal
Last Modified:	08/11/2025
Last Modified User:	Rowan
QTRA Risk Category:	
Tree Location	
Longitude:	115.866590
Latitude:	-31.746749
Address:	95 Paini Way
City:	Jandabup
Photos Street View Map View

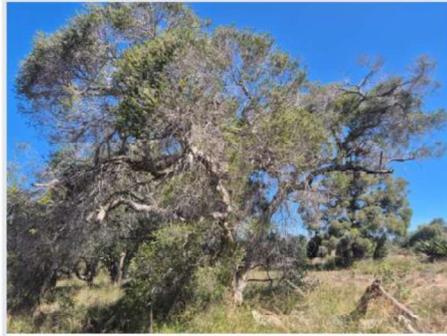
<p>17625841450367429837200378476467.jpg 08/11/2025</p>

<u>Moonah, Dryland Tea-tree Tree ID #14</u> 95 Paini Way	
Tree Details	
Tree Id:	14
Botanical Name:	Melaleuca lanceolata
Common Name:	Moonah, Dryland Tea-tree
Genus:	
Health:	Fair
Status:	Alive
Number of Stems (Multi Calc):	Multiple Stems
DBH [cm]:	53.85
DBH Range:	46-60cm
Height Range:	<5 Metres
Priority of Works:	
Canopy Spread [m]:	12
Useful Life Expectancy:	11-20 years
Observation Comments:	Remove prior to construction
Recommended Works:	Removal
Last Modified:	08/11/2025
Last Modified User:	Rowan
QTRA Risk Category:	
Tree Location	
Longitude:	115.866623
Latitude:	-31.746710
Address:	95 Paini Way
City:	Jandabup
Photos Street View Map View

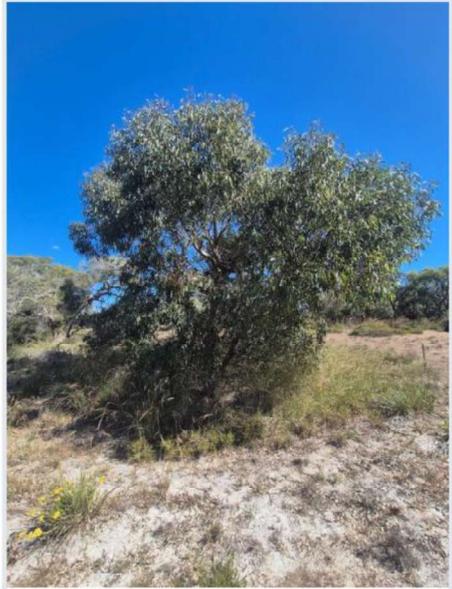
<p>17625846589635164367753383662007.jpg 08/11/2025</p>

Flooded Gum Tree ID #15 95 Paini Way	
Tree Details	
Tree Id:	15
Botanical Name:	Eucalyptus rudis subsp. rudis
Common Name:	Flooded Gum
Genus:	
Health:	Good
Status:	Alive
Number of Stems (Multi Calc):	
DBH [cm]:	40
DBH Range:	30-45cm
Height Range:	5-10 Metres
Priority of Works:	Moderate
Canopy Spread [m]:	10
Useful Life Expectancy:	40+ years
Observation Comments:	Cluster of suckers
Recommended Works:	Removal
Last Modified:	08/11/2025
Last Modified User:	Rowan
QTRA Risk Category:	
Tree Location	
Longitude:	115.866493
Latitude:	-31.746648
Address:	95 Paini Way
City:	Jandabup
Photos Street View Map View

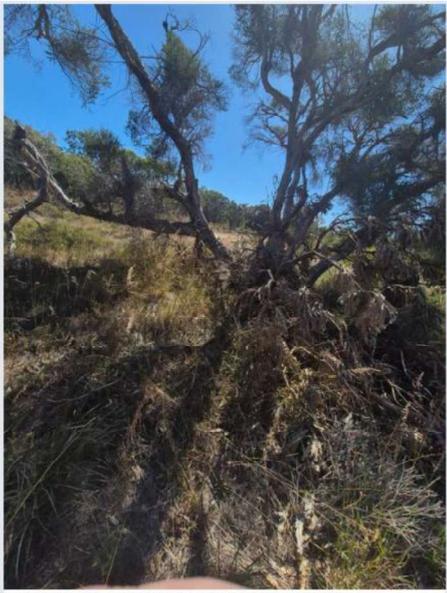
<p>17625847860788008145163581645077.jpg 08/11/2025</p>

<u>Moonah, Dryland Tea-tree Tree ID #16</u> 95 Paini Way	
Tree Details	
Tree Id:	16
Botanical Name:	Melaleuca lanceolata
Common Name:	Moonah, Dryland Tea-tree
Genus:	
Health:	Poor
Status:	Alive
Number of Stems (Multi Calc):	1
DBH [cm]:	10
DBH Range:	8-16cm
Height Range:	<5 Metres
Priority of Works:	
Canopy Spread [m]:	10
Useful Life Expectancy:	6-10 years
Observation Comments:	Cluster of suckers
Recommended Works:	Removal
Last Modified:	12/11/2025
Last Modified User:	Rowan
QTRA Risk Category:

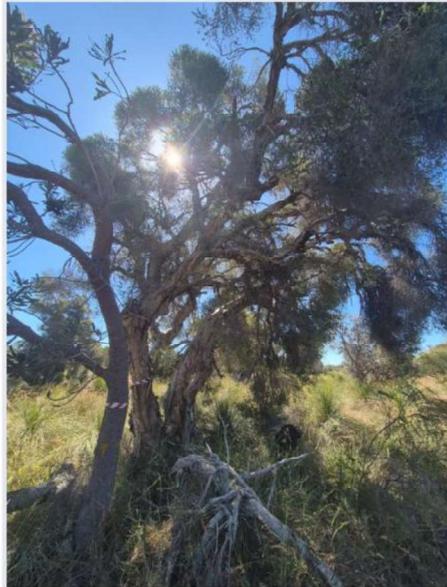
<p>17625850239087458674157195184797.jpg 08/11/2025</p>

<u>Moonah, Dryland Tea-tree Tree ID #17</u> 95 Paini Way	
Tree Details	
Tree Id:	17
Botanical Name:	Melaleuca lanceolata
Common Name:	Moonah, Dryland Tea-tree
Genus:	
Health:	Good
Status:	Alive
Number of Stems (Multi Calc):	Multiple Stems
DBH [cm]:	67.08
DBH Range:	60-75cm
Height Range:	>40 Metres
Priority of Works:	
Canopy Spread [m]:	12
Useful Life Expectancy:	11-20 years
Observation Comments:	
Recommended Works:	Removal
Last Modified:	08/11/2025
Last Modified User:	Rowan
QTRA Risk Category:	
Tree Location	
Longitude:	115.866447
Latitude:	-31.746489
Address:	95 Paini Way
City:	Jandabup
Photos Street View Map View

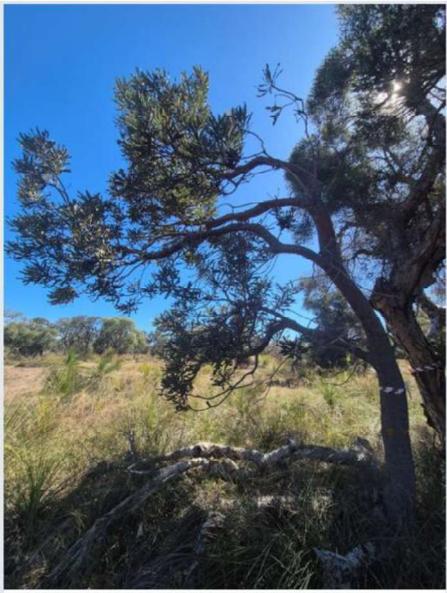
Firewood Banksia Tree ID #18 95 Paini Way	
Tree Details	Tree Location
Tree Id: 18	Longitude: 115.866409
Botanical Name: Banksia mensiezii	Latitude: -31.746509
Common Name: Firewood Banksia	Address: 95 Paini Way
Genus:	City: Jandabup
Health: Good	
Status: Alive	
Number of Stems (Multi Calc): 1	Photos Street View Map View
DBH [cm]:

DBH Range: N/A	
Height Range: N/A	
Priority of Works:	
Canopy Spread [m]:	
Useful Life Expectancy: 11-20 years	
Observation Comments:	
Recommended Works: Removal, Grind Stump	
Last Modified: 12/11/2025	
Last Modified User: Rowan	
QTRA Risk Category:	
	17625851232529107620756193341330.jpg 08/11/2025

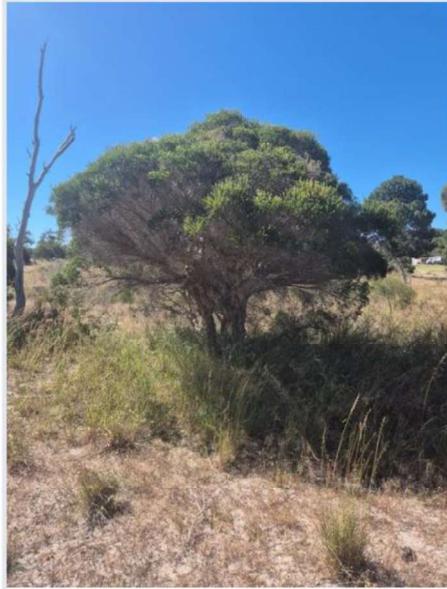
17625854593514548989067436318547.jpg 08/11/2025

<u>Moonah, Dryland Tea-tree Tree ID #19</u> 95 Paini Way	
Tree Details	
Tree Id:	19
Botanical Name:	Melaleuca lanceolata
Common Name:	Moonah, Dryland Tea-tree
Genus:	
Health:	Good
Status:	Alive
Number of Stems (Multi Calc):	1
DBH [cm]:	30
DBH Range:	30-45cm
Height Range:	<5 Metres
Priority of Works:	
Canopy Spread [m]:	4
Useful Life Expectancy:	21-40 years
Observation Comments:	
Recommended Works:	
Last Modified:	12/11/2025
Last Modified User:	Rowan
QTRA Risk Category:	
Tree Location	
Longitude:	115.866529
Latitude:	-31.746402
Address:	95 Paini Way
City:	Jandabup
<u>Photos</u> Street View Map View

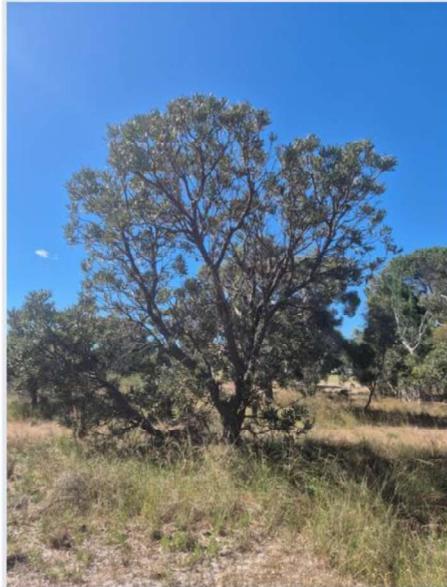
<p>17625856081381433433907149326575.jpg 08/11/2025</p>

Firewood Banksia Tree ID #20 95 Paini Way		Tree Location	
Tree Details		Longitude: 115.866614	
Tree Id:	20	Latitude: -31.746355	
Botanical Name:	Banksia mensiezii	Address: 95 Paini Way	
Common Name:	Firewood Banksia	City: Jandabup	
Genus:			
Health:	Good		
Status:	Alive		
Number of Stems (Multi Calc):	1		
DBH [cm]:	15		
DBH Range:	8-16cm		
Height Range:	5-10 Metres		
Priority of Works:			
Canopy Spread [m]:	5		
Useful Life Expectancy:	11-20 years		
Observation Comments:	Protect during construction		
Recommended Works:			
Last Modified:	12/11/2025		
Last Modified User:	Rowan		
QTRA Risk Category:			
		Photos Street View Map View

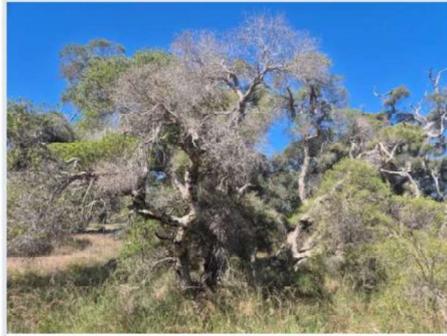
<p>17625856710668243094922195997910.jpg 08/11/2025</p>

<u>Moonah, Dryland Tea-tree Tree ID #21</u> 95 Paini Way	
Tree Details	
Tree Id:	21
Botanical Name:	Melaleuca lanceolata
Common Name:	Moonah, Dryland Tea-tree
Genus:	
Health:	Good
Status:	Alive
Number of Stems (Multi Calc):	1
DBH [cm]:	15
DBH Range:	8-16cm
Height Range:	5-10 Metres
Priority of Works:	
Canopy Spread [m]:	10
Useful Life Expectancy:	11-20 years
Observation Comments:	Cluster of suckers
Recommended Works:	
Last Modified:	08/11/2025
Last Modified User:	Rowan
QTRA Risk Category:	
Tree Location	
Longitude:	115.866697
Latitude:	-31.746510
Address:	95 Paini Way
City:	Jandabup
Photos Street View Map View

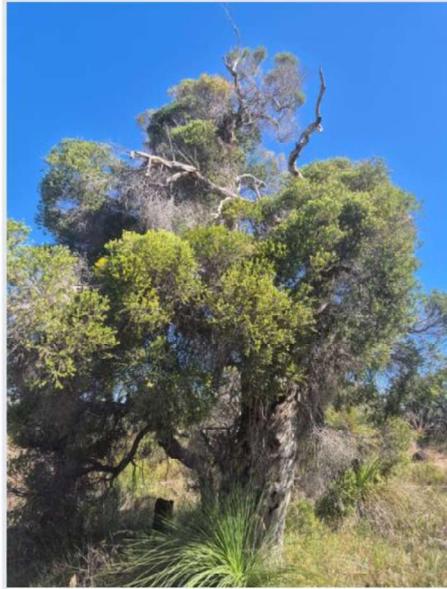
<p>17625859834905203993767012241280.jpg 08/11/2025</p>

<u>Moonah, Dryland Tea-tree Tree ID #22</u> 95 Paini Way	
Tree Details	
Tree Id:	22
Botanical Name:	Melaleuca lanceolata
Common Name:	Moonah, Dryland Tea-tree
Genus:	
Health:	Very Poor
Status:	Alive
Number of Stems (Multi Calc):	1
DBH [cm]:	80
DBH Range:	>75cm
Height Range:	5-10 Metres
Priority of Works:	
Canopy Spread [m]:	12
Useful Life Expectancy:	0 years
Observation Comments:	Tree has failed approx 2.5m
Recommended Works:	Removal
Last Modified:	08/11/2025
Last Modified User:	Rowan
QTRA Risk Category:	
Tree Location	
Longitude:	115.866281
Latitude:	-31.746549
Address:	95 Paini Way
City:	Jandabup
Photos Street View Map View

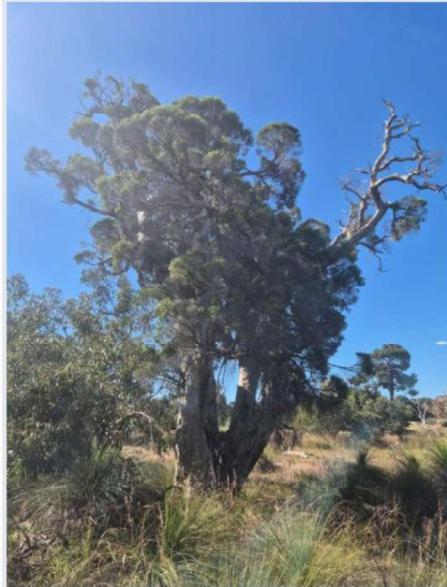
17625861030925317132896280955087.jpg 08/11/2025

<u>Moonah, Dryland Tea-tree Tree ID #23</u> 95 Paini Way	
Tree Details	
Tree Id:	23
Botanical Name:	Melaleuca lanceolata
Common Name:	Moonah, Dryland Tea-tree
Genus:	
Health:	Fair
Status:	Alive
Number of Stems (Multi Calc):	Multiple Stems
DBH [cm]:	162.48
DBH Range:	>75cm
Height Range:	10-20 Metres
Priority of Works:	
Canopy Spread [m]:	15
Useful Life Expectancy:	11-20 years
Observation Comments:	Protect during construction
Recommended Works:	
Last Modified:	12/11/2025
Last Modified User:	Rowan
QTRA Risk Category:	
Tree Location	
Longitude:	115.866180
Latitude:	-31.746378
Address:	95 Paini Way
City:	Jandabup
Photos Street View Map View

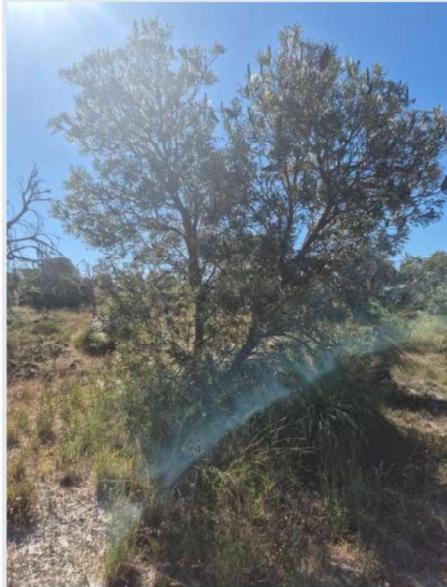
Firewood Banksia Tree ID #24 95 Paini Way		Tree Location	
Tree Details		Longitude:	115.866240
Tree Id:	24	Latitude:	-31.746665
Botanical Name:	Banksia mensiezii	Address:	95 Paini Way
Common Name:	Firewood Banksia	City:	Jandabup
Genus:			
Health:	Good		
Status:	Alive		
Number of Stems (Multi Calc):	1	Photos	Street View
DBH [cm]:	10		Map View
DBH Range:	8-16cm

<p>17625862045837293425731929189562.jpg 08/11/2025</p>	
Height Range:	<5 Metres		
Priority of Works:			
Canopy Spread [m]:	3		
Useful Life Expectancy:	11-20 years		
Observation Comments:			
Recommended Works:	Removal		
Last Modified:	08/11/2025		
Last Modified User:	Rowan		
QTRA Risk Category:

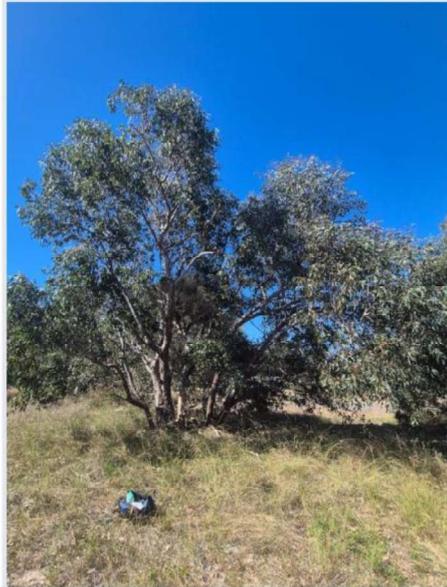
17625865133424256663523964600154.jpg 08/11/2025

Flooded Gum Tree ID #25 95 Paini Way	
Tree Details	
Tree Id:	25
Botanical Name:	Eucalyptus rudis subsp. rudis
Common Name:	Flooded Gum
Genus:	
Health:	Good
Status:	Alive
Number of Stems (Multi Calc):	1
DBH [cm]:	15
DBH Range:	8-16cm
Height Range:	5-10 Metres
Priority of Works:	
Canopy Spread [m]:	20
Useful Life Expectancy:	40+ years
Observation Comments:	Cluster of suckers - 1 melaleuca within cluster
Recommended Works:	
Last Modified:	08/11/2025
Last Modified User:	Rowan
QTRA Risk Category:	
Tree Location	
Longitude:	115.866803
Latitude:	-31.746438
Address:	95 Paini Way
City:	Jandabup
Photos Street View Map View
