City of Stirling Recycling Centre Balcatta Redevelopment (RCB)

Application for New Permit to Clear Native Vegetation Supporting Documents:

Date: 20 March 2026

Arboricultural Report - Balcatta Recycling Centre

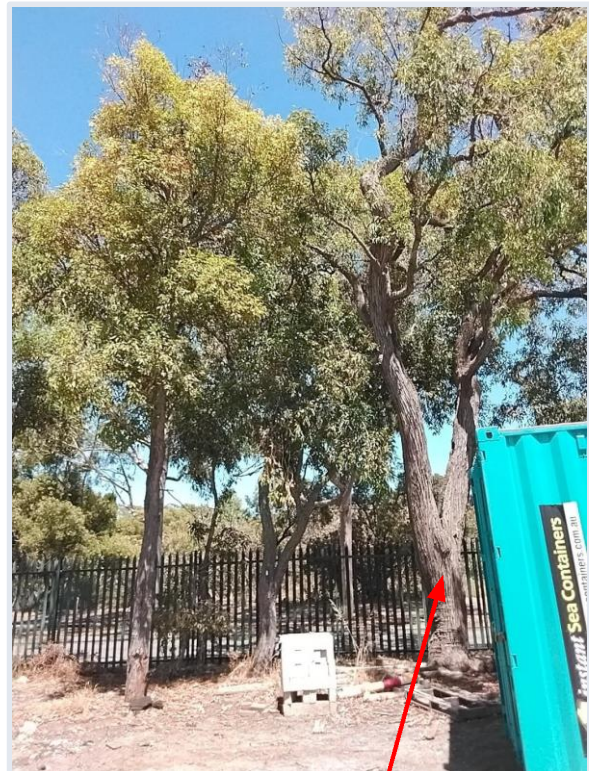
TREE #56

Jarrah Tree ID #56

Problems: Codominant Stem, Deadwood minor <50

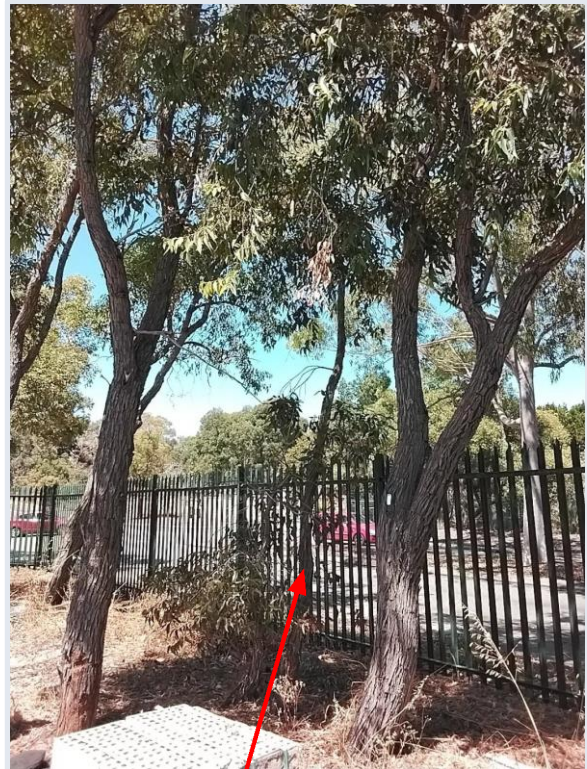
TREE #57

Jarrah Tree ID #57

Latin Name:	Eucalyptus marginata
Latitude:	-31.864682998233
Longitude:	115.81740006733
Tree Height (Estimated) [m]:	6.5
Canopy Spread [m]:	1.5
DBH [cm]:	10
Health:	Fair
Structure:	Fair
Problems:	
Notes:	
Priority:	None
Tree Work:	No Works
Observation Comments:	
Tree Protection Zone (TPZ) [m]:	2
Structural Root Zone (SRZ) [m]:	1.36
Useful Life Expectancy:	40+ years
Retention Value:	Medium
Risk of Harm Number:	Not applicable

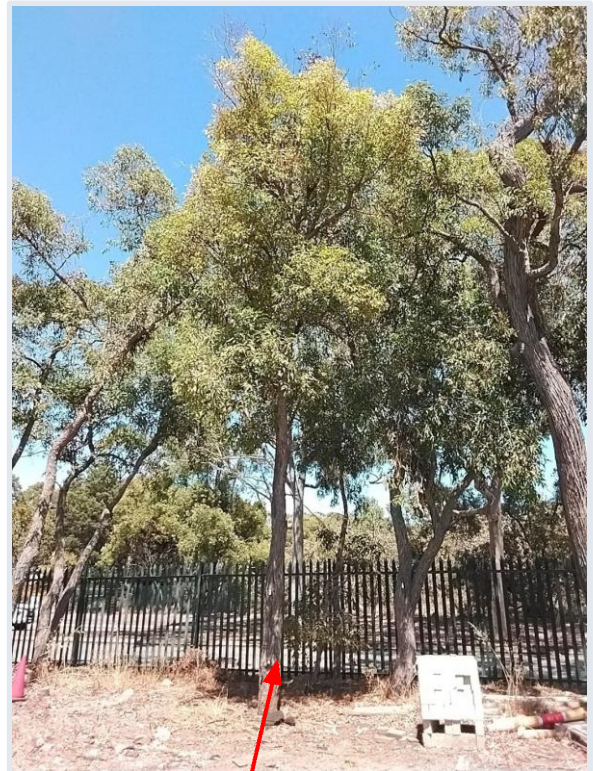
TREE #58

Jarrah Tree ID #58

Latin Name:	Eucalyptus marginata
Latitude:	-31.86472698245
Longitude:	115.81740992442
Tree Height (Estimated) [m]:	13.5
Canopy Spread [m]:	3.5
DBH [cm]:	30
Health:	Good
Structure:	Fair
Problems:	Codominant Stem
Notes:	
Priority:	None
Tree Work:	No Works
Observation Comments:	
Tree Protection Zone (TPZ) [m]:	3.6
Structural Root Zone (SRZ) [m]:	2
Useful Life Expectancy:	40+ years
Retention Value:	High
Risk of Harm Number:	Not applicable

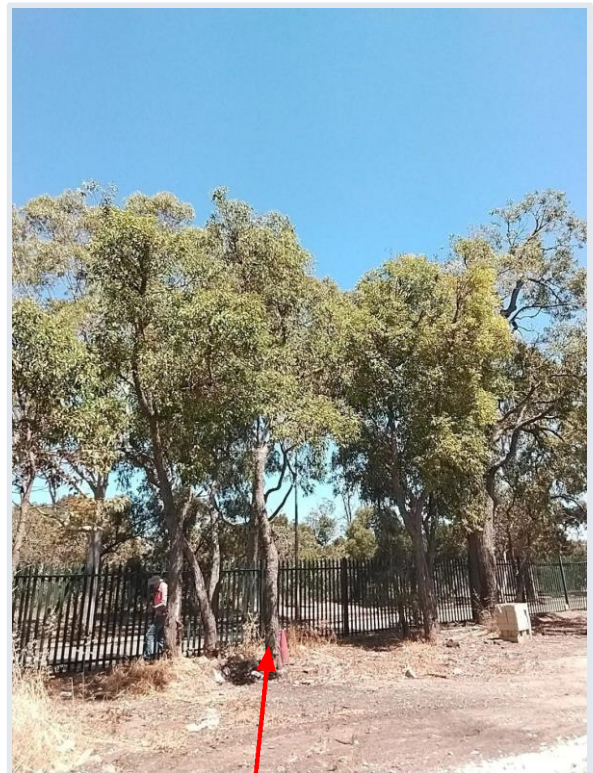
TREE #59

Jarrah Tree ID #59

Latin Name:	Eucalyptus marginata
Latitude:	-31.864780268395
Longitude:	115.81744387669
Tree Height (Estimated) [m]:	13
Canopy Spread [m]:	4
DBH [cm]:	26
Health:	Good
Structure:	Fair
Problems:	Leaning
Notes:	
Priority:	None
Tree Work:	No Works
Observation Comments:	
Tree Protection Zone (TPZ) [m]:	3.12
Structural Root Zone (SRZ) [m]:	2.05
Useful Life Expectancy:	40+ years
Retention Value:	High
Risk of Harm Number:	Not applicable

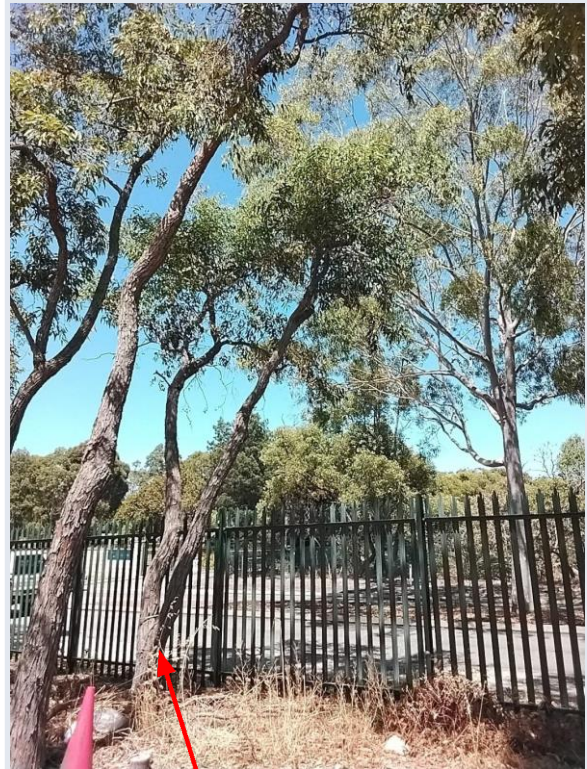
TREE #60

Jarrah Tree ID #60

Latin Name:	Eucalyptus marginata
Latitude:	-31.864798207515
Longitude:	115.81741101959
Tree Height (Estimated) [m]:	10.5
Canopy Spread [m]:	4
DBH [cm]:	27
Health:	Good
Structure:	Fair
Problems:	Codominant Stem, Leaning
Notes:	
Priority:	None
Tree Work:	No Works
Observation Comments:	
Tree Protection Zone (TPZ) [m]:	3.24
Structural Root Zone (SRZ) [m]:	1.91
Useful Life Expectancy:	40+ years
Retention Value:	High
Risk of Harm Number:	Not applicable

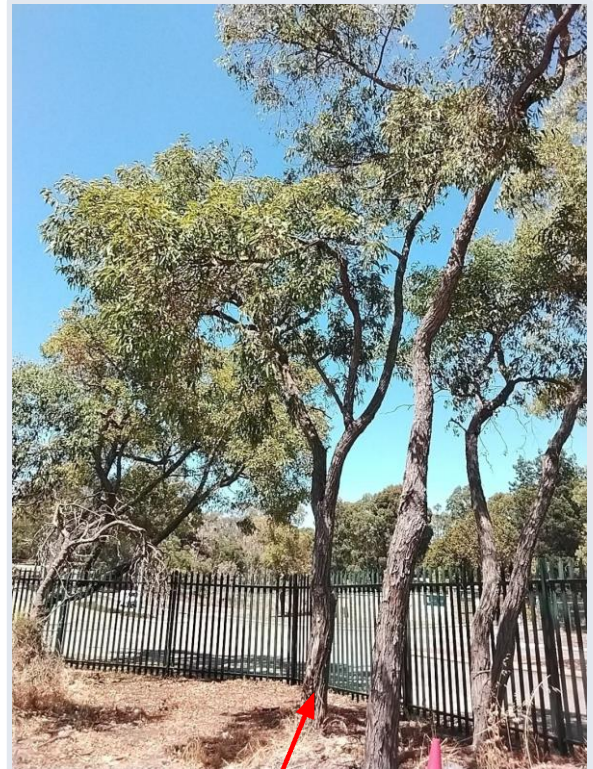
TREE #61

Jarrah Tree ID #61

Latin Name:	Eucalyptus marginata
Latitude:	-31.864833820097
Longitude:	115.81745263852
Tree Height (Estimated) [m]:	10.5
Canopy Spread [m]:	5
DBH [cm]:	25
Health:	Good
Structure:	Fair
Problems:	Codominant Stem
Notes:	
Priority:	None
Tree Work:	No Works
Observation Comments:	
Tree Protection Zone (TPZ) [m]:	3
Structural Root Zone (SRZ) [m]:	2.05
Useful Life Expectancy:	40+ years
Retention Value:	High
Risk of Harm Number:	Not applicable

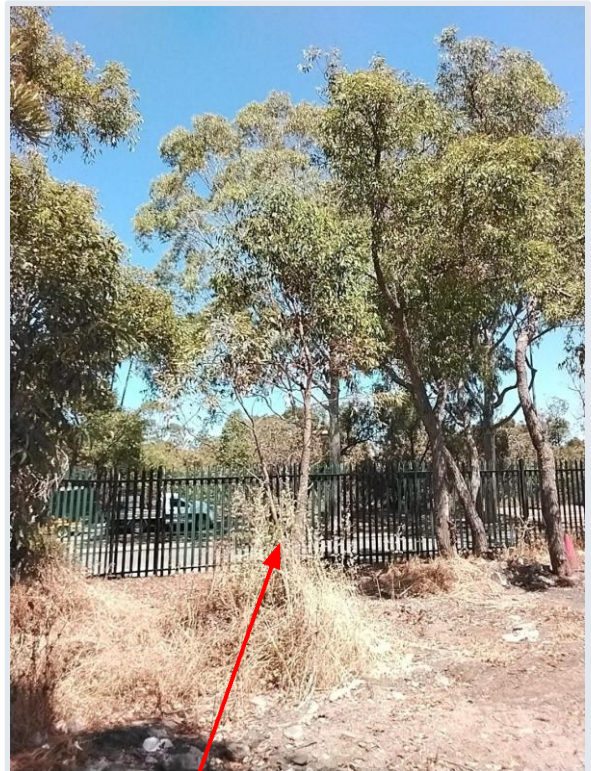
TREE #62

Jarrah Tree ID #62

Latin Name:	Eucalyptus marginata
Latitude:	-31.864833155724
Longitude:	115.81750849548
Tree Height (Estimated) [m]:	5.5
Canopy Spread [m]:	1.5
DBH [cm]:	12
Health:	Good
Structure:	Fair
Problems:	
Notes:	
Priority:	None
Tree Work:	No Works
Observation Comments:	
Tree Protection Zone (TPZ) [m]:	2
Structural Root Zone (SRZ) [m]:	1.49
Useful Life Expectancy:	40+ years
Retention Value:	High
Risk of Harm Number:	Not applicable

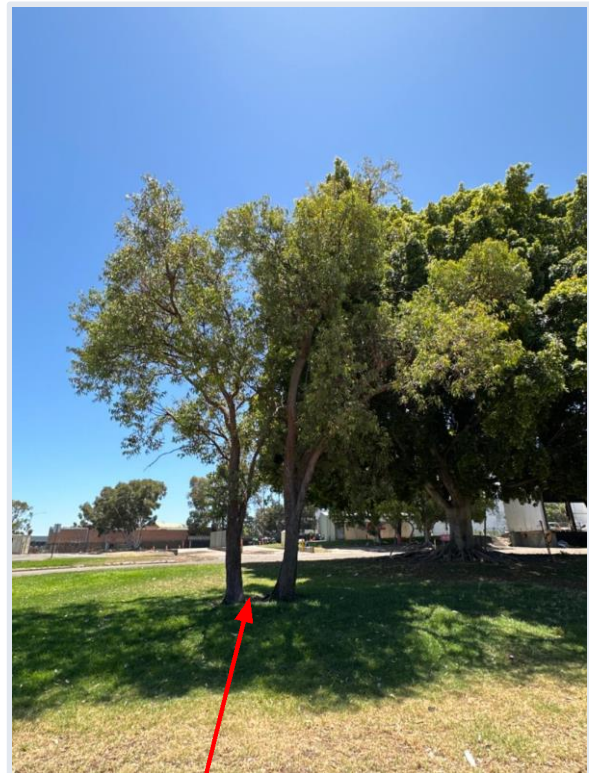
TREE #65

Jarrah Tree ID #65

Latin Name:	Eucalyptus marginata
Latitude:	-31.864242251807
Longitude:	115.81787045618
Tree Height (Estimated) [m]:	9.8
Canopy Spread [m]:	6
DBH [cm]:	50.99
Health:	Good
Structure:	Fair
Problems:	Deadwood minor <50, Multi Crown leaders
Notes:	
Priority:	None
Tree Work:	No Works
Observation Comments:	
Tree Protection Zone (TPZ) [m]:	6.12
Structural Root Zone (SRZ) [m]:	3.68
Useful Life Expectancy:	40+ years
Retention Value:	High
Risk of Harm Number:	Not applicable

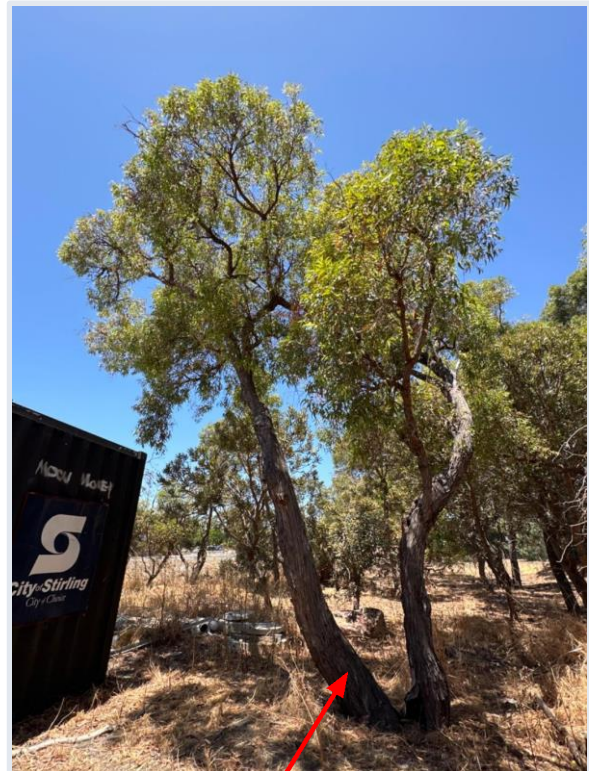
TREE #84

Jarraah Tree ID #84

Latin Name:	Eucalyptus marginata
Latitude:	-31.864758122566
Longitude:	115.81769094704
Tree Height (Estimated) [m]:	9.3
Canopy Spread [m]:	5
DBH [cm]:	44.41
Health:	Good
Structure:	Fair
Problems:	Hollow, Deadwood minor <50, Epicormic growth, Basal bifurcation, Leaning
Notes:	
Priority:	None
Tree Work:	No Works
Observation Comments:	
Tree Protection Zone (TPZ) [m]:	5.33
Structural Root Zone (SRZ) [m]:	3.04
Useful Life Expectancy:	40+ years
Retention Value:	High
Risk of Harm Number:	Not applicable

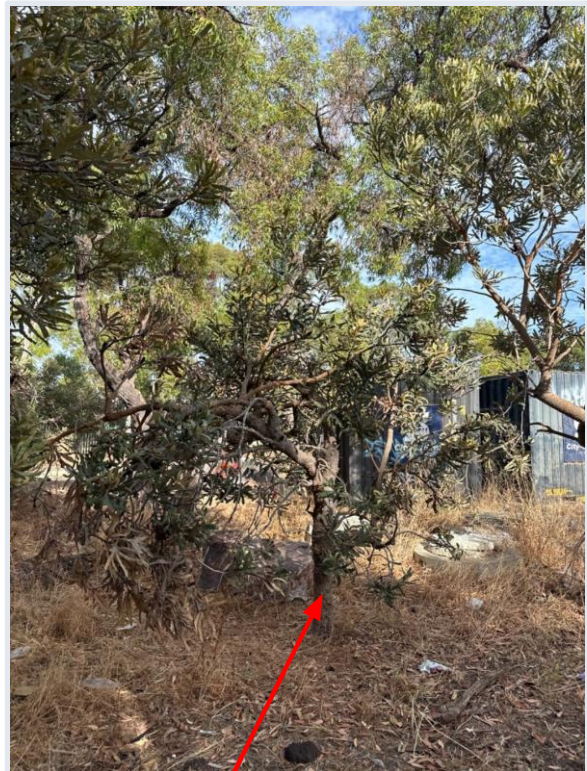
TREE #105

Candle Banksia Tree ID #105

Tree Details	
Latin Name:	Banksia attenuata
Latitude:	-31.864824184278
Longitude:	115.81778616546
Tree Height (Estimated) [m]:	3.2
Canopy Spread [m]:	3.5
DBH [cm]:	15
Health:	Fair
Structure:	Fair
Problems:	
Notes:	
Priority:	None
Tree Work:	No Works
Observation Comments:	
Tree Protection Zone (TPZ) [m]:	2
Structural Root Zone (SRZ) [m]:	1.53
Useful Life Expectancy:	11-20 years
Retention Value:	High
Risk of Harm Number:	Not applicable

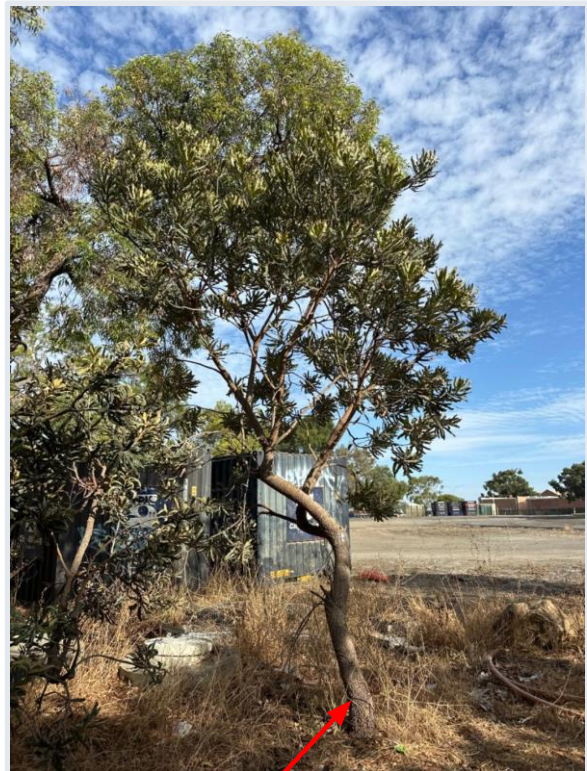
TREE #106

Candle Banksia Tree ID #106

Tree Details	
Latin Name:	Banksia attenuata
Latitude:	-31.864804821368
Longitude:	115.81776068447
Tree Height (Estimated) [m]:	6
Canopy Spread [m]:	3.5
DBH [cm]:	14
Health:	Good
Structure:	Fair
Problems:	
Notes:	
Priority:	None
Tree Work:	No Works
Observation Comments:	
Tree Protection Zone (TPZ) [m]:	2
Structural Root Zone (SRZ) [m]:	1.57
Useful Life Expectancy:	11-20 years
Retention Value:	High
Risk of Harm Number:	Not applicable

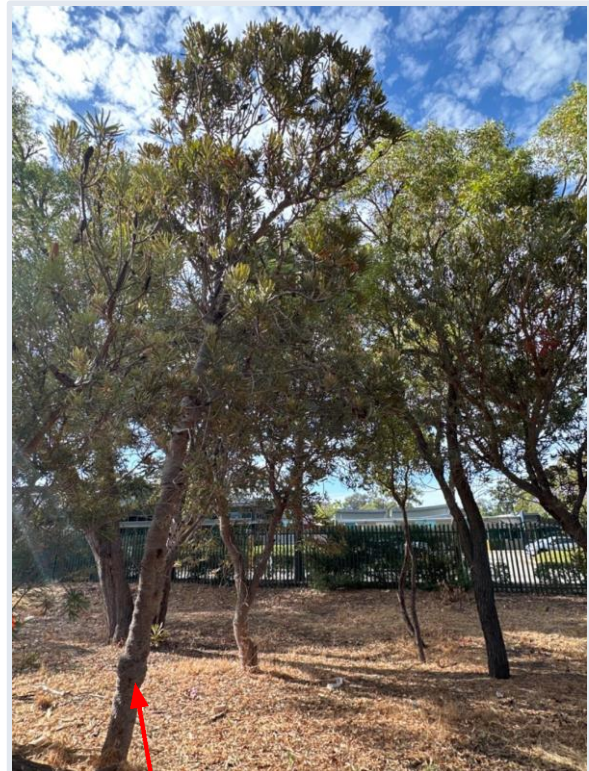
TREE #112

Candle Banksia Tree ID #112

Latin Name:	Banksia attenuata
Latitude:	-31.86483215724
Longitude:	115.81781969307
Tree Height (Estimated) [m]:	6.6
Canopy Spread [m]:	3.5
DBH [cm]:	20
Health:	Good
Structure:	Fair
Problems:	Leaning
Notes:	
Priority:	None
Tree Work:	No Works
Observation Comments:	
Tree Protection Zone (TPZ) [m]:	2.4
Structural Root Zone (SRZ) [m]:	1.85
Useful Life Expectancy:	11-20 years
Retention Value:	High
Risk of Harm Number:	Not applicable

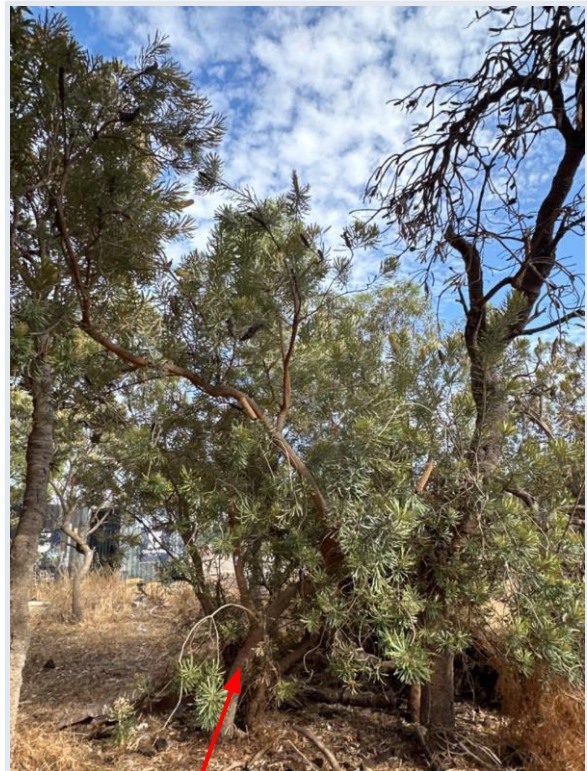
TREE #113

Candle Banksia Tree ID #113

Latin Name:	Banksia attenuata
Latitude:	-31.864816211316
Longitude:	115.81781969307
Tree Height (Estimated) [m]:	5
Canopy Spread [m]:	2.5
DBH [cm]:	17.2
Health:	Good
Structure:	Fair
Problems:	Secondary stem
Notes:	
Priority:	None
Tree Work:	No Works
Observation Comments:	
Tree Protection Zone (TPZ) [m]:	2.06
Structural Root Zone (SRZ) [m]:	1.57
Useful Life Expectancy:	6-10 years
Retention Value:	Medium
Risk of Harm Number:	Not applicable

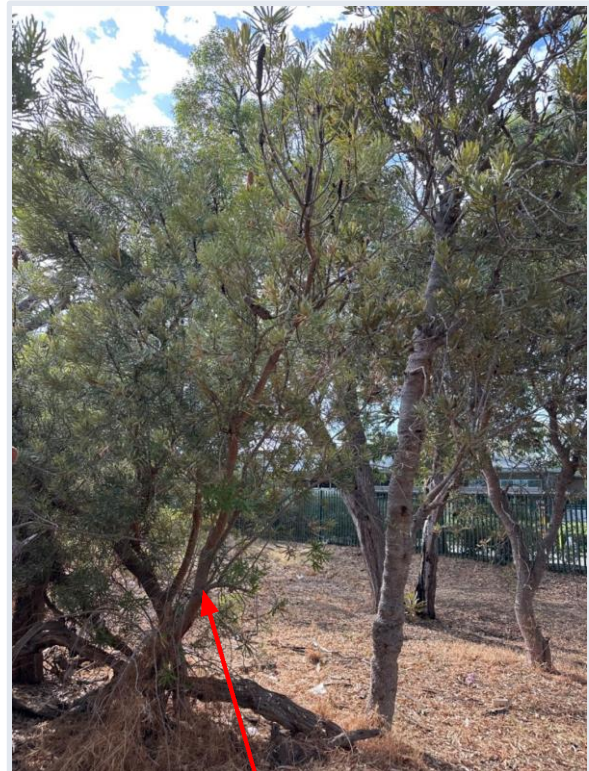
TREE #114

Candle Banksia Tree ID #114

Latin Name:	Banksia attenuata
Latitude:	-31.864804821368
Longitude:	115.81778884767
Tree Height (Estimated) [m]:	4
Canopy Spread [m]:	2
DBH [cm]:	8
Health:	Fair
Structure:	Fair
Problems:	
Notes:	
Priority:	None
Tree Work:	No Works
Observation Comments:	
Tree Protection Zone (TPZ) [m]:	2
Structural Root Zone (SRZ) [m]:	1.31
Useful Life Expectancy:	6-10 years
Retention Value:	Medium
Risk of Harm Number:	Not applicable

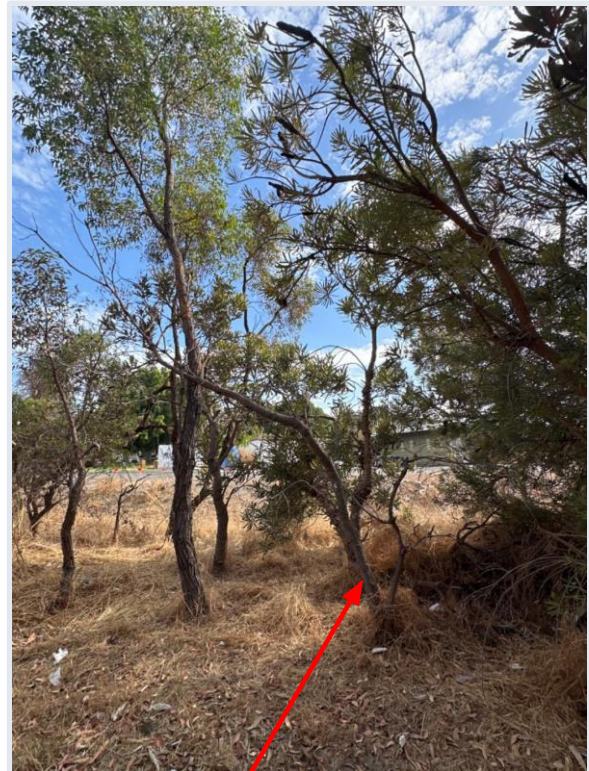
TREE #115

Banksia Tree ID #115

Latin Name:	Banksia species
Latitude:	-31.864785458453
Longitude:	115.81778884767
Tree Height (Estimated) [m]:	4
Canopy Spread [m]:	0
DBH [cm]:	8
Health:	Dead
Structure:	Fair
Problems:	Deadwood major >50
Notes:	
Priority:	Low
Tree Work:	Remove Tree
Observation Comments:	
Tree Protection Zone (TPZ) [m]:	2
Structural Root Zone (SRZ) [m]:	1.36
Useful Life Expectancy:	0 years
Retention Value:	Low
Risk of Harm Number:	Not applicable

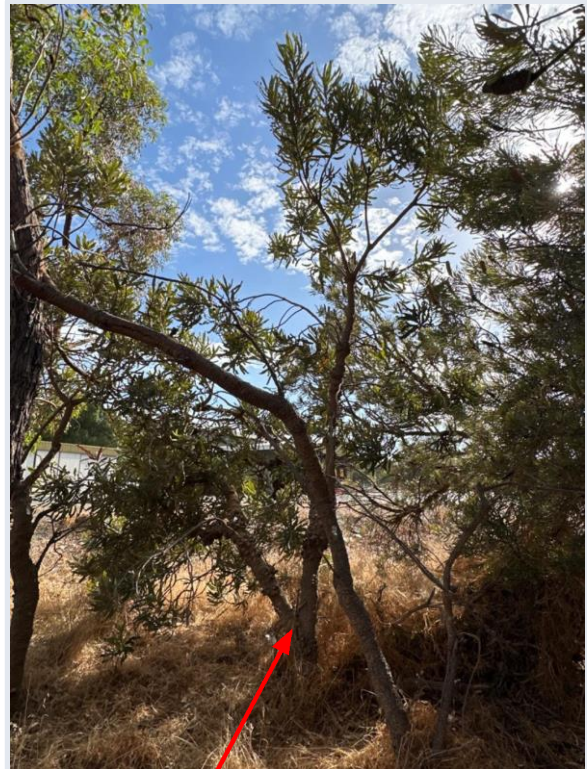
TREE #116

Candle Banksia Tree ID #116

Latin Name:	Banksia attenuata
Latitude:	-31.864785458453
Longitude:	115.81781164644
Tree Height (Estimated) [m]:	5.6
Canopy Spread [m]:	3
DBH [cm]:	16
Health:	Good
Structure:	Fair
Problems:	Codominant Stem
Notes:	
Priority:	None
Tree Work:	No Works
Observation Comments:	
Tree Protection Zone (TPZ) [m]:	2
Structural Root Zone (SRZ) [m]:	1.53
Useful Life Expectancy:	11-20 years
Retention Value:	Medium
Risk of Harm Number:	Not applicable

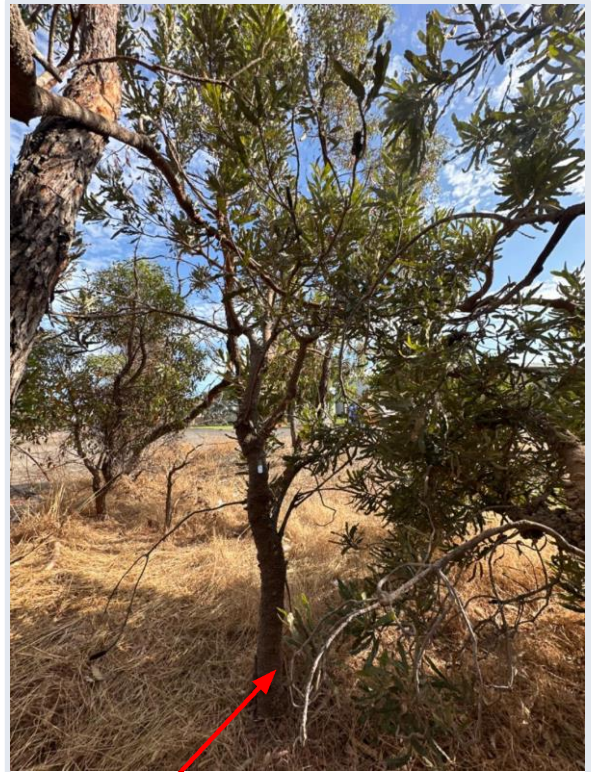
TREE #117

Candle Banksia Tree ID #117

Latin Name:	Banksia attenuata
Latitude:	-31.864767234529
Longitude:	115.81778884767
Tree Height (Estimated) [m]:	4.3
Canopy Spread [m]:	2
DBH [cm]:	14.5
Health:	Good
Structure:	Fair
Problems:	
Notes:	
Priority:	None
Tree Work:	No Works
Observation Comments:	
Tree Protection Zone (TPZ) [m]:	2
Structural Root Zone (SRZ) [m]:	1.53
Useful Life Expectancy:	11-20 years
Retention Value:	Medium
Risk of Harm Number:	Not applicable

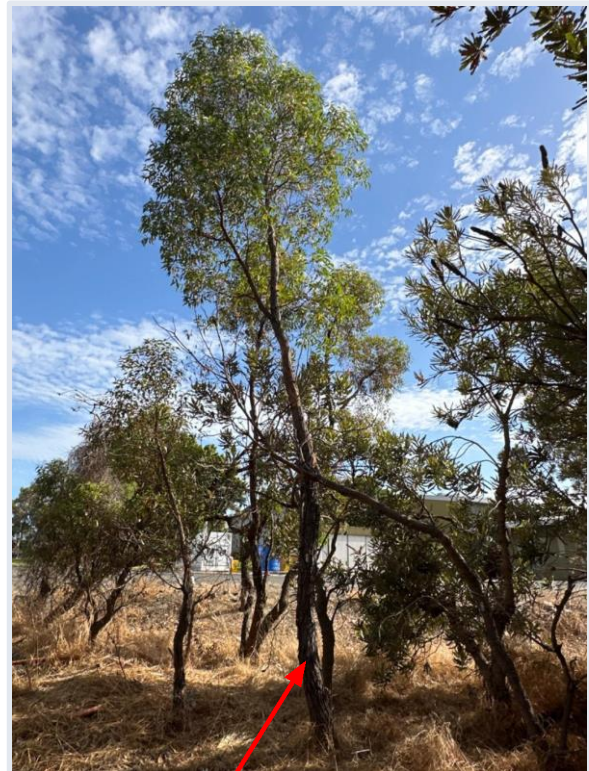
TREE #118

Jarrah Tree ID #118

Latin Name:	Eucalyptus marginata
Latitude:	-31.864758122566
Longitude:	115.81776068447
Tree Height (Estimated) [m]:	7.4
Canopy Spread [m]:	2
DBH [cm]:	16
Health:	Good
Structure:	Fair
Problems:	
Notes:	
Priority:	None
Tree Work:	No Works
Observation Comments:	
Tree Protection Zone (TPZ) [m]:	2
Structural Root Zone (SRZ) [m]:	1.68
Useful Life Expectancy:	40+ years
Retention Value:	High
Risk of Harm Number:	Not applicable

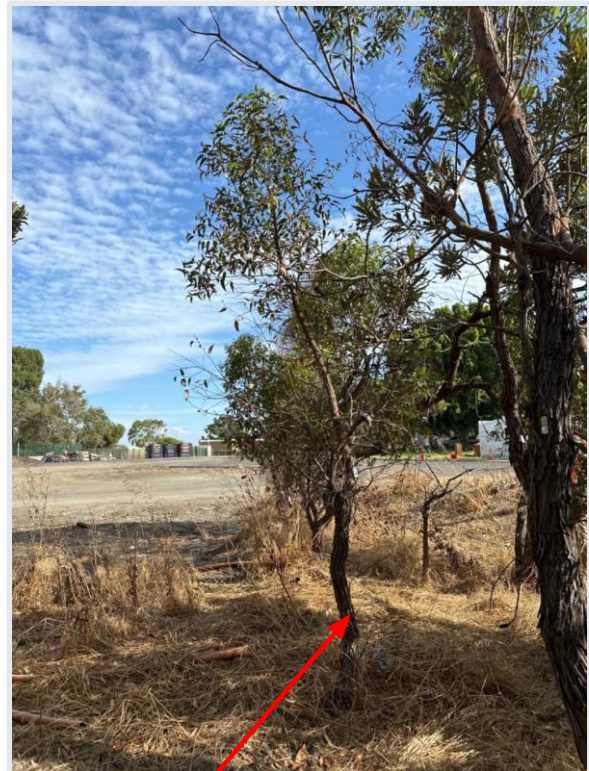
TREE #119

Jarrah Tree ID #119

Latin Name:	Eucalyptus marginata
Latitude:	-31.864743315624
Longitude:	115.81775666116
Tree Height (Estimated) [m]:	3.8
Canopy Spread [m]:	1.3
DBH [cm]:	9
Health:	Fair
Structure:	Fair
Problems:	
Notes:	
Priority:	None
Tree Work:	No Works
Observation Comments:	
Tree Protection Zone (TPZ) [m]:	2
Structural Root Zone (SRZ) [m]:	1.4
Useful Life Expectancy:	40+ years
Retention Value:	Medium
Risk of Harm Number:	Not applicable

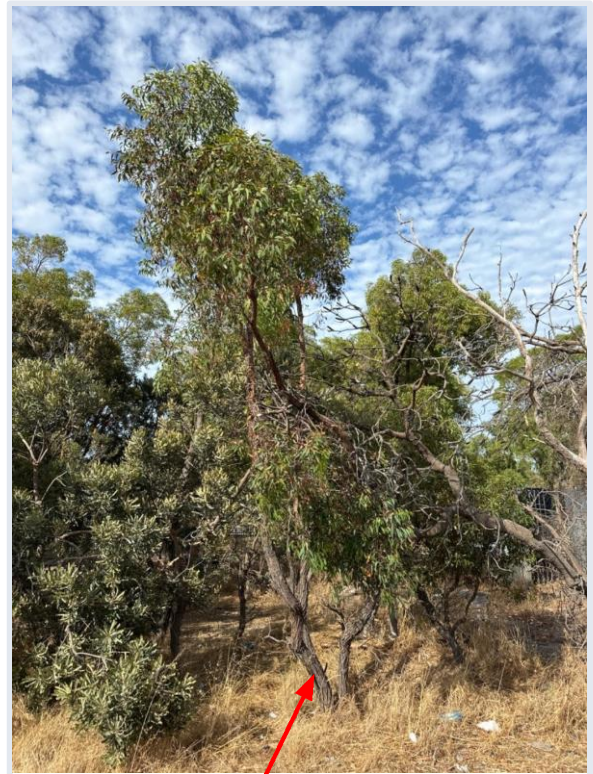
TREE #120

Jarrah Tree ID #120

Latin Name:	Eucalyptus marginata
Latitude:	-31.864729647675
Longitude:	115.81775934337
Tree Height (Estimated) [m]:	8.3
Canopy Spread [m]:	3
DBH [cm]:	23.15
Health:	Good
Structure:	Fair
Problems:	Multi Crown leaders
Notes:	
Priority:	None
Tree Work:	No Works
Observation Comments:	
Tree Protection Zone (TPZ) [m]:	2.78
Structural Root Zone (SRZ) [m]:	1.88
Useful Life Expectancy:	40+ years
Retention Value:	High
Risk of Harm Number:	Not applicable

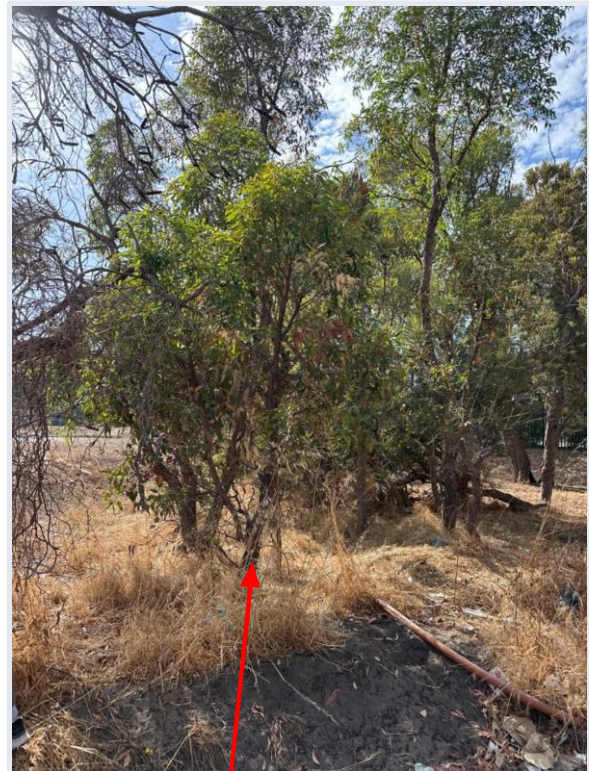
TREE #121

Jarrah Tree ID #121

Latin Name:	Eucalyptus marginata
Latitude:	-31.864694338799
Longitude:	115.81775934337
Tree Height (Estimated) [m]:	2.7
Canopy Spread [m]:	2
DBH [cm]:	9
Health:	Good
Structure:	Fair
Problems:	
Notes:	
Priority:	None
Tree Work:	No Works
Observation Comments:	
Tree Protection Zone (TPZ) [m]:	2
Structural Root Zone (SRZ) [m]:	1.49
Useful Life Expectancy:	40+ years
Retention Value:	Medium
Risk of Harm Number:	Not applicable

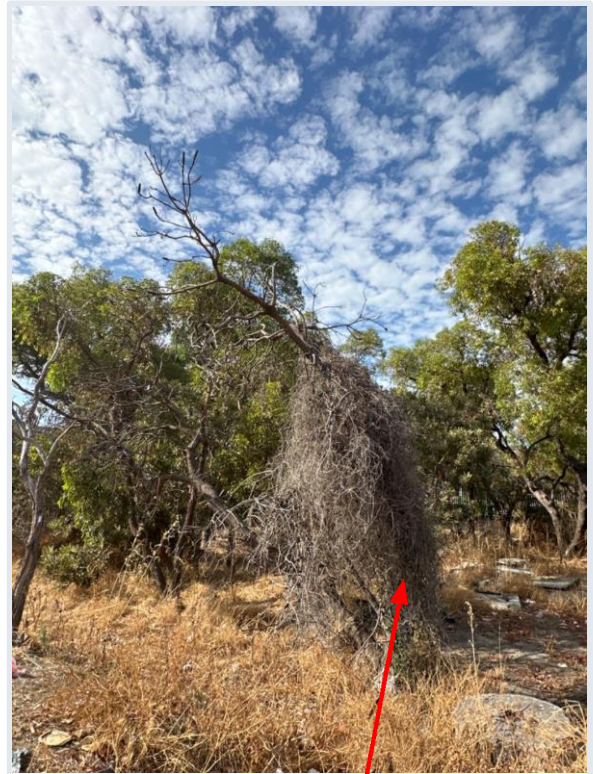
TREE #122

Banksia Tree ID #122

Tree Details	
Latin Name:	Banksia species
Latitude:	-31.864734203659
Longitude:	115.81780494092
Tree Height (Estimated) [m]:	6
Canopy Spread [m]:	0
DBH [cm]:	35.38
Health:	Dead
Structure:	Fair
Problems:	Deadwood major >50
Notes:	
Priority:	Low
Tree Work:	Remove Tree
Observation Comments:	
Tree Protection Zone (TPZ) [m]:	4.25
Structural Root Zone (SRZ) [m]:	2.05
Useful Life Expectancy:	0 years
Retention Value:	Low
Risk of Harm Number:	Not applicable

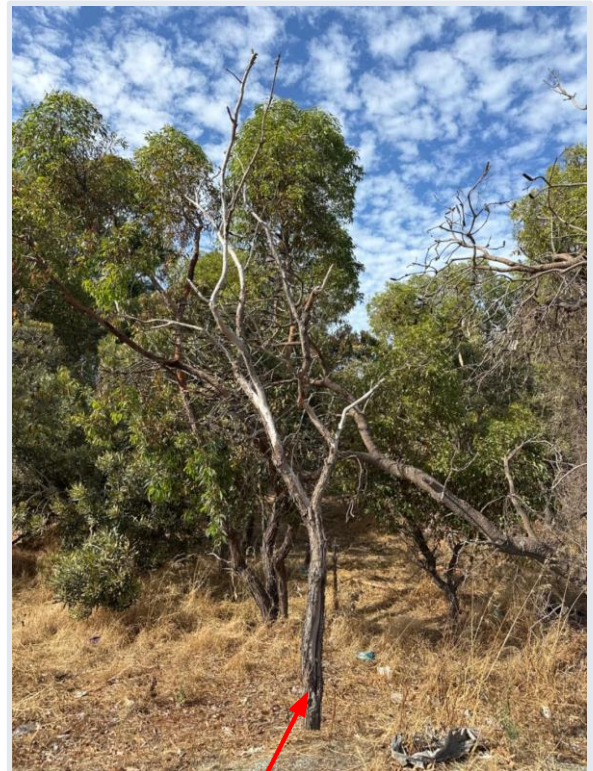
TREE #123

Jarraah Tree ID #123

Latin Name:	Eucalyptus marginata
Latitude:	-31.864763817543
Longitude:	115.81783846853
Tree Height (Estimated) [m]:	5
Canopy Spread [m]:	0
DBH [cm]:	14
Health:	Dead
Structure:	Fair
Problems:	Deadwood major >50
Notes:	
Priority:	Low
Tree Work:	Remove Tree
Observation Comments:	
Tree Protection Zone (TPZ) [m]:	2
Structural Root Zone (SRZ) [m]:	1.49
Useful Life Expectancy:	0 years
Retention Value:	Low
Risk of Harm Number:	Not applicable

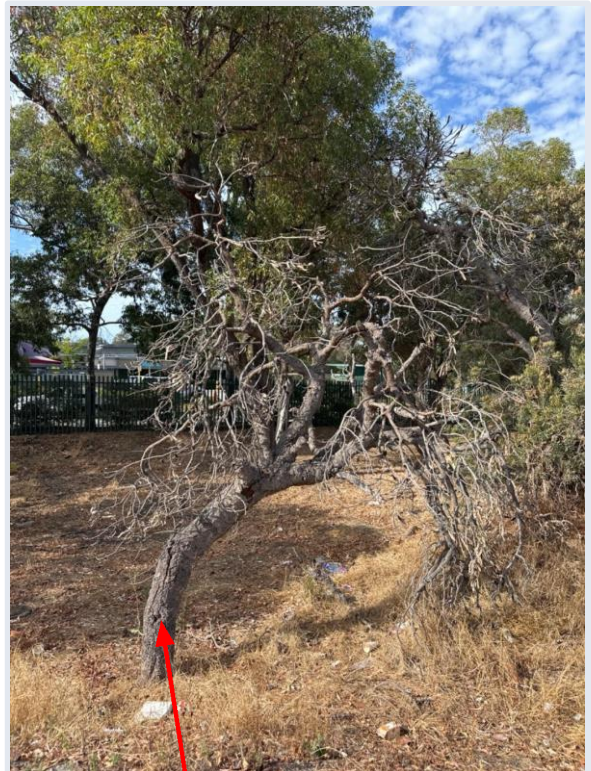
TREE #124

Jarrah Tree ID #124

Latin Name:	Eucalyptus marginata
Latitude:	-31.864845825174
Longitude:	115.8179162526
Tree Height (Estimated) [m]:	5
Canopy Spread [m]:	0
DBH [cm]:	36
Health:	Dead
Structure:	Fair
Problems:	Deadwood major >50
Notes:	
Priority:	Low
Tree Work:	Remove Tree
Observation Comments:	
Tree Protection Zone (TPZ) [m]:	4.32
Structural Root Zone (SRZ) [m]:	2.05
Useful Life Expectancy:	0 years
Retention Value:	Low
Risk of Harm Number:	Not applicable

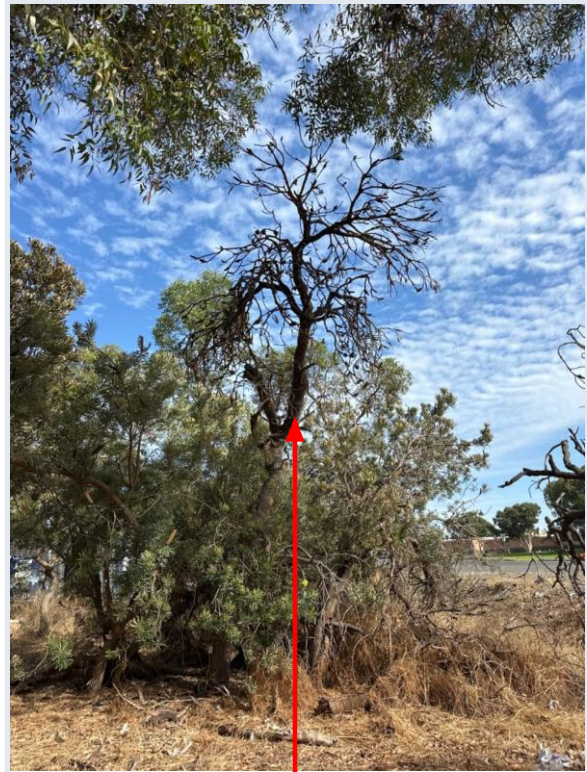
TREE #126

Banksia Tree ID #126

Latin Name:	Banksia species
Latitude:	-31.864821906289
Longitude:	115.81792966364
Tree Height (Estimated) [m]:	8
Canopy Spread [m]:	0
DBH [cm]:	20
Health:	Dead
Structure:	Poor
Problems:	Deadwood major >50
Notes:	
Priority:	Low
Tree Work:	Remove Tree
Observation Comments:	
Tree Protection Zone (TPZ) [m]:	2.4
Structural Root Zone (SRZ) [m]:	2.02
Useful Life Expectancy:	0 years
Retention Value:	Low
Risk of Harm Number:	Not applicable
