PRECINCTS 1 & 2 THOMAS ROAD, CASUARINA

SIGNIFICANT TREE SURVEY

Report Date: 7 March 2018

Report No. 2017-369

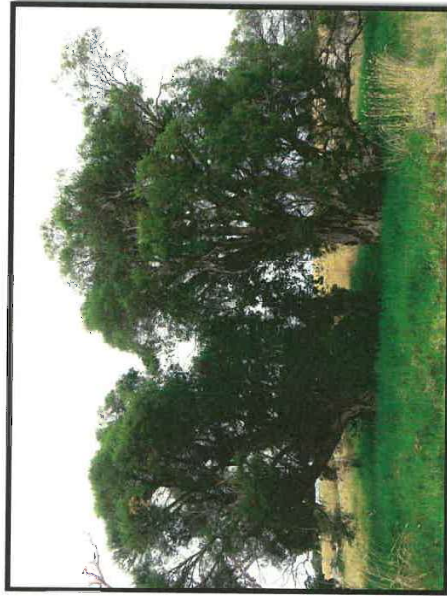
There were no trees recorded in Excellent condition. Eight of the trees were classified as being in Good condition, however have evidence of fire damage (Plate 4).

Plate 4: Tree 23 and 24 in Good condition but impacted by fire

The site contained 16 significant trees in Fair condition, eight in Good condition and the remaining fourteen trees are in Poor condition, largely due to the impacts of regular fires. The eight trees in Good condition still showed the impacts of fire.

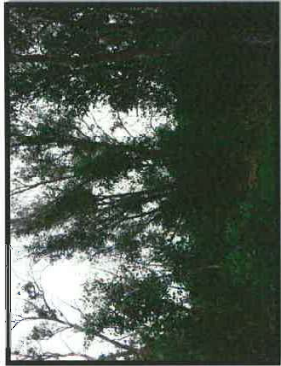
Tree 9

9	392250	6433401	Flooded Gum (Eucalyptus rudis)	11	40	40	32	64	64	Fair condition, sprouting after fire damage
10	392188	6433460	Paperbark (Melaleuca preissiana)	6	45	28	50	70	70	Fair condition, sprouting after fire damage
11	392152	6433463	Paperbark (Melaleuca preissiana)	6	6	6	50	70	70	Fair condition, burnt
12	392097	6433333	Paperbark (Melaleuca preissiana)	8	40	39	38	78	78	Fair condition, burnt
13	392097	6433333	Paperbark (Melaleuca preissiana)	8	40	39	38	68	68	Fair condition, burnt
14	392094	6433336	Paperbark (Melaleuca preissiana)	8	65	26	26	70	70	Poor, burnt large dead portions
15	392106	6433344	Paperbark (Melaleuca preissiana)	9	40	40	40	57	57	Poor, burnt large dead portions
16	392111	6433351	Paperbark (Melaleuca preissiana)	9	35	35	35	55	55	Poor, burnt large dead portions
17	392011	6433356	Paperbark (Melaleuca preissiana)	11	89	89	43	89	89	Poor, burnt large dead portions
18	392124	6433337	Paperbark (Melaleuca preissiana)	9	38	38	43	57	57	Poor, burnt large dead portions

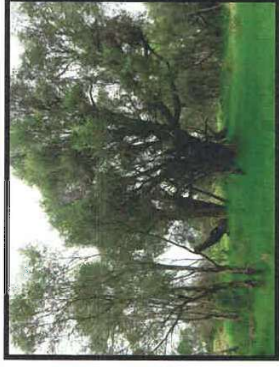
Trees 18 and 19

19	392128	6433335	Paperbark (Melaleuca preissiana)	9	70	70	70	70	70	Fair condition, burnt
20	392134	6433358	Paperbark (Melaleuca preissiana)	11	54	54	46	71	71	Good condition, minor fire damage
21	392147	6433356	Paperbark (Melaleuca preissiana)	9	65	65	46	65	65	Fair condition, burnt
22	392115	6433305	Paperbark (Melaleuca preissiana)	11	70	70	85	110	110	Good condition, large specimen, minor fire damage
23	392146	6433394	Paperbark (Melaleuca preissiana)	10	47	40	40	86	86	Good condition, minor fire damage
24	391919	6433109	Paperbark (Melaleuca preissiana)	8	45	49	35	76	76	Good condition, minor fire damage
25	391917	6433106	Paperbark (Melaleuca preissiana)	9	70	70	50	70	70	Good condition, minor fire damage
26	391931	6433087	Flooded Gum (Eucalyptus rudis)	8	74	74	50	89	89	Good condition, minor fire damage
27	391941	6433070	Flooded Gum (Eucalyptus rudis)	12	100	100	100	100	100	Good condition, large specimen

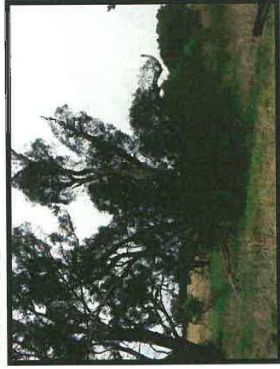
Trees 28 and 29

28	391945	6433065	Paperbark (Melaleuca preissiana)	10	53	53	53	53	53	Fair condition, impacted by fire
29	391946	6433063	Paperbark (Melaleuca preissiana)	10	65	30	30	72	72	Fair condition, impacted by fire
30	391941	6433023	Paperbark (Melaleuca preissiana)	7	58	41	41	73	73	Fair condition, impacted by fire
31	391939	6433018	Paperbark (Melaleuca preissiana)	8	43	36	38	78	78	Fair condition, impacted by fire
32	391940	6432948	Flooded Gum (Eucalyptus rudis)	10	61	45	45	76	76	Good condition, large specimen, minor fire damage
33	391921	6432936	Flooded Gum (Eucalyptus rudis)	12	70	70	70	70	70	Poor condition, fire damage
34	391920	6432930	Flooded Gum (Eucalyptus rudis)	12	73	73	73	73	73	Poor condition, fire damage
35	391841	6432068	Sheoak (Allocasuarina fraseriana)	9	63	63	63	63	63	Poor condition, fire damage
36	392005	6433403	Candlestick Banksia (Banksia attenuata)	9	37	37	38	53	53	Poor condition recently burnt and fire damage

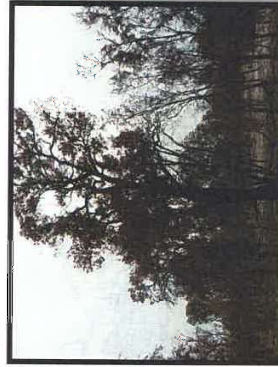
Tree 37

37	391956	6433385	Jarrah (Eucalyptus marginata)	11	43	29	29	52	52	Poor condition recently burnt and fire damage
38	391935	6433429	Candlestick Banksia (Banksia attenuata)	10	40	32	32	51	51	Poor condition recently burnt and fire damage
