CLEARING PERMIT APPLICATION – LILIAN AVE, ARMADALE

Attachment 2: Arboricultural Assessment Report

Attachment 2: Arboricultural Assessment Report (17/12/2018)

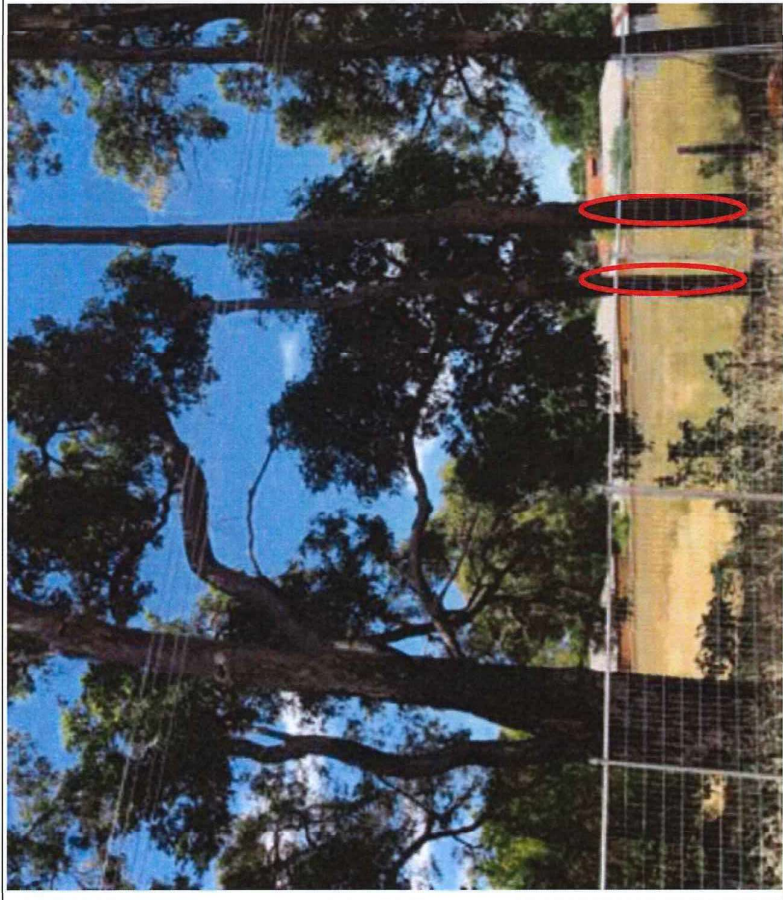
Plate 2 – Trees number 4 and 5

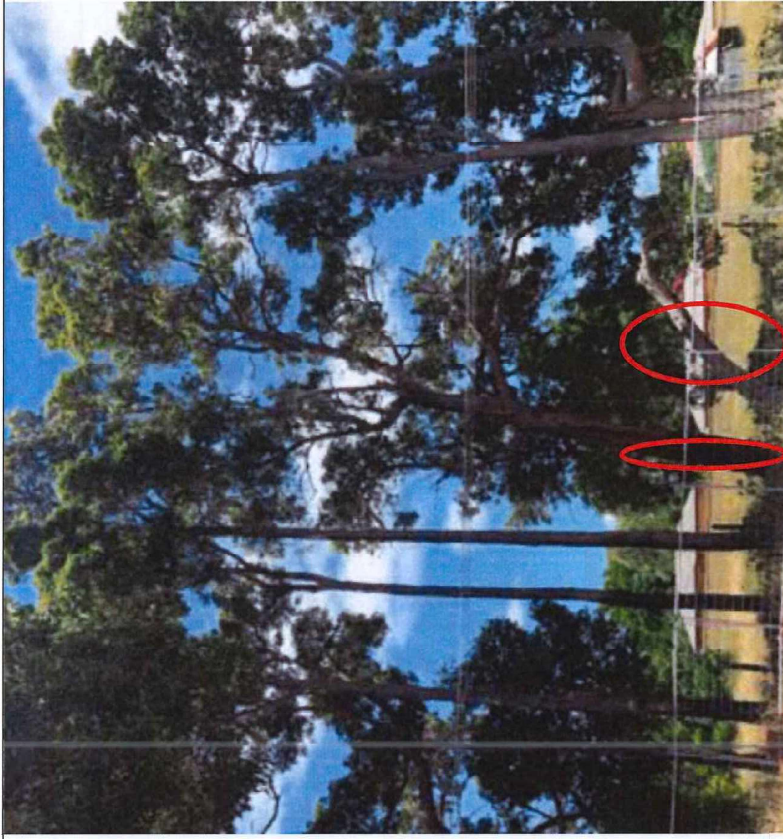
Plate 3 – Trees number 8 and 9

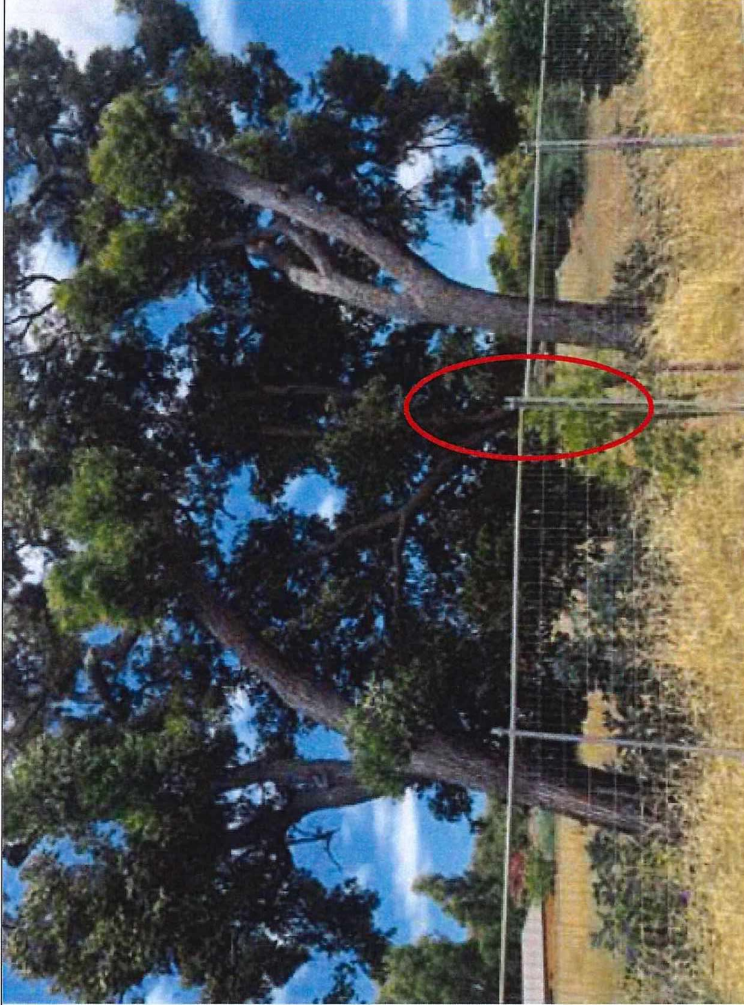
Plate 4 – Tree number 13

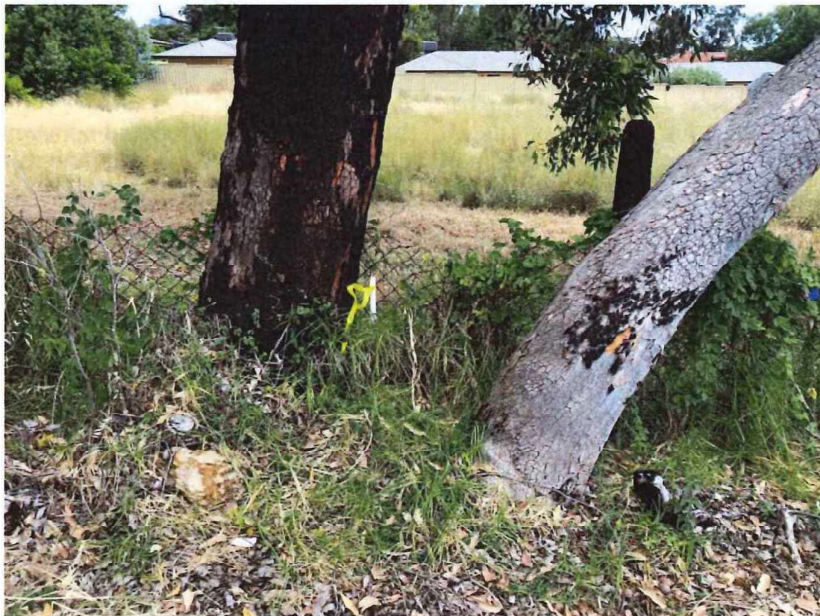
Figure 4. Crossover construction was proposed within close proximity (see yellow peg) of several trees on site – to alleviate the potential for tree/ rootplate damage and to mitigate root/ crossover conflicts in the future, where possible consideration could be given to narrowing crossover width to site the crossover further away from such trees.

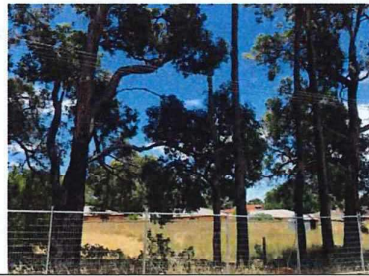
Tree Number: 4
Botanical Name: *Corymbia calophylla*
Common Name: marri
Retention Value: Low
Height: 10m
DBH: 0.31m
TPZ radius: 3.7m
SRZ radius: 1.6m
Remedial options: Consider removal for crossover

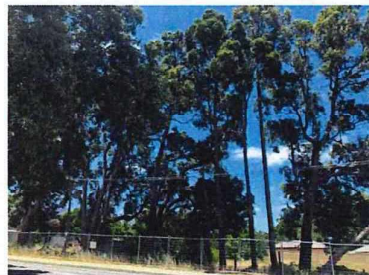
Tree Number: 5
Botanical Name: *Corymbia calophylla*
Common Name: marri
Retention Value: Medium
Height: 24m
DBH: 0.45m
TPZ radius: 5.4m
SRZ radius: 2.3m
Remedial options: Consider removal for crossover

5	<i>Corymbia calophylla</i>	marri	24m	0.45m	8/5m	5.4	2.3	Fair	High	15-40yrs	Medium	1.4m east of crossover peg (within crossover), extensive reduction pruning works observed, upper crown foliage concentration, dead branches nominal in size and amount	Low	Consider removal for crossover

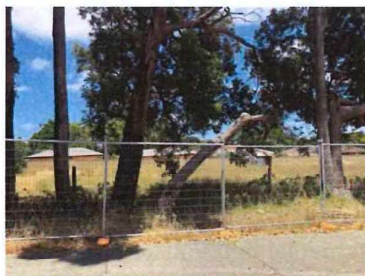
Tree Number: 9
Botanical Name: *Corymbia calophylla*
Common Name: marri
Retention Value: Low
Height: 6m
DBH: 0.38m
TPZ radius: 4.6m
SRZ radius: 1.9m
Remedial options: Consider removal for crossover

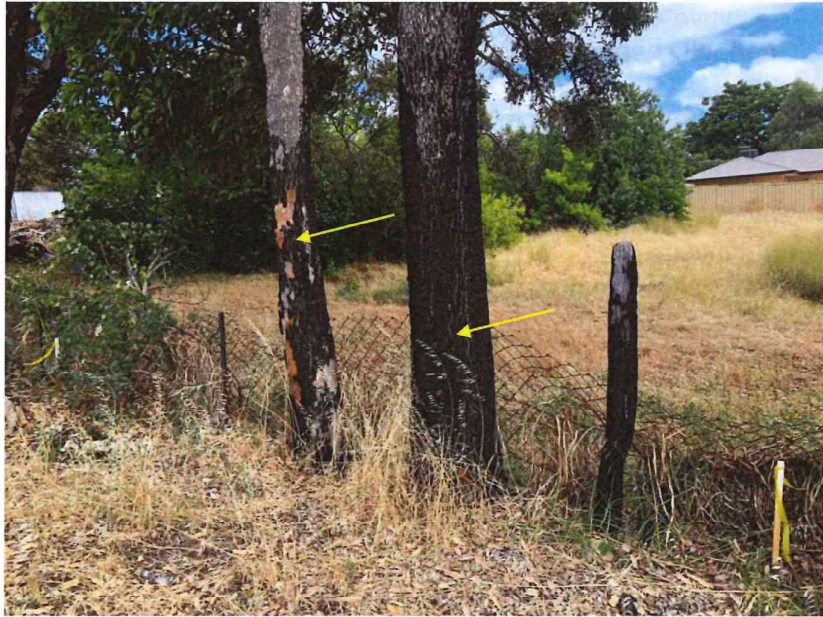
Figure 11. Tree numbers 4 & 5 (see arrows) where located within the middle section of the proposed crossover, with tree retention as part of crossover construction not likely; looking towards the southeast.

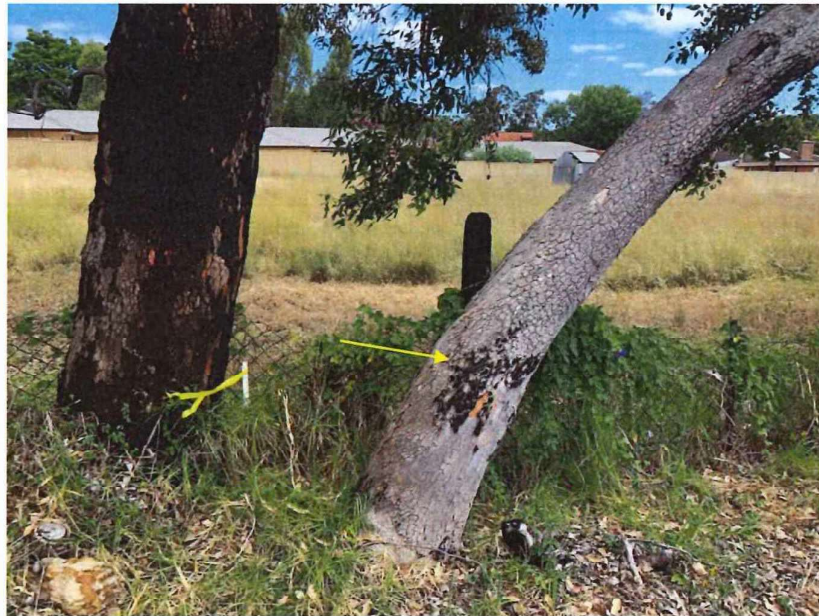
Figure 12. Significant trunk lean was evident for tree number 9 (see arrow) and as such is not likely to allow vehicle traffic to pass within the dripline of the tree; looking towards the south.
