**Black Cockatoo  
Habitat Tree Assessment  
CPS 8482/1**

**Lot 12140  
Jones Road  
Yanmah**

December 2019

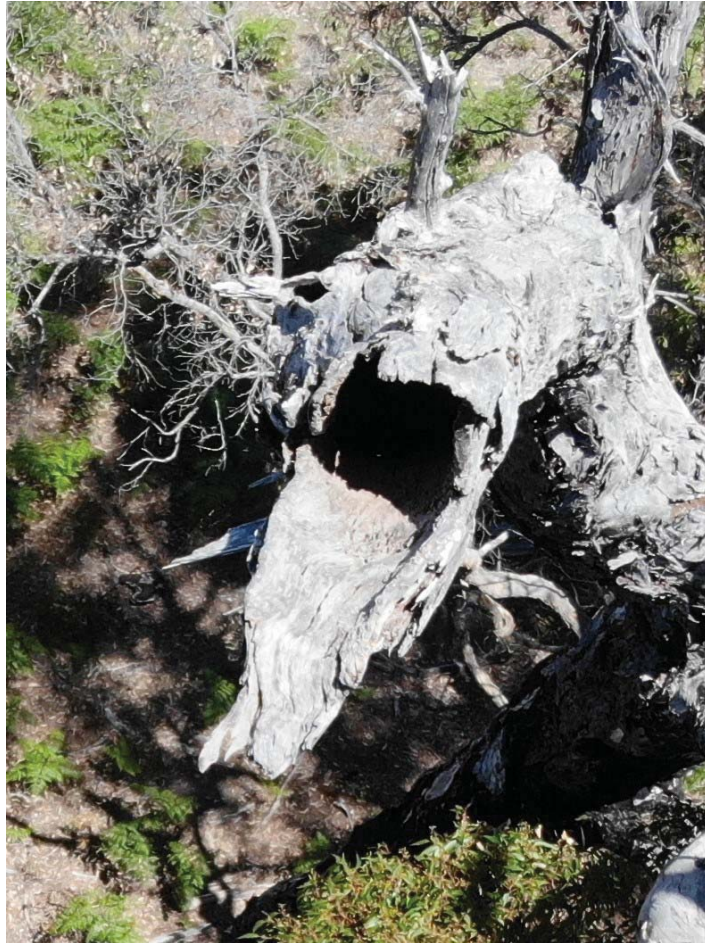
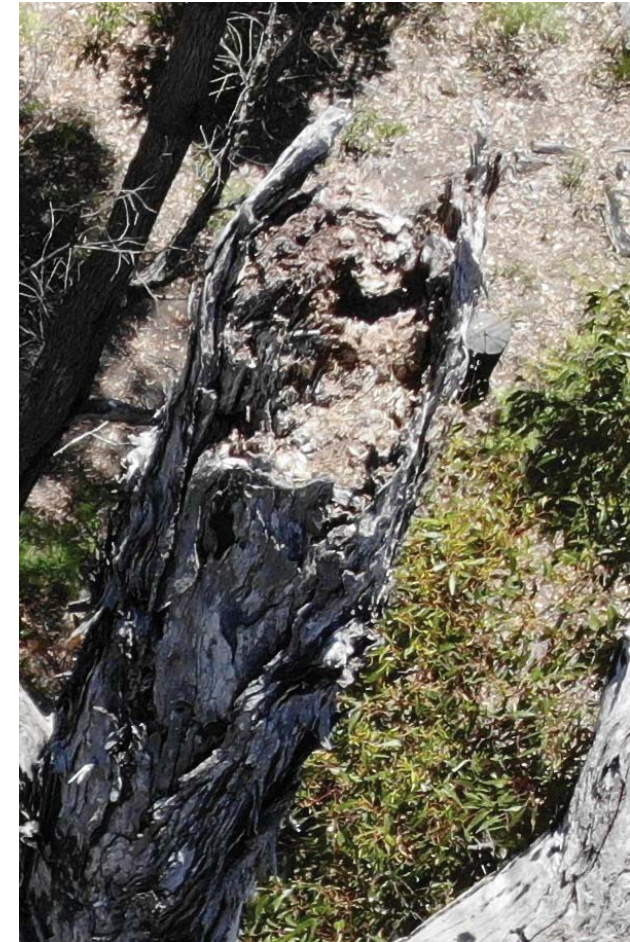
ID	Location Data (MGA 94/Z50)	408724 mE	6217194 mN	Species	Jarrah (dead)	Survey Date	12/12/2019
1	Comments	Dead jarrah stag. From ground level some of the upper branches appeared to have possible hollows. Drone pictures indicate the presence of one spout type hollow in a branch (pictured on left), but the branch itself was near horizontal and appeared to be too narrow in diameter to provide enough floor space for a nesting black cockatoo (i.e. less than ~20cm). No evidence of any use. Other branches did not contain hollows (e.g. picture on right) or if present, were too small.				Classification	Unsuitable Hollows

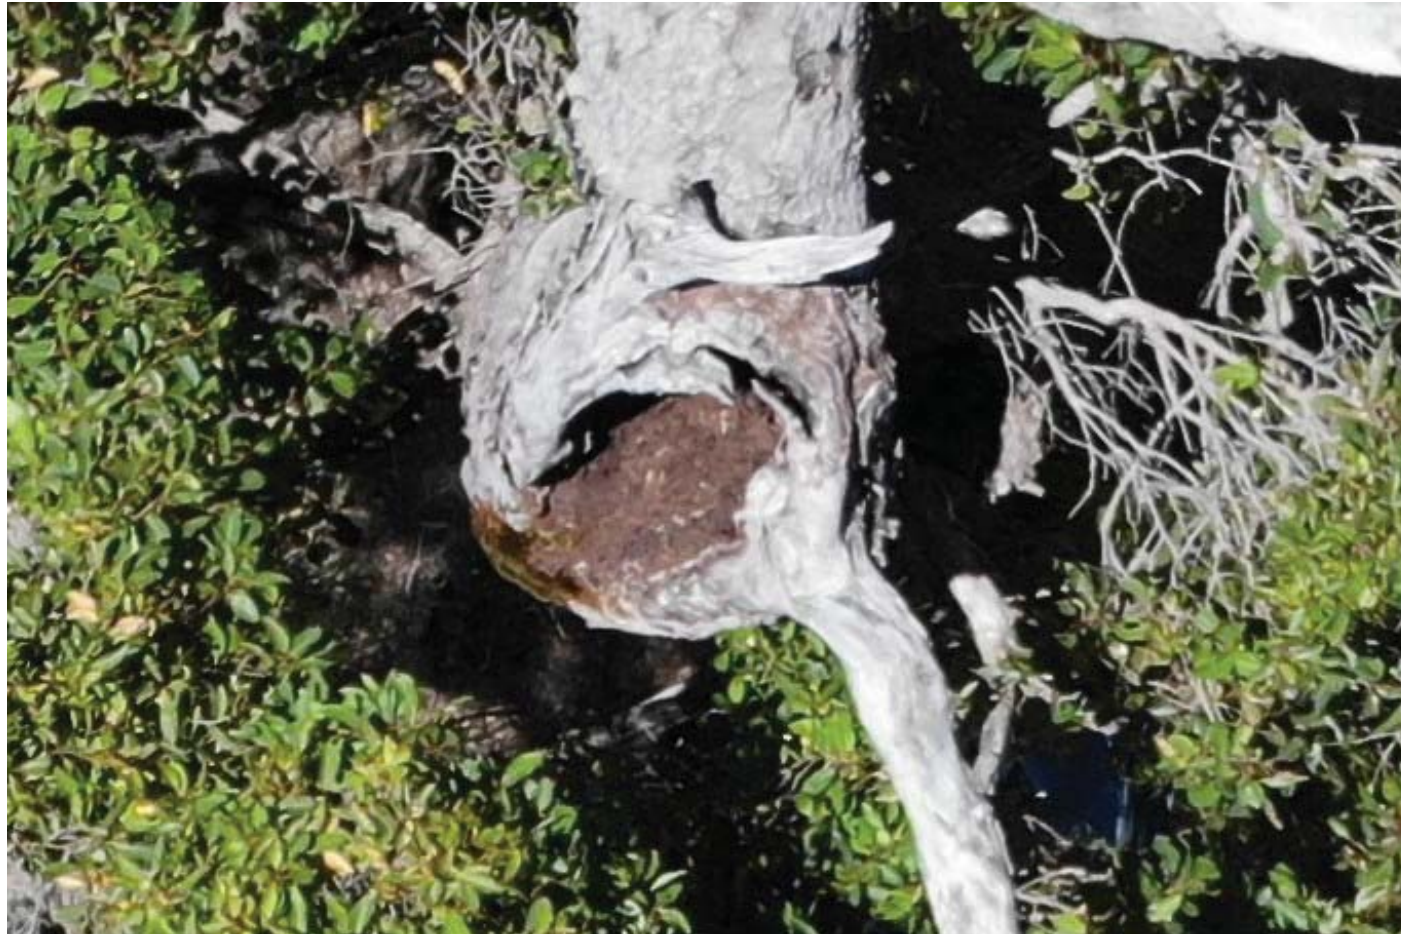
ID	Location Data (MGA 94/Z50)	408843 mE	6217160 mN	Species	Marri	Survey Date	12/12/2019
2	Comments	Marri with dead upper branches. From ground level appeared to have possible large chimney style hollow. Drone pictures indicate the presence of a very shallow hollow with well expose floor (pictured below). This hollow appears to be too shallow for black cockatoos to use for nesting purposes. No evidence of any use. Some smaller unsuitable hollows in branches.				Classification	Unsuitable Hollows

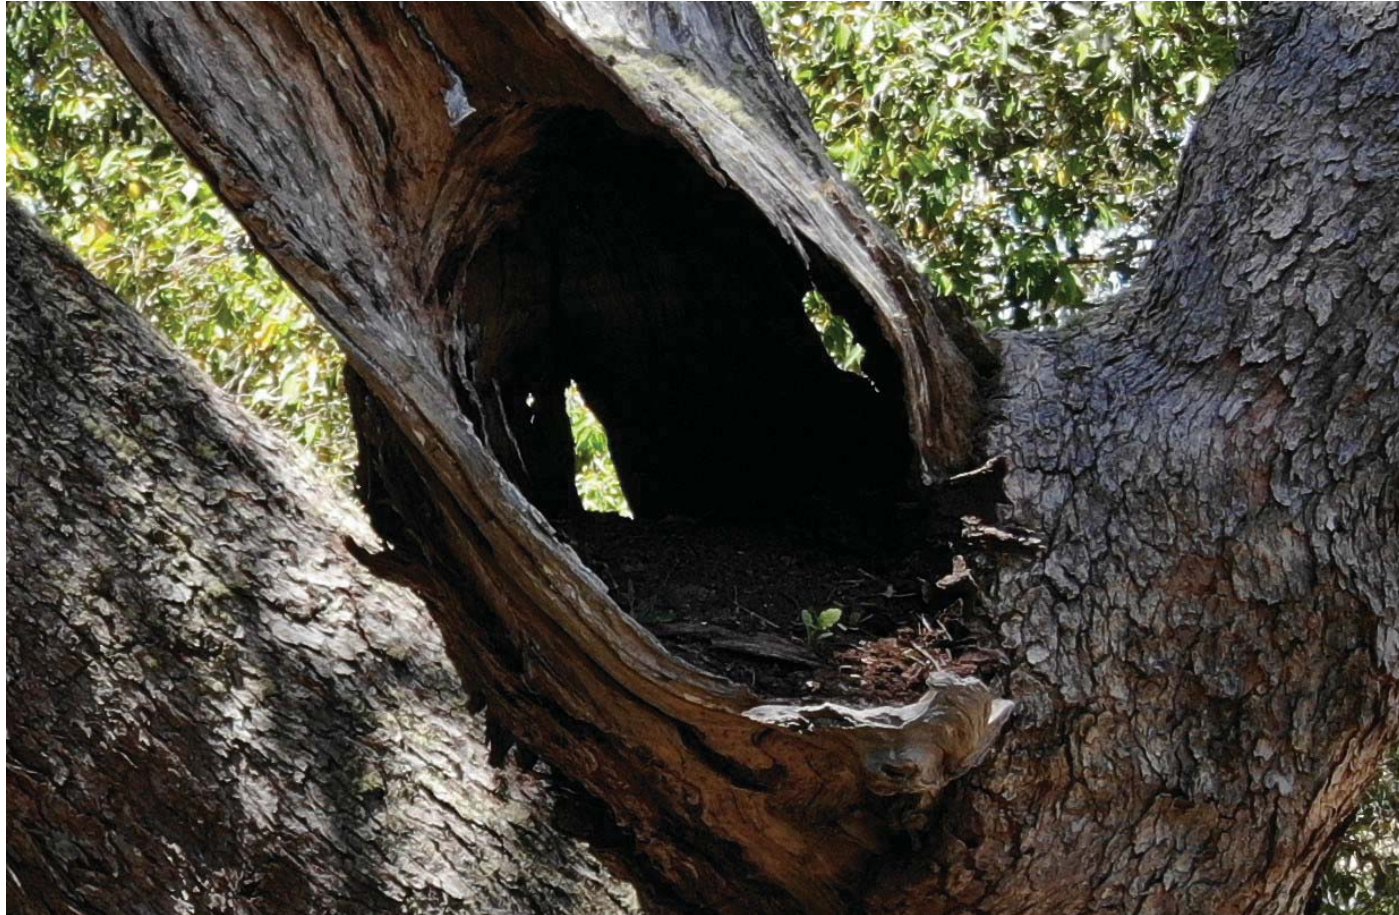
ID	Location Data (MGA 94/Z50)	409002 mE	6217194 mN	Species	Marri	Survey Date	12/12/2019
3	Comments	Marri. From ground level appeared to have possible large side entry style hollow. Drone pictures indicate the presence of a very shallow hollow with well expose floor with smaller openings on the opposite side (pictured below). This hollow appears to be too shallow for black cockatoos to use for nesting purposes. No evidence of any use.				Classification	Unsuitable Hollow

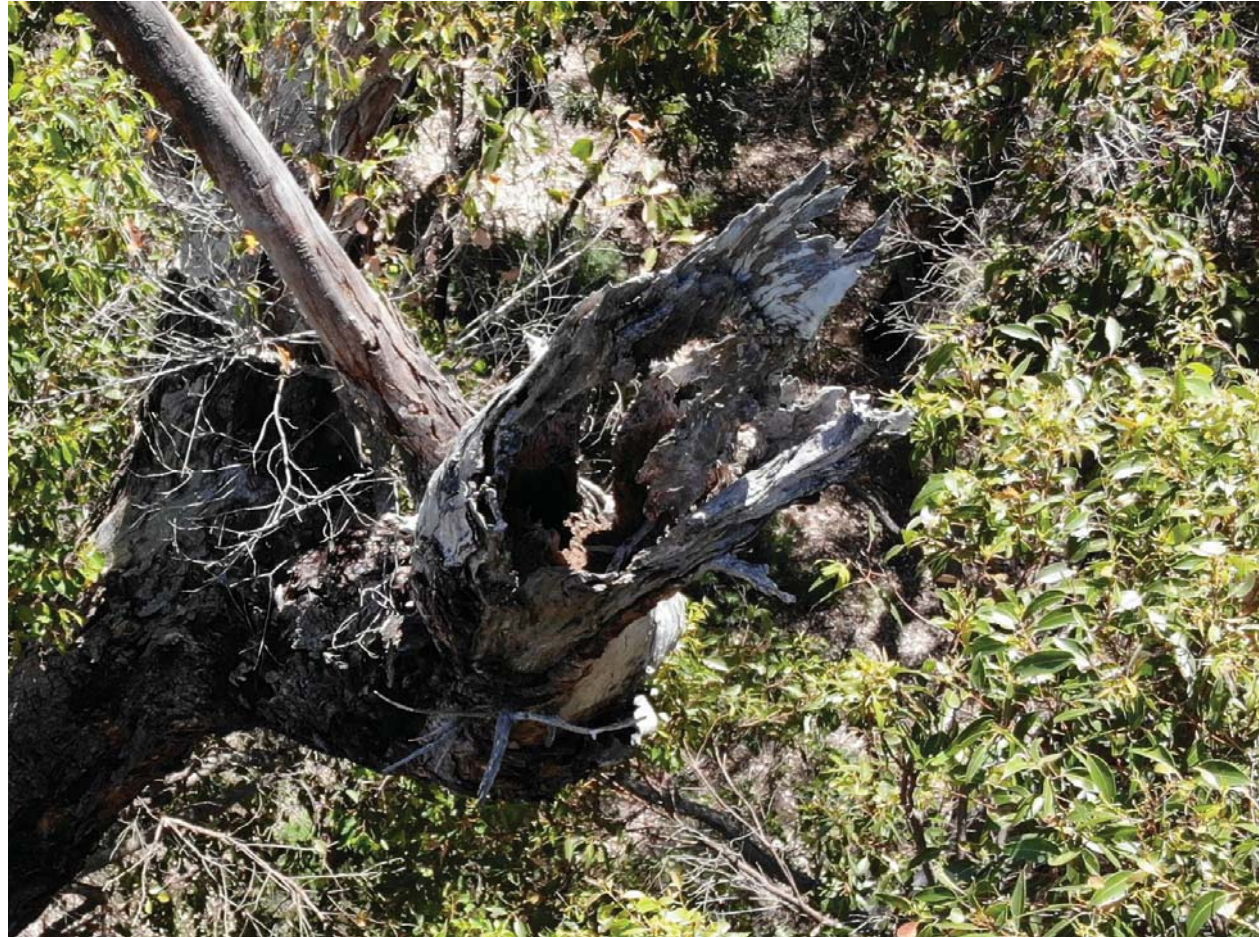
ID	Location Data (MGA 94/Z50)	408529 mE	6217436 mN	Species	Marri	Survey Date	12/12/2019
4	Comments	Marri with dead upper branches. From ground level some of the upper branches appeared to have possible hollows. Drone pictures indicate the presence of one spout type hollow in a branch (pictured below), but the hollow appeared to be very shallow and too narrow in diameter to provide enough floor space for a nesting black cockatoo (i.e. less than ~20cm). No evidence of any use. Other branches did not contain hollows or if present, were too small.				Classification	Unsuitable Hollows

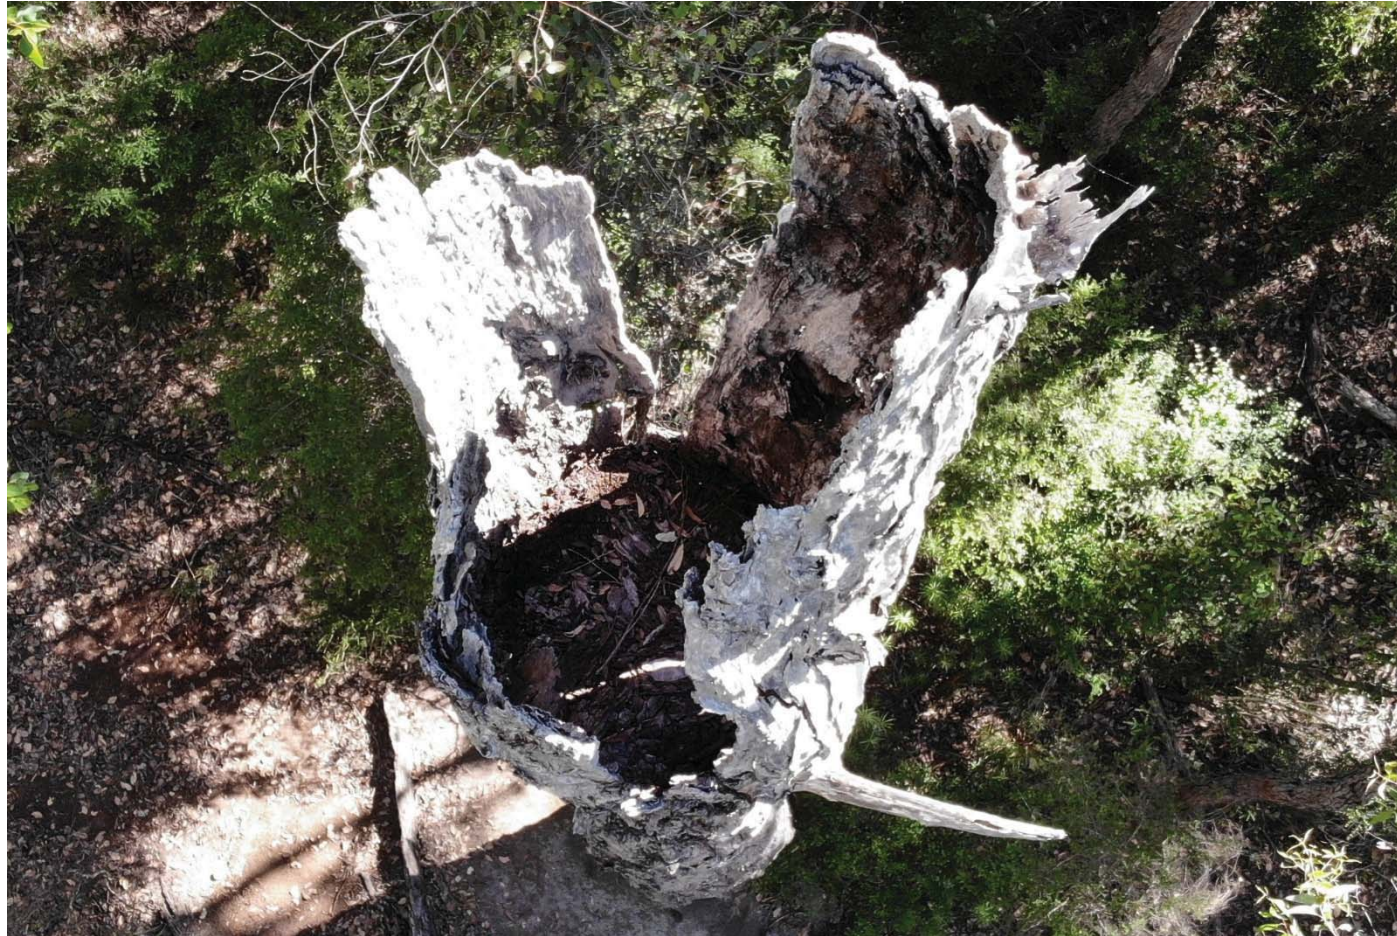
ID	Location Data (MGA 94/Z50)	408317 mE	6217741 mN	Species	Marri (dead)	Survey Date	12/12/2019
5	Comments	Dead marri. From ground level appeared to have large chimney type hollow in broken off trunk. Drone pictures indicate the presence of very shallow, open hollow (pictured below), that appeared unsuitable for nesting black cockatoos. No evidence of any use.				Classification	Unsuitable Hollow

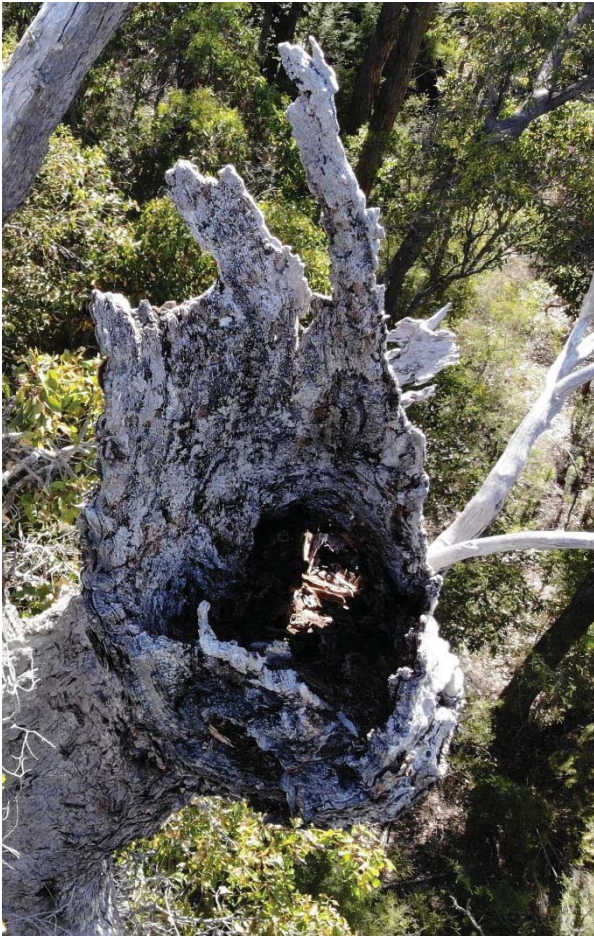
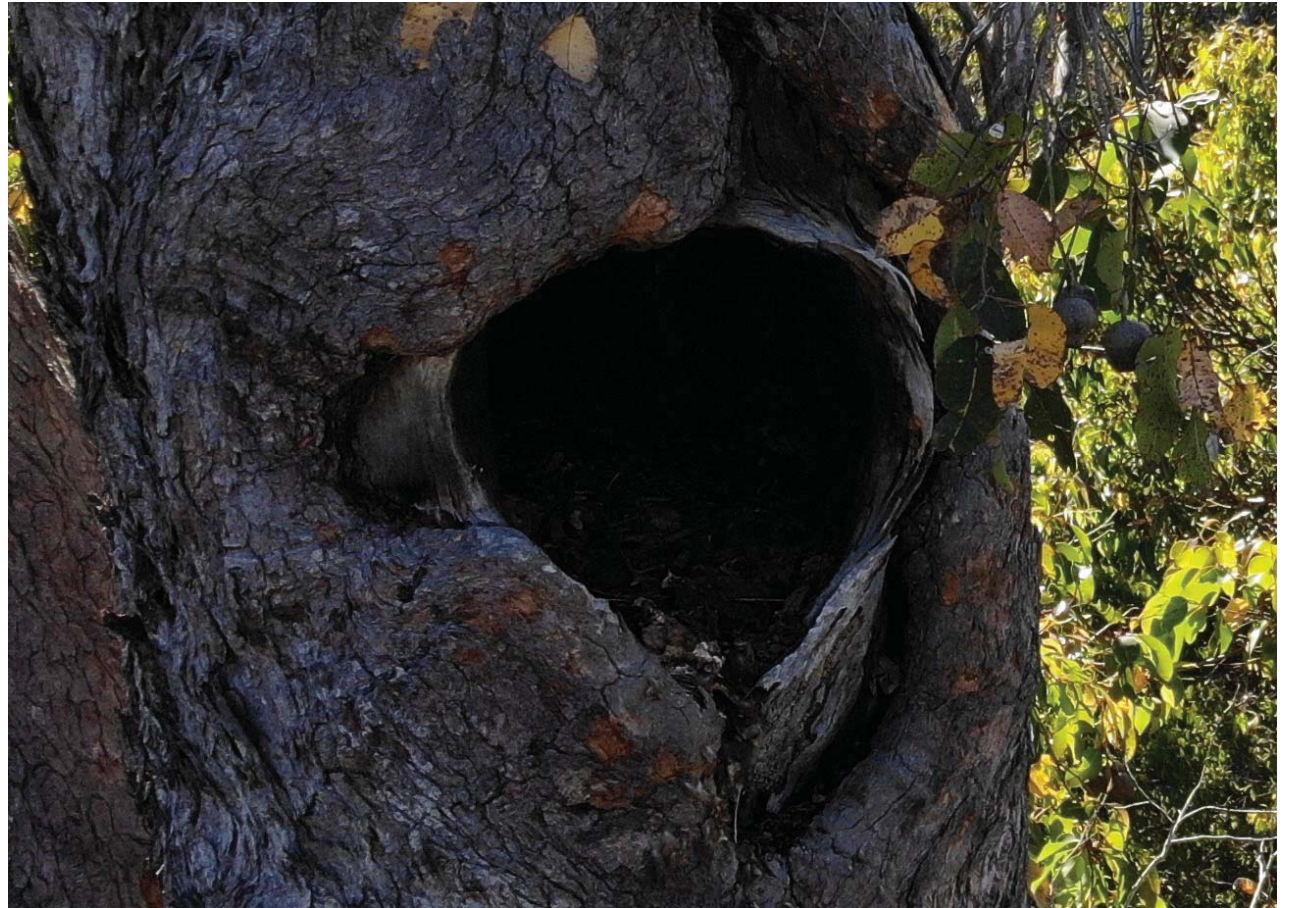
Tree 6 contain a side entry hollow which had some possible chew marks around its entrance however it appeared to have little vertical depth which suggested it was not very favourable for black cockatoos. The marks around the entrance were not very extensive also suggesting only a minor level of activity possibly associated with investigating (“prospecting”) and not actual nesting or possibly galah activity. The status of this hollow therefore remains inconclusive.

ID	Location Data (MGA 94/Z50)	408275 mE	6217764 mN	Species	Marri	Survey Date	12/12/2019
6	Comments	Marri that from ground level appeared to have large chimney type hollow and a side entry hollow. Drone pictures show the chimney type hollow (pictured on left) as being very open/shallow suggesting it would be unsuitable for black cockatoos. No evidence of any use. The side entry hollow (pictured on right) appeared to go in some distance but had little vertical depth which may limit its favourability for black cockatoos. Some possible chew marks around entrance but inconclusive if caused by black cockatoos or galahs.				Classification	Unsuitable Hollow + Chewed Hollow?

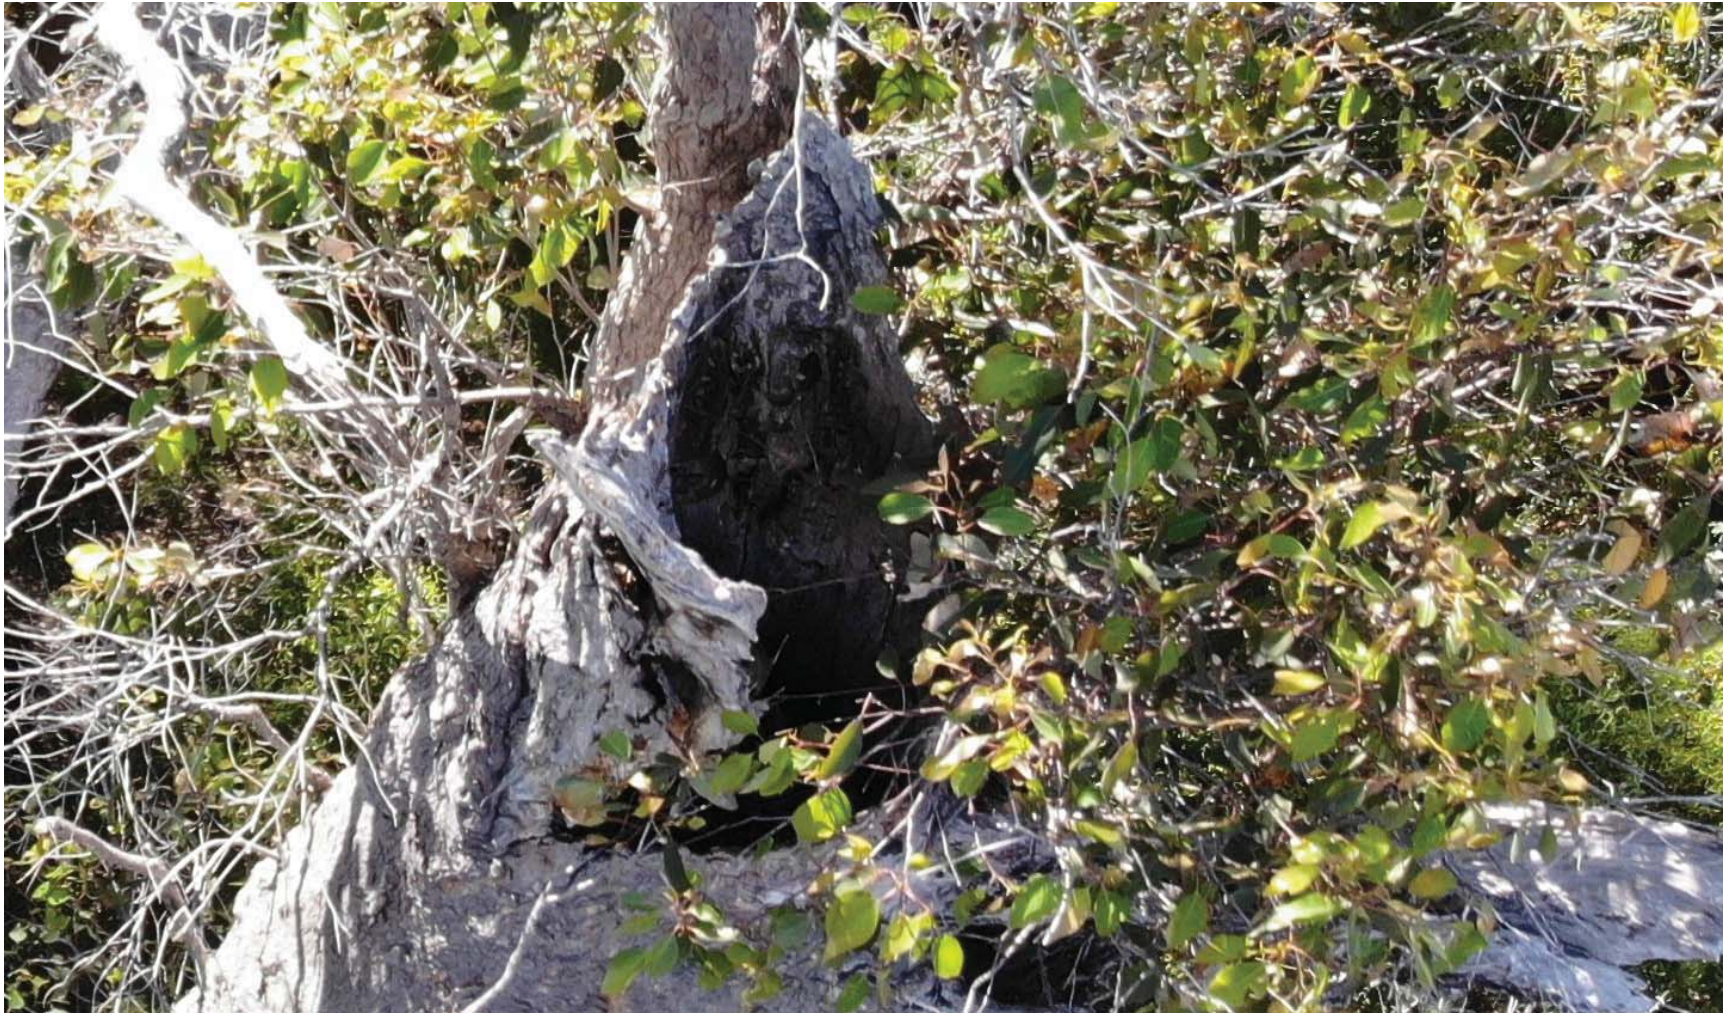
One tree appeared to have a suitable sized chimney type hollow (Tree 7) but no signs of it having been used were evident.

ID	Location Data (MGA 94/Z50)	408654 mE	6217371 mN	Species	Marri	Survey Date	12/12/2019
7	Comments	Marri that from ground level appeared to have large chimney type hollow. Drone pictures show the chimney type hollow as being present and having some depth suggesting it may be suitable for black cockatoos though the entrance was partly over hung with branches which could restrict access. No evidence of any use.				Classification	Unused Hollow

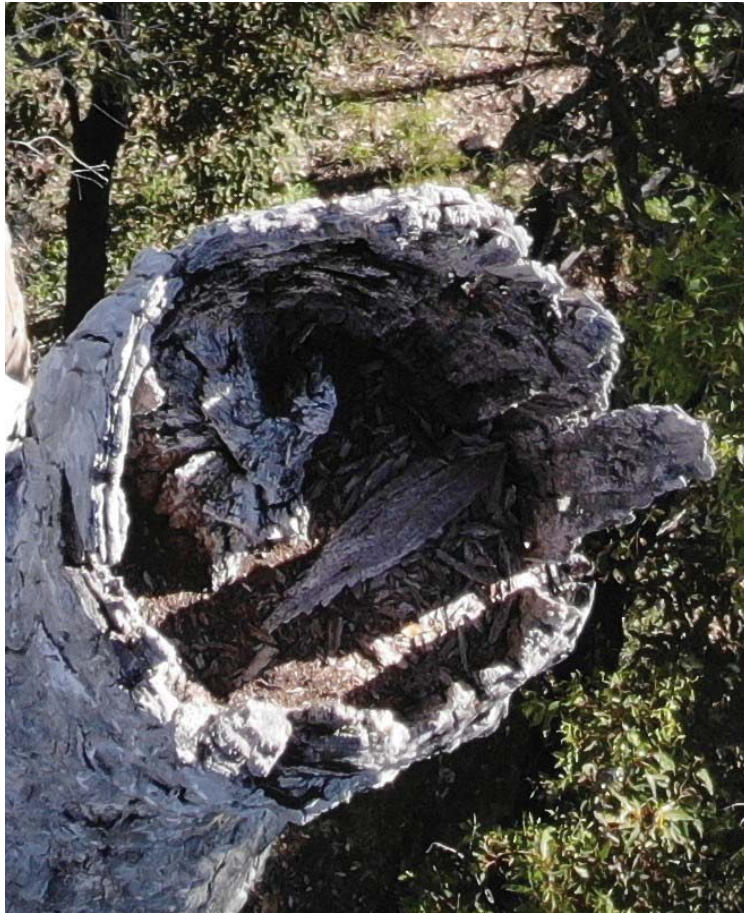
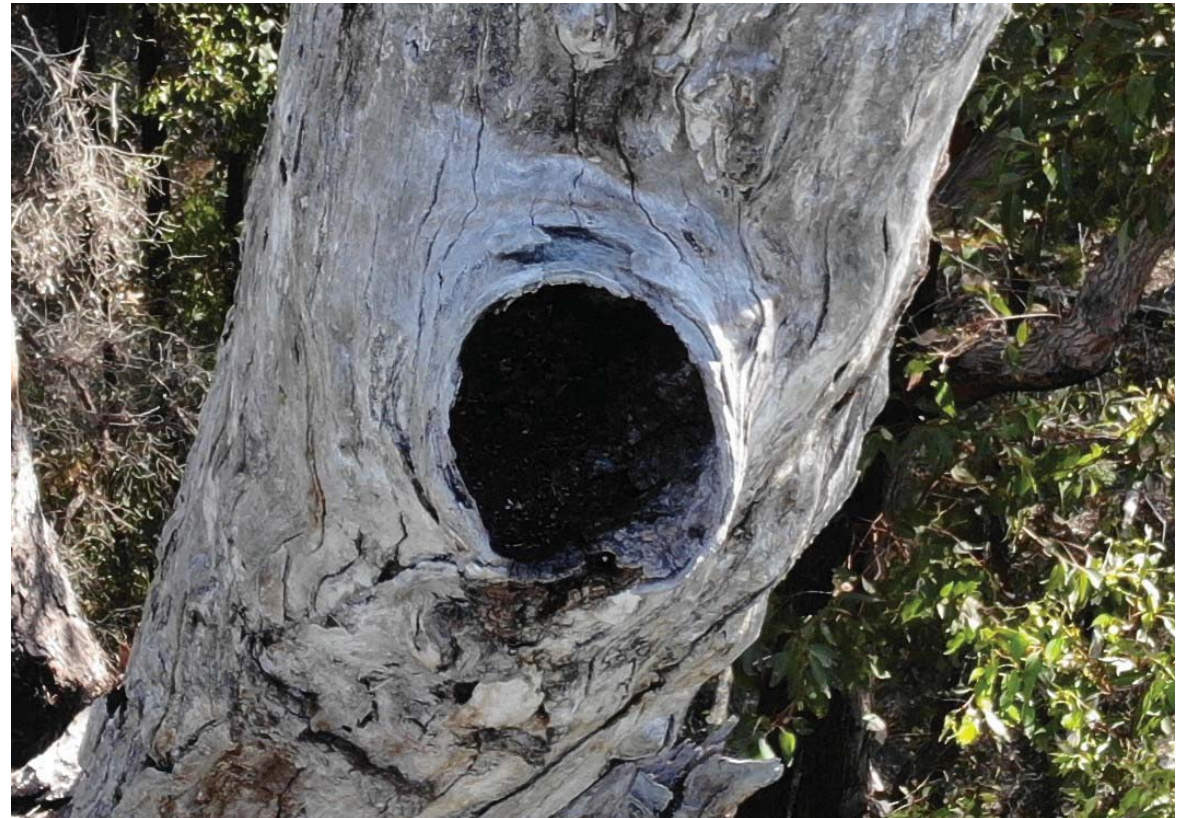
ID	Location Data (MGA 94/Z50)	408819 mE	6217340 mN	Species	Marri (dead)	Survey Date	12/12/2019
8	Comments	Dead marri that from ground level appeared to have large chimney type hollow and a side entry hollow. Drone pictures show the chimney type hollow (pictured on left) as being very open/shallow suggesting it would be unsuitable for black cockatoos. No evidence of any use. The side entry hollow (pictured on right) had marginal entrance size (~10cm) and had little vertical depth which may limit its favourability for black cockatoos. No evidence of any use.				Classification	Unsuitable Hollows
