2 December 2018

This letter outlines the results of a survey of vegetation condition undertaken by myself on the 30th November 2018 over part of Lot 3 Buller Rd, Waroona (herein referred to as the subject area). The purpose of the survey was to assess whether the vegetation condition within the subject area had returned, or was returning, to that which existed prior to the fire of January 2016 that also burnt large parts of the surrounding region.

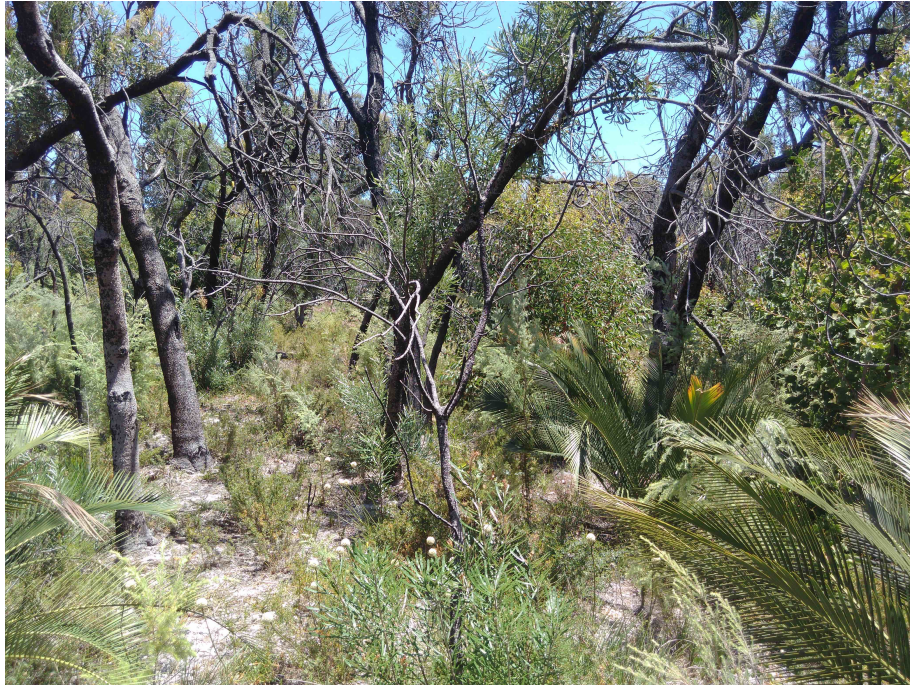
The condition of the vegetation in the southern half of the subject area was rated as 'Very Good', which is the same category as previously assigned by Woodman Environmental (2015) (Figures 1 and 2). The vegetation in this area is recovering its structure and diversity following the fire with a minor infestation of mainly non-aggressive weeds. Many native plants were observed to be resprouting and seedlings of *Banksia attenuata* were common. This area is a *Eucalyptus marginata* - *Banksia attenuata* woodland, and the vegetation condition meets the criterion for inclusion as part of the Commonwealth-listed Threatened Ecological Community (TEC) 'Banksia Dominated Woodlands of the Swan Coastal Plain IBRA Region' (Banksia Woodlands TEC).

**Plate 1: 'Very Good' vegetation showing native understorey with mid- and upper strata regenerating following fire (32.8634 S, 115.8229 E).**

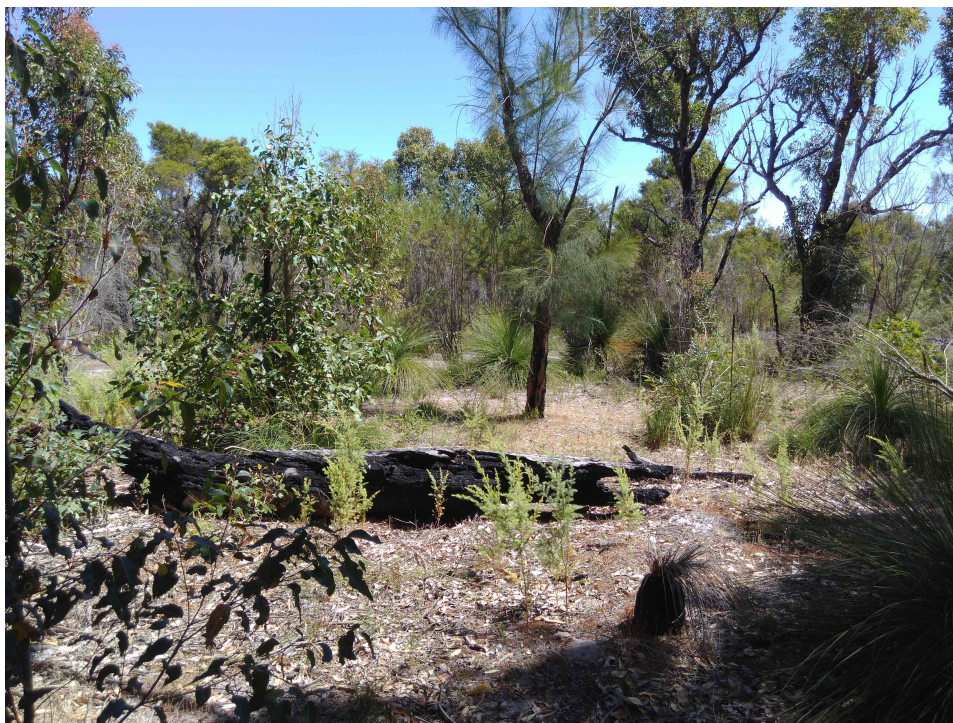
**Plate 2: 'Very Good' vegetation, showing more open understorey but few weeds and intact vertical structure (32.8954 S, 115.8299 E).**

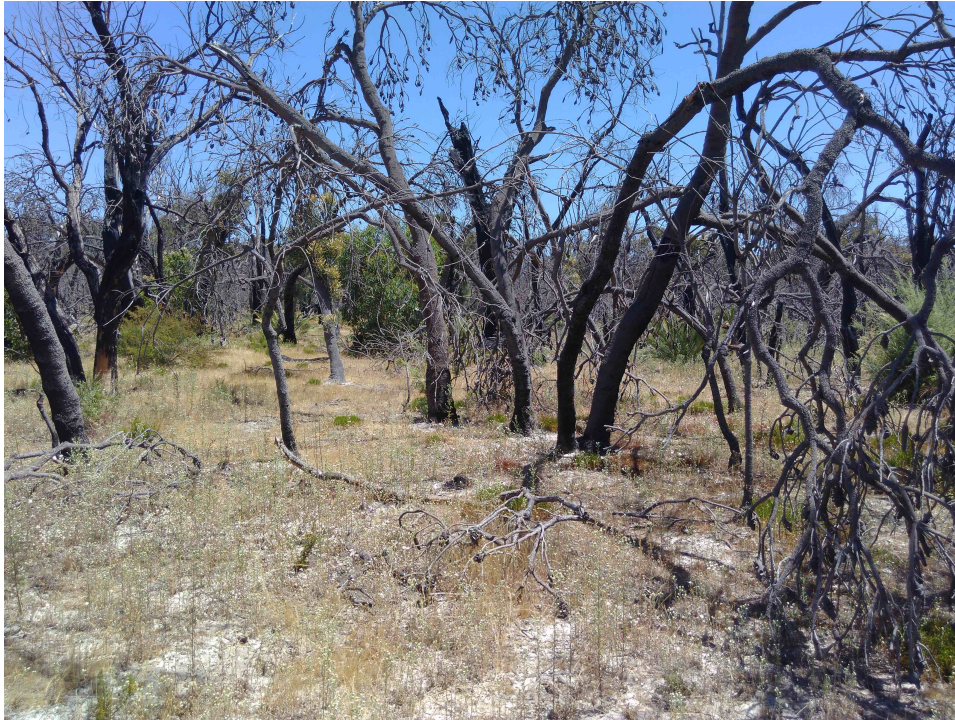
The vegetation of the northern half of the site was mostly in a 'Completely Degraded' to 'Degraded' condition. The original vegetation structure has been largely lost and the understorey is dominated by weed species (Figure 3). This area had been rated as 'Degraded' by Woodman Environmental (2015) and the fire may have adversely affected the vegetation even further. As such, the northern part of the subject area does not meet the criteria to be considered part of the Banksia Woodlands TEC. There were some small parts of the northern section that could be rated as 'Good', as the basic vertical structure is still intact but weeds dominated the understorey (Figure 4). The 'Good' areas mostly coincided with those mapped in the same category by Woodman Environmental (2015). While there is a degree of subjectivity in the rating of vegetation condition and may vary between observers, it is clear the vegetation condition in most of the northern part of the subject area has not improved since the fire and may have declined further.

**Plate 3: 'Completely Degraded' vegetation with almost no ground layer and very open upper canopy (32.8553 S, 115.8233 E).**

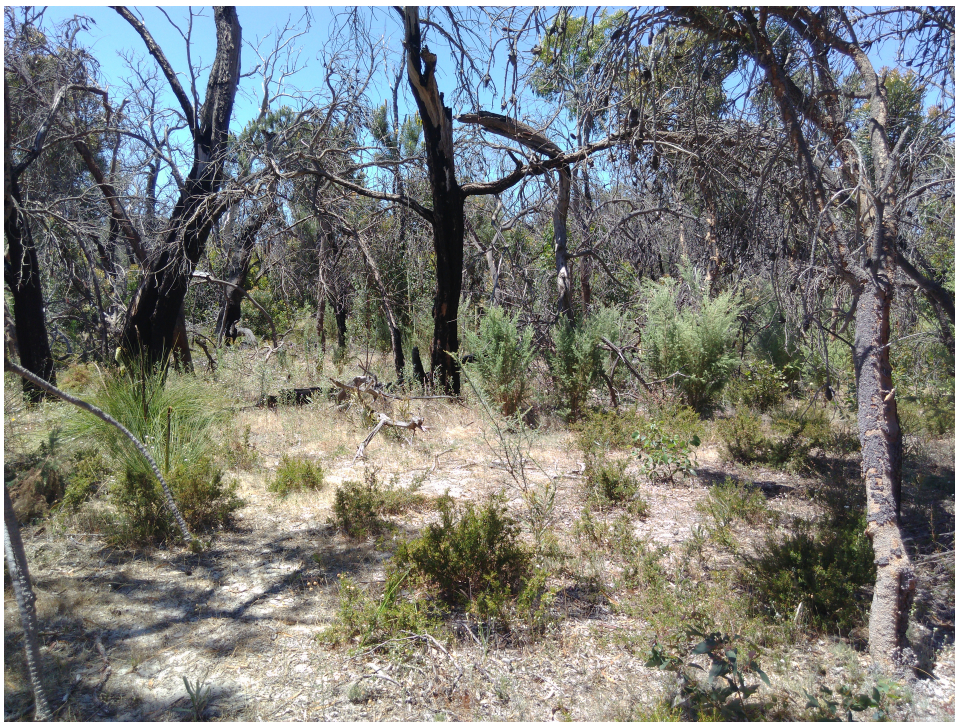
**Plate 4: 'Good' vegetation with a weedy understorey and some native species, but vertical structure is still present (32.8589 S, 115.8227 E).**
