## ENVIRONMENTAL SITE INSPECTION REPORT

### Stephenson Avenue, Osborne Park

SITE INSPECTION DETAILS				
<b>Date:</b>	22 <sup>nd</sup> May 2019			
<b>Location:</b>	Stephenson Avenue, Osborne Park			
<b>Region</b>	IDD			
<b>Purpose:</b>	Determine remnant vegetation and condition			
<b>Attendees:</b>	Gaynor Owen	Senior Environment Officer Main Roads Western Australia	Fiona Van Rijnswood	Environment Officer Main Roads Western Australia

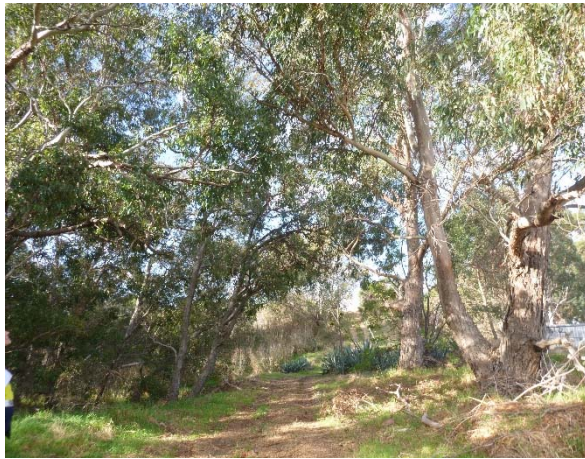
Photo 1. Remnant vegetation (*Eucalyptus rudis* (Flooded Gum)) in Degraded to Completely Degraded condition to north of track, planted *Eucalyptus camaldulensis* (River Gum) south of track.

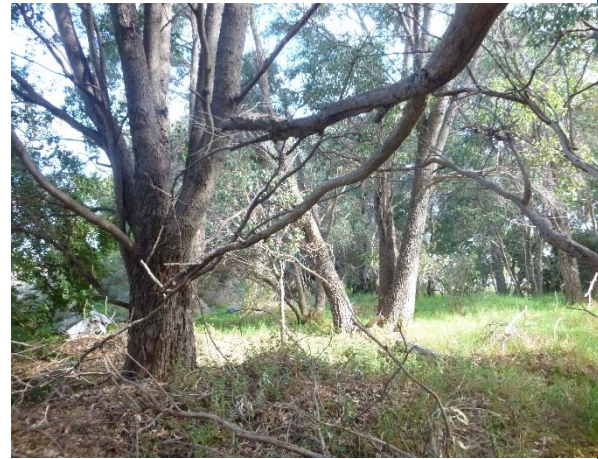
Photo 2. Remnant vegetation (*Eucalyptus rudis* (Flooded Gum)) closed forest in Degraded to Completely Degraded condition. Understorey comprised of weeds. Understorey has been cleared in the past and spoil piles, fill and rubbish occur throughout.

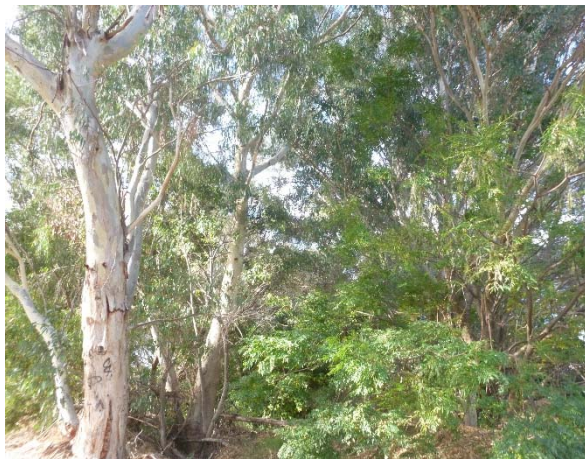
Photo 3. *Eucalyptus camaldulensis* (River Gum) and Japanese Pepper tree.

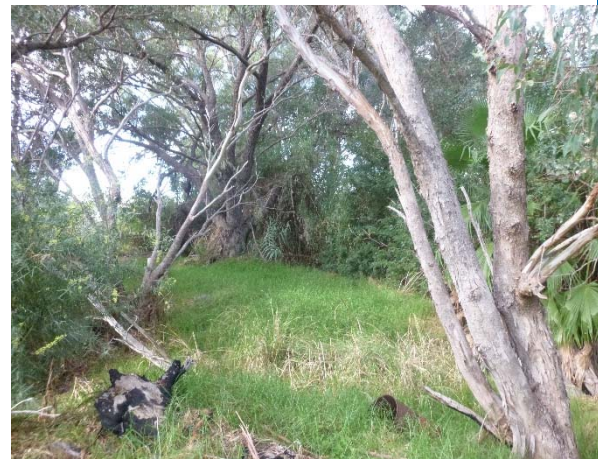
Photo 4. Remnant vegetation (*Eucalyptus rudis* (Flooded Gum)) closed forest in Degraded to Completely Degraded condition. Understorey comprised of weeds. Spoil piles, fill and rubbish were evident throughout remnant vegetation.
