# Flora and Vegetation of a Proposed Footpath Alignment through Banksia Woodland Halifax Drive, Bunbury, 2019.

Prepared for the City of Bunbury  
July 2019

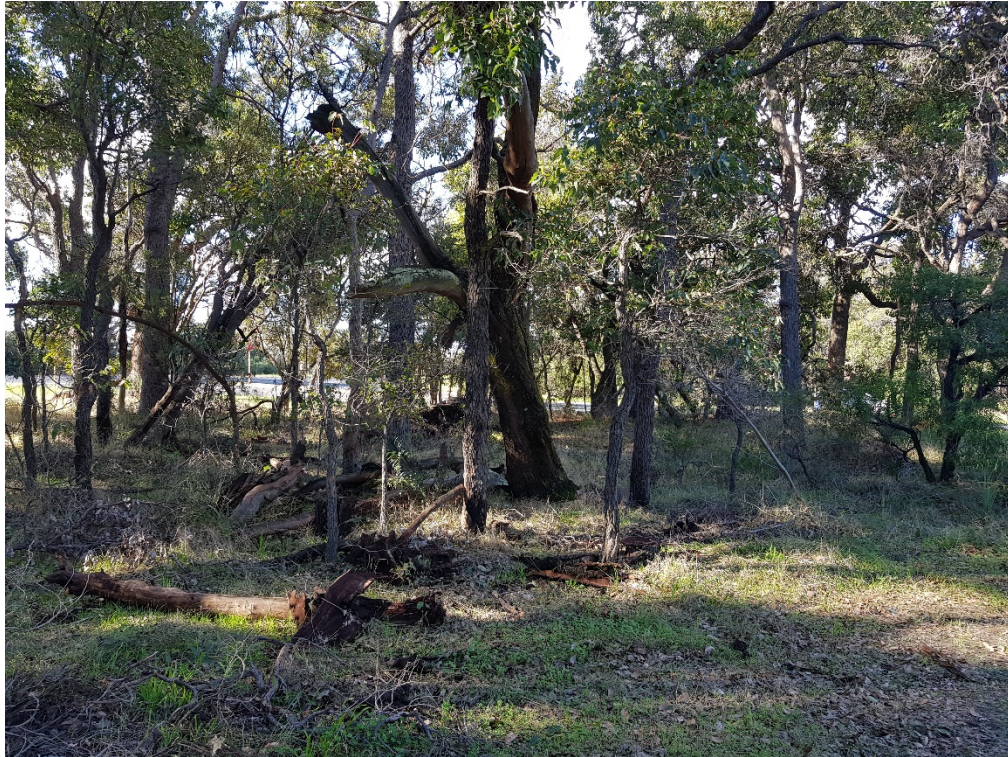
With regard to condition the vegetation it is Good in parts (relatively high native species diversity but with weed cover of 30-50%) but was mainly (80%+) classed as Degraded. The immediate area where the proposed footpath is to be sited was classed as Degraded.

Figure 1. Looking toward the location of the proposed footpath. [Condition: Degraded]

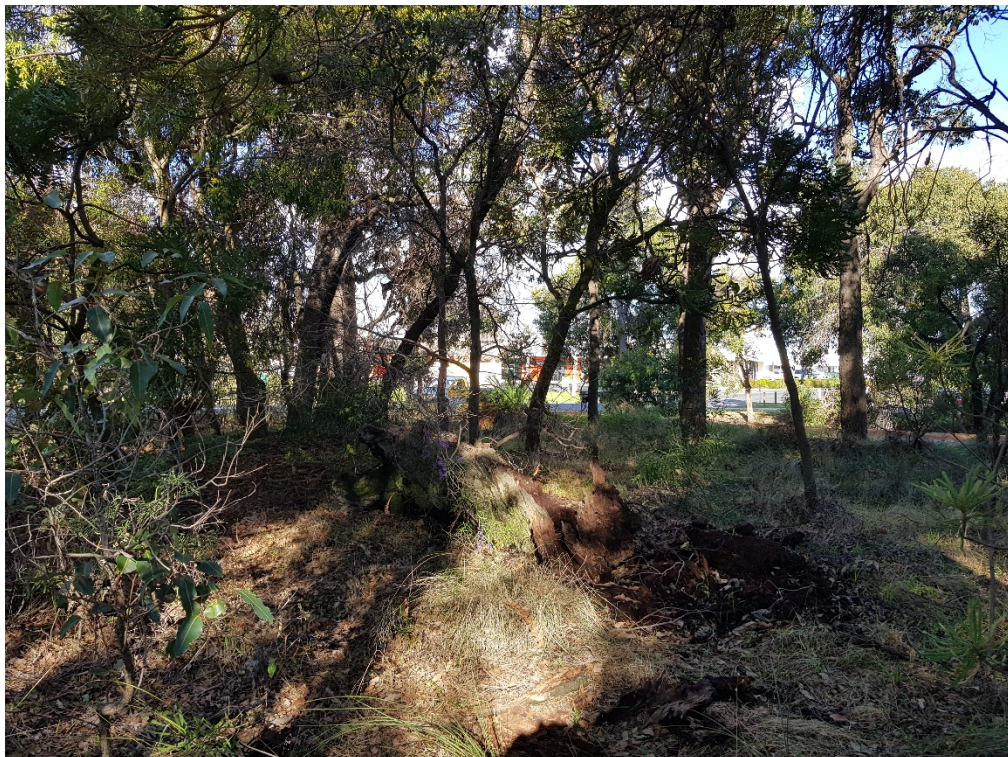
Figure 2. Looking toward the location of the proposed footpath. [Condition: Degraded]

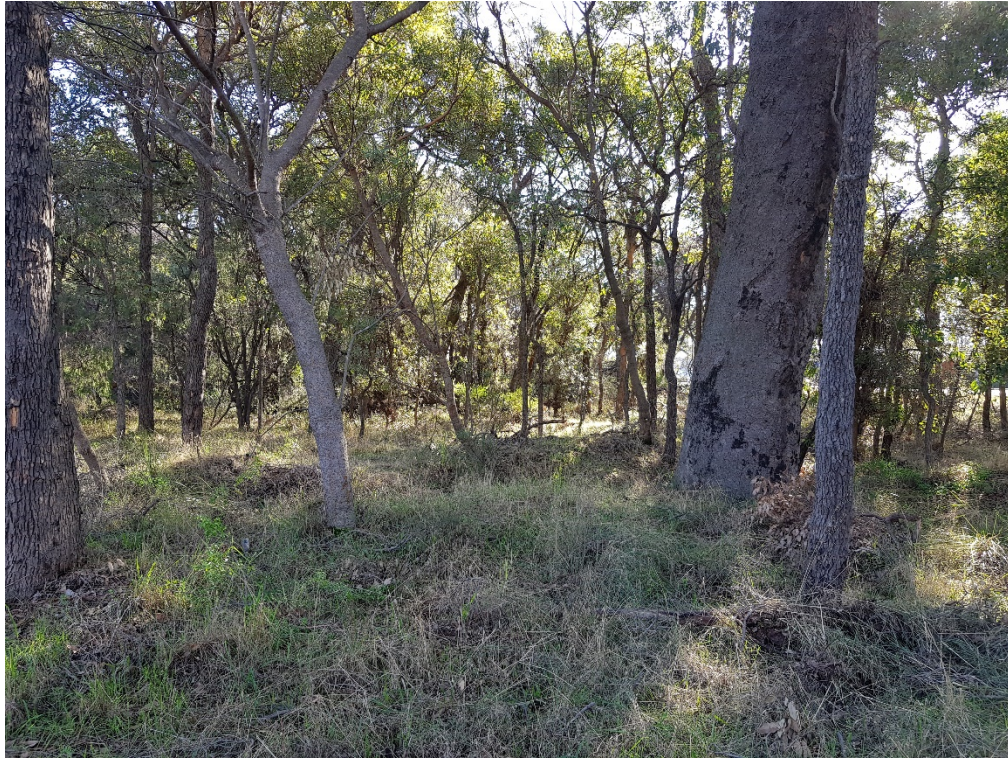
Figure 3. 40 m west of Halifax Drive, looking north [Condition: Degraded]

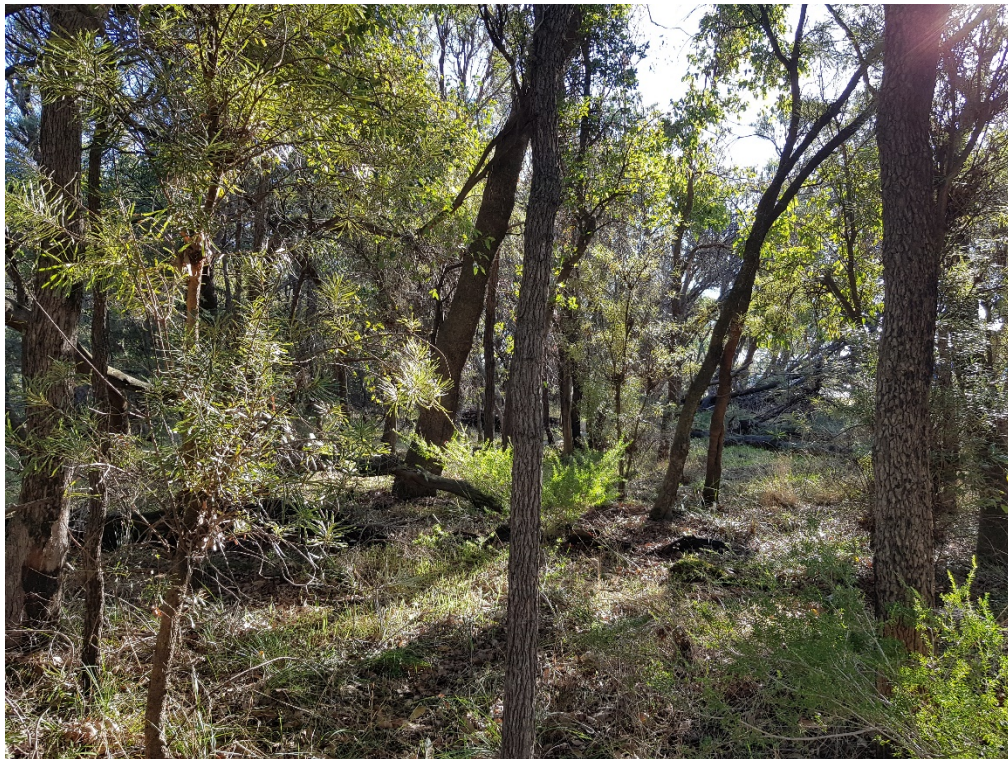
Figure 4. 40 m west of Halifax Drive. [Condition: Good/Very Good].

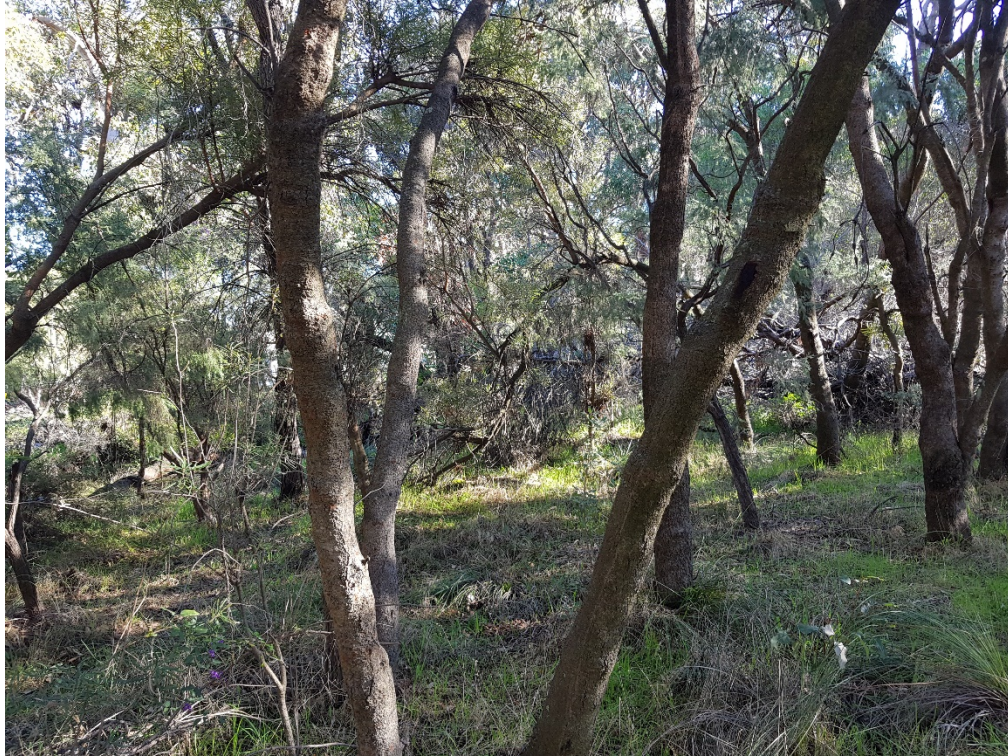
Figure 5. 80 m west of Halifax Drive [Condition: Degraded].

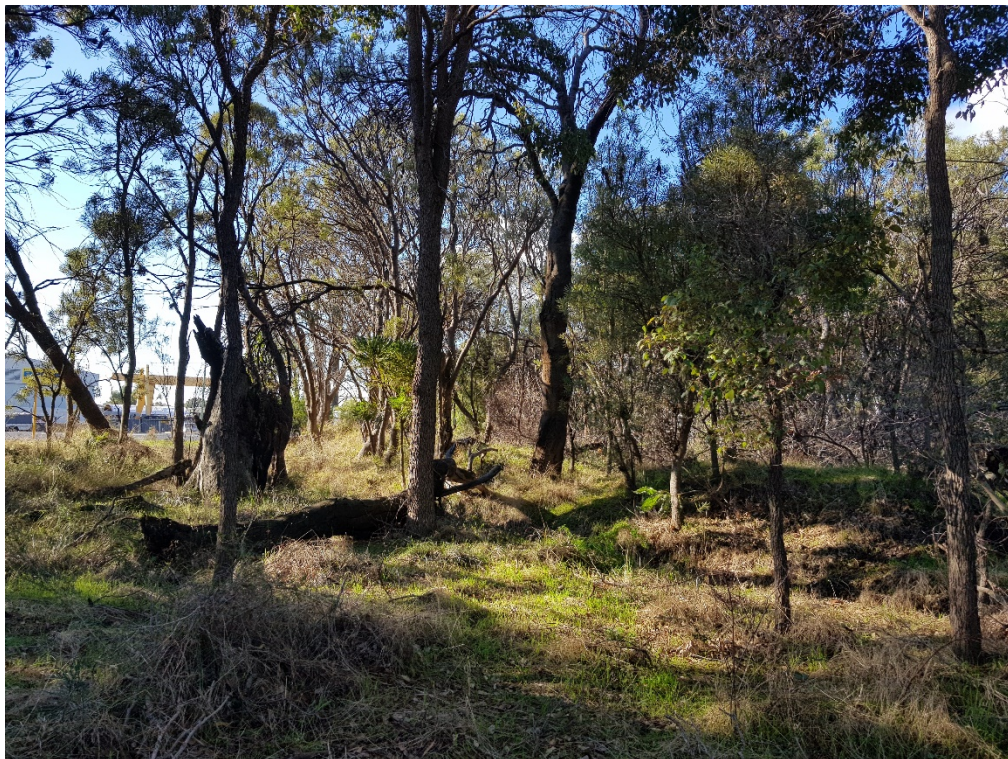
Figure 6. 120 m west of Halifax Drive [Condition: Degraded].
