# **Tree Survey**

## **Proposed Clearing Area**

### **Mountford Road**

### **Shire of Dardanup**

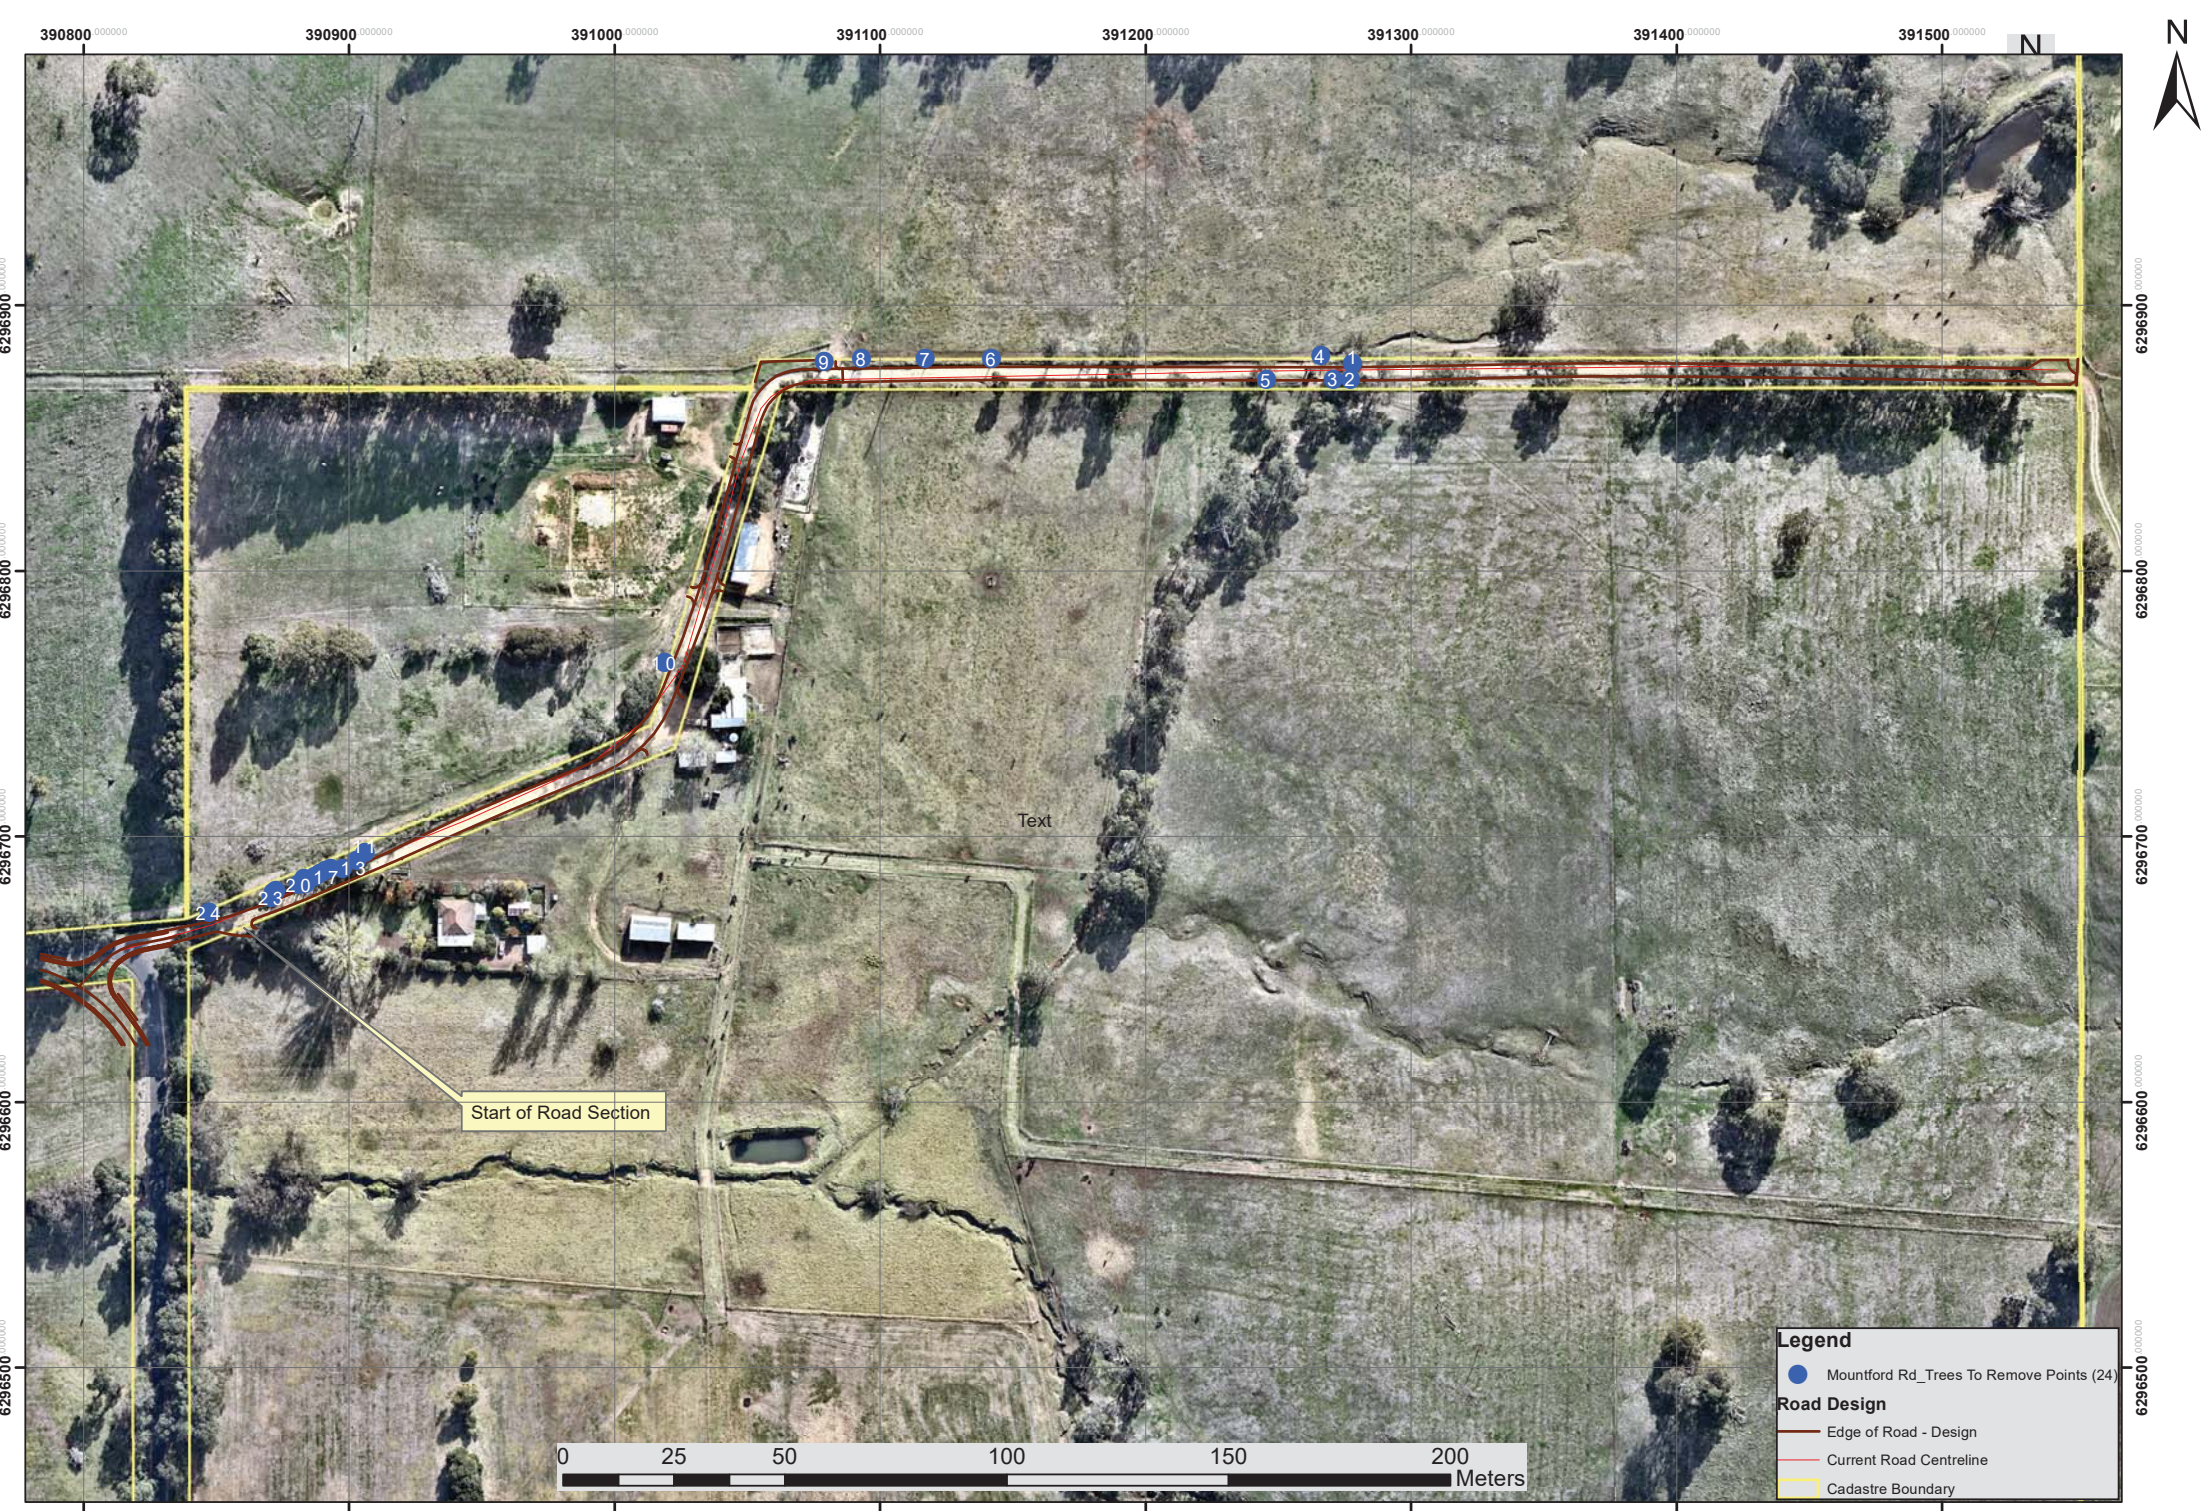
Mountford Road Tree Clearing Areas Overview Map - Dardanup Shire

The works footprint contains 24 trees of various species and sizes, details of which can be found in Appendix A. The location of each tree is shown in Figure 1.

None of the trees present were found to contain hollows that would be suitable or potentially suitable for black cockatoos. The vegetation was also found to be completely degraded with groundcover dominated by sparse grassland of introduced weed species.
