16 December 2019

Plantecology Consulting was commissioned by B & J Catalano to undertake a reconnaissance vegetation survey at the Donnington Quarry, 4884 Gt Northern Highway, Chittering, which is bounded by Great Northern Highway, Maddern Rd and Blue Plains Rd (the site), in the Shire of Chittering (Figure 1). The site consisted of six separate areas for assessment, of which, Areas 3 – 6 (covering approximately 63 ha) are the subject of this report (Figure 2). Areas 1 and 2 required a detailed survey and will be discussed in a separate report. The purpose of the survey was to inform the proposed expansion of an active quarry and this letter outlines the results of that survey.

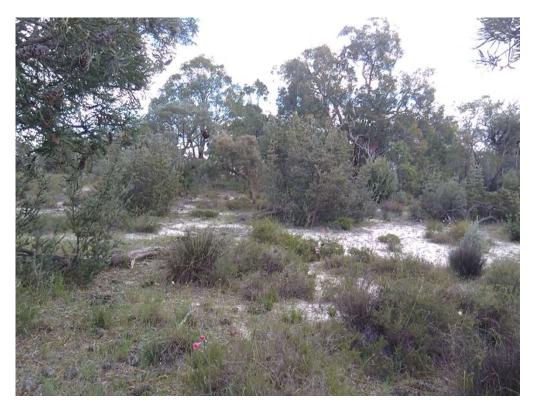
Area 3 contains the only Banksia woodland within the site at Plot 3-1 (Plate 1). The vegetation in this remnant is a very open *Eucalyptus marginata – Corymbia calophylla* woodland with *Banksia attenuata* and *Banksia menziesii* as sub-dominants on grey sands. *Eremaea pauciflora* and *Adenanthos cygnorum* are the most common shrub species in the midstorey. The vegetation structure has been altered from past disturbance/s and some introduced species such as *Gladiolus caryophyllaceus are common in the understorey. The vegetation condition of this patch is rated as 'Good' to 'Very Good' and is approximately 2.2 ha in size. Given the condition and patch size, the vegetation at Plot 3-1 can be considered as part of the Commonwealth-listed "Banksia Woodlands of the Swan Coastal Plain Ecological Community" Threatened Ecological Community (TEC).

The vegetation at Plot 3-1 is consistent with being part of the Commonwealth-listed TEC 'Banksia-dominated woodlands of the Swan Coastal Plain IBRA region'. The upper stratum contains *Banksia attenuata* and *Banksia menziesii* along with *Corymbia calophylla* and *Eucalyptus marginata*. The shrub layer is dominated by *Adenanthos cygnorum* and appears to have been disturbed previously and is regenerating. There are still many native species present in the ground layer and although there are exotic species such as **Ehrharta calycina* present, they are not dominant. The vegetation condition, therefore, has been rated as 'Very Good', and as the remnant patch is in excess of 1 ha (approximately 2.55 ha), it may be considered part of the Banksia woodland TEC.

Plate 1: Site 3-1. View of Banksia woodland

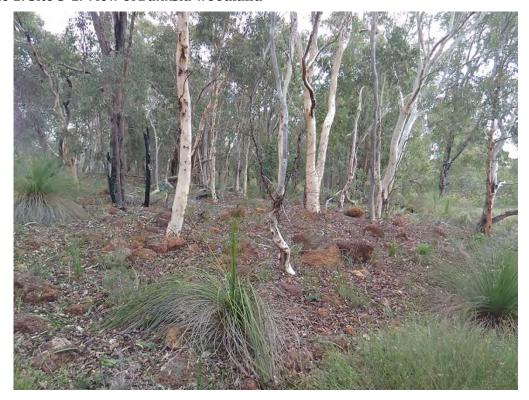
The vegetation remnant at Plot 3-2 is an open woodland of *Eucalyptus accedens – Corymbia calophylla* over *Xanthorrhoea preissii* (Plate 2) on a small lateritic breakaway. The vegetation is in 'Excellent' condition with a largely intact structure and the presence of minor weed species.

Plate 2: Site 3-2. View of Eucalyptus accedens - Corymbia calophylla woodland

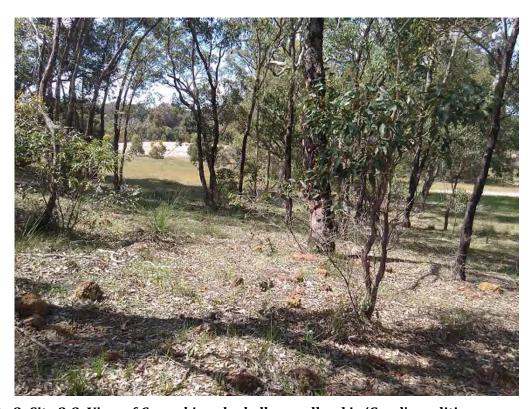
The vegetation at Plots 3-3, 3-4 and 3-5 are open woodlands of *Corymbia calophylla* with *Eucalyptus wandoo, Eucalyptus marginata* and *Eucalyptus accedens* variously as co-dominants (Plates 3-5). These patches may have been cleared previously as their original structure has been significantly altered. The understorey is sparse with aggressive weeds such as **Ehrharta calycina, *Briza maxima* and **Gladiolus caryophyllaceus* present. The condition is rated as either 'Good' or 'Degraded'.

Plate 3: Site 3-3. View of Corymbia calophylla woodland in 'Good' condition.

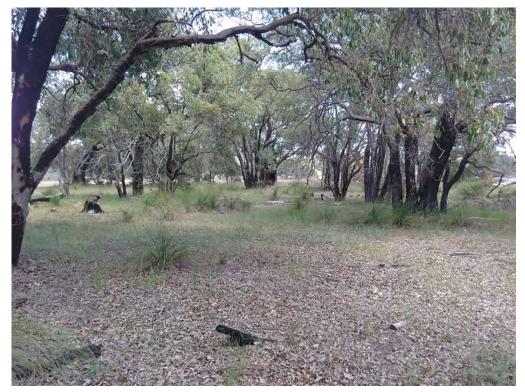
Plate 4: Site 3-4. View of Corymbia calophylla woodland in 'Degraded' condition.

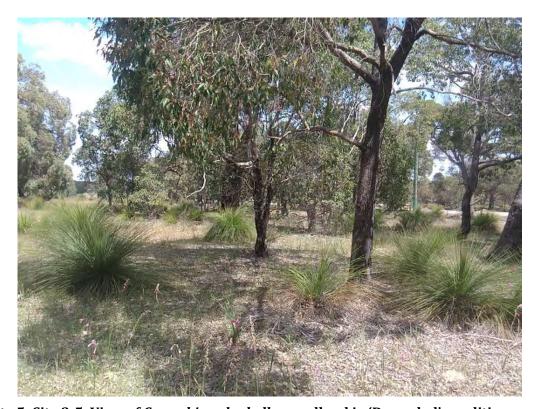
Plate 5: Site 3-5. View of Corymbia calophylla woodland in 'Degraded' condition.

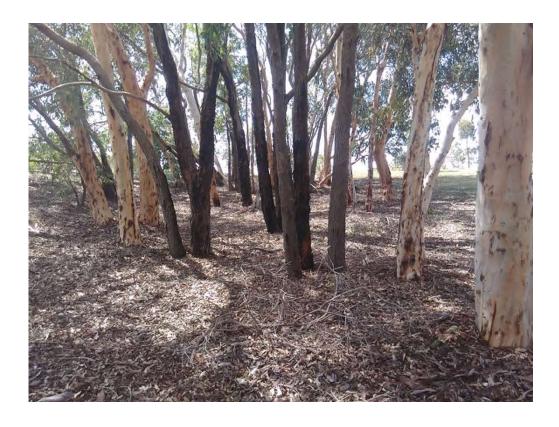
Both remnant patches within Area 4 have been highly disturbed and are rated as 'Degraded to Completely Degraded' (Plates 6 and 7). The vegetation is an open *Corymbia calophylla* woodland

Plate 6: Site 4-1. View of *Eucalyptus accedens - Corymbia calophylla* woodland in 'Completely Degraded' condition.

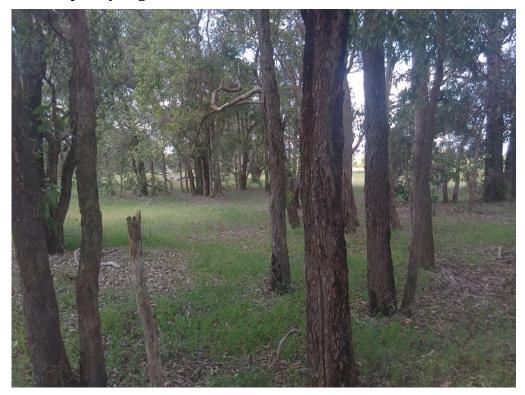
Plate 7: Site 4-2. View of *Corymbia calophylla* woodland in 'Completely Degraded' condition.

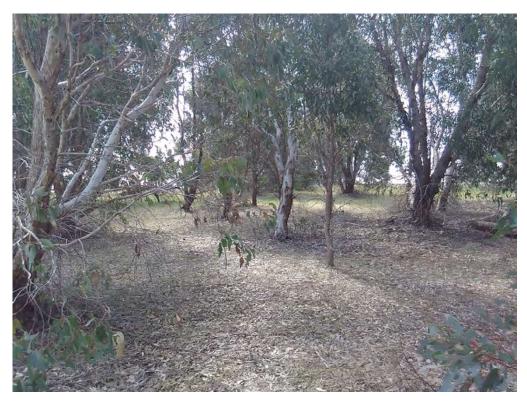
The remnant patches in Area 5 are 'Completely Degraded', with little to no native understorey (Plates 8-10). The vegetation consists of regenerating *Eucalyptus wandoo* over pasture grasses and other introduced taxa such as *Ehrharta longiflora, *Romulea rosea and *Arctotheca calendula.

Plate 8: Site 5-1. View of *Eucalyptus wandoo* woodland in 'Completely Degraded' condition.

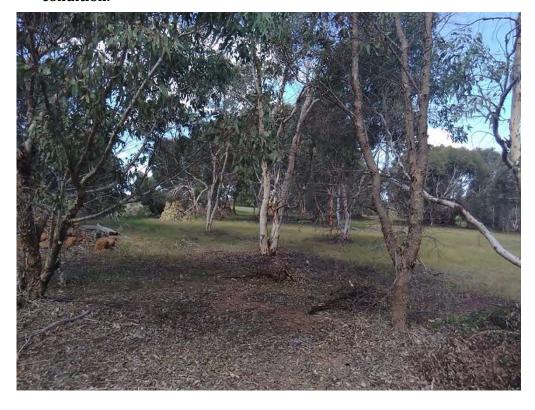
Plate 9: Site 5-2. View of *Eucalyptus wandoo* woodland in 'Completely Degraded' condition.

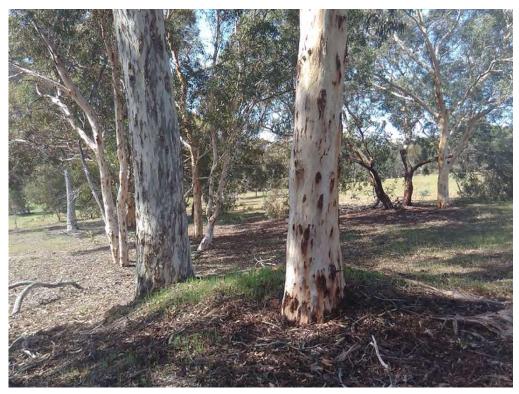
Plate 10: Site 5-3. View of *Eucalyptus wandoo* woodland in 'Completely Degraded' condition.

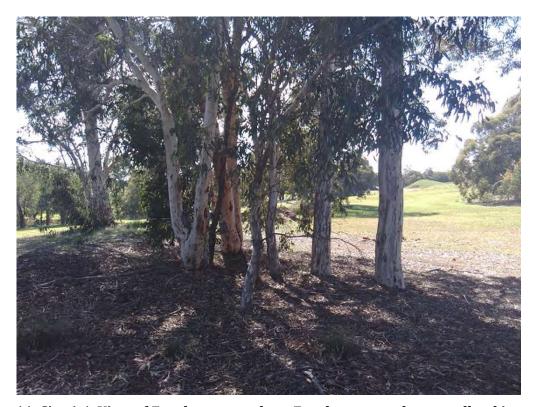
Plate 11: Site 6-1. View of *Eucalyptus wandoo – Eucalyptus accedens* woodland in 'Completely Degraded' condition.

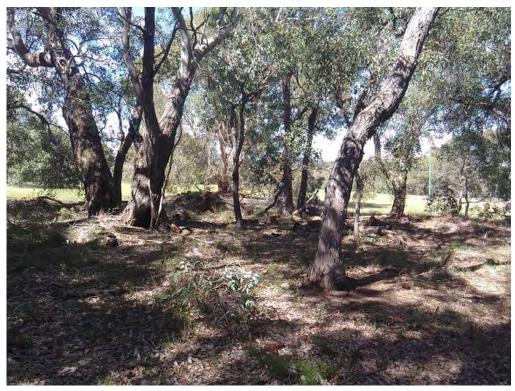
Plate 12: Site 6-2. View of *Eucalyptus marginata - Eucalyptus wandoo* woodland in 'Very Good' condition.

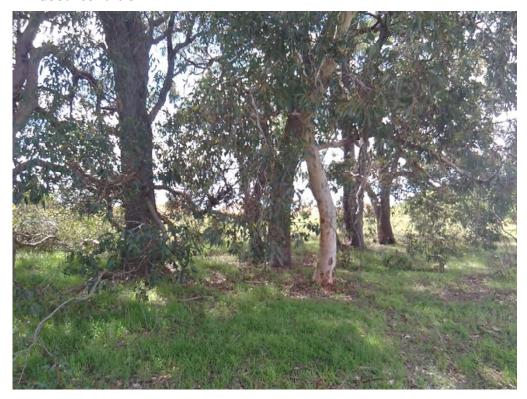
Plate 13: Site 6-3. View of *Eucalyptus marginata* – *Corymbia calophylla* woodland in 'Completely Degraded' condition.

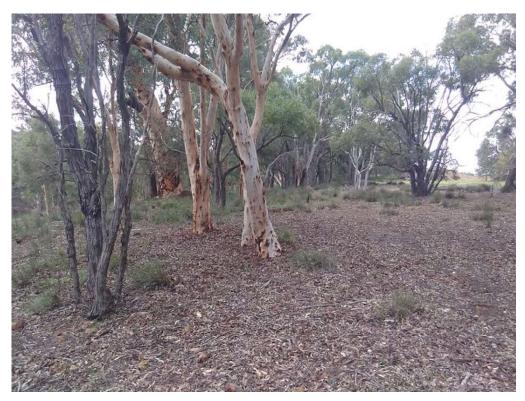
Plate 14: Site 6-4. View of *Eucalyptus wandoo – Eucalyptus accedens* woodland in 'Very Good' condition.

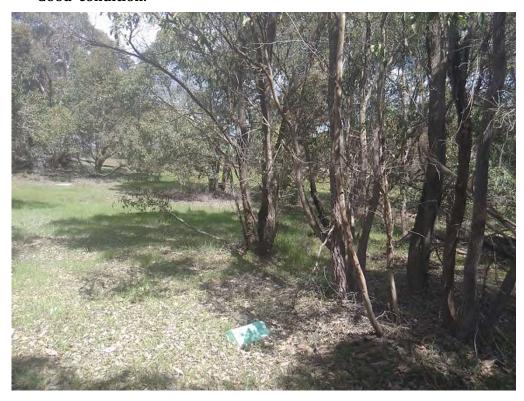
Plate 15: Site 6-5. View of *Corymbia calophylla – Eucalyptus wandoo* woodland in 'Completely Degraded' condition.

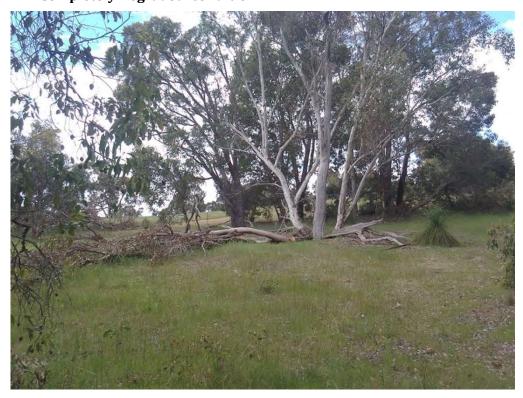
Plate 16: Site 6-6. View of *Corymbia calophylla – Eucalyptus wandoo* woodland in 'Completely Degraded' condition.

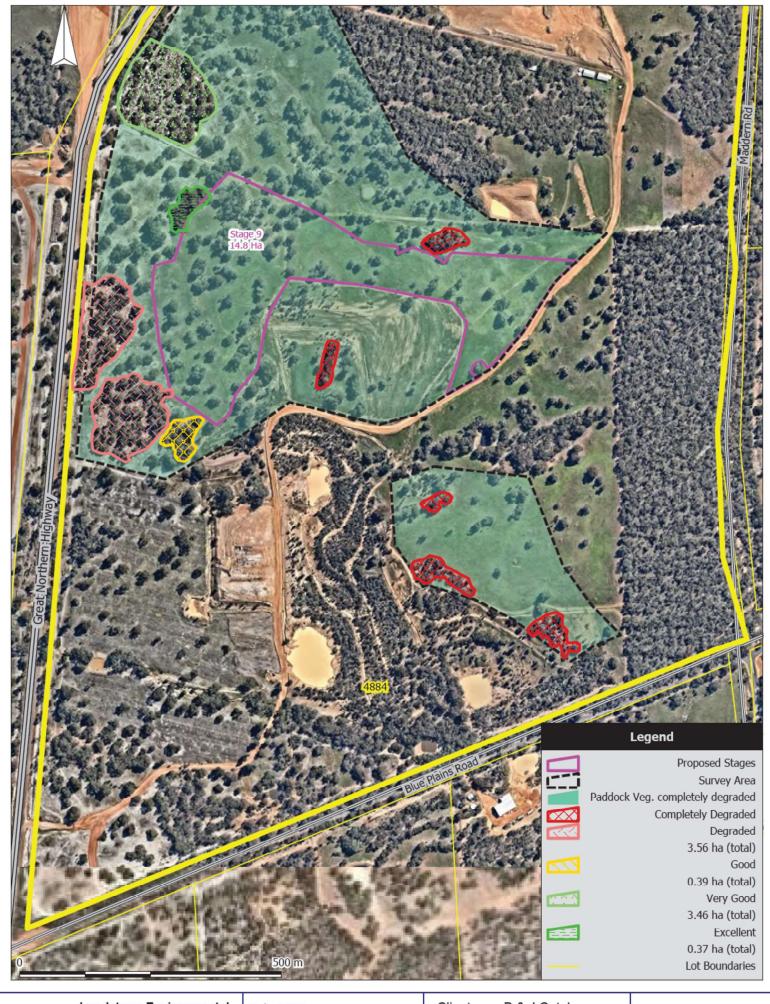
Figure 3a:

The site has previously been largely cleared for pasture with some remnants of native vegetation. The remnants are mostly smaller than one hectare and range in condition from 'Completely Degraded' where only the native tree stratum remains to 'Excellent' where the original vegetation structure remains intact and few weeds have established (Figure 3).
