MEMORANDUM

Attention:	H.O. Yelverton	From:	Kirsi Kauhanen
Company:	Cowara Contractors Pty Ltd	Date:	23 June 2020
Subject:	Environmental Site Inspections	Project:	Lot 230 Elgin Road, Elgin

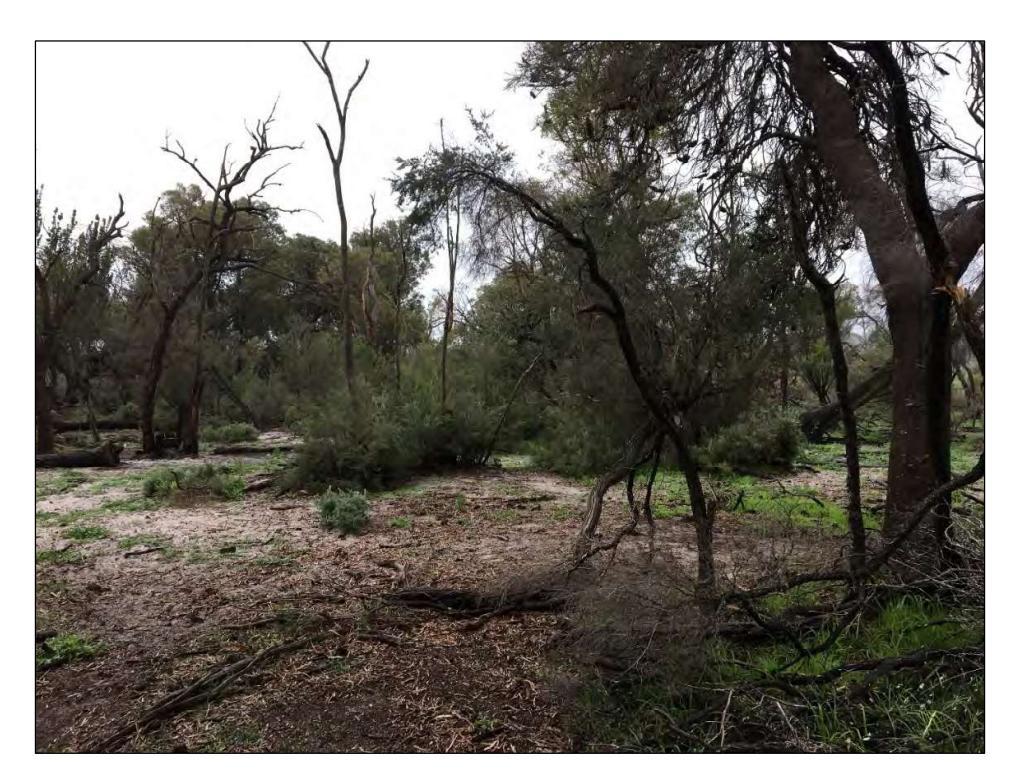
Plate 1: Photo Point #1 - View East

The majority of the vegetation within the project envelope comprised open woodland of *Eucalyptus marginata*, *Banksia attenuata*, *Banksia ilicifolia*, *Xylomelum occidentale* and *Nuytsia floribunda* over patches of *Kunzea glabrescens* over bare ground and weeds (Figure 2, Plate 1, Plate 2). In the lower lying areas in the southern part, there were isolated *Corymbia calophylla* and *Agonis flexuosa* over pasture (Plate 3). The proposed drain crossing area contained regrowth *Kunzea* spp., *Acacia saligna*, *Melaleuca* spp. and *Astartea* sp. over weeds (Plate 4). Vegetation in the road reserve was outside the scope of the inspection. There was a small area of *Melaleuca preissiana* with emergent *Corymbia calophylla* over *Kunzea glabrescens* immediately to the north-northeast of the project envelope, outside the currently proposed project area.

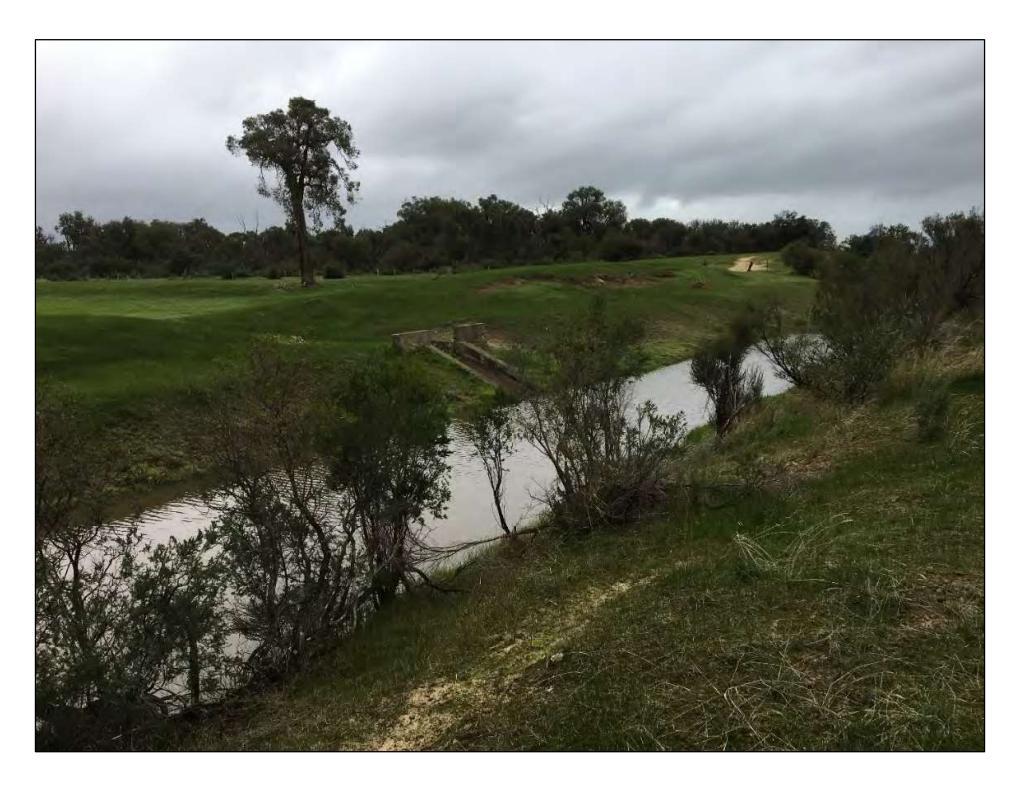
Additionally, the proposed drain crossing included regrowth *Kunzea* spp., *Acacia saligna*, *Melaleuca* spp. and *Astartea* sp. over weeds.

Plate 4: Photo Point #4 - View Northwest into Proposed Drain Crossing
